Lecture PA5

Explosion of Smokeless Powder Ingredients

T Torikai
Oita Propellant Plant, Oita, Japan

1. BRIEF DESCRIPTION OF THE ACCIDENT

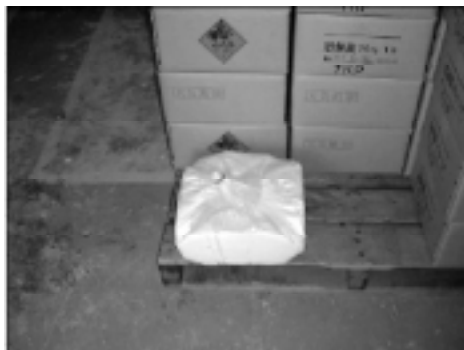
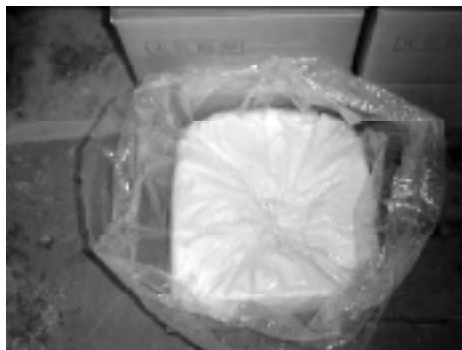
Nitrocellulose containing about 25% of ethanol. Pressed in a flat column shape of about 460 mm \varnothing in diameter and about 170 mm in thickness after going through the water removal process. (Approx. 25 kg/piece)

A mixture of 18 kg of nitroglycerine, 2.86 kg of wet (moisture: 30%) nitrocellulose and 0.36 kg of ethanol. Gelatinoid muddy white substance. (Approx. 21 kg/piece. Packed in a polyethylene bag.)

(See Photos 1 and 2.)

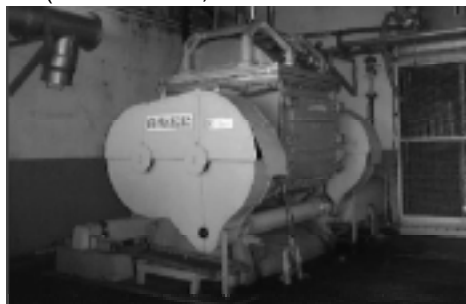
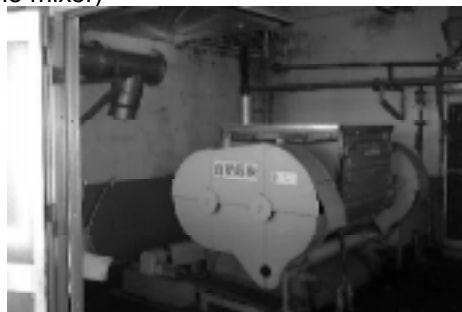
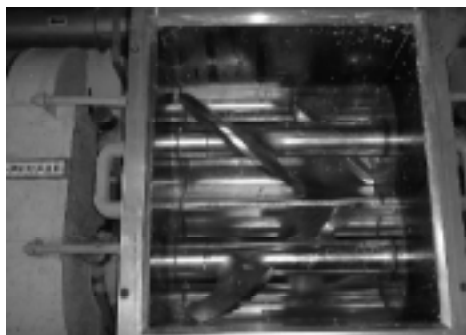
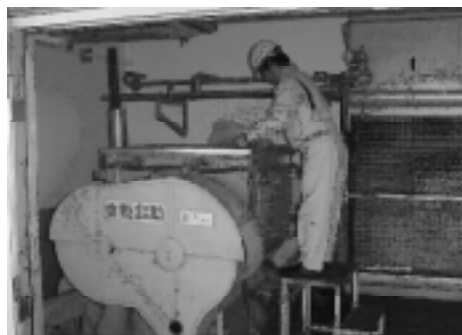
3. The worker A checked the humidity of the mixing room No.6 with a psychrometer and found that it was 63% RH being more than the plant standard 55% RH. He fed the all of the Dehydrated Nitrocellulose into the mixer without blowing fresh steam for humidifying into the mixing room, put a lid on it and operated the mixer to start crushing the Dehydrated Nitrocellulose. (Time of operation = about 10 minutes. The temperature of the water jacket was controlled at 42.5°C)

(See Photo-3, 4 and 5 of the same type of the mixer)

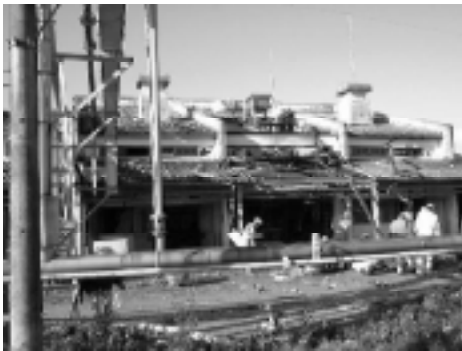
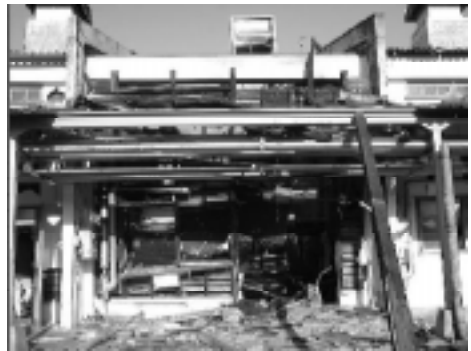
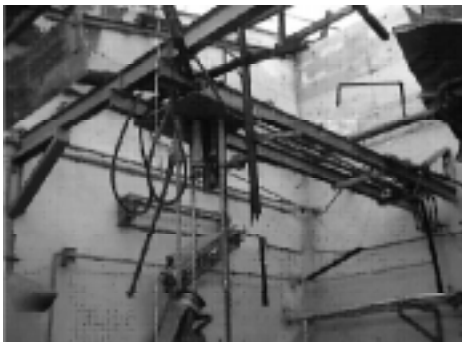
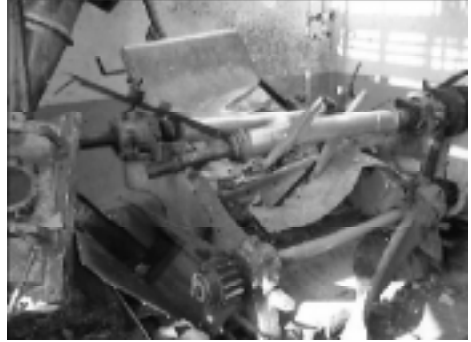
(2) Mixing room No.6: Completely destroyed (See Fig.1, Photos 7–10)

The flame of ethanol ignited Nitrocellulose and Gelatinized Nitroglycerine in the mixer. Burning of the Gelatinized Nitroglycerine was transferred to deflagration several minutes later. (the first 'bang')

Another lump of Gelatinized Nitroglycerine on the cart in the mixing room also started to burn and finally deflagrated. (the second 'bang')

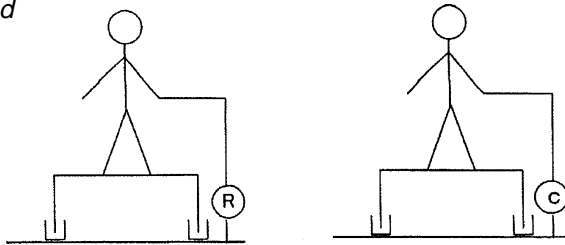
Fig. 1 Test method

- 1) In case the platform is conductive. Applied voltage = DC 250 V

Leakage resistance	Electrostatic capacity
Operator A	3.5 MΩ	153 pF
Operator B	1.5 MΩ	149 pF
Operator C	4.0 MΩ	127 pF

- 2) In case the platform is insulated. Applied voltage = DC 1000 V

Leakage resistance	Electrostatic capacity
Operator A	> 2000 MΩ	122 pF
Operator B	> 2000 MΩ	105 pF
Operator C	> 2000 MΩ	116 pF

1. Measurements of leakage resistance and electrostatic capacity of operator

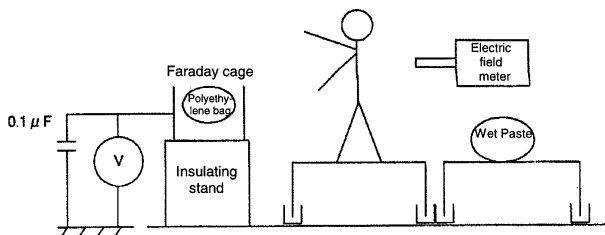
Test No.	Human body electrified potential	Polyethylene bag electrified charge
1	1.1 kV	0.23 Ω C
2	1.1 kV (1.5 kV instantly)	0.24 Ω C
3	1.0 kV	0.14 Ω C
4	0.8 kV	0.21 Ω C

1. Electrostatic induction from the polyethylene bag to human body was proved.

It was shown that human body is electrified at about 1 kV, by electrostatic induction from the polyethylene bag.

3. Measurements of electrified potential to human body and electrified charge of polyethylene bag
