## **Lecture PA7**

# **Incident Involving Carrick Fuseheads at Initiating Explosives Plant**

Rajesh Sharma  
Initiating Explosives Systems India Limited  
India

Fusehead ignition  
Gomia Works , India

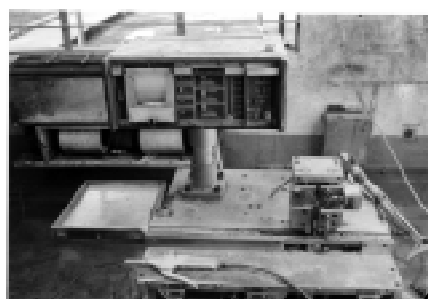
7

Scene after the fire/explosion
