# **AN SHIPMENT FIRE – THE EVENT AND KEY LESSONS**

**Luis Calvo – Managing Director. Modern Chemicals and Services MCS**

**Thiyaga Rajan – Safety Specialist. Modern Chemicals and Services MCS**

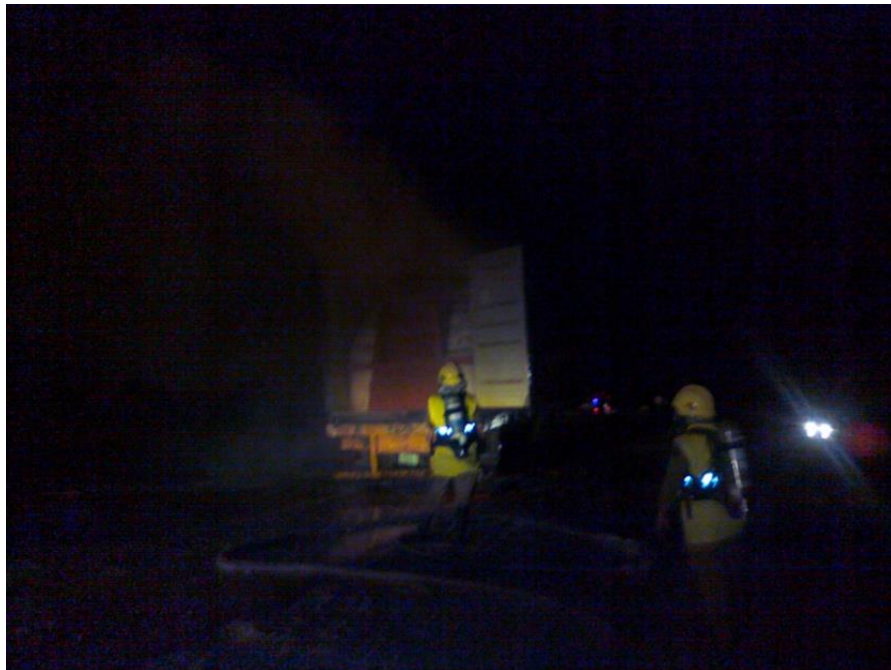
The heat transferred from tyres ignited the plywood under the container. The ammonium nitrate jumbo bags caught fire and a big amount of smoke and fire started to come out from the containers.

The container was opened to avoid confinement and allow extinguishing the fire.

*Figure 2: Image taken during fire fighting*

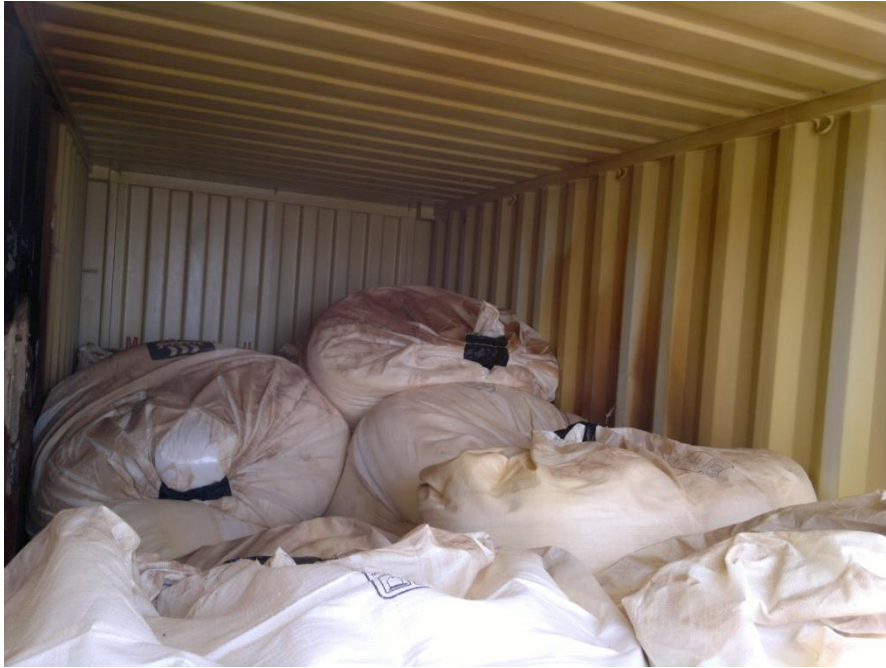
Fortunately there was no fatality or injury to persons. The 21 tons of ammonium nitrate that were affected in the fire were declared as waste. Whatever was left of the material after the fire fighting was destroyed.

*Figure 3: Condition of the ammonium nitrate big bags after fire has been extinguished*

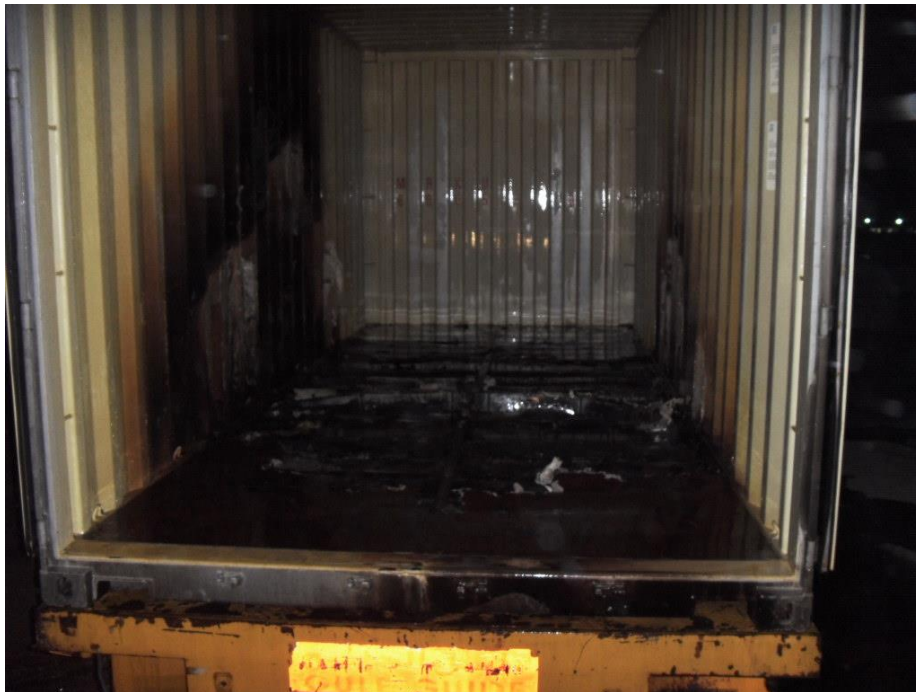
*Figure 4a: Condition of the container after removal of ammonium nitrate load*

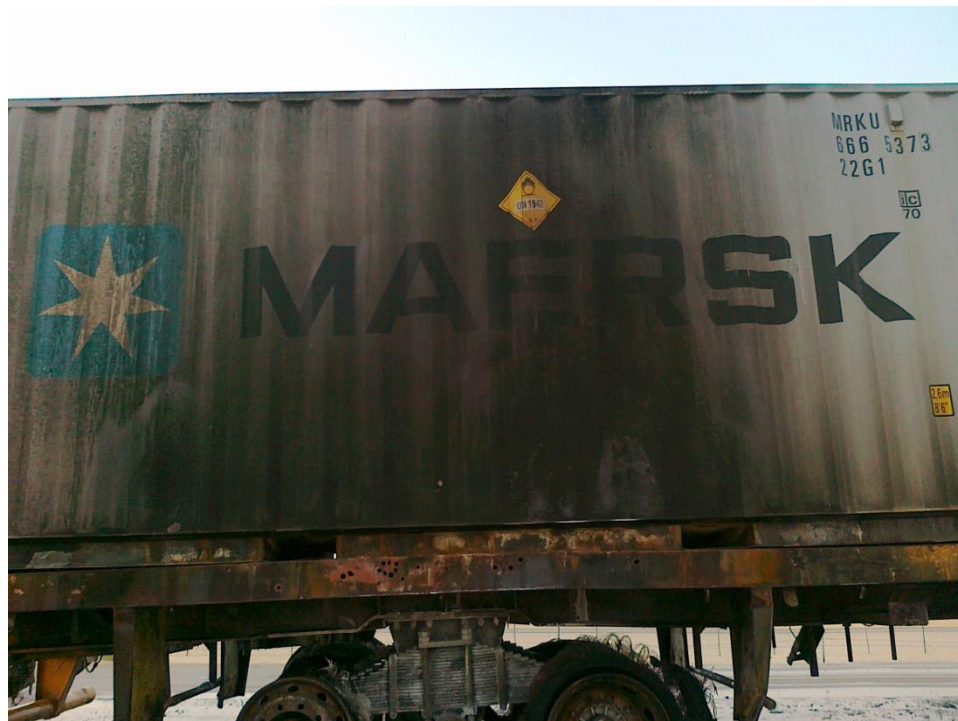
*Figure 4b: Condition of the container after fire extinguishing*

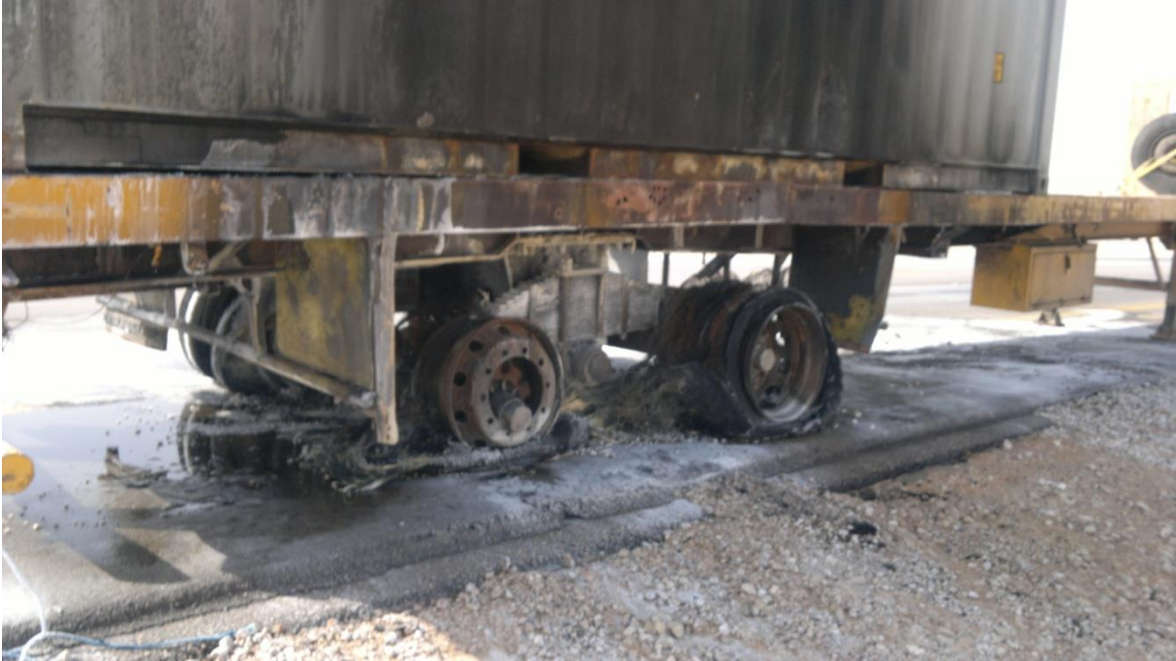
The fire started in the back right axle of the trailer, when one of the tyres caught fire probably due to friction in the rim. After the accident, it was found that there were only 7 wheels in the 2 rear axles, when it was supposed to be 8 (see figure 5 A and B). It is believed that the disk of the rim got damaged, and the sparks of the disk ignited the tyre.

The fire of the tyre subsequently transferred to the plywood under the container, and from there to the load.

*Figure 5a: Condition of the rear right axle after the fire*

The reasons that led to the tyre to fail in the way described above have to be found in the maintenance of the vehicle. The mentioned missing wheel in the axle where the tyre burst was a weak point present in the truck due to defective maintenance and to lack of control of the conditions of the truck.

- Establish a procedure of homologation of transport companies that comprised the safety perspective, including the selection of specific trucks and drivers within those companies.
- Establish a certification system for MCS employees in key positions related to transport, use of industrial vehicles and use of explosives
- Specify in the subcontract agreement the minimum safety and maintenance conditions of the trucks
- Inspection of all vehicles (own and subcontracted) before and after the deliveries. Use of verification checklists
- Review emergency procedures
- Perform mock trials in coordination with Civil Defense and Security Forces
- Clarify key actions for key events. Train personnel in these situations (decision to open container; and fight or flight)
- Review the communication process

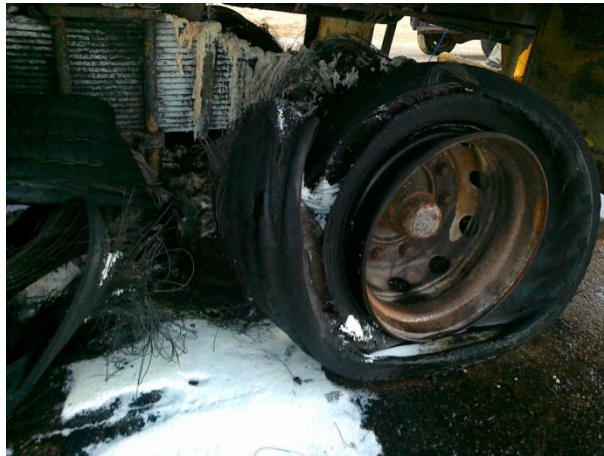
*Figure 5b: Detail of the rear right axle*
