Contractor management and employee awareness in transportation of explosives and hazardous raw materials demonstrated on two incidents (booster, MMA (monomethylamine))

Author: Dr. Martin Held¹

INCIDENT 1

INCIDENT 2

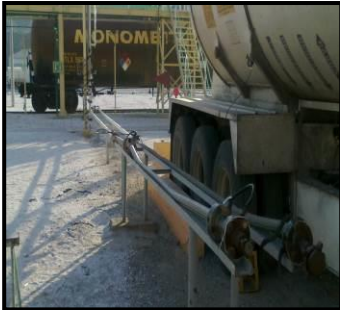
Picture 1: MMA unloading area with tanks and unconnected discharge hoses

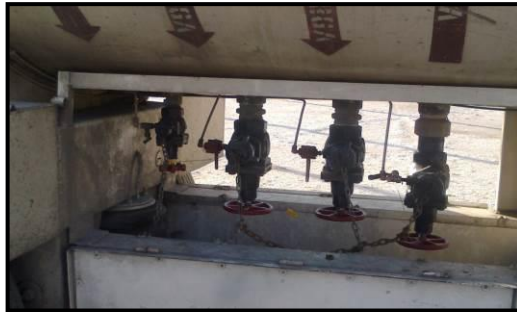
Picture 2: Tank trailer discharge valves (one for each chamber)

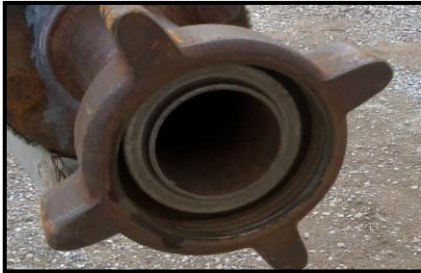
Furthermore, the operator in charge of the initial unloading failed to tighten the connection from the discharge hose to the tank trailer valve correctly. There was a quarter turn missing for complete closing which caused the MMA inside the discharge hose to leak slowly to the atmosphere. On detecting the leaking MMA prior to restarting the unloading, the operator loosened the connection even more as he manually checked the connection.

Picture 3: Hose coupling

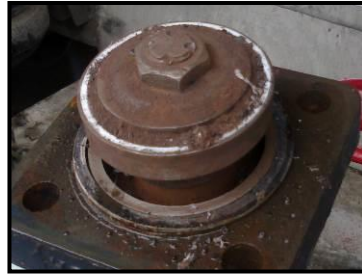
The tank trailer (owned by the forwarding agency and used for transport of MMA only) had been on repair prior to be refilled with MMA for delivery. Due to ageing of the welding joint between an internal stabilizer bar and the inner wall of the tank, the joint had to be re-welded. This was done by the tank owner. Even though the tank had been prepared and cleaned properly prior to welding, it appears that cleaning of the welding area had not been done properly after completion of the job. Small particles of slag remained inside the tank

close to the discharge valve outlet. These particles entered the Teflon gasket of the valve where they accumulated (Picture 4). As a consequence the gasket sprung a leak.

Picture 4: Dismantled gasket showing slag particles that contaminated the Teflon sealing

The transport company hauling MMA is experienced in handling and transportation of dangerous goods such as natural gas, propane and ammonia. The trailer tanks used here are exclusively for the transport of MMA. It was agreed – as an amendment to the contract - that future repairs on tank trailers will be announced and an independent inspection of the repair will be conducted prior to customer's authorization for re-use.

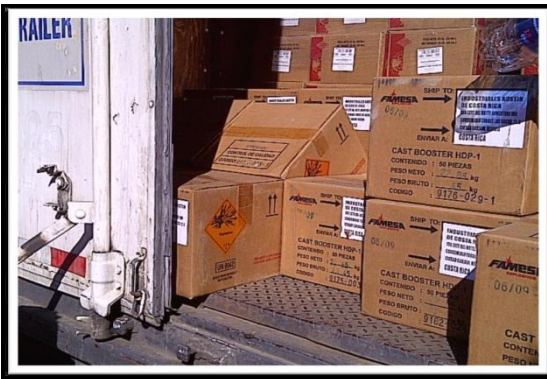
While loading the trailer with explosives, the boxes of 1 lb Boosters were placed in the last row behind pallets with 1.5 D product (packaged emulsion explosives) with no additional load securing for the stacked boxes with boosters. During road transportation, the upper rows of boxes started to shift and boxes slid towards the back door of the truck during transportation. There was enough space between the secured pallets and the back door for boxes to fall to the trailer bottom and become jammed between the full load and the back doors (Pictures 5 and 6).

Picture 5: Boxes fallen off from stack

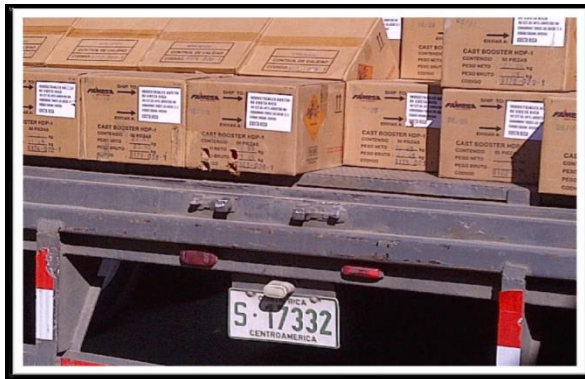
Picture 6: Punctured box (center)

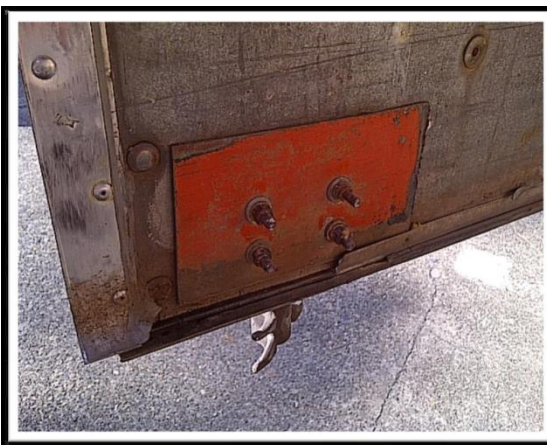
One wing of the trailer back doors had been previously repaired by the forwarding company and a steel plate at the bottom of the door wing had been fixed with four screws/bolts that protruded to the inside of the trailer (Picture 7). The protruding screws punctured one of the boxes and also damaged the booster shells (Picture 8). Ongoing friction could have caused an ignition of the then open pentolite mass.

Picture 7: Repaired door and protruding screws

The Costa Rican entity agreed with the forwarding agency to review maintenance procedures and report forms and conducted training in explosive BOS principles for transportation. Trailers used in transportation of explosives were inspected at the site of all contractors and audits were conducted. In cooperation with the transportation companies an agreed internal norm on trucks and trailers for transportation of explosives material was developed that refers to legal requirements but also goes beyond those. This norm can be used as a practical guidance in giving examples of good and poor practices.

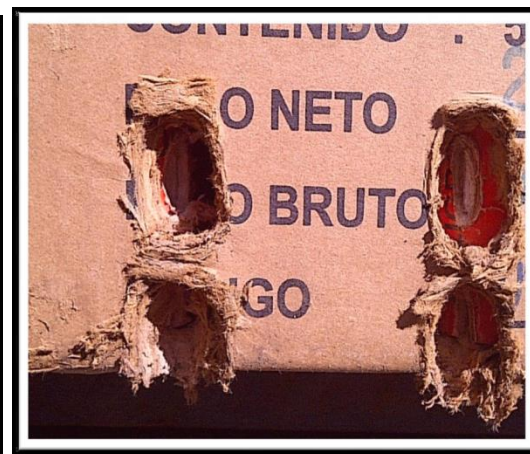
Picture 8: Detail of punctured box
