Incident of a MEMU Truck (Multiblend Truck) during a loading of ANFO : causes, analysis , evolution

Author : David JACQUET, technical manager EPC-Belgium

19th June 2012 at 9h30 am

EPC – Belgium, subsidiary of EPC Group – in a quarry in Belgium

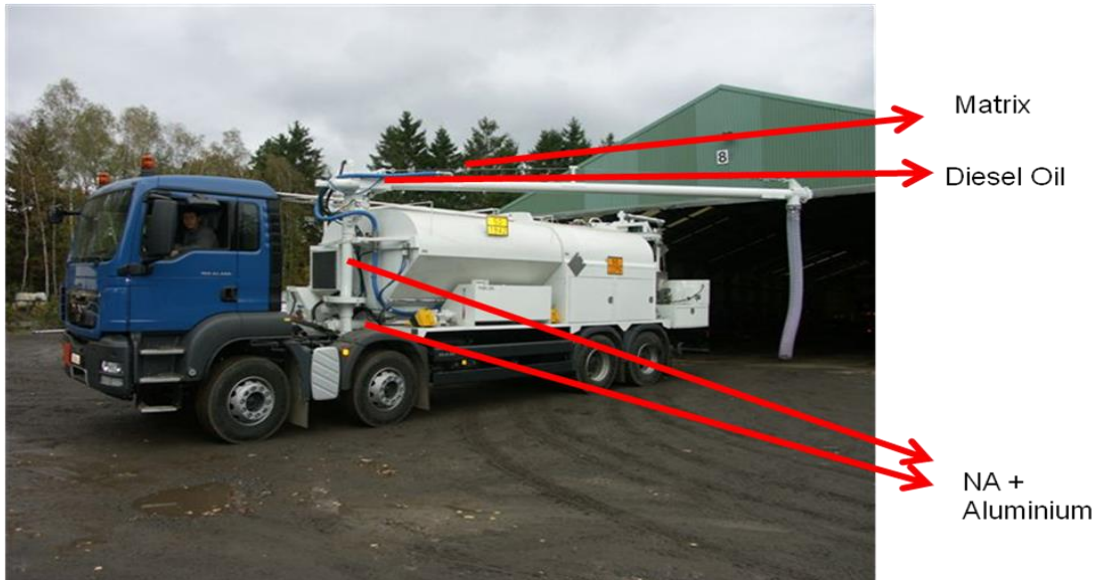
Picture 1 : EPC-Belgium –Multiblend truck (Tradestar unit)

In the MEMU Truck of EPC-Belgium (see Picture n°1), the raw materials are technical grade ammonium nitrate (porous prill), emulsion (Matrix), aluminium, and fuel-oil.

During a loading of heavy ANFO, the ammonium nitrate prills are mixed with the aluminium particles in the bottom of the horizontal auger. The product then moves through the vertical auger. In the top horizontal auger, the emulsion-matrix (which is pumped through the large blue pipe) and the fuel oil (injection by the small blue pipe) are mixed together with the ammonium nitrate and aluminium.

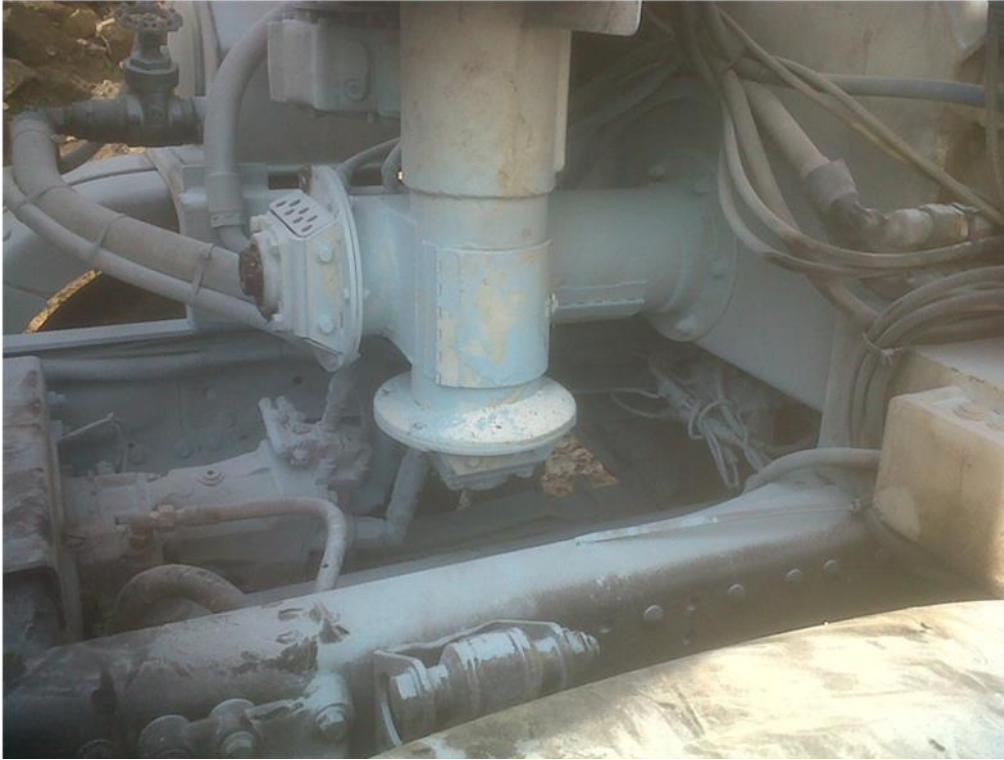
The picture n°2 shows the part of the vertical auger directly after the intervention with the extinguisher (powder blue on the picture)

Picture n°2 : vertical auger with the bearing after the use of the extinguisher

The principal cause of this incident was a lack of tightness of the seal in the vertical auger. This lack of tightness comes from the design of this auger, but also we have to note a lack of good housekeeping and preventive maintenance rules.

An accumulation of fine particles (aluminium, nitrate) in contact with grease in the confined chamber had been discovered in the bearing. This confinement has increased the friction and reduced heat dissipation. Heat source by friction was located inside the bearing (ball bearings) at the bottom of vertical auger.

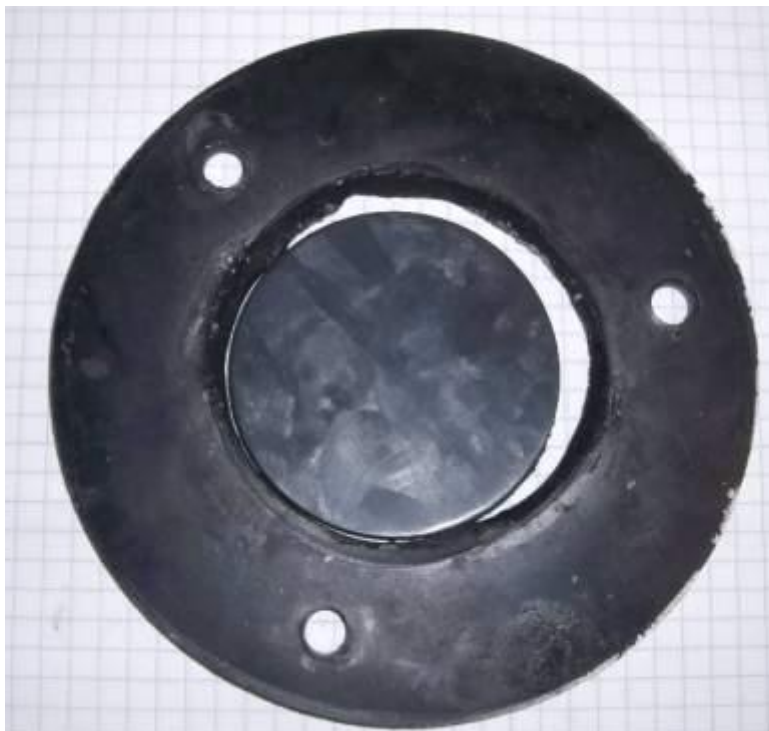
The gasket seal located below the flange and above the bearing on the bottom of the vertical auger must guarantee the tightness of the auger. After the disassembly of the auger, we noticed that the seal (picture n°3) was deformed which allows solids to fall down onto the bearing.

Picture n°3 : gasket seal deformed (inside circle with the diameter of the shaft)

Now, once a month, visual inspection of the gasket seal and the bearing is carried out. At 12 months, the gasket seal and the bearing are replaced.

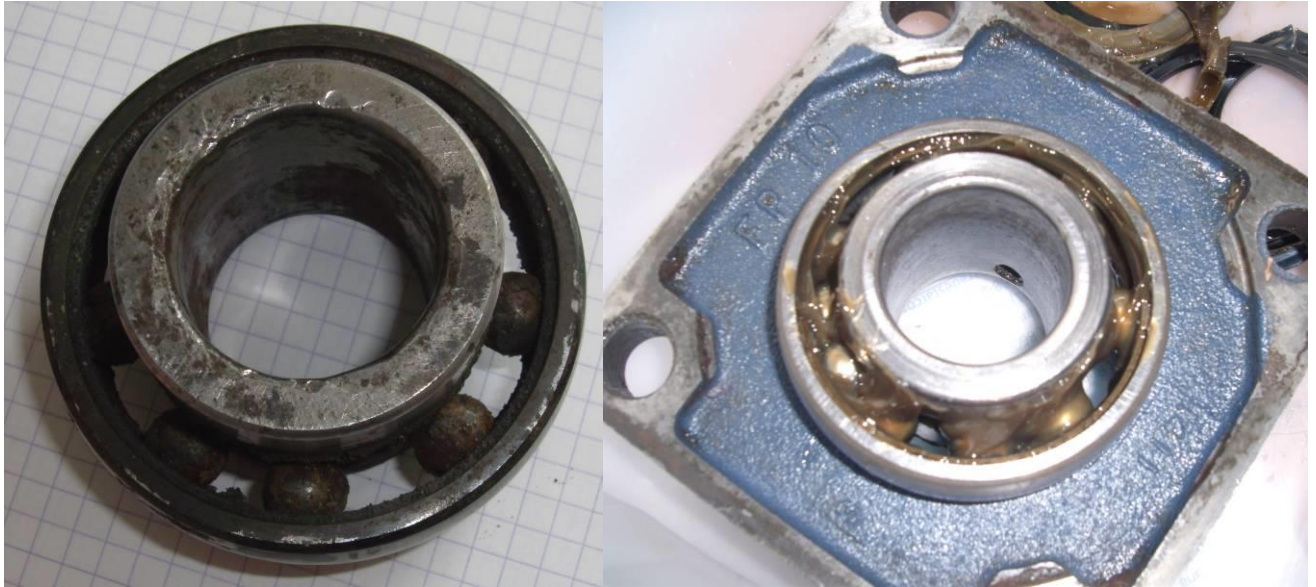
The dismantling of the bearing has yielded other important facts and findings. The remainder of the grease was found at the peripheral of the bearing but not with the balls inside the bearing. The picture n°4 shows the bearing after the incident together with a new bearing

Picture n°4: ball bearing after the incident and a new ball bearing

We also noticed that the balls were oxidized and without grease. Normally, this type of bearing is greased for life (sealed for life)

From the results of the tests from the EPC-France Lab, we have changed the type of bearing by using a bearing with structured steel (which cannot burn in case of overheating).

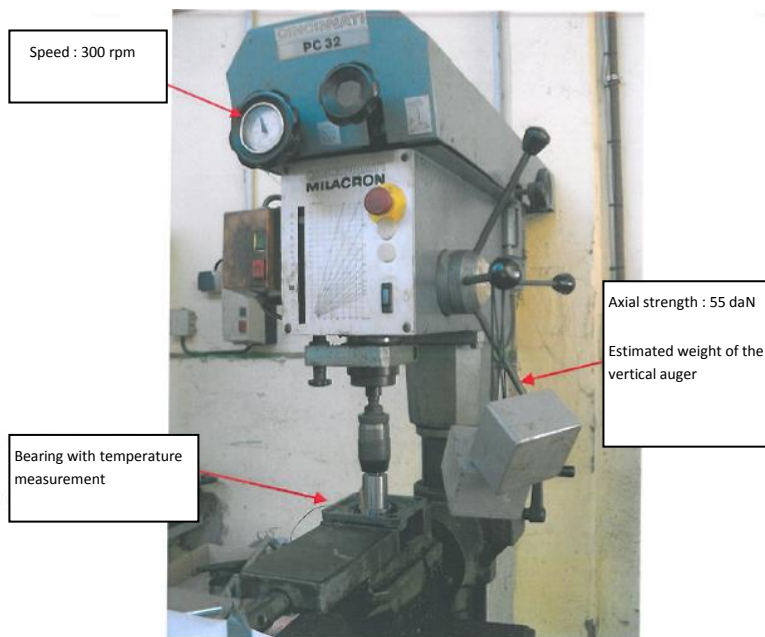
Picture n°5: reproducibility of the incident with the drill equipment – EPC-France

This equipment was able to reproduce the incident and characterize the mechanical performances of the bearing.

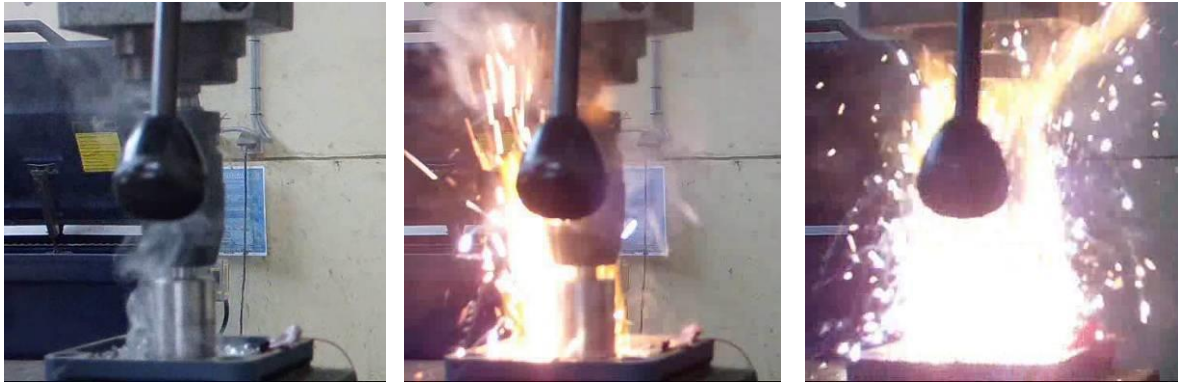
With a mixture of 50% ammonium nitrate and 50% aluminium, without grease, we noted, after 8 minutes of rotation, a violent fire with glowing particles. The temperature is about 150°C. The pictures n°6-7-8 came from the video of the experiment.

Pictures 6-7-8: reproduction of the fire in the lab – bearing SKF

The analysis from the tests to reproduce this incident within the Lab of EPC-France, show 2 essential factors: The presence of an energetic mixture of aluminium and ammonium nitrate on/in the bearing and the use of a bearing with a polyamide structure.

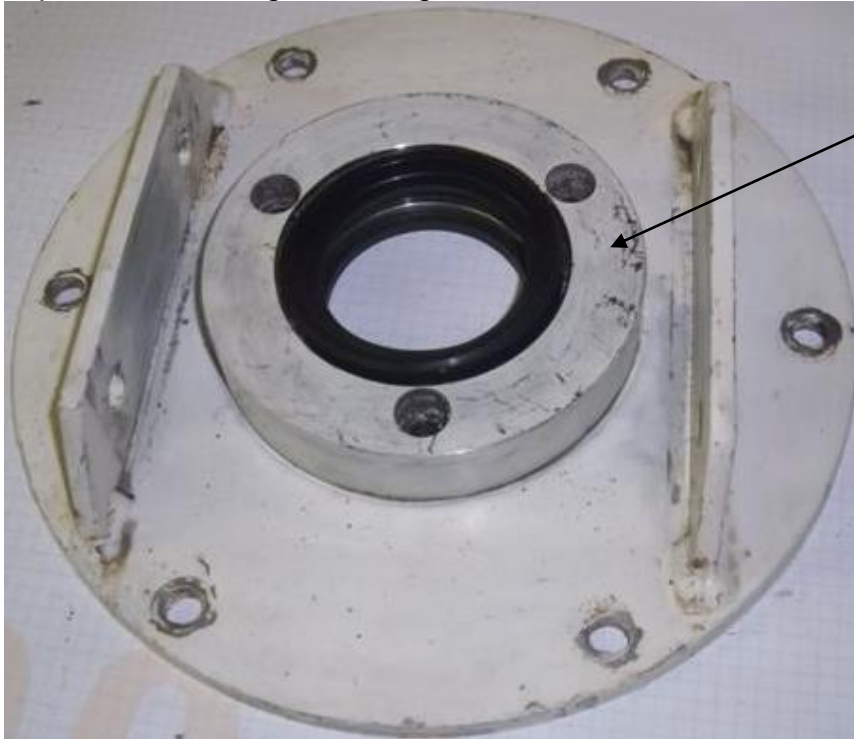
Picture 9 : Additional element to improve the sealing of the auger.

With this design (Picture 9), new lip seals and a V-ring are added on the shaft to improve the sealing of the auger.

New piece with lip seal and circlips

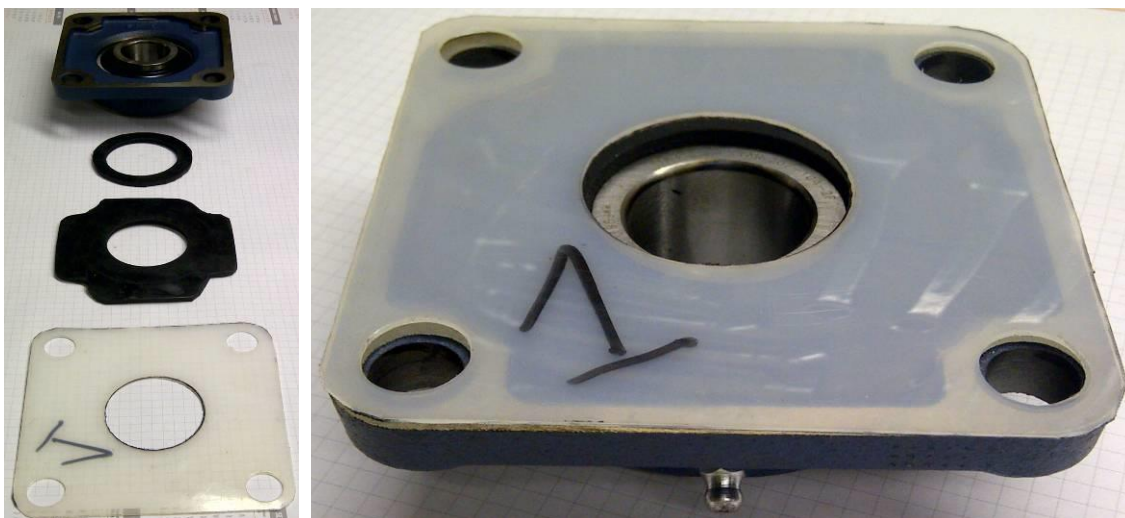
Picture 10 : layer of Ertacetal on the bearing – (additional protection)

Also to reduce the quantity of ammonium nitrate and aluminium in case of failure of the seal on the bearing, there is a layer of protection of Ertacetal on the bearing as shown in picture 10
