THE GENERAL PRINCIPLES OF INTERMEDIATE STORAGE DURING EXPLOSIVES MANUFACTURE DURING THE PROCESSING OF ENERGETIC MATERIALS

PRESENTED BY
MERVYN D TRAUT (MD TRAUT CONSULTING)

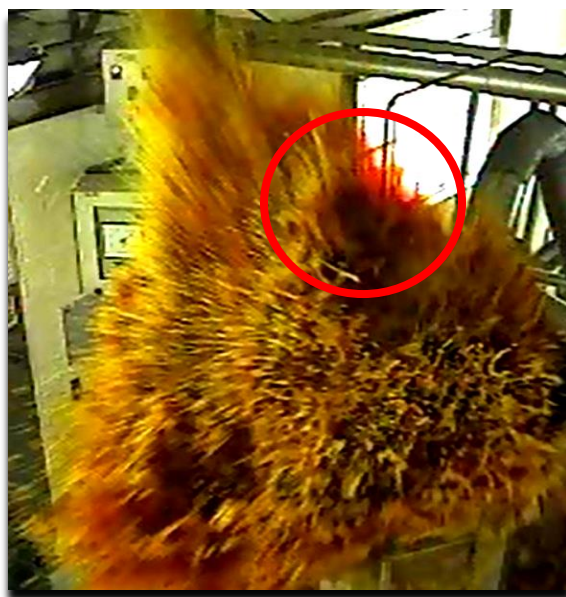
UNCONTROLLED DECOMPOSITION IN A PETN NITRATOR

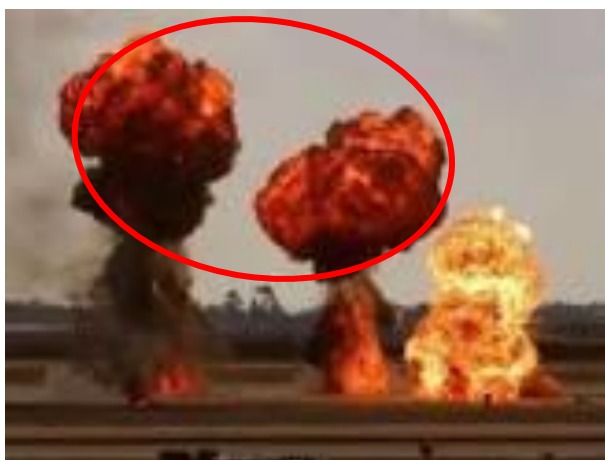
DETONATION WITH NO_x EVOLUTON

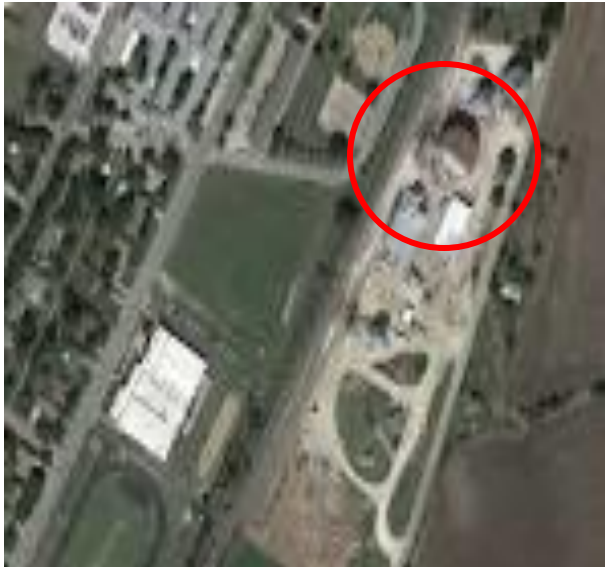
*An explosion occurred during the **PASSIVE STORAGE OF DERELICT AMMUNITION** awaiting disposal on an open site. The 20 mm ammunition concerned was known to be in an extremely bad condition and many of the shells were heavily rusted. The exact reason for the explosion was not found but the most likely explanation was that sensitive copper azide had been produced in one shell and that the high temperatures on the day of the incident caused movement of some part of the detonator which ignited the sensitive copper azide and fired the detonator.*

SITE BEFORE

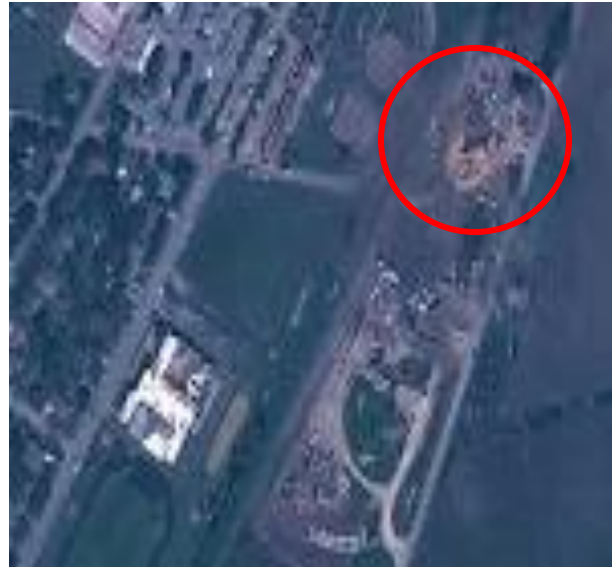
SITE AFTER

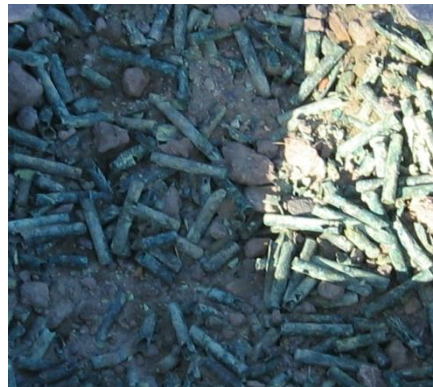
*An explosion wrecked a magazine at a quarry. Corroded **DETONATORS BEING STORED** there were later recovered from the remains of the demolished building.*

CORRODED DETONATORS

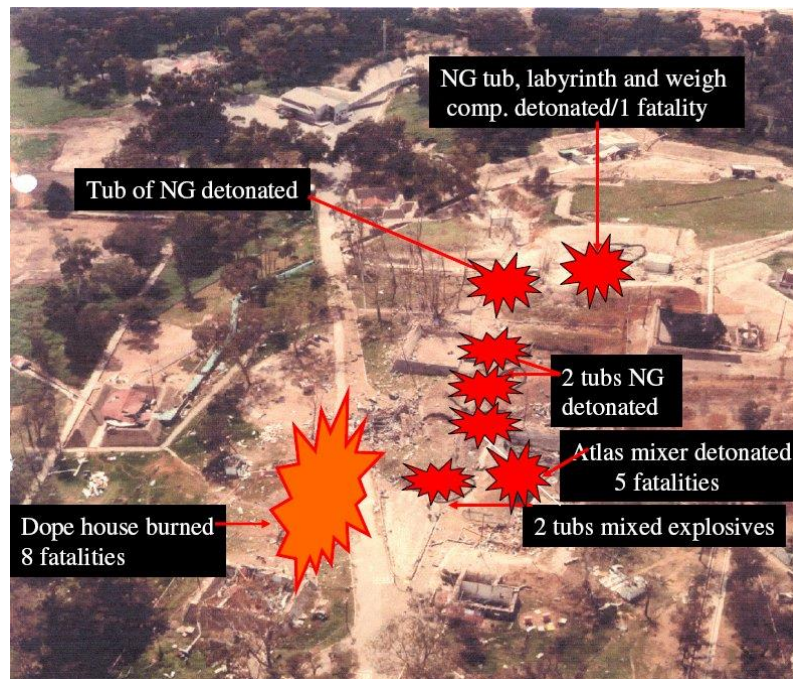
An initial explosion in a NG tub in one building, caused one fatality. But because **NG tubs were left between buildings** (presumably because it was convenient), each was triggered in an explosive chain **by sympathetic detonations** and ultimately by a fireball. The result was a further 13 fatalities, turning a tragedy into a disaster.

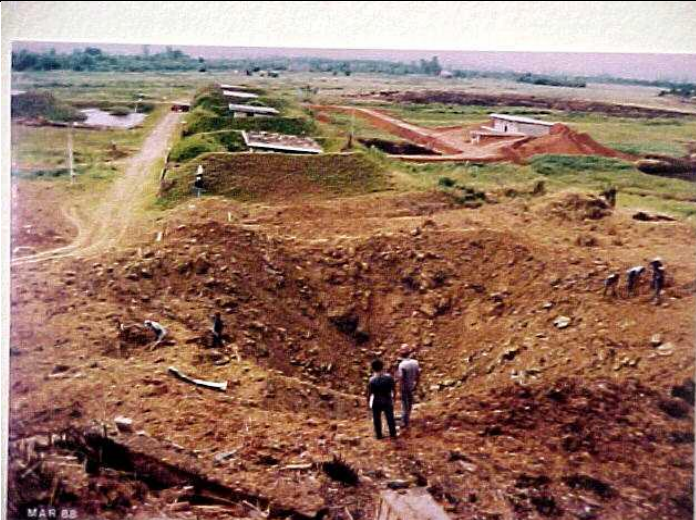
BUILDING	TIME	DAY	DATE	SEQUENCE OF EVENTS
MAGAZINE 307 (LORENA)	22h30	SUNDAY	8/11/1987	29te CAUGHT FIRE 24te BURNT REMAINING 5te DETONATED

MAGAZINE AFTER DETONATION

- Some materials stored in the magazine were acidic (both externally and occluded)
- In some cases the materials were highly acidic with added contaminants e.g. recovered “save-all” material
- The material had been stored for longer periods than specified either verbally or as per the operating instructions (OI’s)
- Specifications

- The method of storage was not specified in OI'S and only ad hoc tests were done on PETN prior to storage.
- In all three cases the findings were that the PETN had chemically decomposed in to the presence of "high" acidity. It was highly likely that this decomposition was autocatalytic leading to elevated temperatures, fire and finally detonation.
- In all three cases "crude" PETN was stored together with other products such as material recovered from the "save alls" (labyrinths).
- IN THE CASE OF LORENA SOME MATERIAL HAD BEEN STORED IN THE MAGAZINE FOR MORE THAN **A YEAR!**

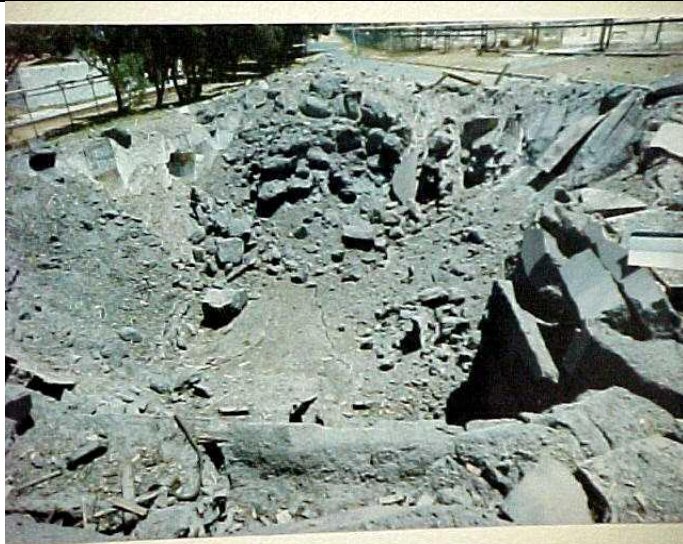
**500kg CAUGHT FIRE
300kg DETONATED**

**Y14 AFTER DETONATION
NOTE MAGAZINE BELOW GROUND**

At Y14 rotation of stocks was not recorded. The procedure was informal. Stock in the magazine was not recorded.

At Y1 the crude PETN had not been washed free of external HNO₃ (channelling)

The Na₂CO₃ solution was under-strength. The set of OI'S detailing the make-up of this solution were poorly written.

There had been a mechanical failure of plant at Y3 stabiliser, thus no material could be processed.

- OI's need to explicit detailed and updated regularly
- stock rotation was critical and had to controlled (colour coding was introduced to avoid exceeding specified storage times)
- operators had to be fully conversant with OI'S and needed to be retrained (and re-passed out) at regular intervals
- areas of responsibilities needed to be clearly defined
- and tasks in those operational areas needed to be clearly defined
- plant checks for important parameters are critical to the safety process.
- working under pressure creates situations where safety is often compromised.

A FINAL DECISION WAS TAKEN TO ELIMINATE THE STEP OF STORAGE OF NON-STABILISED PETN AT Y14 AND IN ADDITION, THE MITIGATING STEPS IN THE OTHER AREAS WERE IMPLEMENTED BEFORE FURTHER PRODUCTION TOOK PLACE.

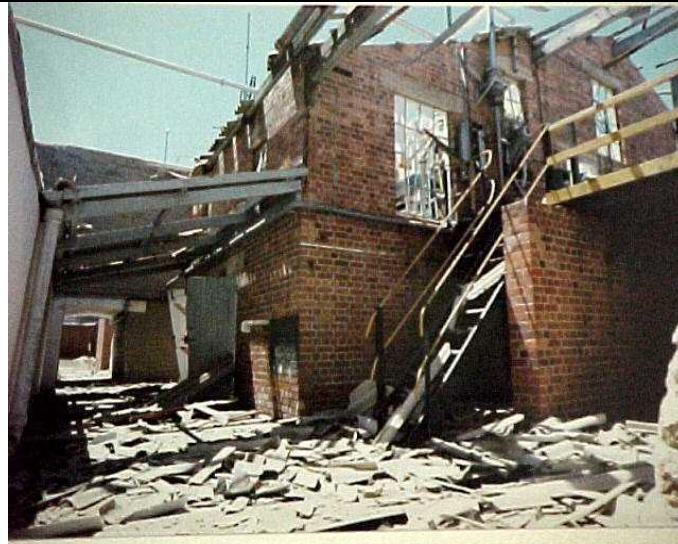
BUILDING NEXT DOOR 30M AWAY

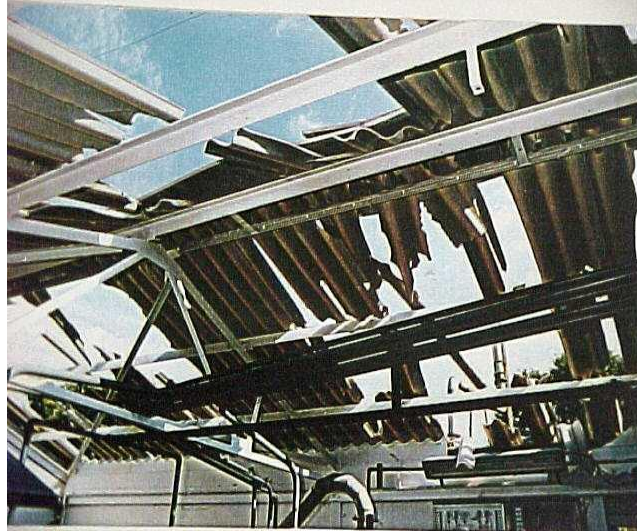
ROOF OF BUILDING 50M AWAY

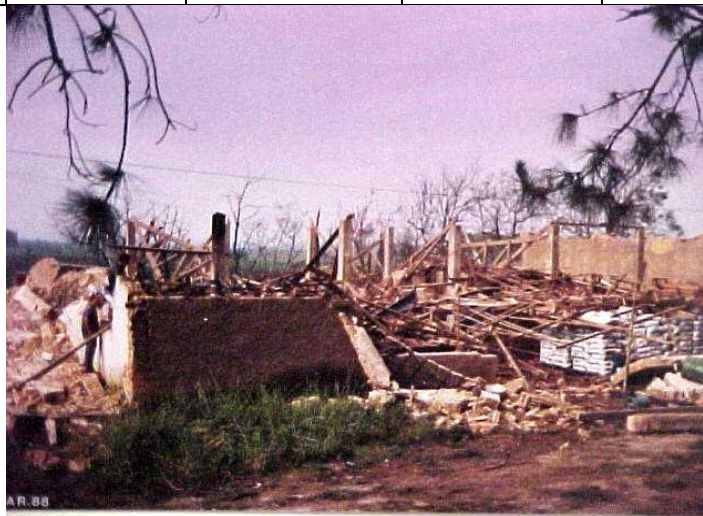
**670kg CAUGHT FIRE
250kg DETONATED**

PE02 NOTE THE DESTRUCTION OF MOUND
