## A SERIES OF PRESS INCIDENTS AND THE RESULT OF THE ROOT CAUSE INVESTIGATION

Jaroslav Konarik (Austin Detonator s.r.o.), [jaroslav.konarik@austin.cz](mailto:jaroslav.konarik@austin.cz)  
Antonin Kovarik (Austin Detonator s.r.o.), [antonin.kovarik@austin.cz](mailto:antonin.kovarik@austin.cz)

Press Building 221, Vsetin, Czech Republic

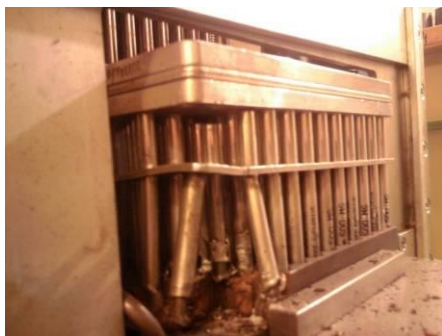
Explosion of 3 detonators: Only the tool had to be replaced. The roof over the room and the door were in good condition. Damage was insignificant in these cases.

Figure 2:  
Explosion of 3 detonators

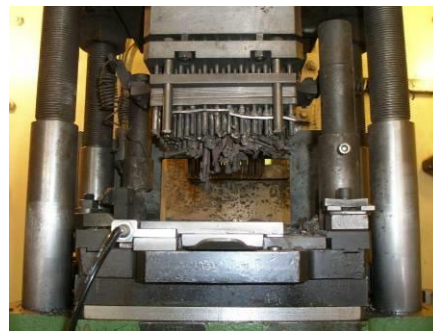
Explosion of 100 detonators: The loading line was out of operation for 3 days, the exhaust roof and doors were totally destroyed after the explosions, material damages were about \$10.000

Figure 3:  
Explosion of 100 detonators

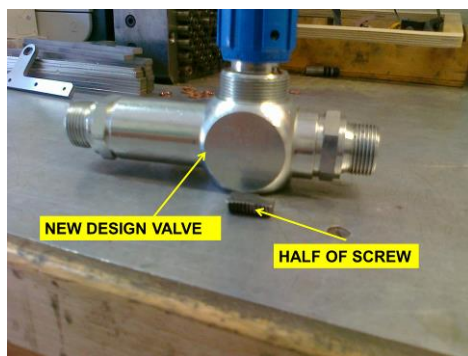
After much hard work we observed that after the third explosion half of a screw blocked the valve in the hydraulic unit. This piece of broken screw must have worked loose over 40 year's operation. The blocked valve changed the pressure drag and raised speed of the press equipment. Then the piece of loose screw disappeared again into the hydraulic system after equipment returned to the base position. The screw was now in the hydraulic system and it was only a matter of time until it found its way back into the valve and cause another blockage - and possible explosion.

Figure 6:  
New design valve and screw

- removed the lost screw,
- reinstalled the old design valve
- slightly widened the inner diameter of shell to reduce friction between the shell and delay element.

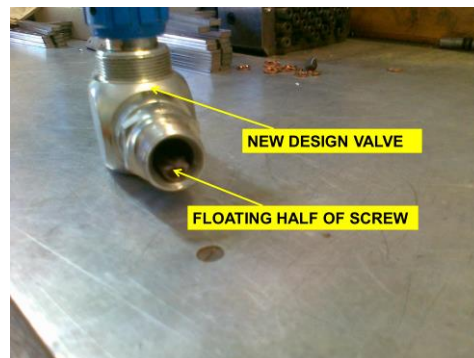
Three months after the first explosion we dismantled the "old design" valve and we found the other piece of the screw inside.

Figure 7:  
Screw into new design valve
