# FIRE DURING THE MANUFACTURE OF DETONATING SEMIFUSE

Jeff Soper (Orica SHEC Manager Asia)

MONDAY, December 17<sup>th</sup> 2012

GOMIA IS/PE MANUFACTURING FACILITY INDIA

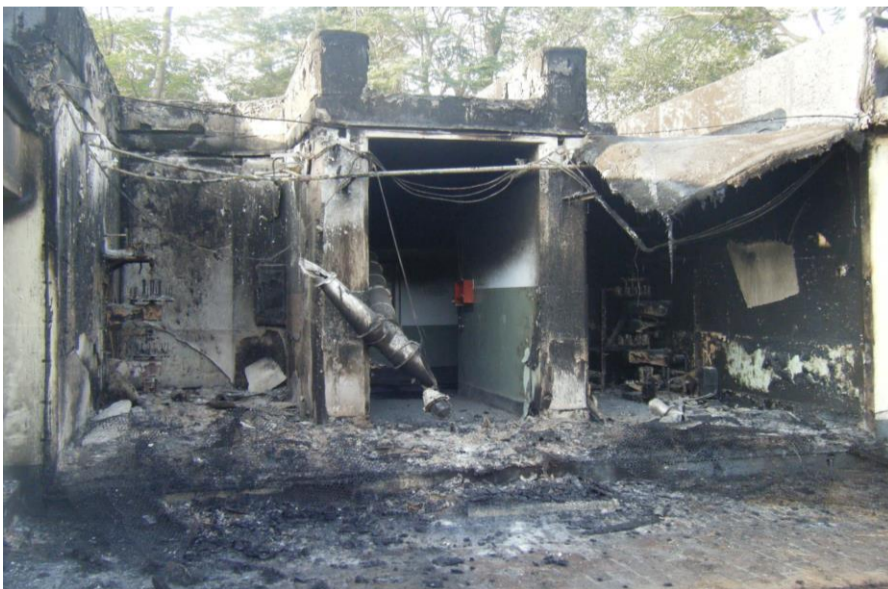
On 17<sup>th</sup> December 2012 during the manufacture of detonating semifuse, a fire in spinning compartment 1 completely destroyed compartments 1 & 2. It is believed that there was a total of 8 kg of PETN and 1800 metres of semi fuse spread across both machines. There were no injuries and there was no explosion. The resulting fire consumed both spinning compartments and destroyed both machines however the fire was confined to that area only. The rest of the plant suffered smoke and soot damage.

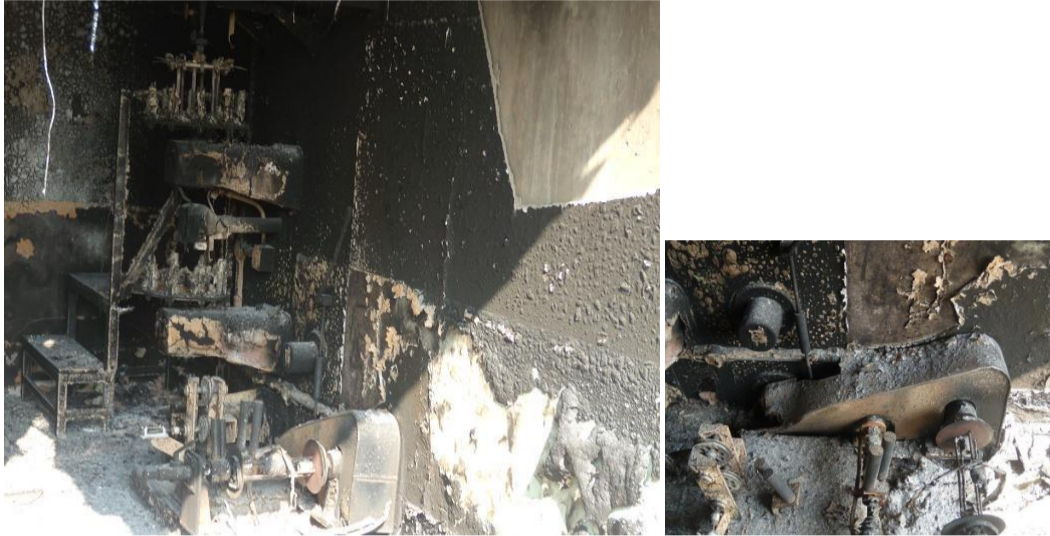
- Examination of the site showed
  - Localised heat scouring on the spinning machine
  - Rub marks on the drive pulley guard
  - Worn through area at end of aluminum pulley guard
  - Slippage marks on drive belt with metal joiner
  - Burnt and melted drive belt

6. Friction: The investigation and RCA concluded that this was the most likely cause of the fire based on;
  - Rub through area of pulley guard
  - Slip marks on the drive belts

- Metal joining clips on belt drive
  - Localised heat marking on spinning machine directly above pulley guard damaged area

From these hypotheses it was concluded that the loose guard rubbing on the pulley for 30 minutes caused a friction event that that generated enough heat to ignite detonating semifuse up through the spinning machine to the PETN.

1. Drive systems to be located outside of manufacturing cubicles.
2. Install tension system without manual intervention or slippage controlled.
3. Drive belts to be fused leather.
4. All guards to be in a fixed position.
5. Automated deluge systems.
