The Fire and Explosion at West Fertilizer Co. Plant

Presentation at SAFEX Congress
May 22-23, 2014

Noel Hsu* and David Kennedy

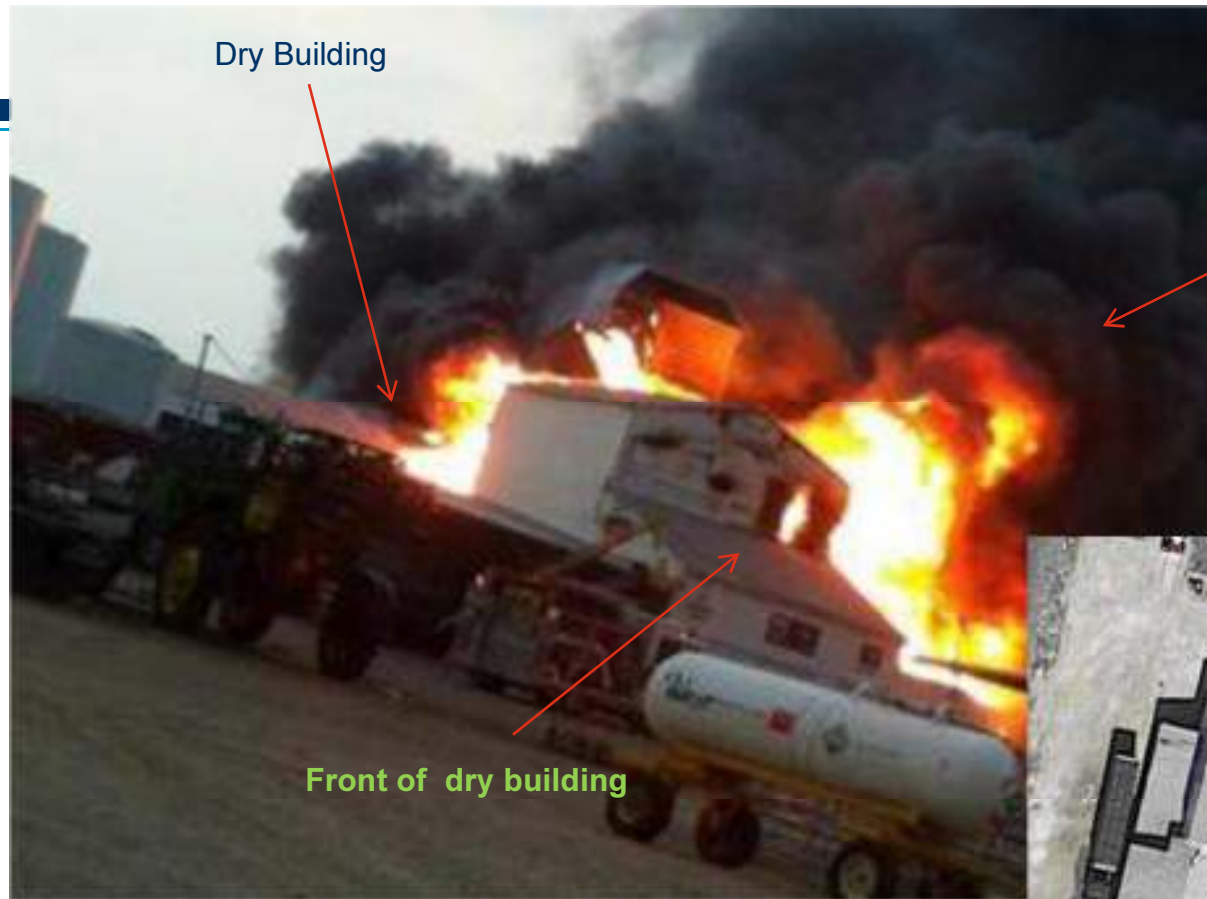
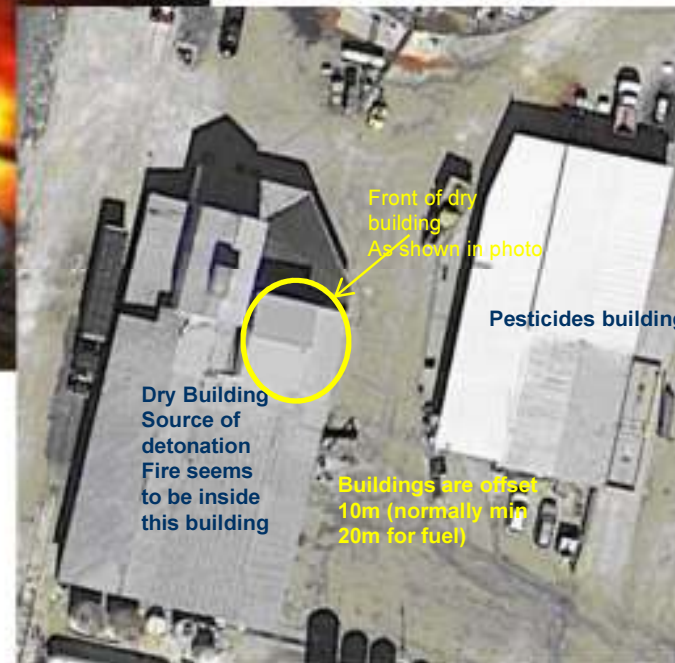
West Fertiliser Texas explosion 18 April 2013

Photograph shows the fire developing in the dry building .
Very large amount of fuel involved

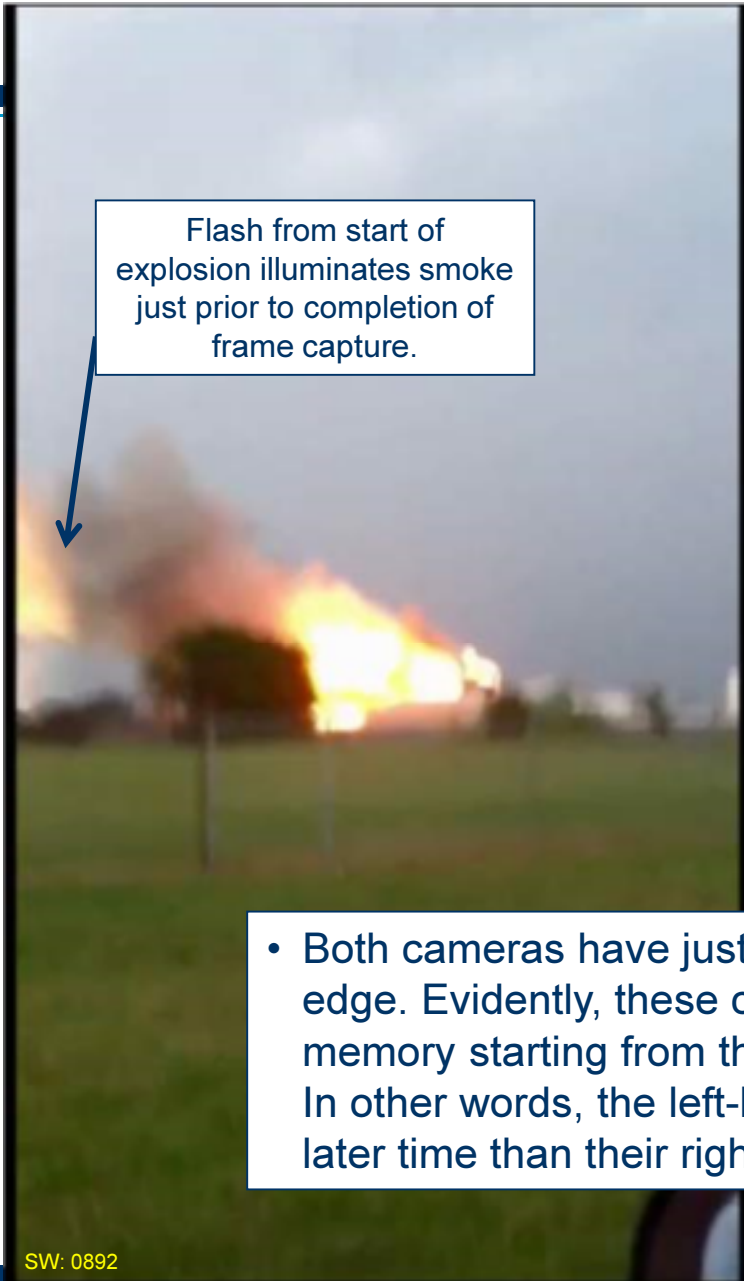
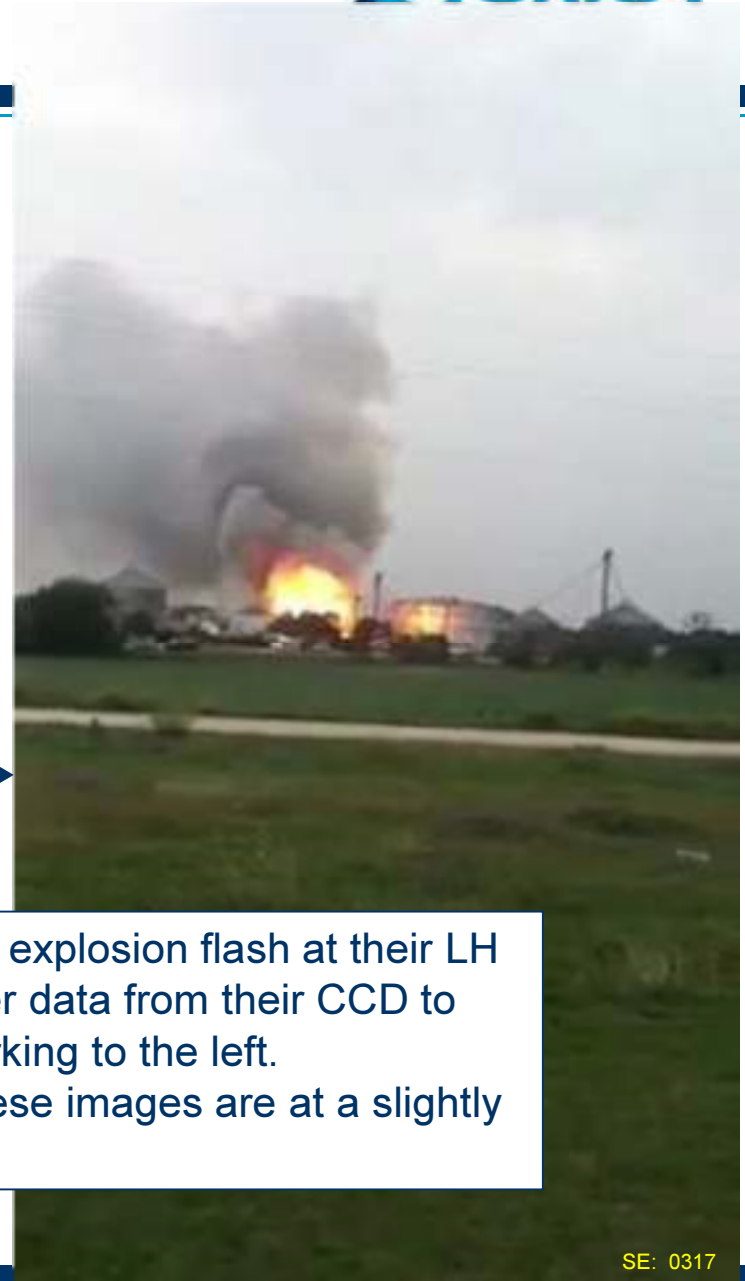
Frame: -001

Flash from start of explosion illuminates smoke just prior to completion of frame capture.

Faint lightening of image along this edge.

- Both cameras have just caught start of explosion flash at their LH edge. Evidently, these cameras transfer data from their CCD to memory starting from the right and working to the left. In other words, the left-hand side of these images are at a slightly later time than their right-hand sides.

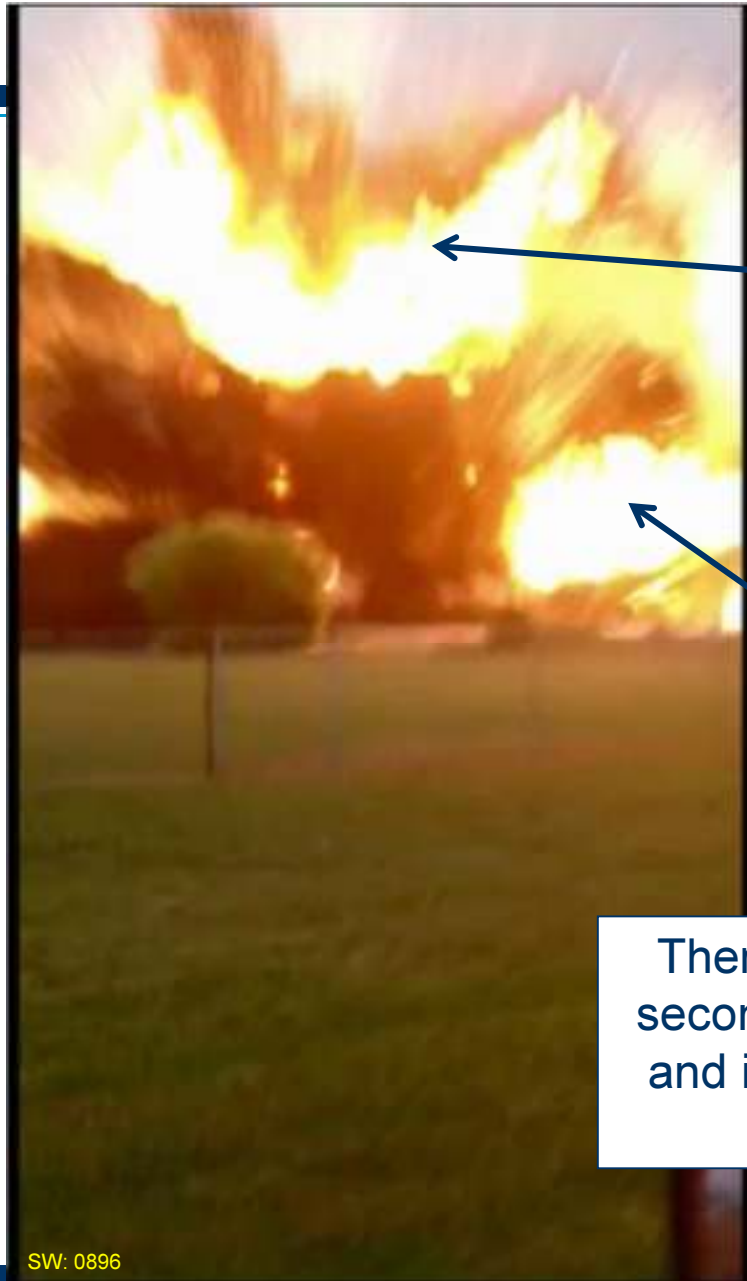
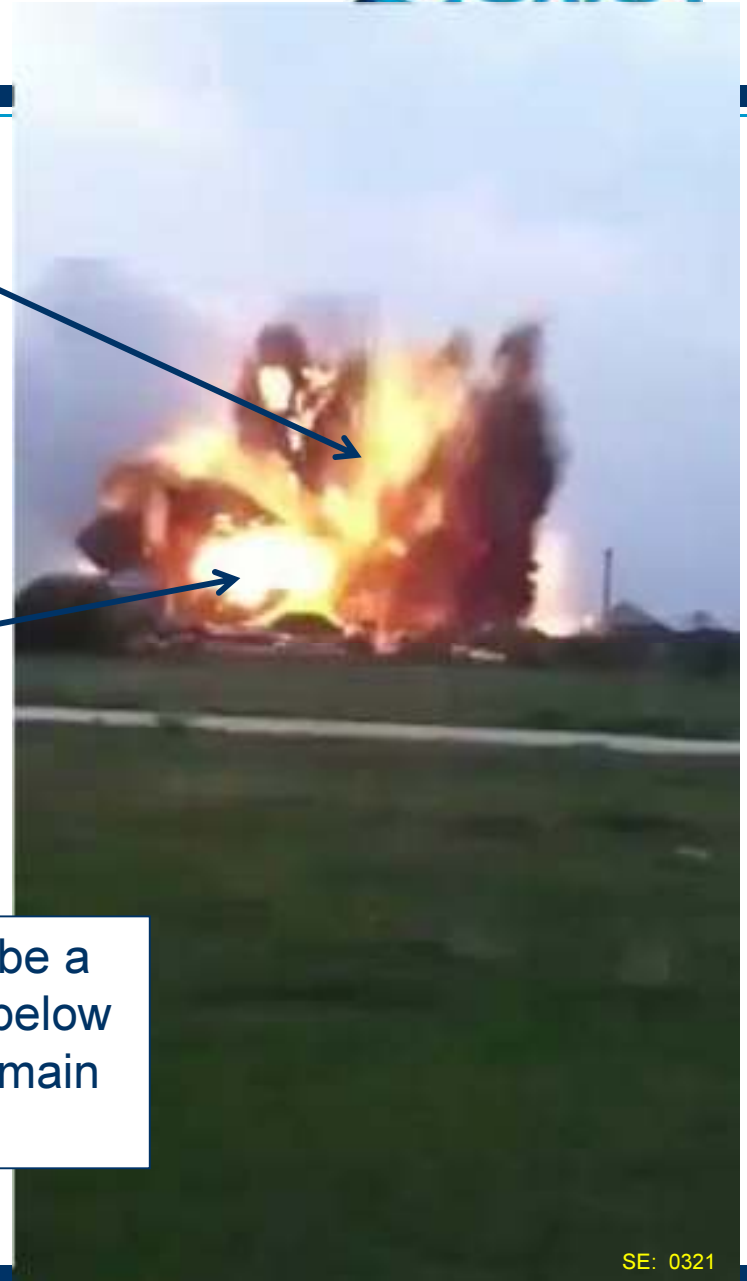
Frame: +003

Main fireball
(from North
end of Dries?)

Secondary fireball
(from South
end of Dries?)

There appears to be a
secondary fireball below
and in front of the main
fireball.

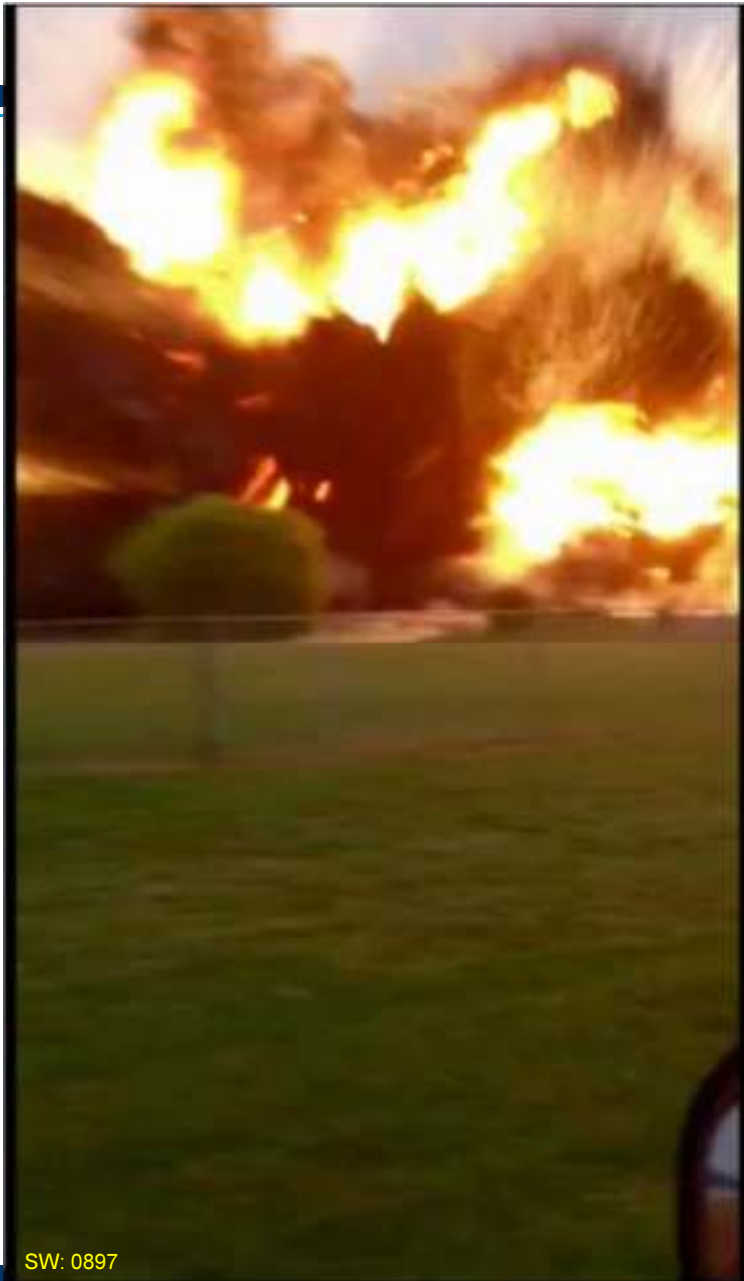
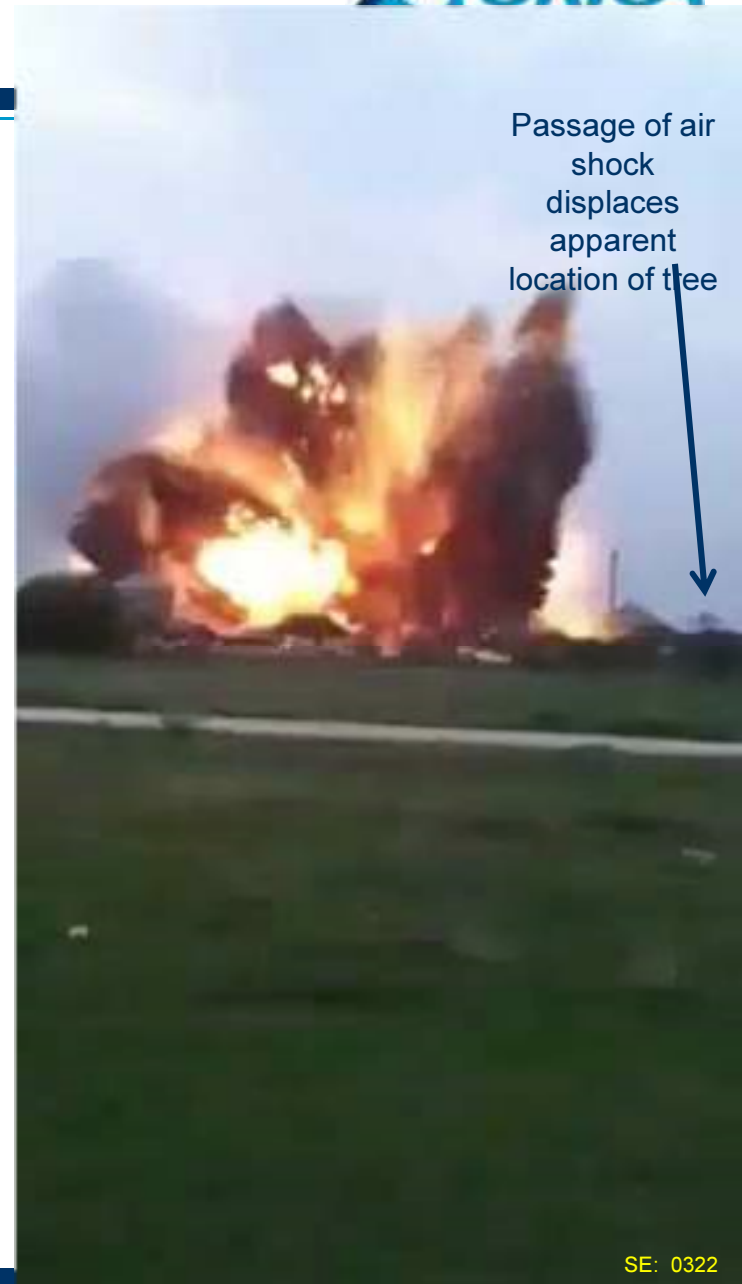
Frame: +004

Passage of air
shock
displaces
apparent
location of tree

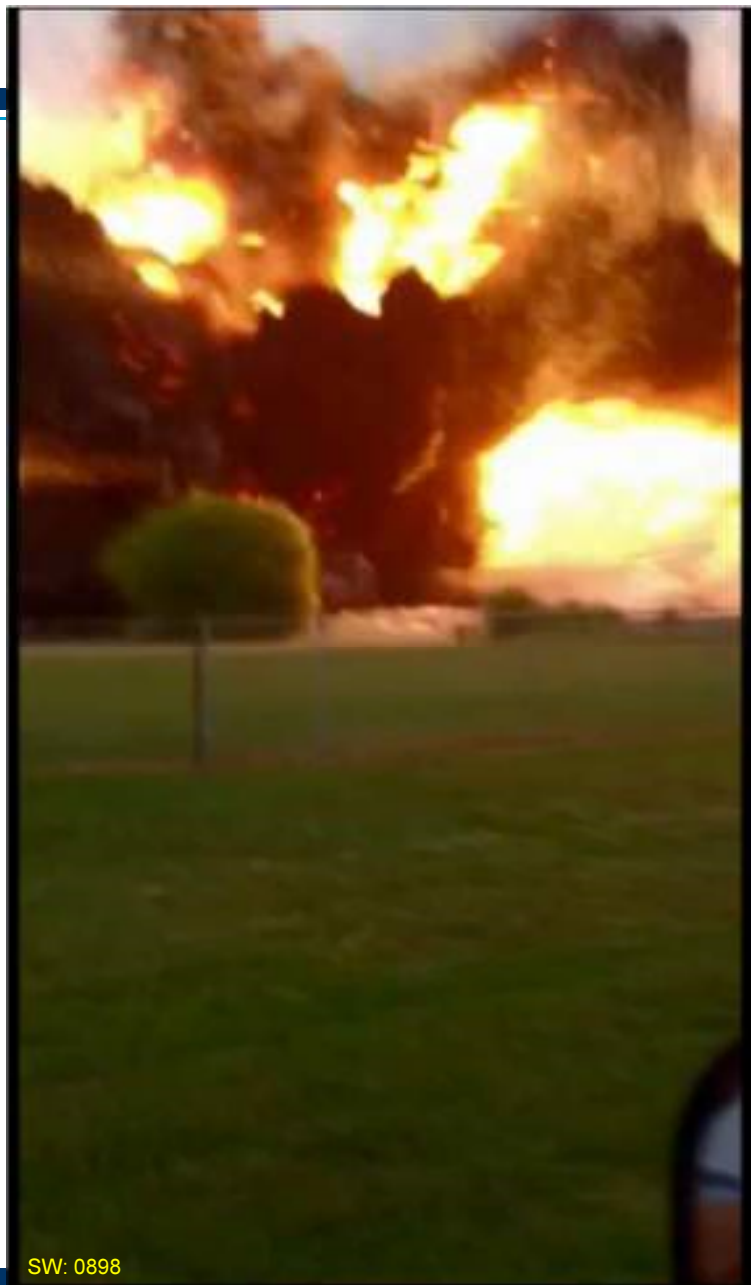
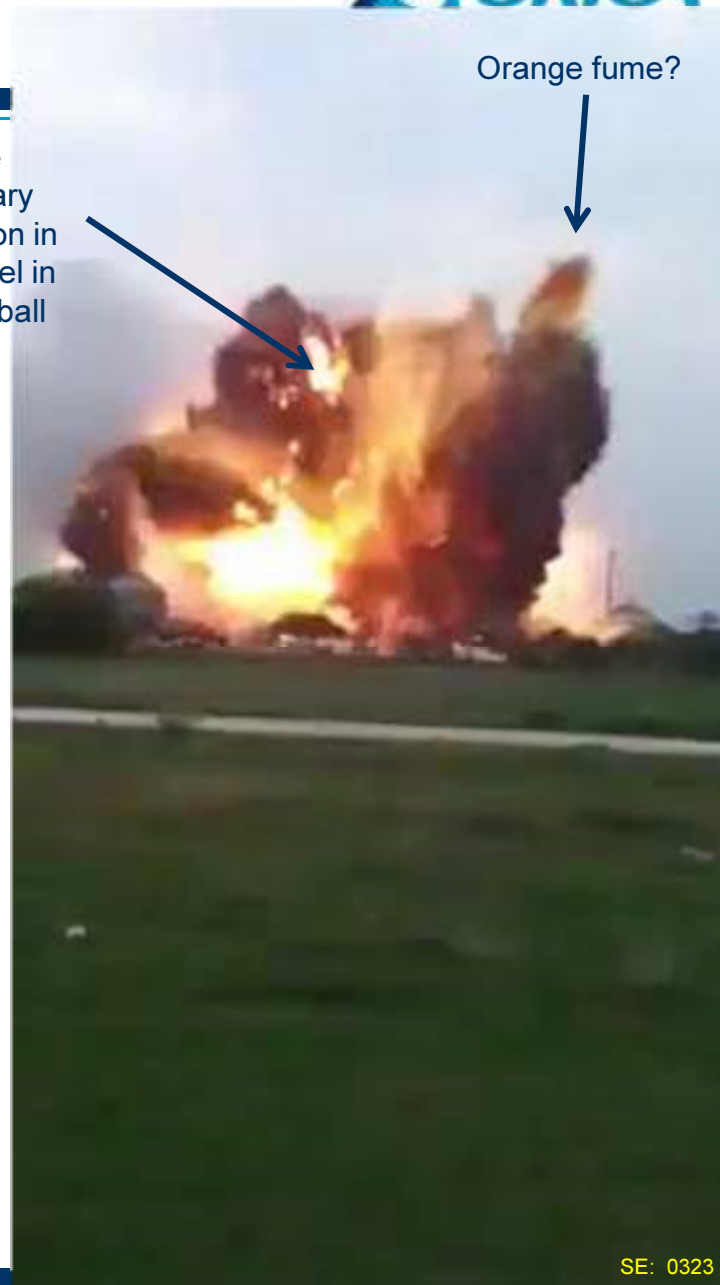
Frame: +005

Some secondary combustion in excess fuel in main fireball

Orange fume?

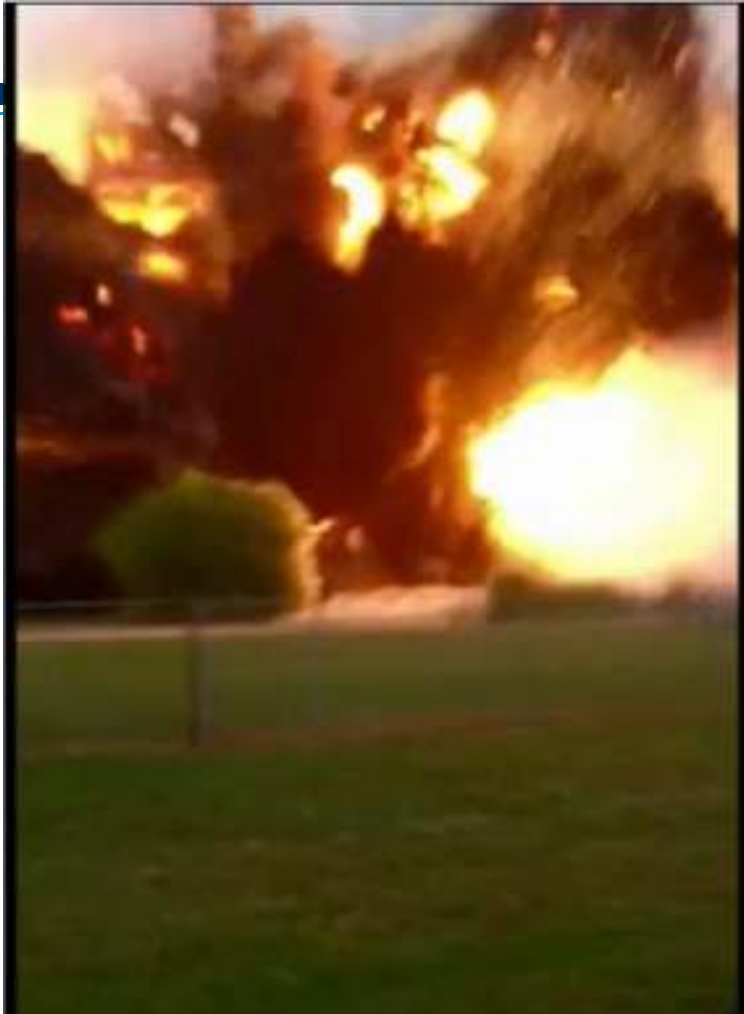
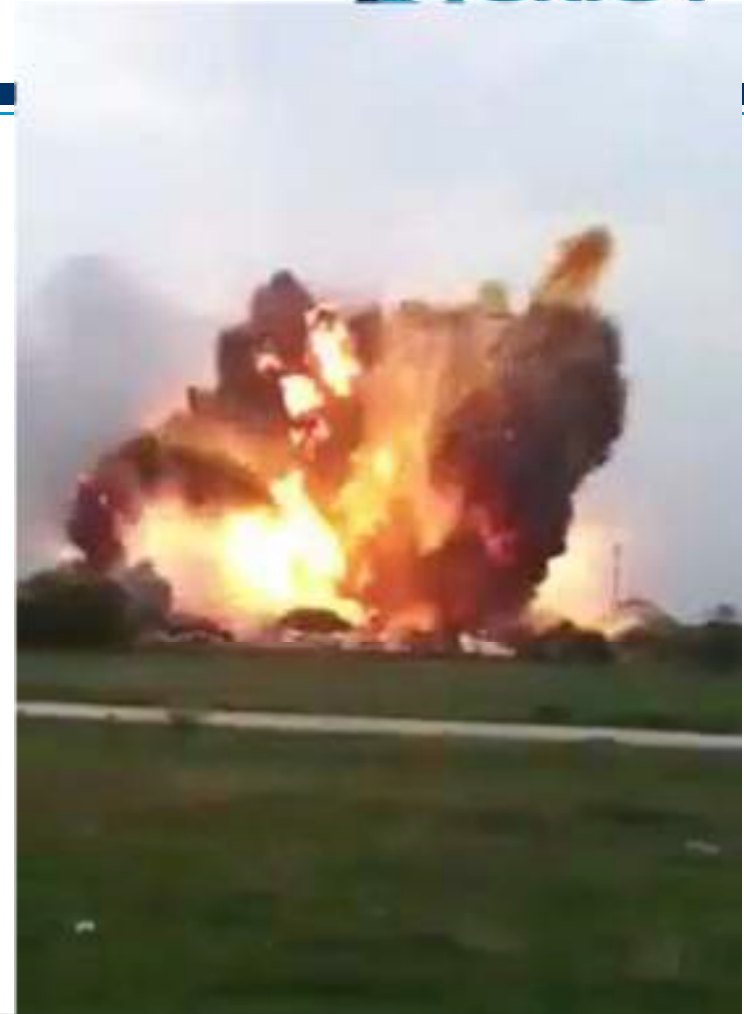
Frame: +006

The main fireball looks consistent with some form of detonation through a material close to oxygen-balance, as very little apparent secondary combustion of excess fuel, yet no appreciable NOx production from

excess oxidiser

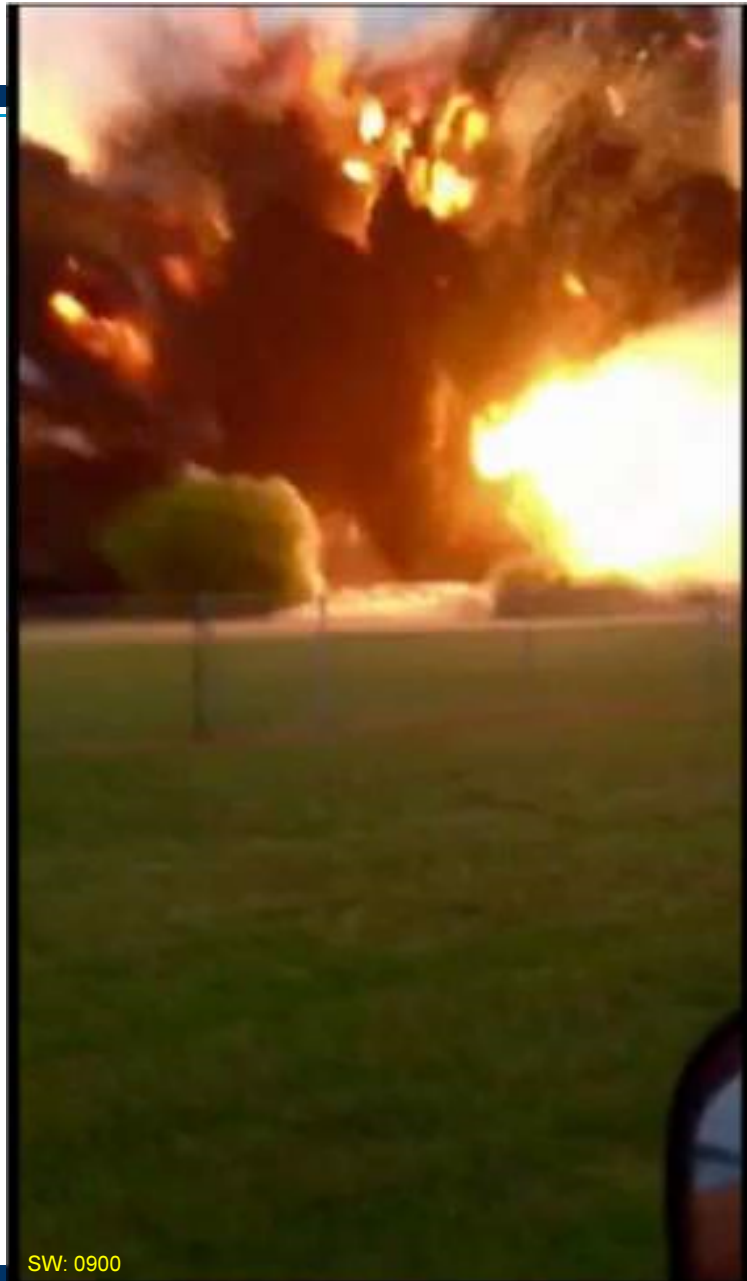
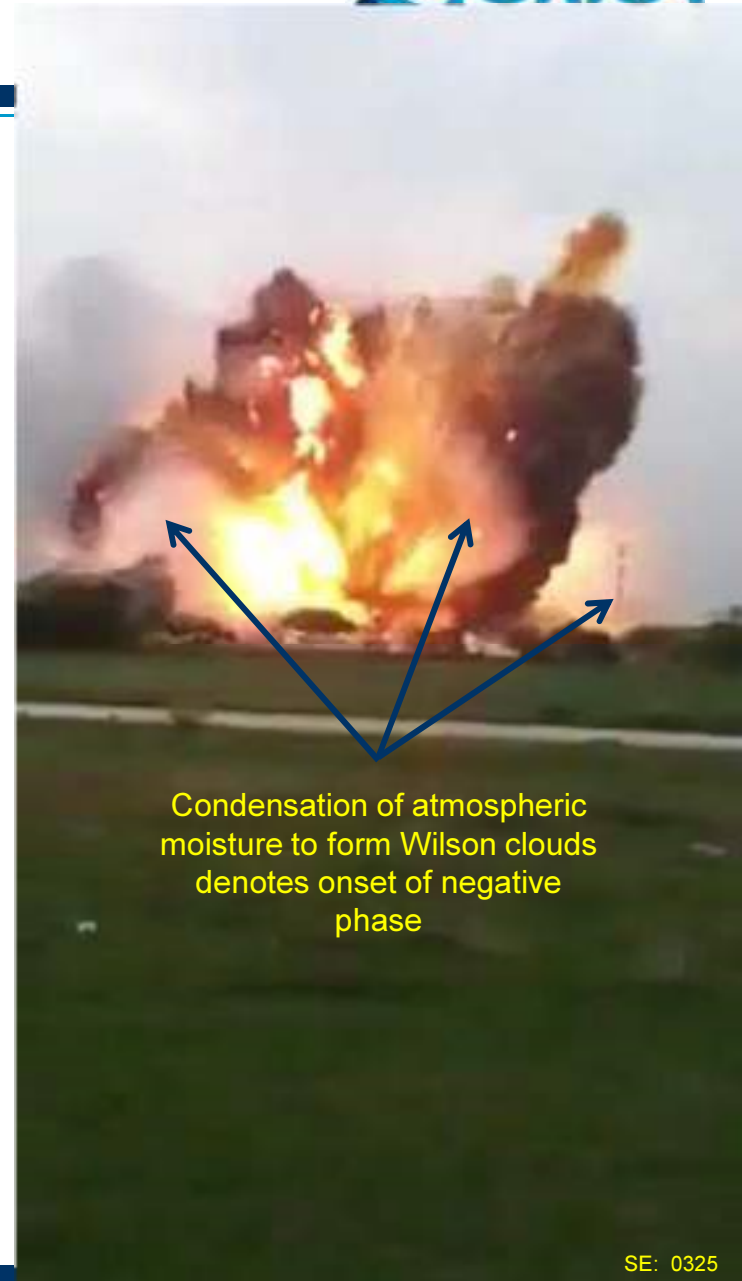
Frame: +007

Condensation of atmospheric moisture to form Wilson clouds denotes onset of negative phase

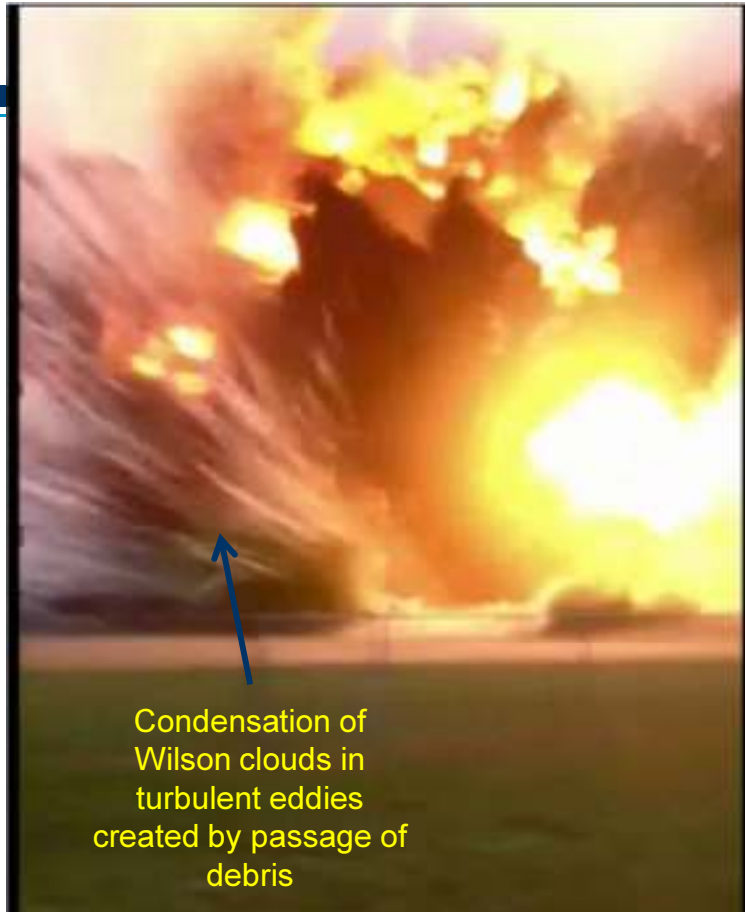
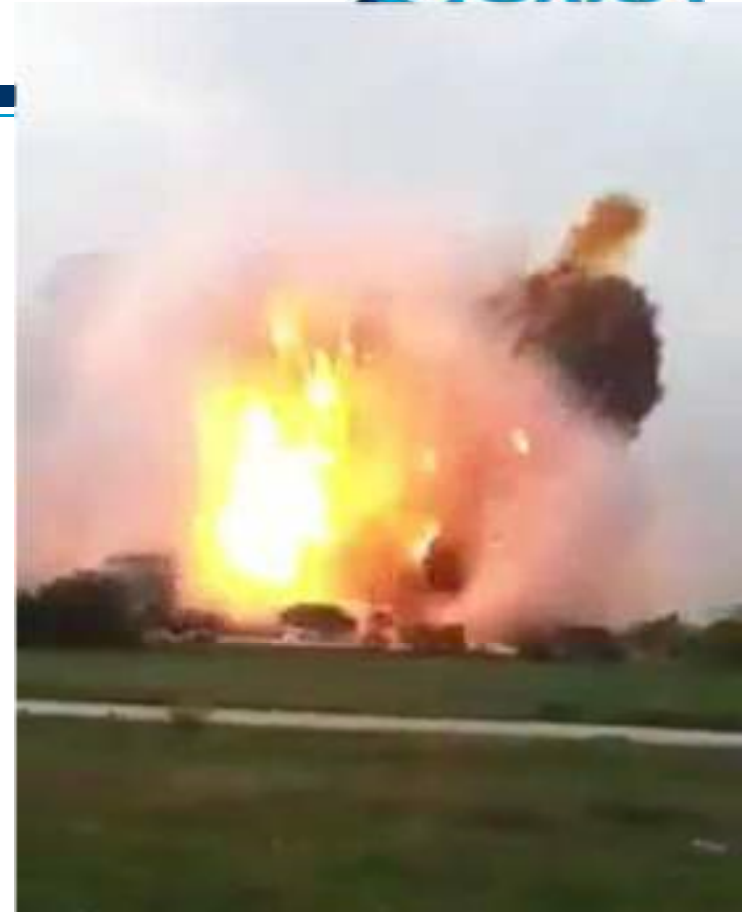
Frame: +009

Condensation of Wilson clouds in turbulent eddies created by passage of debris

The Wilson clouds, and hence by inference the negative phase, were surprisingly long lived some distance out from GZ. This indicates that there was no significant secondary shock generated by the collapse of the negative phase at GZ.

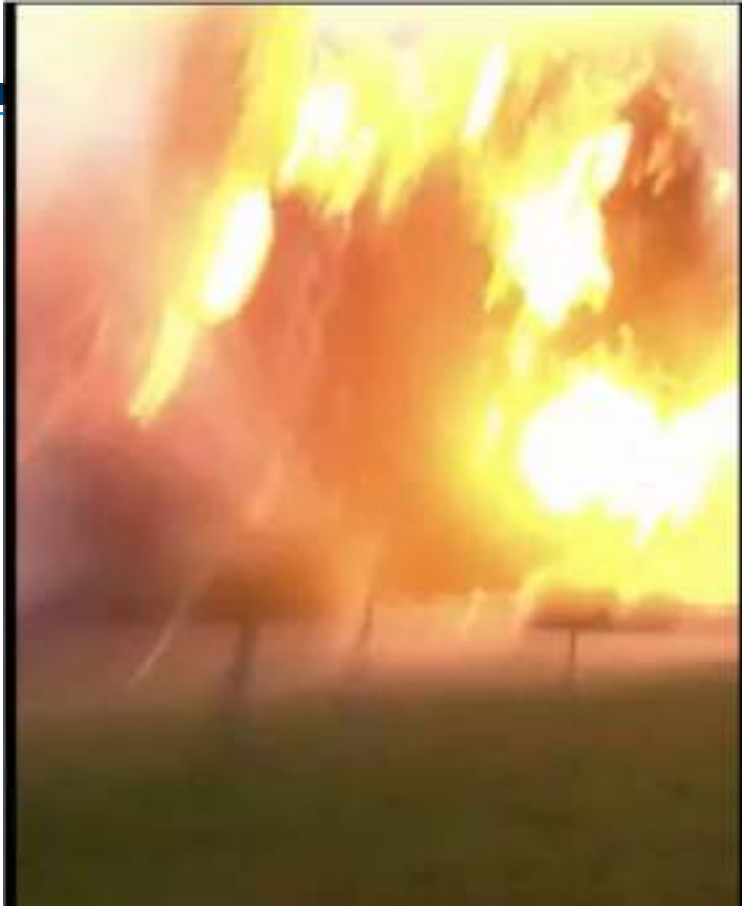
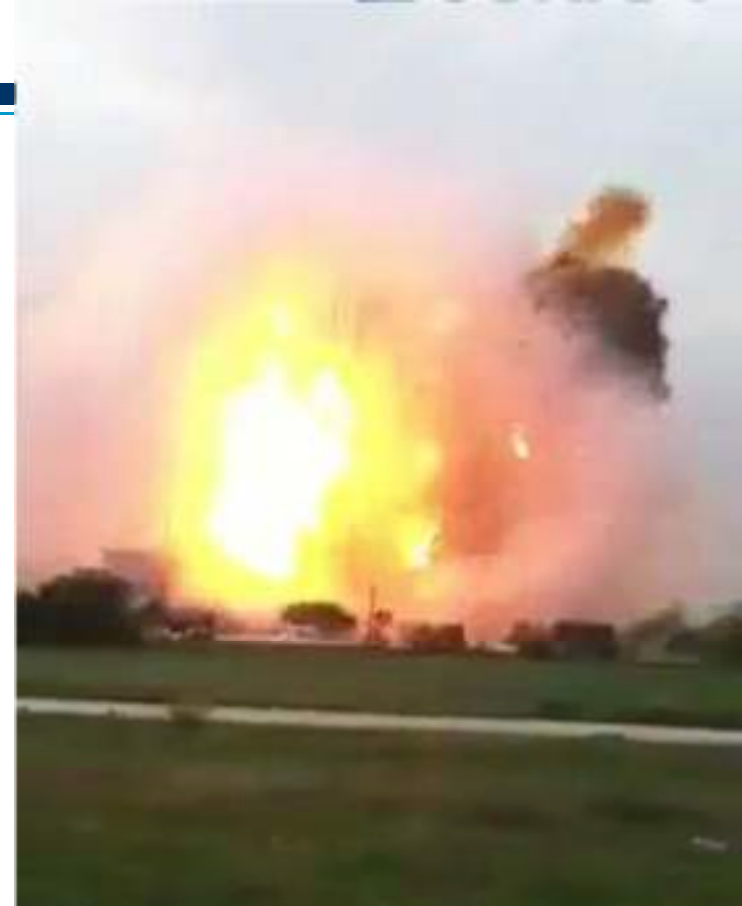
Frame: +010

The secondary fireball intensified, reaching peak brightness at about 500 ms. Whatever caused it, it is not pure AN detonating (wrong fireball colour, too bright, wrong behaviour, wrong fume colour). Seems to be a deflagration through some sort of oxidiser/fuel mixture, as it doesn't appear to be dependant on access to external oxygen from mixing with air to burn.

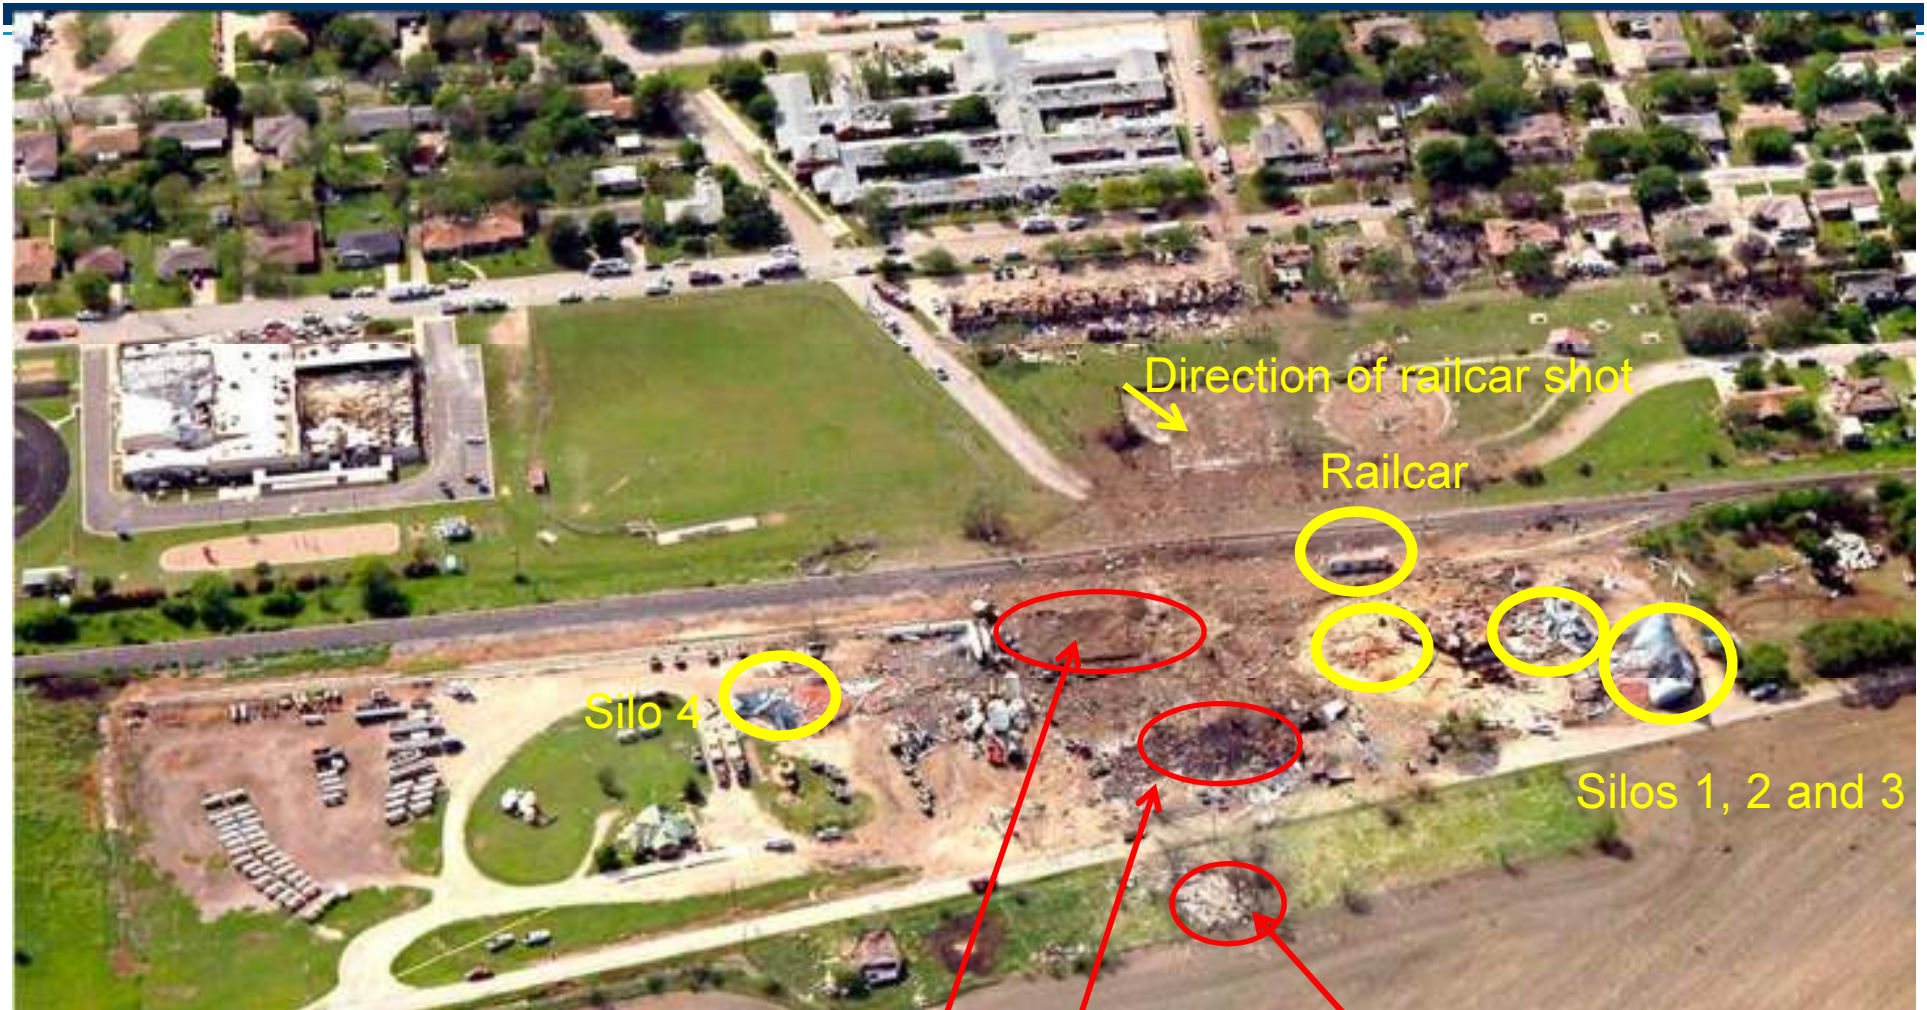
After – showing direction of railcar shot and damaged silos

Ground zero.
Building obliterated

2nd Building also
obliterated

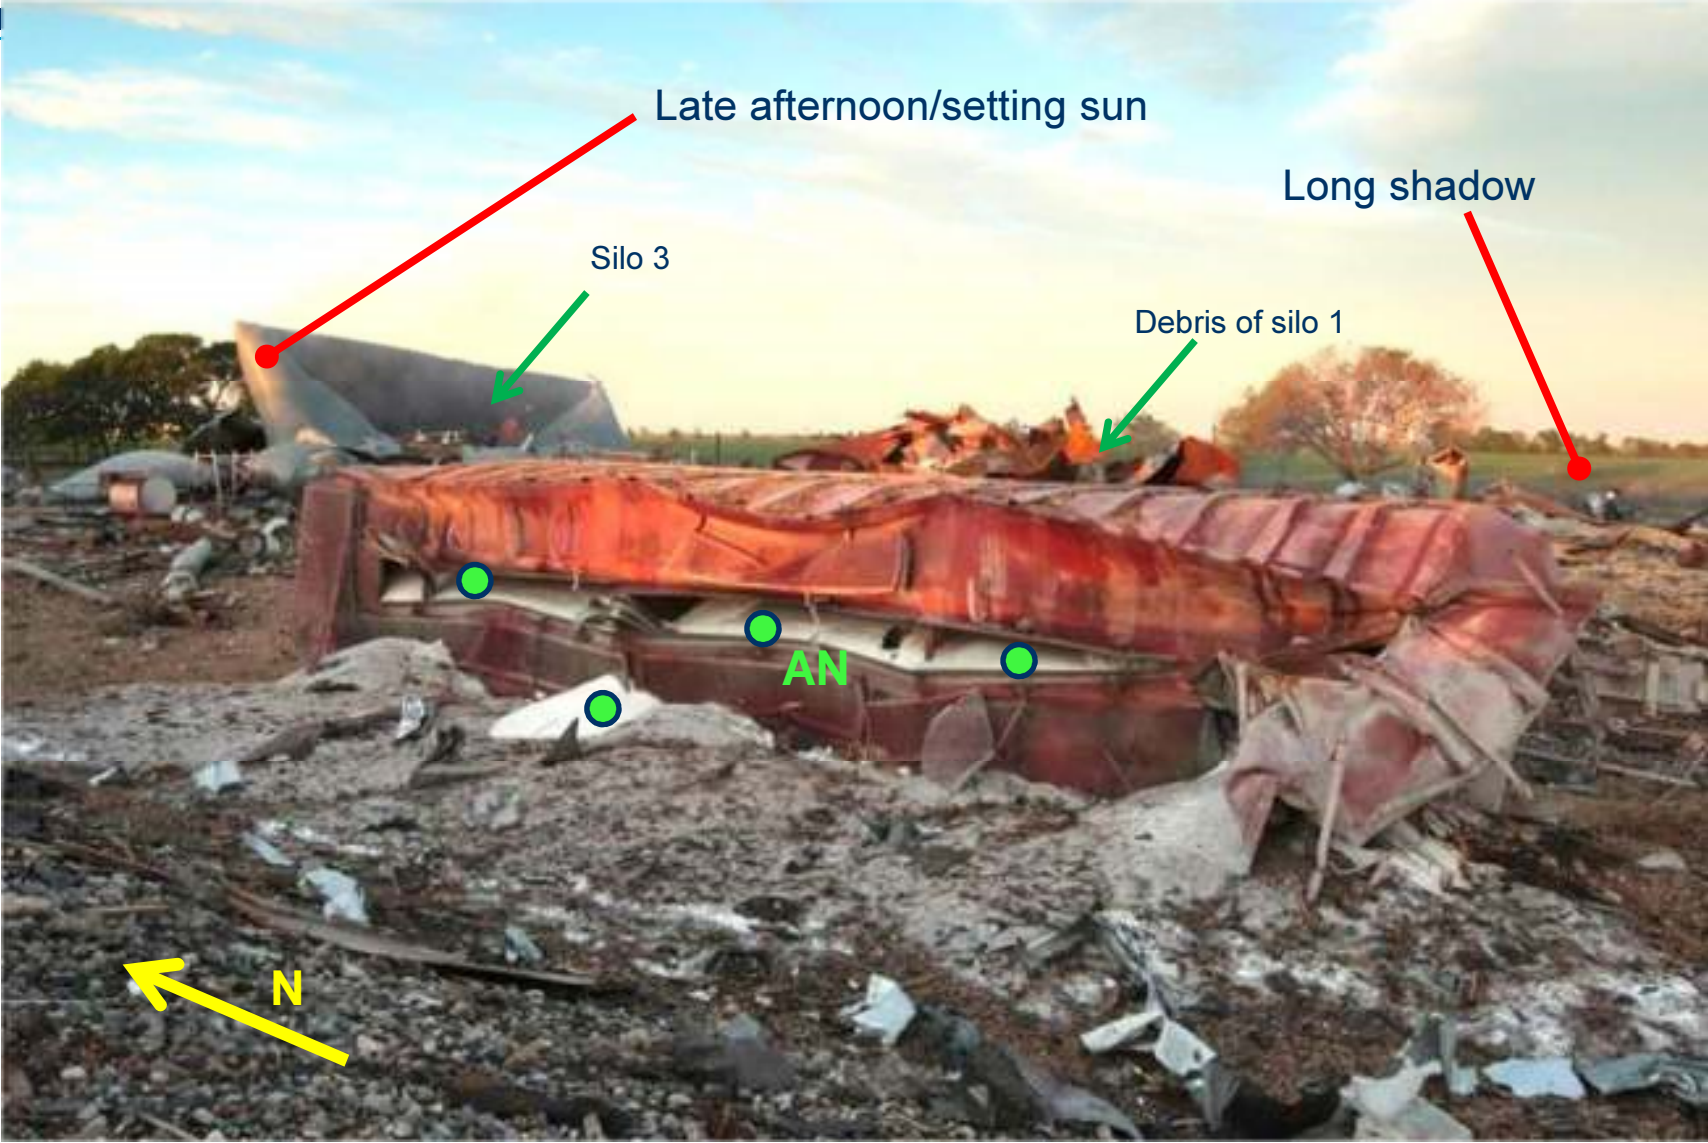
Image of Railcar (Getty Images)

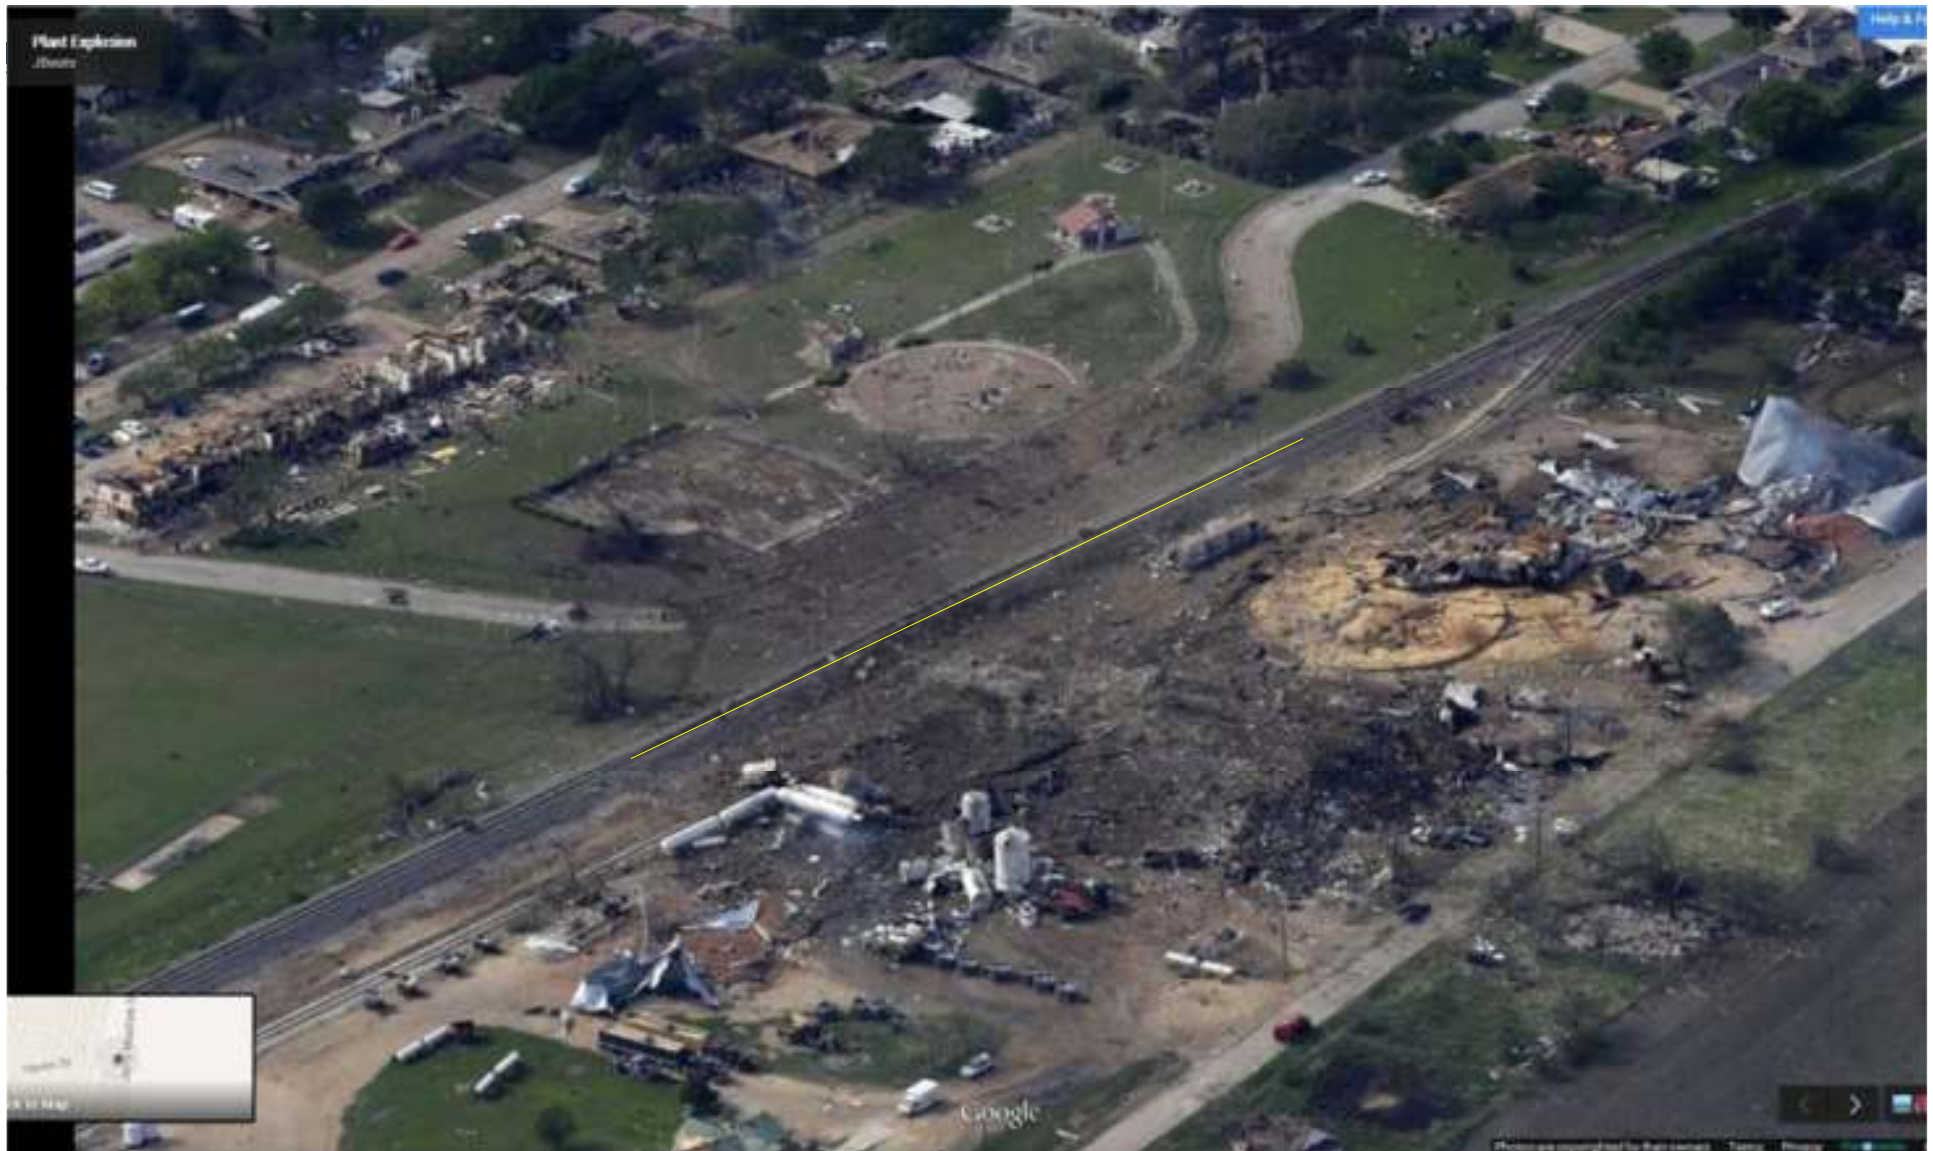
Alternate View (distorted rail line)
