The Fire and Explosion at West Fertilizer Co. Plant

Presentation at SAFEX Congress
May 22-23, 2014

Noel Hsu* and David Kennedy

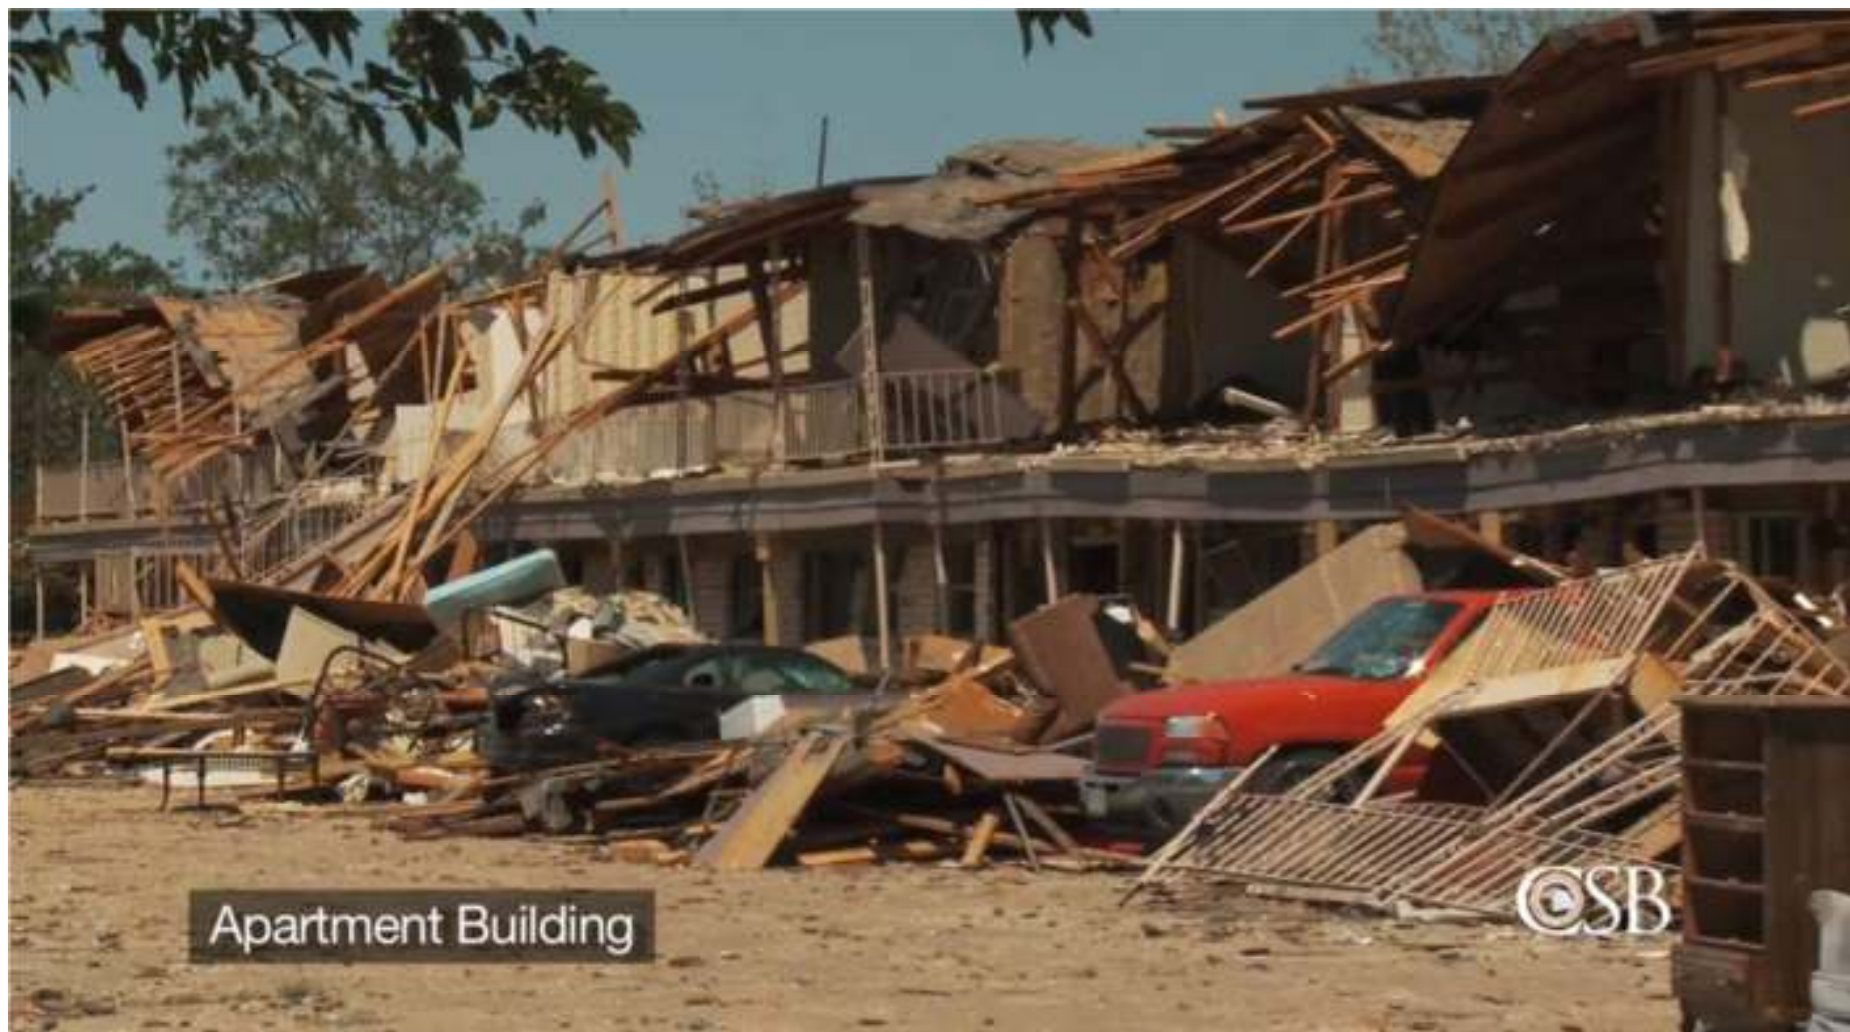
Still from Video of Apartment Complex (CSB)
