# ACCIDENT

13-03-2013

NITROERG S.A.

at production plant in Bieruń

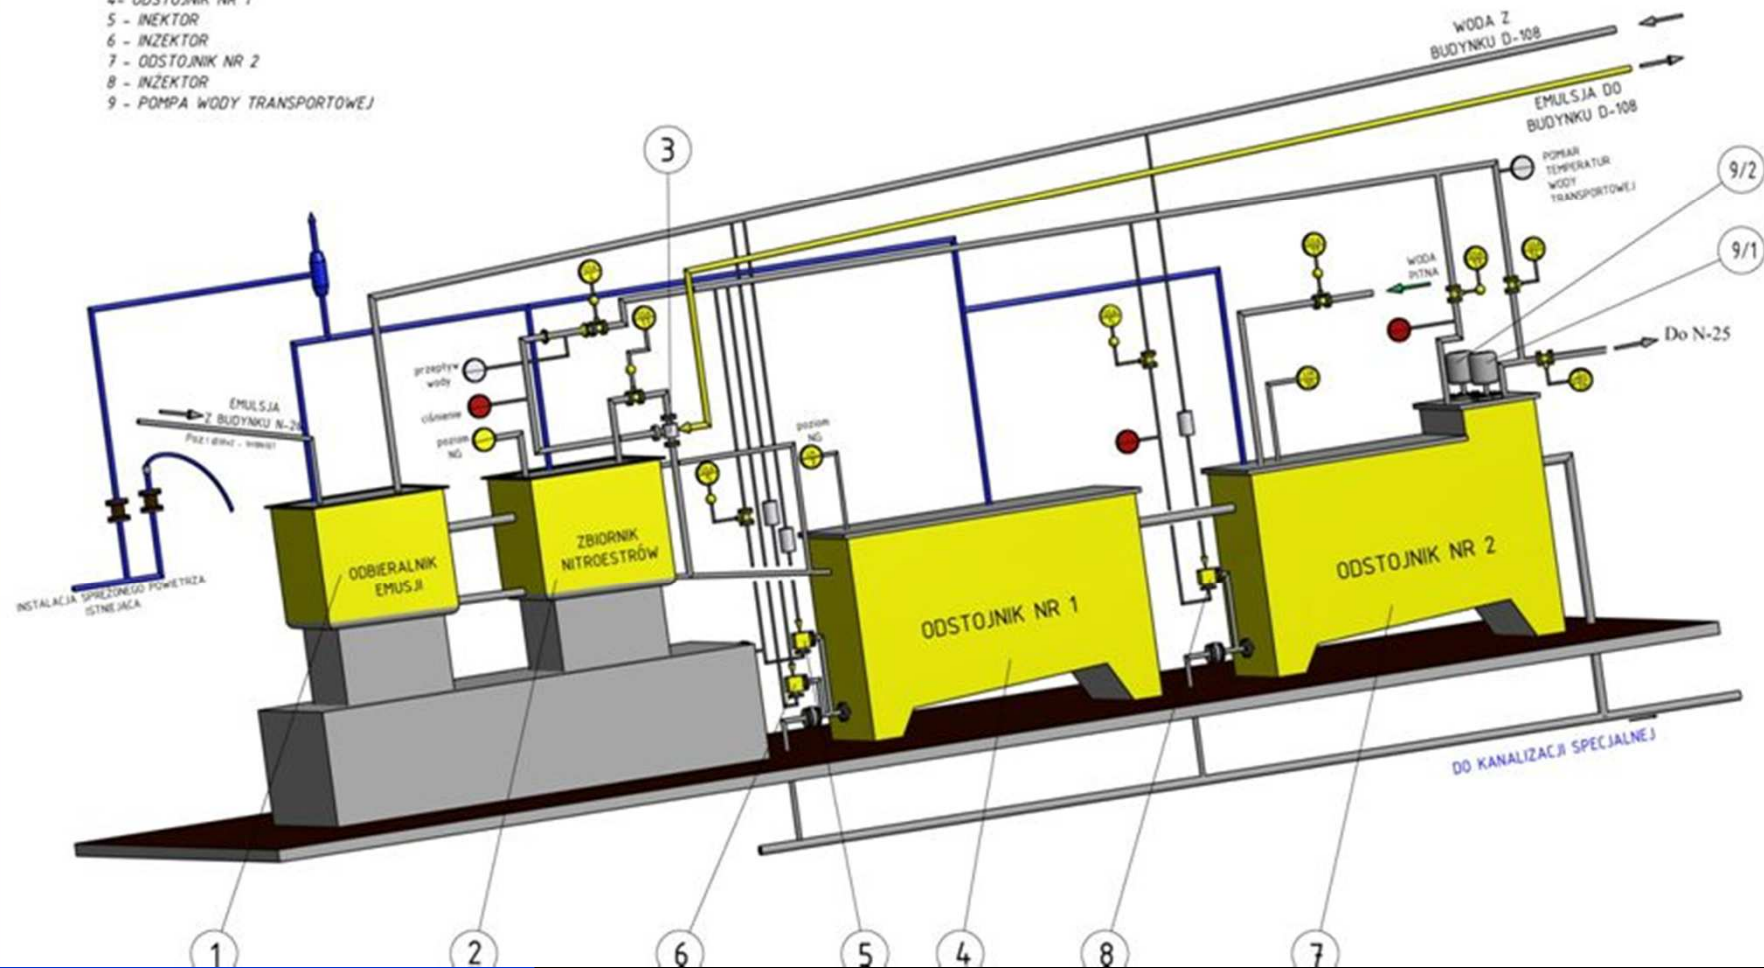
## TRANSPORT NG z N9 do D10b

- 1 - ODBIERNIK EMUSJI
- 2 - ZBIORNIK NITROESTRÓW
- 3 - INJEKTOR TRANSPORTOWY
- 4 - ODSTOJNIK NR 1
- 5 - INEKTOR
- 6 - INEKTOR
- 7 - ODSTOJNIK NR 2
- 8 - INEKTOR
- 9 - POMPA WODY TRANSPORTOWEJ

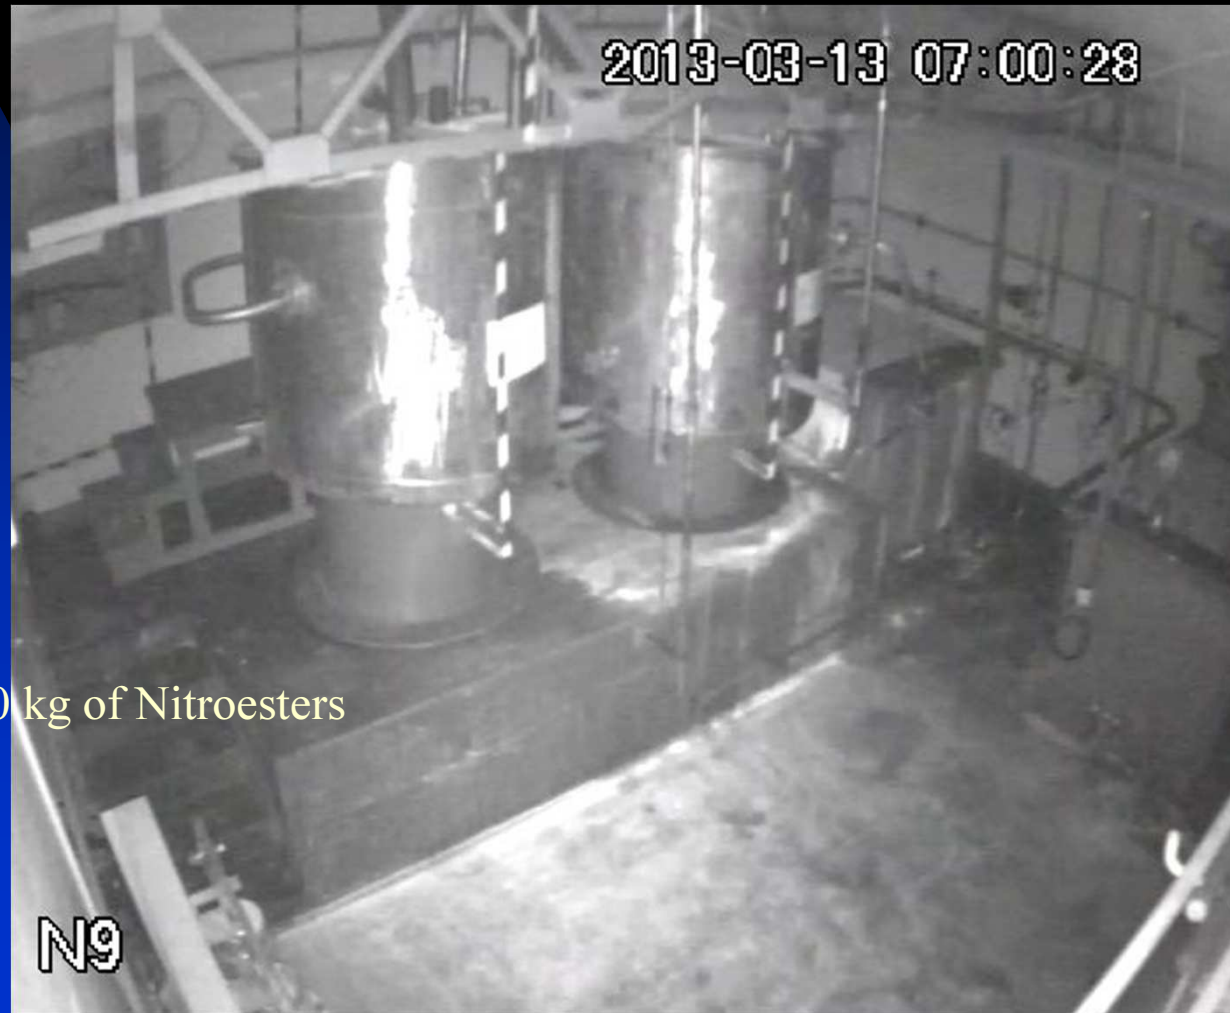
# A view inside the intermediate store (five minutes before the explosion)

There was ~ 600 kg of Nitroesters

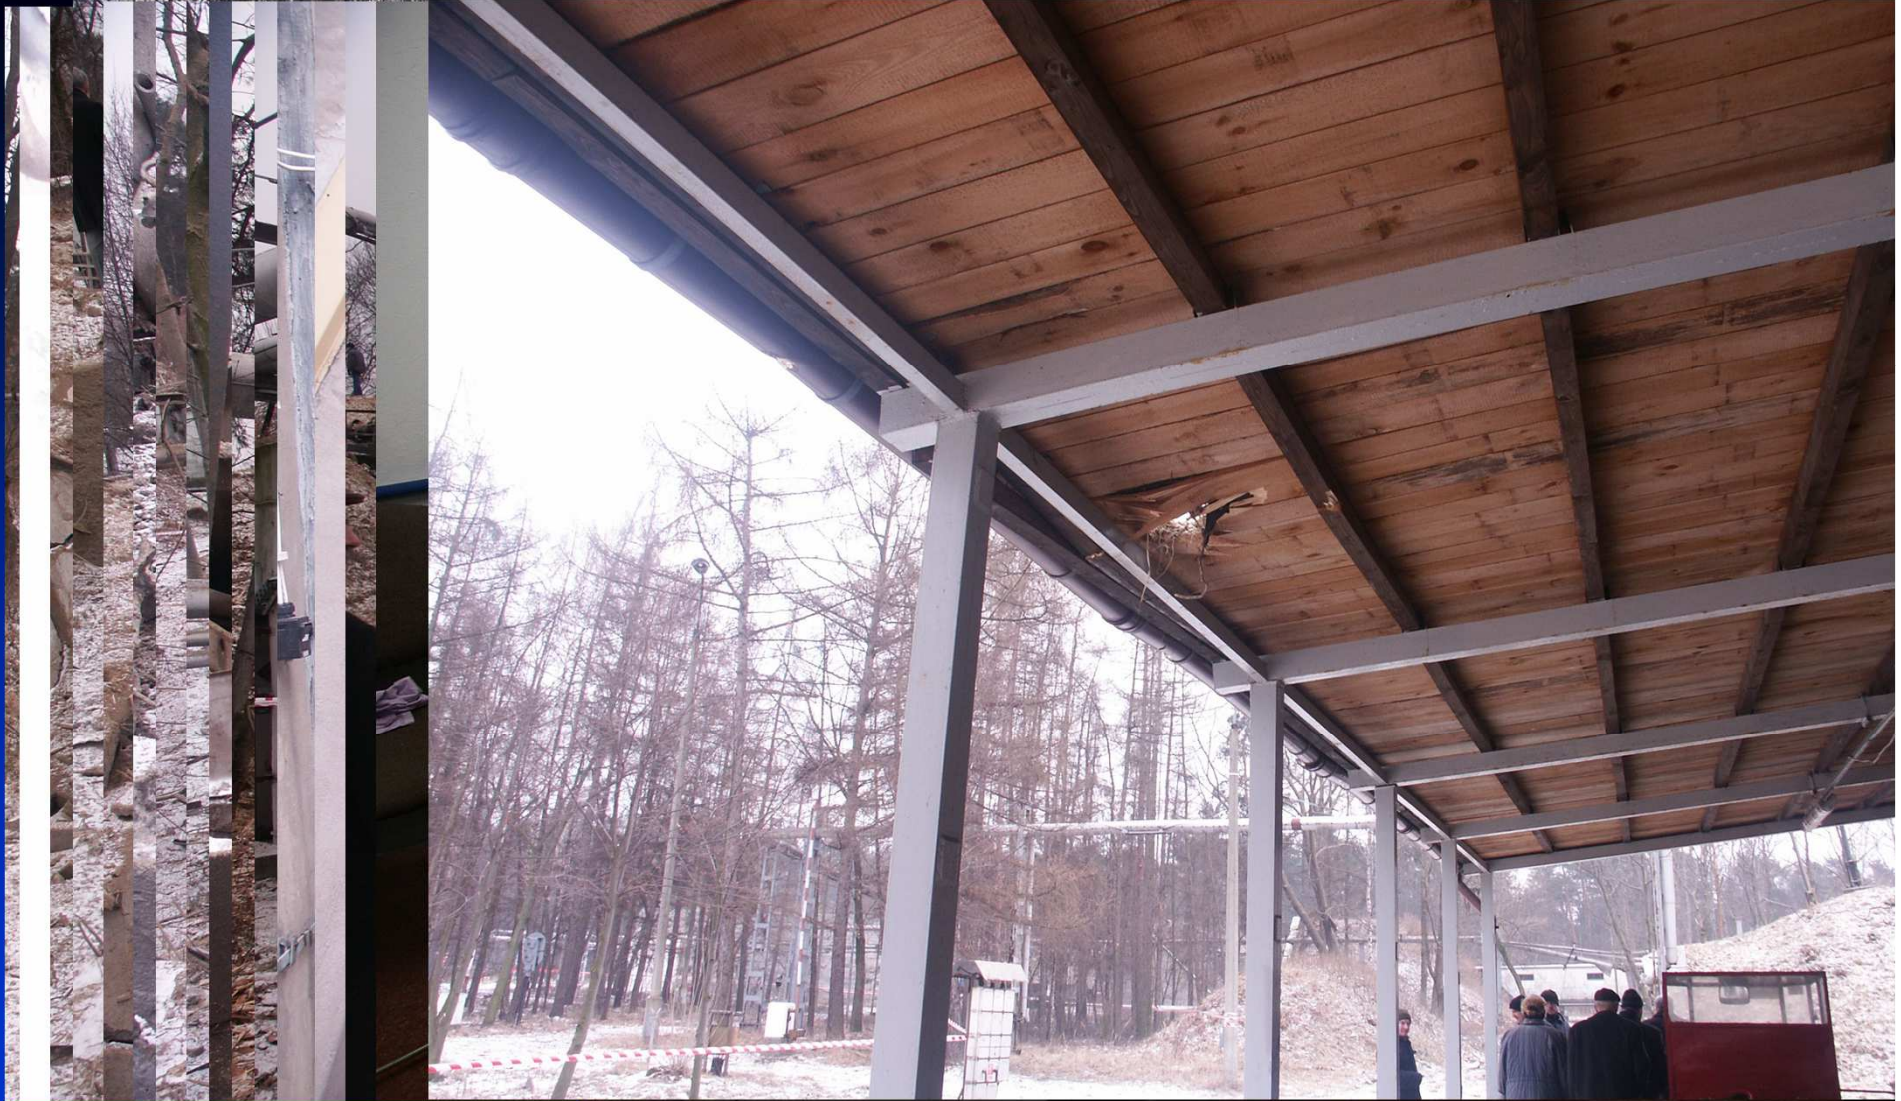
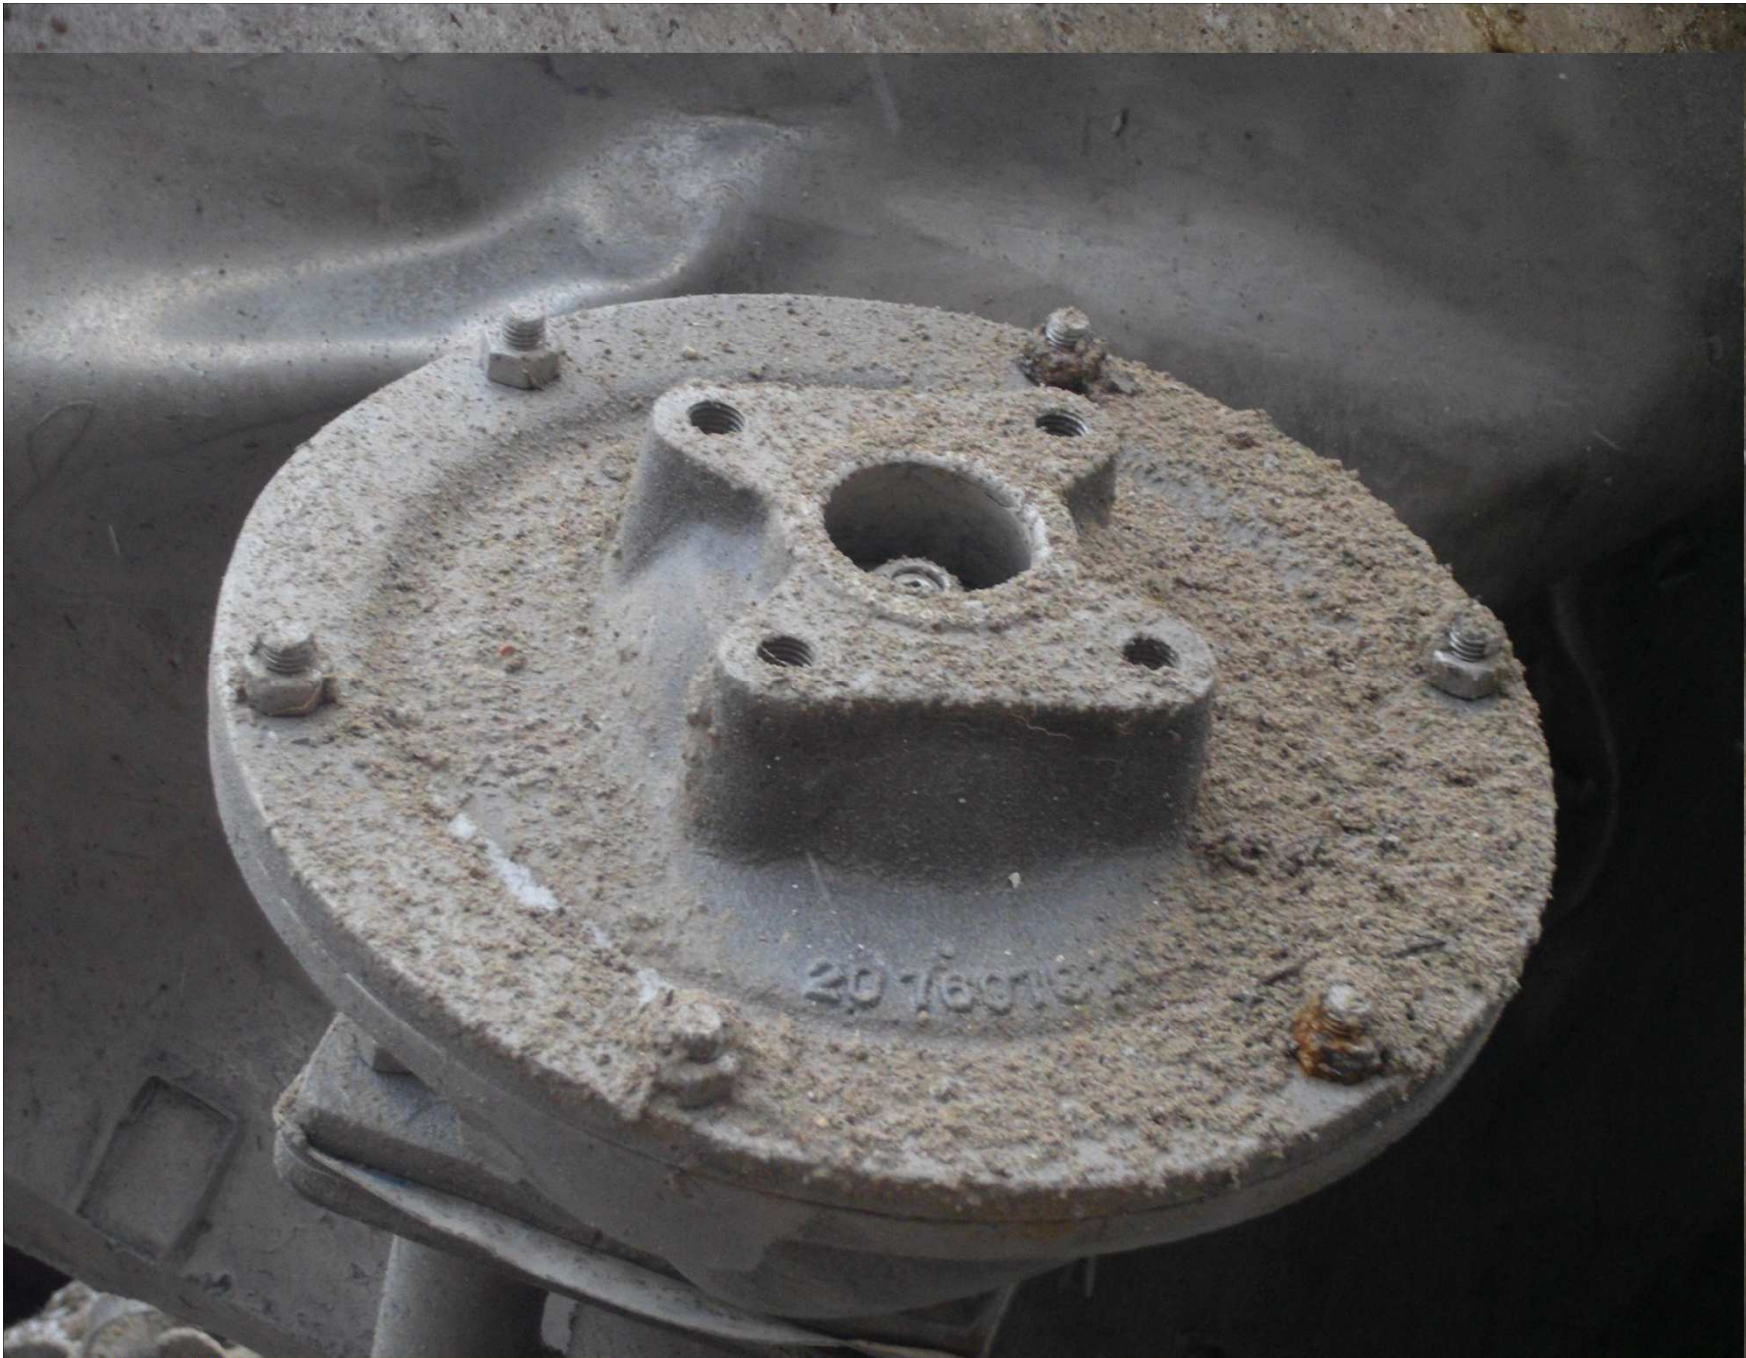
# After explosion:
