# EPC Belgium

## Incident of a Multiblend Truck during a loading of ANFO causes, analysis, evolution

Ir JACQUET David

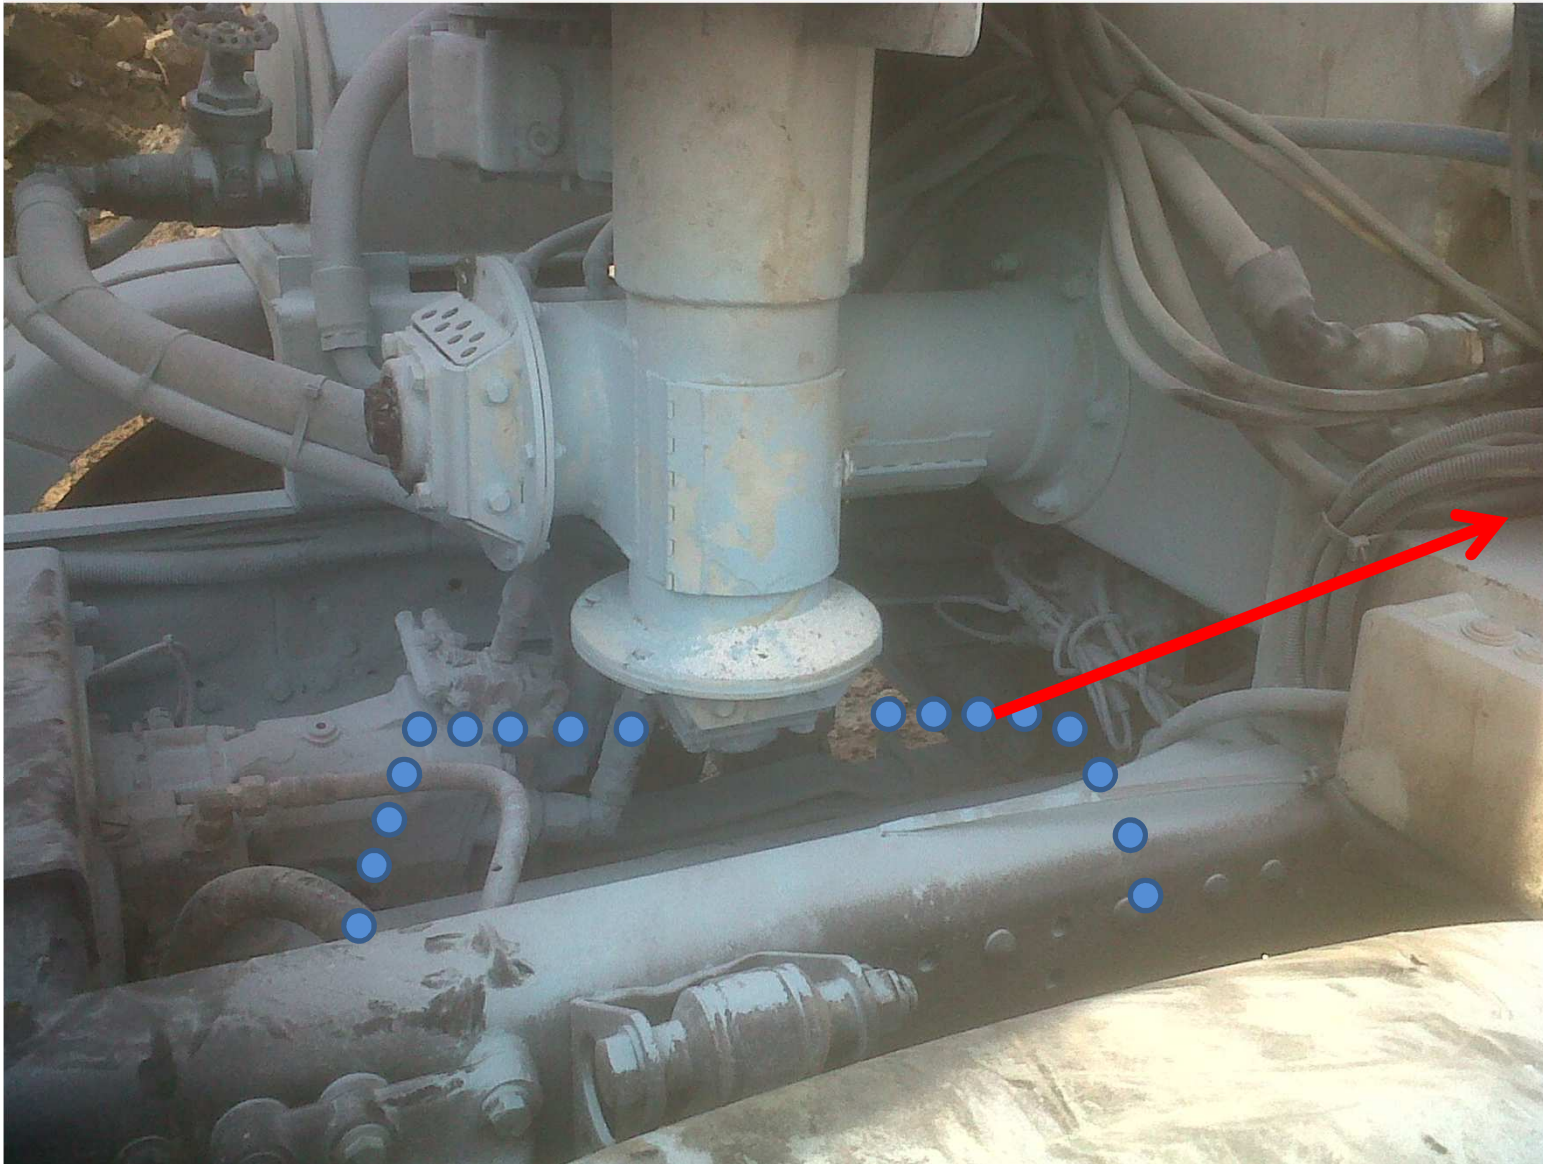
Glowing particles with light blue smoke.

- ❑ Up to 9:30 Normal production except many stop/start due to the blast design.
- ❑ Time zero= 9:30 (Still 18 boreholes to complete) *sound similar to “wet banger”*. David Jacquet and the Multiblend Operator (driver) have seen fumes and glowing particles from the bottom of the Multiblend truck vertical auger .

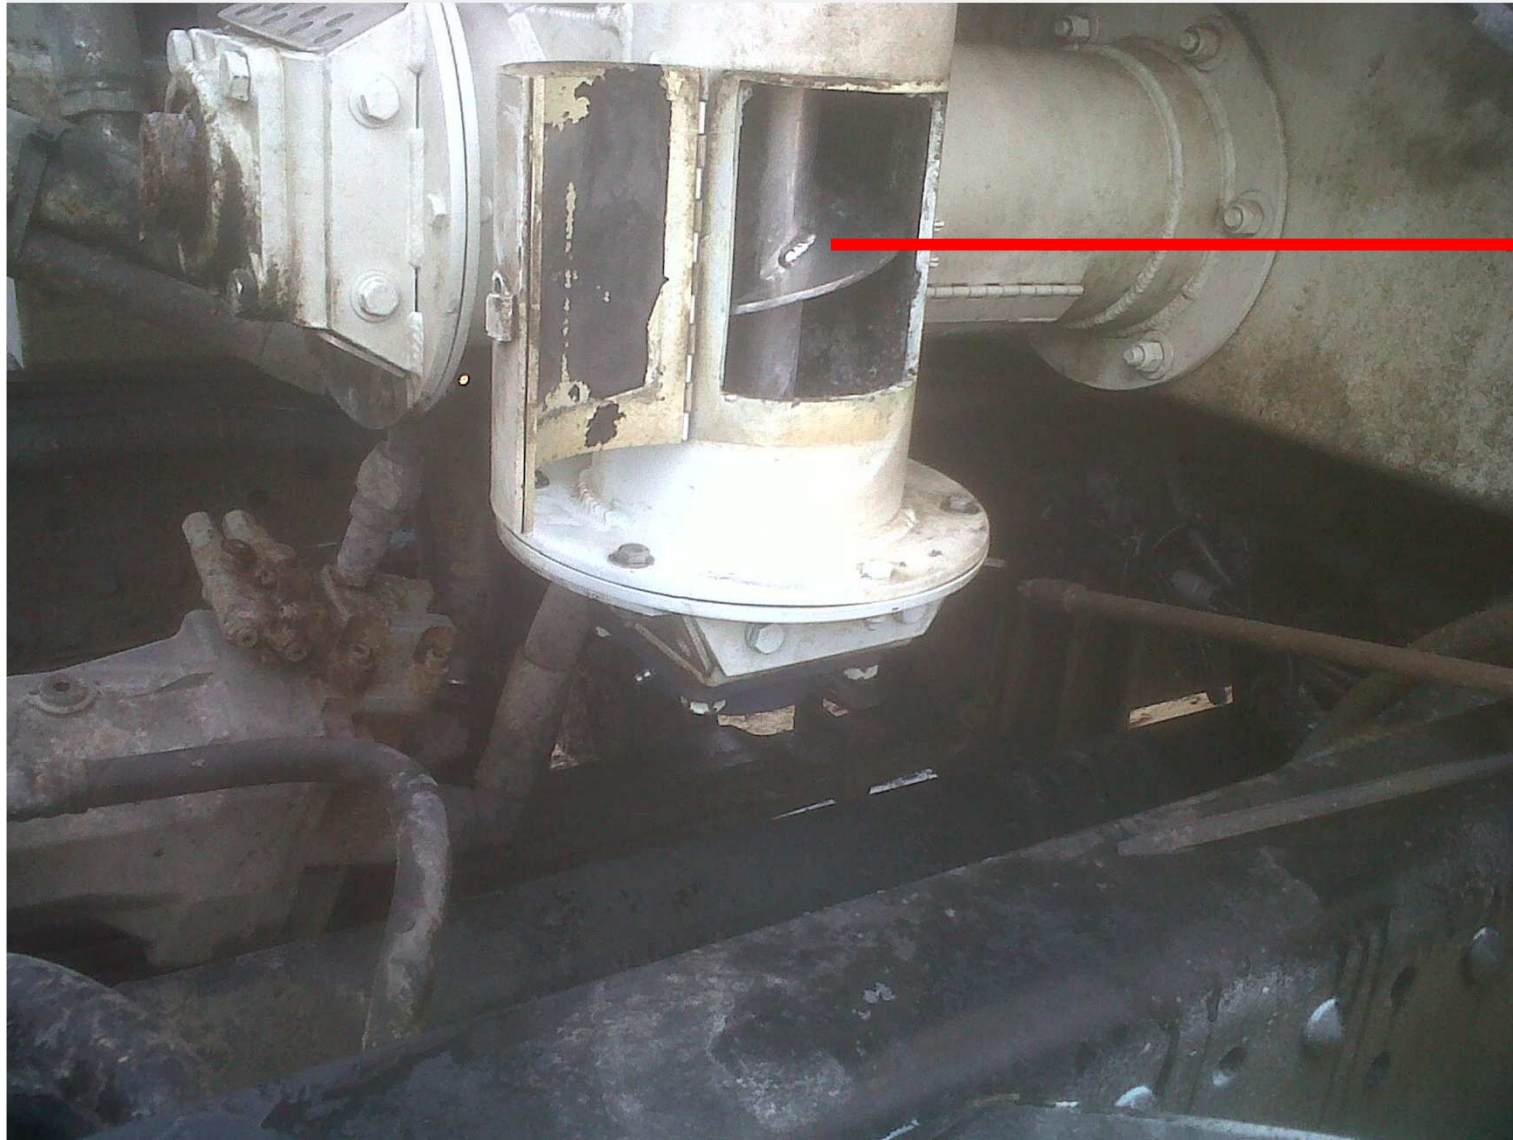
Vertical auger  
with AN (+ Al)

- ❑ **Combustion:** No particular smell, light Blue color fumes, Neither ammoniac odor, neither rubber odor. Location of the combustion at the bottom of the vertical auger just above the bearing and below the flange.

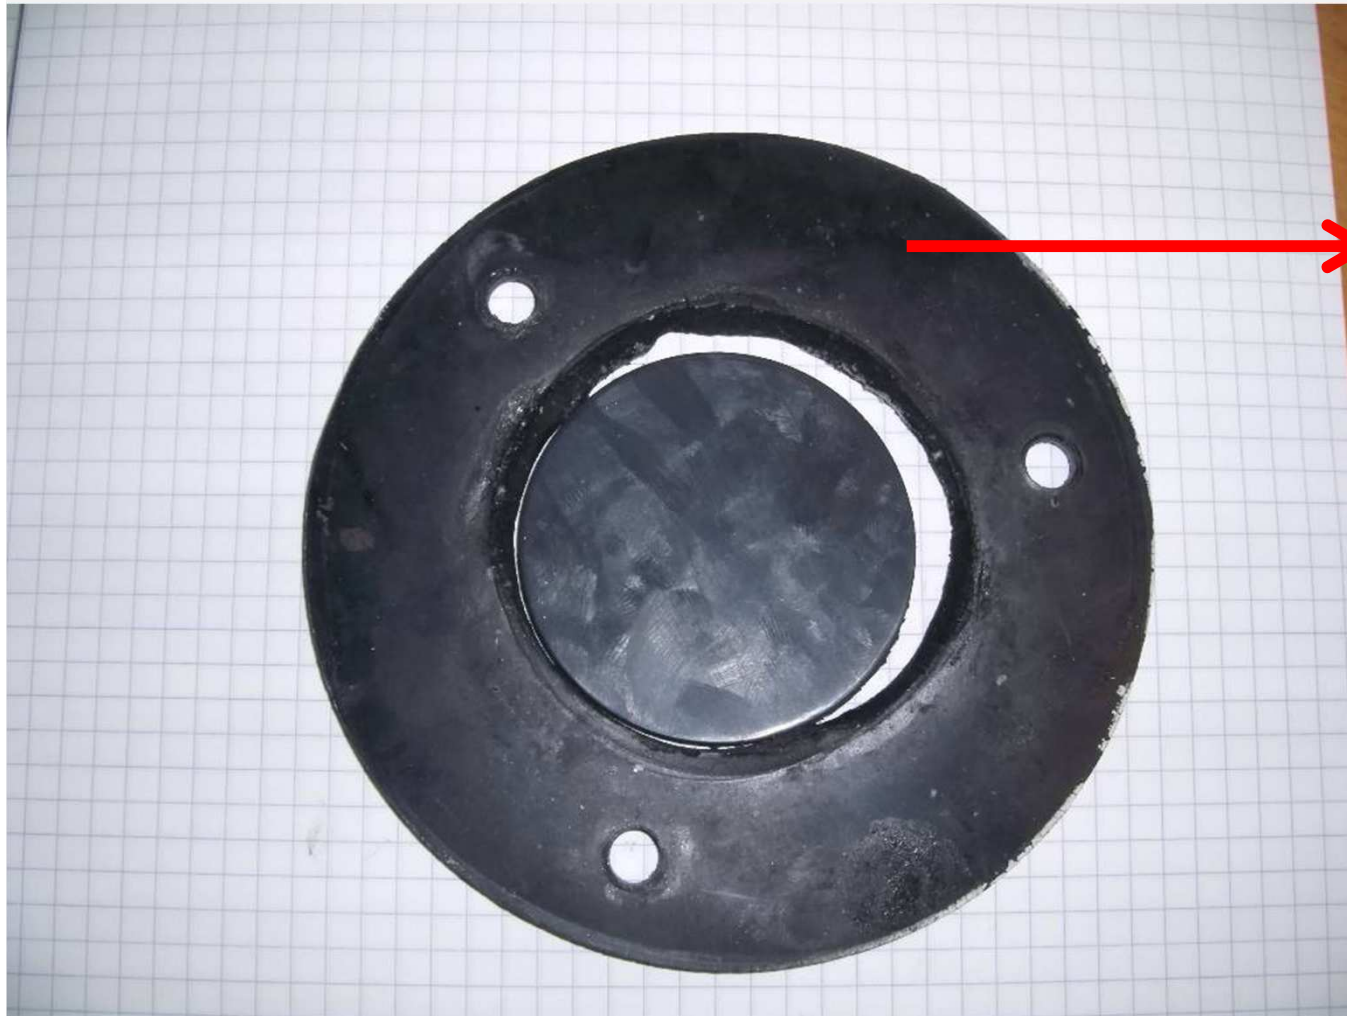
## Pictures of the gasket seal

- ❑ The principal cause of this incident was a lack of tightness of the seal in the vertical auger.
- ❑ This lack of tightness comes from the design of this auger ,but also we have to note a lack of good housekeeping and preventive maintenance rules.

- ❑ Fumes and particles glowing went out from an area just below the flange and above the bearing
- ❑ The gasket seal is in rubber and is worn and deformed. This seal is the original one mounted in 2009. The bearing has been changed in July 2011.
- ❑ An accumulation of fine particles (aluminium, nitrate) in contact with grease in the confined chamber had been discovered in the bearing. This confinement has increased the friction and reduced heat dissipation. Heat source by friction was located inside the bearing (ball bearings) at the bottom of vertical auger.
- ❑ The presence of the shaft guard on the bearing and the lack of cleaning allowed the accumulation of energetic product within the bearing.

- ❑ **Gasket seal located below the flange and above the bearing on the bottom of the vertical auger:** The seal is deformed which leaves the solids to fall down up to the bearing.

Now, once a month, visual inspection of the gasket seal and the bearing is carried out. At 12 months, the gasket seal and the bearing are replaced.

With the contribution of our technical service EPC-Innovation, a new design of the auger was made. The modification on the truck was implemented in January 2013. The modification of the auger has also been implemented to improve the sealing arrangement.

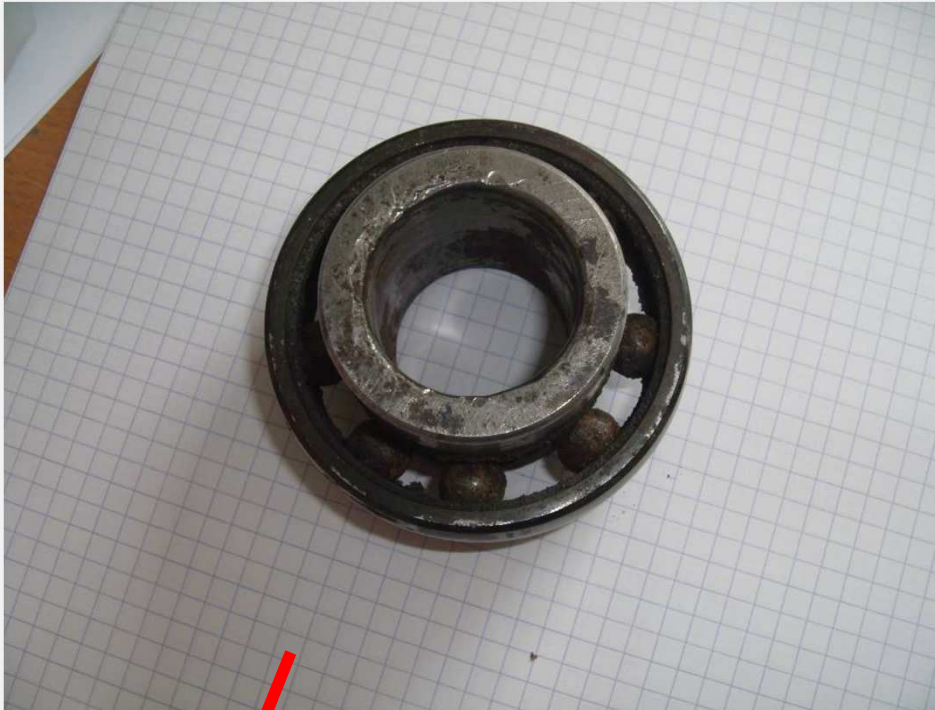
- ❑ **Maintenance:**
  - Bearing of the vertical auger replaced on July 2011.
  - Gasket seal not changed on July 2011 (original one in 2009)
  - Greasing of the bearing had been done 2 weeks before.
  - Rest of grease had been found at the peripheral of the bearing but not with the balls inside the bearing .

- ❑ **Ball Bearing concerned by the incident:** The balls are worn. Absence of grease at all. Balls are yet greased for life .

- The bearing is becoming jammed due to the presence of ammonium nitrate, aluminium on the balls.
- The bearing was jammed and the hydraulic motor had obliged the bearing to run forcing him to be overheated at high temperature. We are sure of that due to an appropriate observation of the bearing.
- The overheating phenomena has initiated a combustion seen by the operators as fumes and glowing particles.

From the results of the tests from the EPC-France Lab, we have changed the type of bearing by using a bearing with structured steel (which cannot burn in case of overheating).

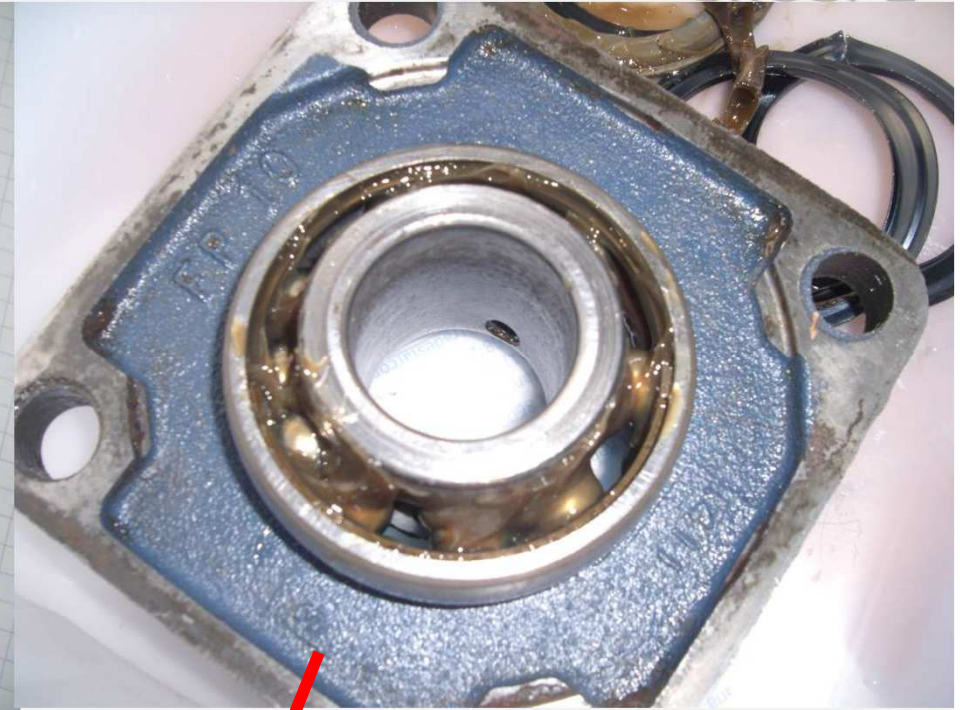
- ❑ **New Ball Bearing:** The balls are surrounded by grease and looks new.
