RDX EXPLOSIVE ACCIDENT INVESTIGATION  
REPORT

# Background to the incident

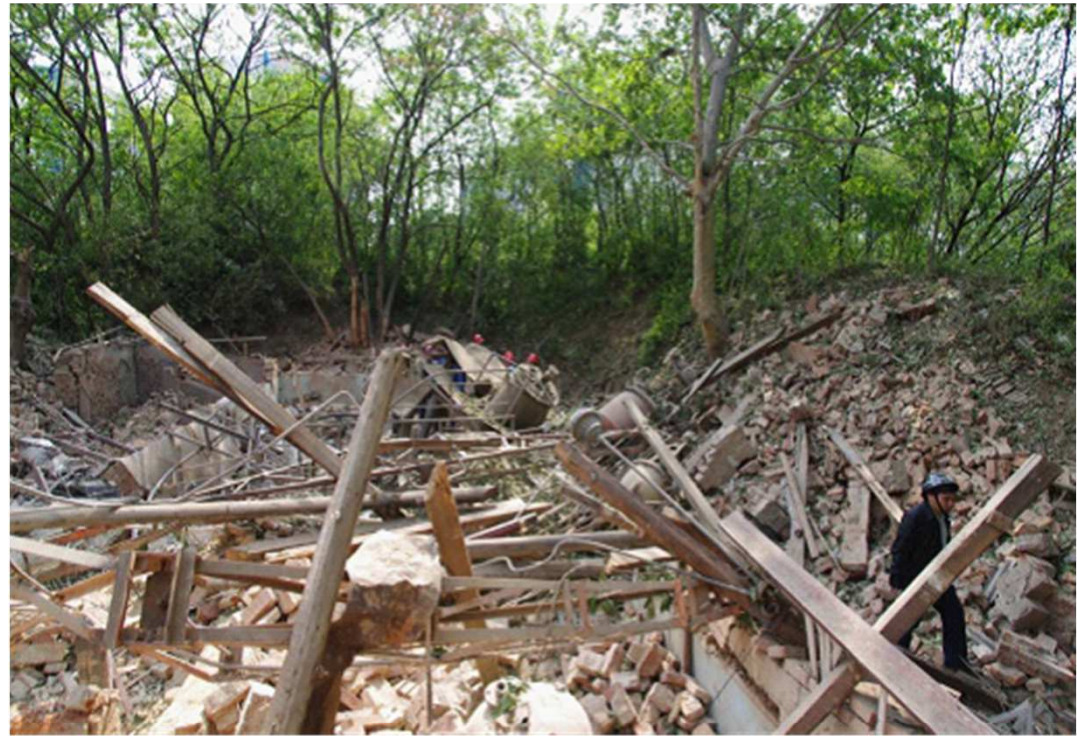
The two kilogram stage reactors were destroyed by a falling concrete slab. The 300 liter reactor on the second floor toppled over and was deflected clockwise.

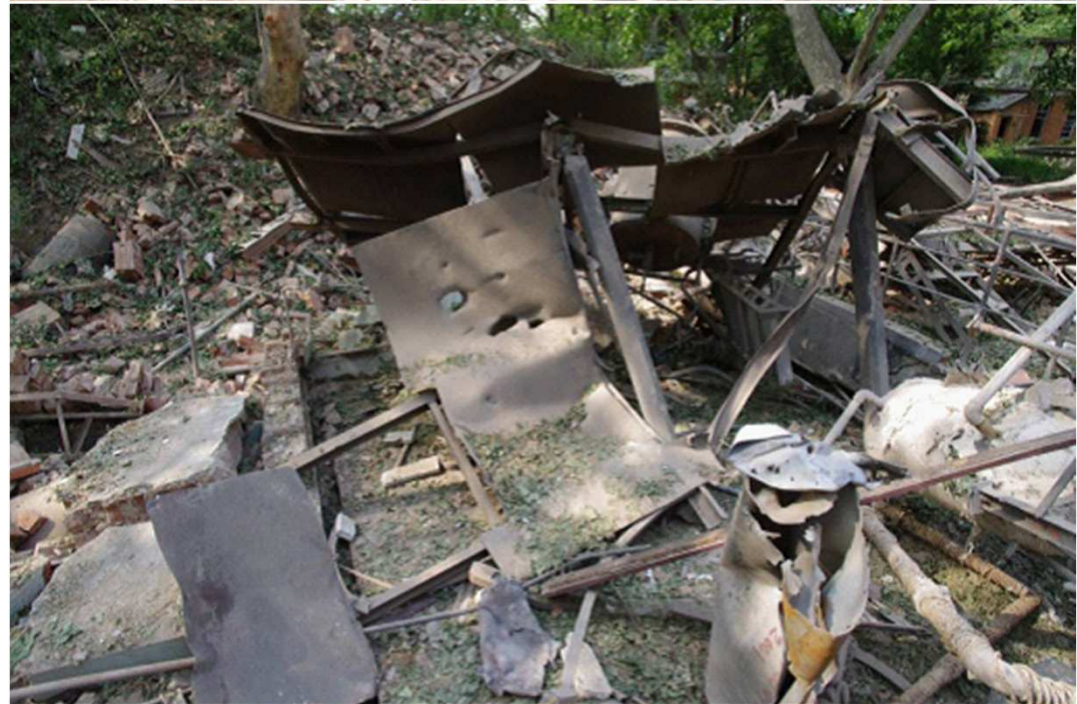
As an effect of the blast wave, the steel structure was displaced Southwest, and was broken. It should be noted that there has been intensive bottom-up perforation of the steel platform of the third floor by shrapnel .

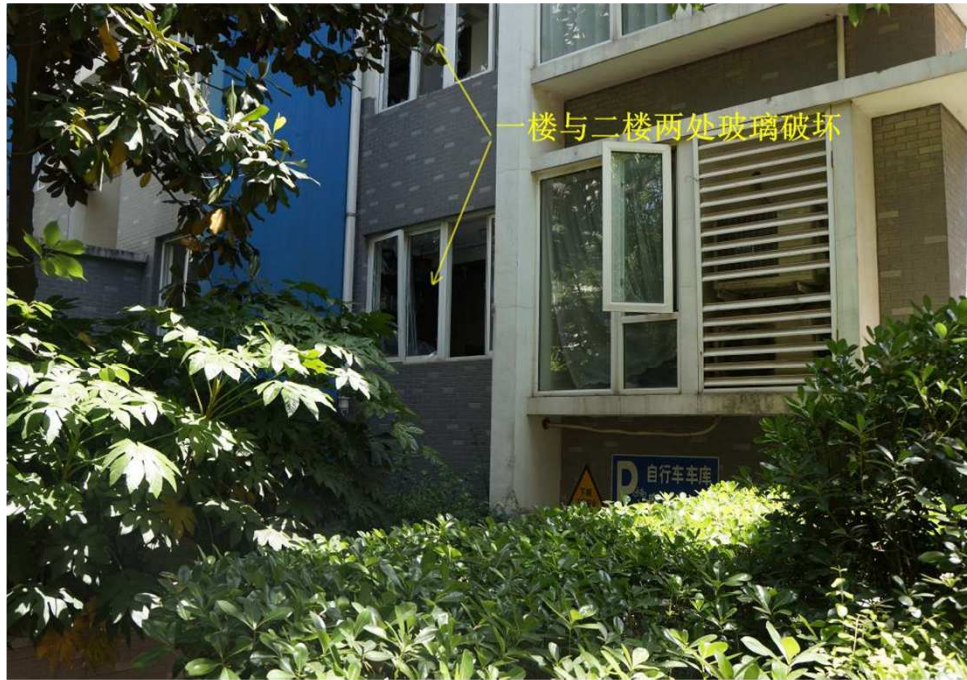
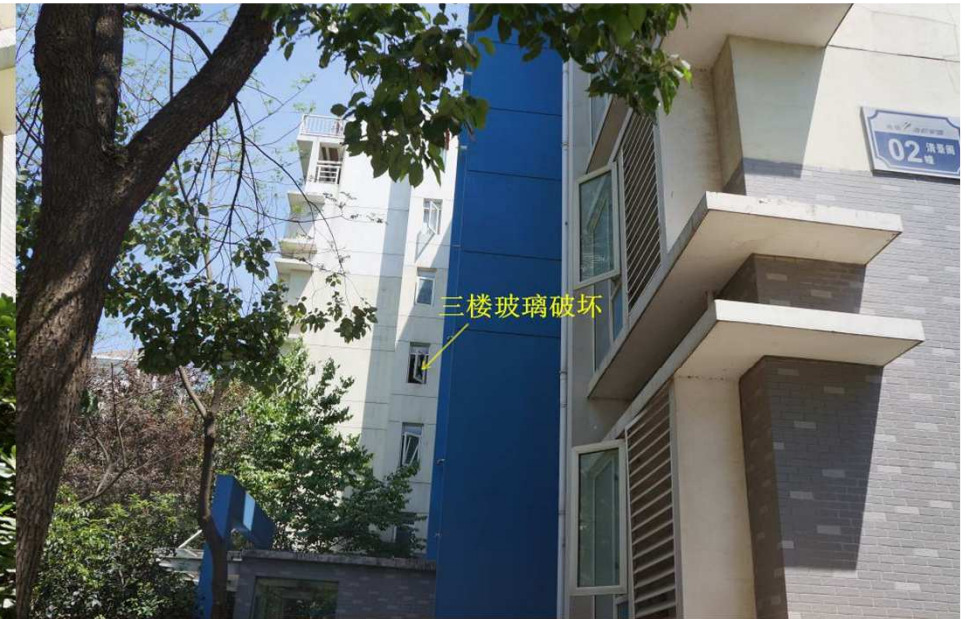
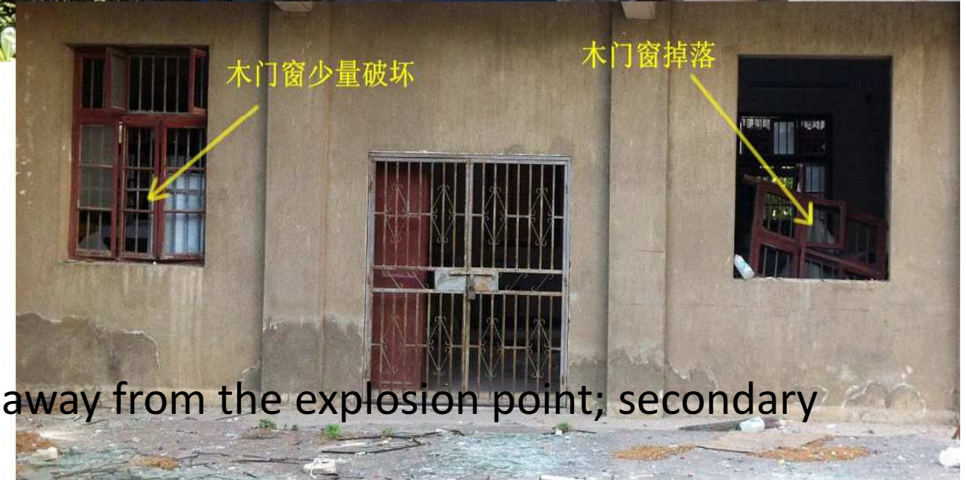
- After the explosion, two damaged windows were selected (marker 1, marker 2) from the surrounding residential area as well as a wooden door and window (marker 3) of the workshop 827 as the markers for estimating the TNT equivalent. The results are shown in Table 1. According to Table 1, we can determine the TNT equivalency of the explosion at about 3.8kg ~ 8.2kg.

Maker 1 This marker was about 46.8 meters away from the explosion point; secondary damage, weak

Maker 2 This marker was about 71.3 meters away from the explosion point; secondary damage, weak

Maker 3 This marker was about 49.7 meters away from the explosion point; secondary damage, strong

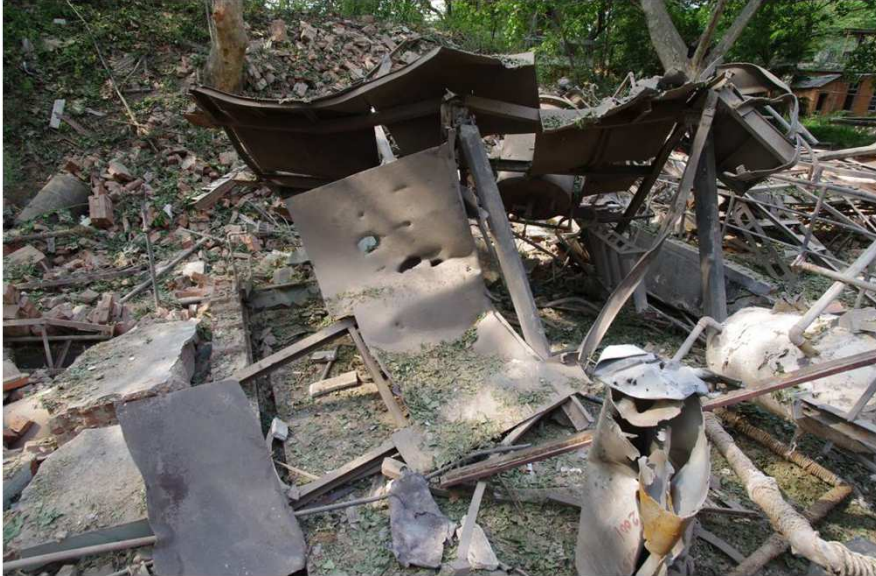
- Evidence 1: the flight direction of the steel platform of the third floor was Northwest, which proved the blast wave was from the Southeast side of the platform. There also has been intensive bottom-up shrapnel perforation on the steel platform of the third floor, which proved the fragments were from the lower part under the platform.

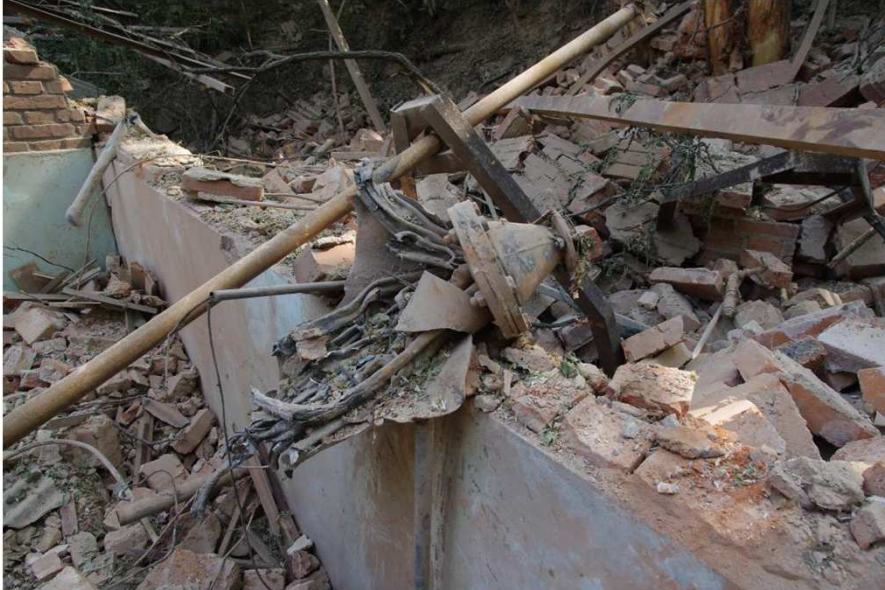
- Evidence 2: The steel platform of the second floor sustained multiple penetrating fragments from top to bottom, which proved the fragments were from the above of the platform. The steel structure was displaced Southwest as a whole, and was broken, which proved the blast wave was from the Northeast side of the whole steel frame.

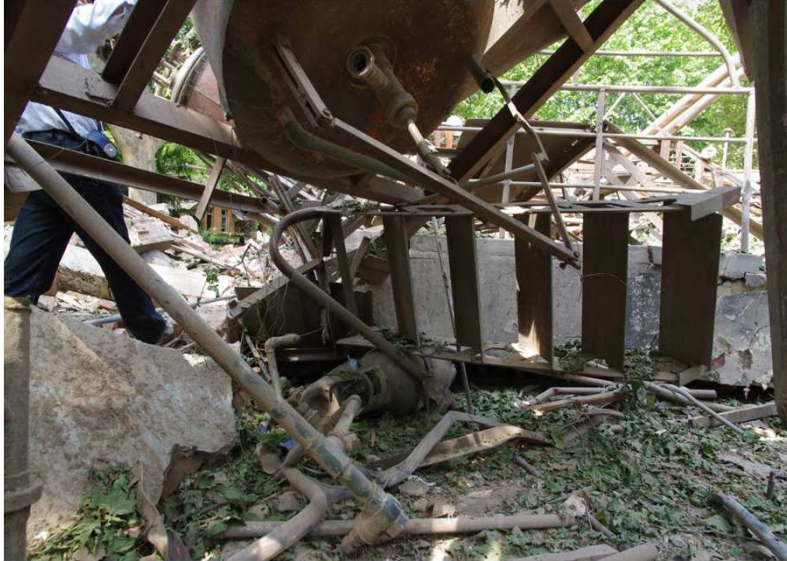
- The cause of this explosion was clearly the gas cutting action which ignited the combustible and flammable residue in the pipe ,which then burned to detonation.

- Evidence 1: Gas and oxygen cylinders used for gas cutting were found at the scene.

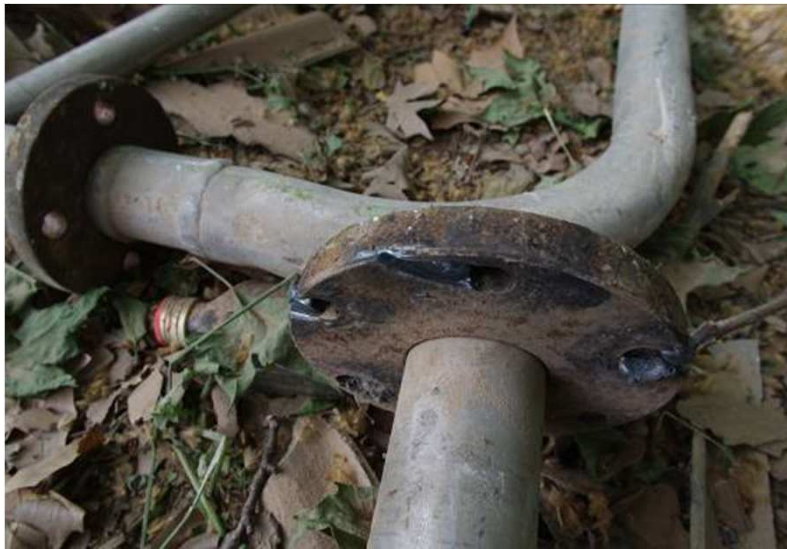
- Evidence 2: From the device and pipes already demolished, it was evident that flame cutting was used
