EXPLOSION IN DETONATOR ASSEMBLY HOUSE

R.K.GUHA

SOLAR INDUSTRIES INDIA LTD.

SUMMARY OF THE INCIDENT

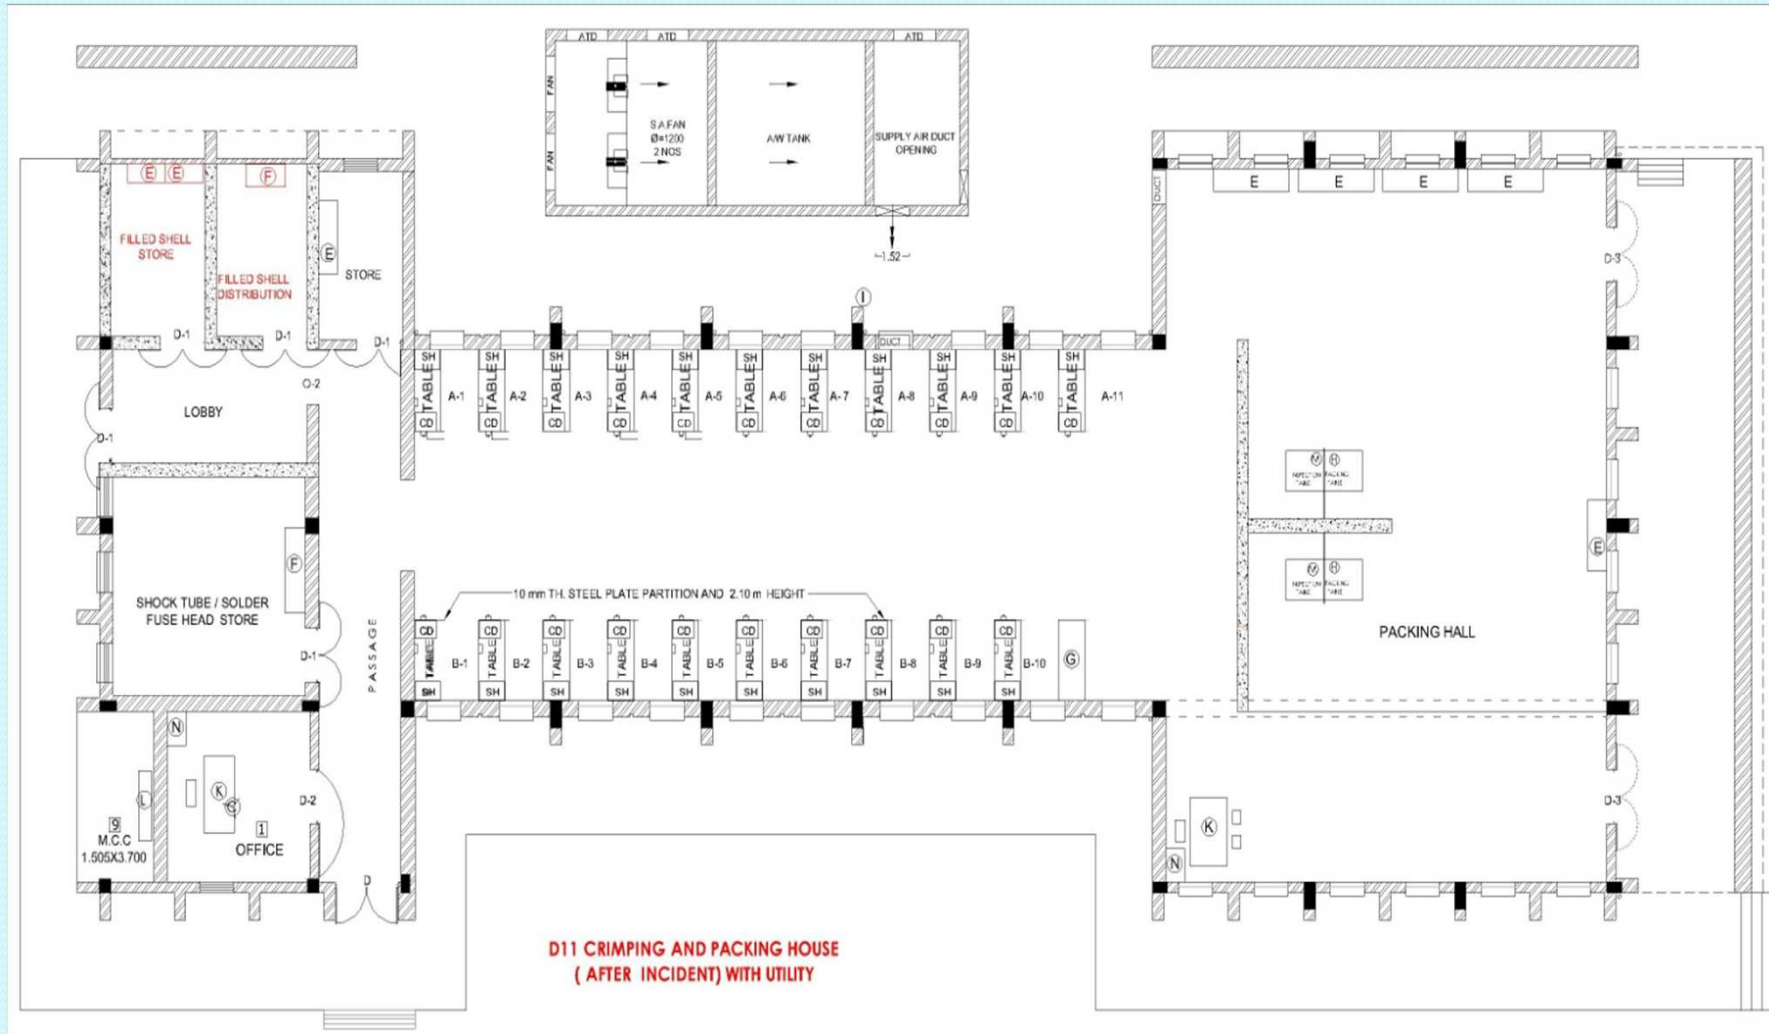
LAYOUT OF BUILDING AFTER EXPLOSION

- **A. EXAMINATION OF SITE OF INCIDENT :**
- CONCRETE ROOF OF THE FILLED SHELL ROOM WAS BLOWN OFF
- ALL WOODEN RACKS AND TABLE HAD BURNT TO ASHES
- SEVERE STRUCTURAL DAMAGE OCCURRED TO THREE OTHER NEARBY ROOMS. THERE WAS ONLY MINOR DAMAGE TO THE CRIMPING HALL
- A NUMBER OF EXPLODED AND UNEXPLODED DETONATORS WERE FOUND
- TWO CRATERS OF ABOUT 2FT. X 1FT. WERE SEEN ON THE FLOOR OF THE FILLED SHELL ROOM
- NO DETONATORS IN THE CRIMPING HALL WERE AFFECTED
- THE CHARRED BUT INTACT BODY OF THE OPERATOR WAS SEEN LYING ON THE FLOOR WITH HIS LEGS FACING THE DOOR OF THE ROOM.

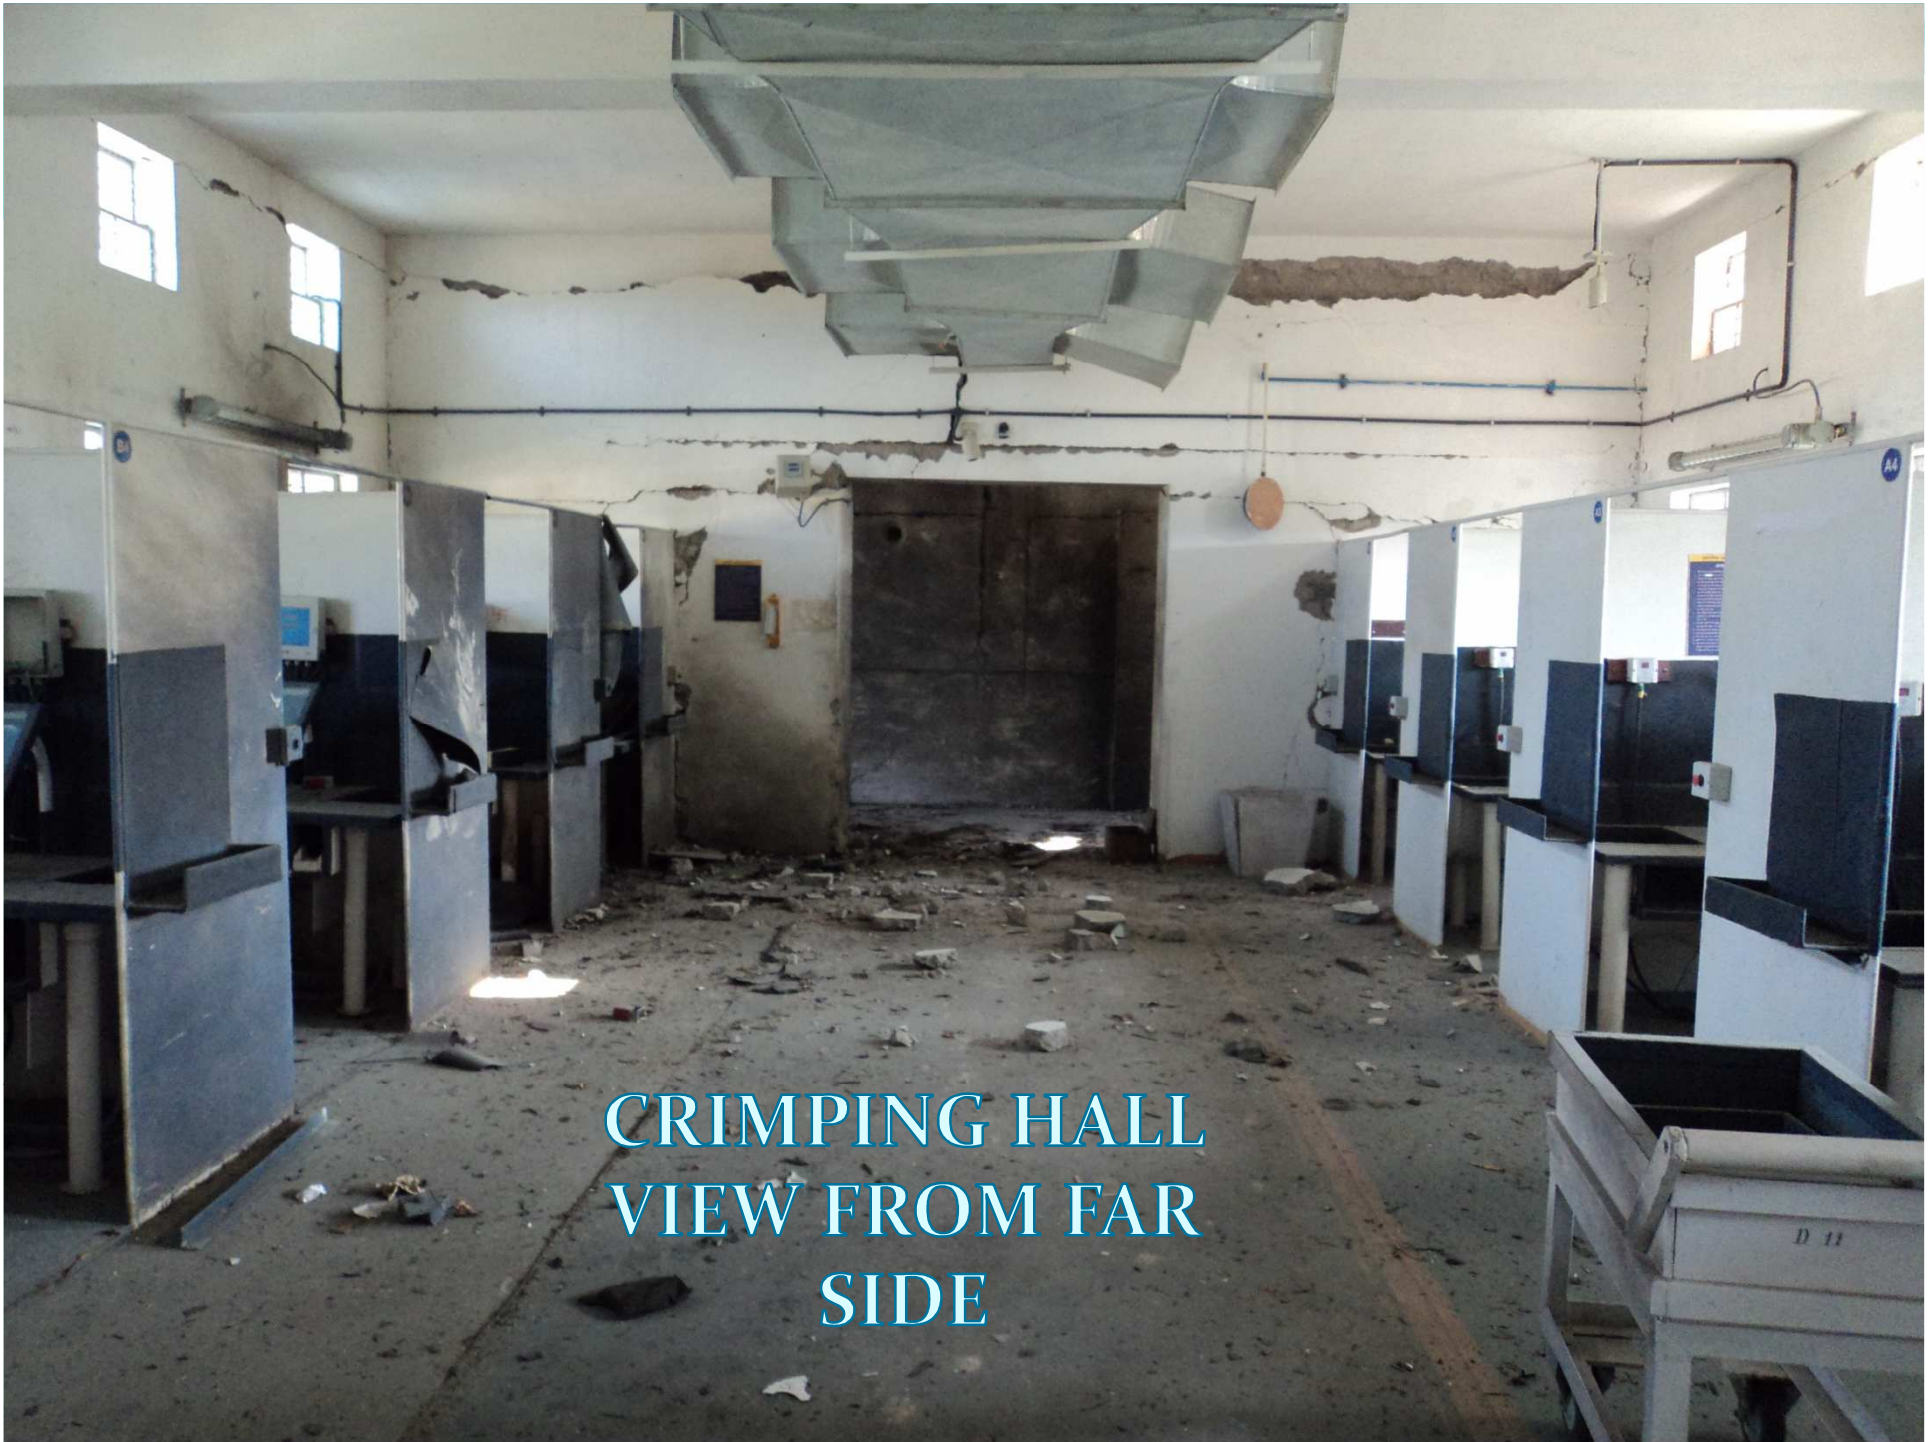
CRIMPING HALL
VIEW FROM FAR
SIDE

ROOM FROM WHERE
EXPLOSION INITIATED

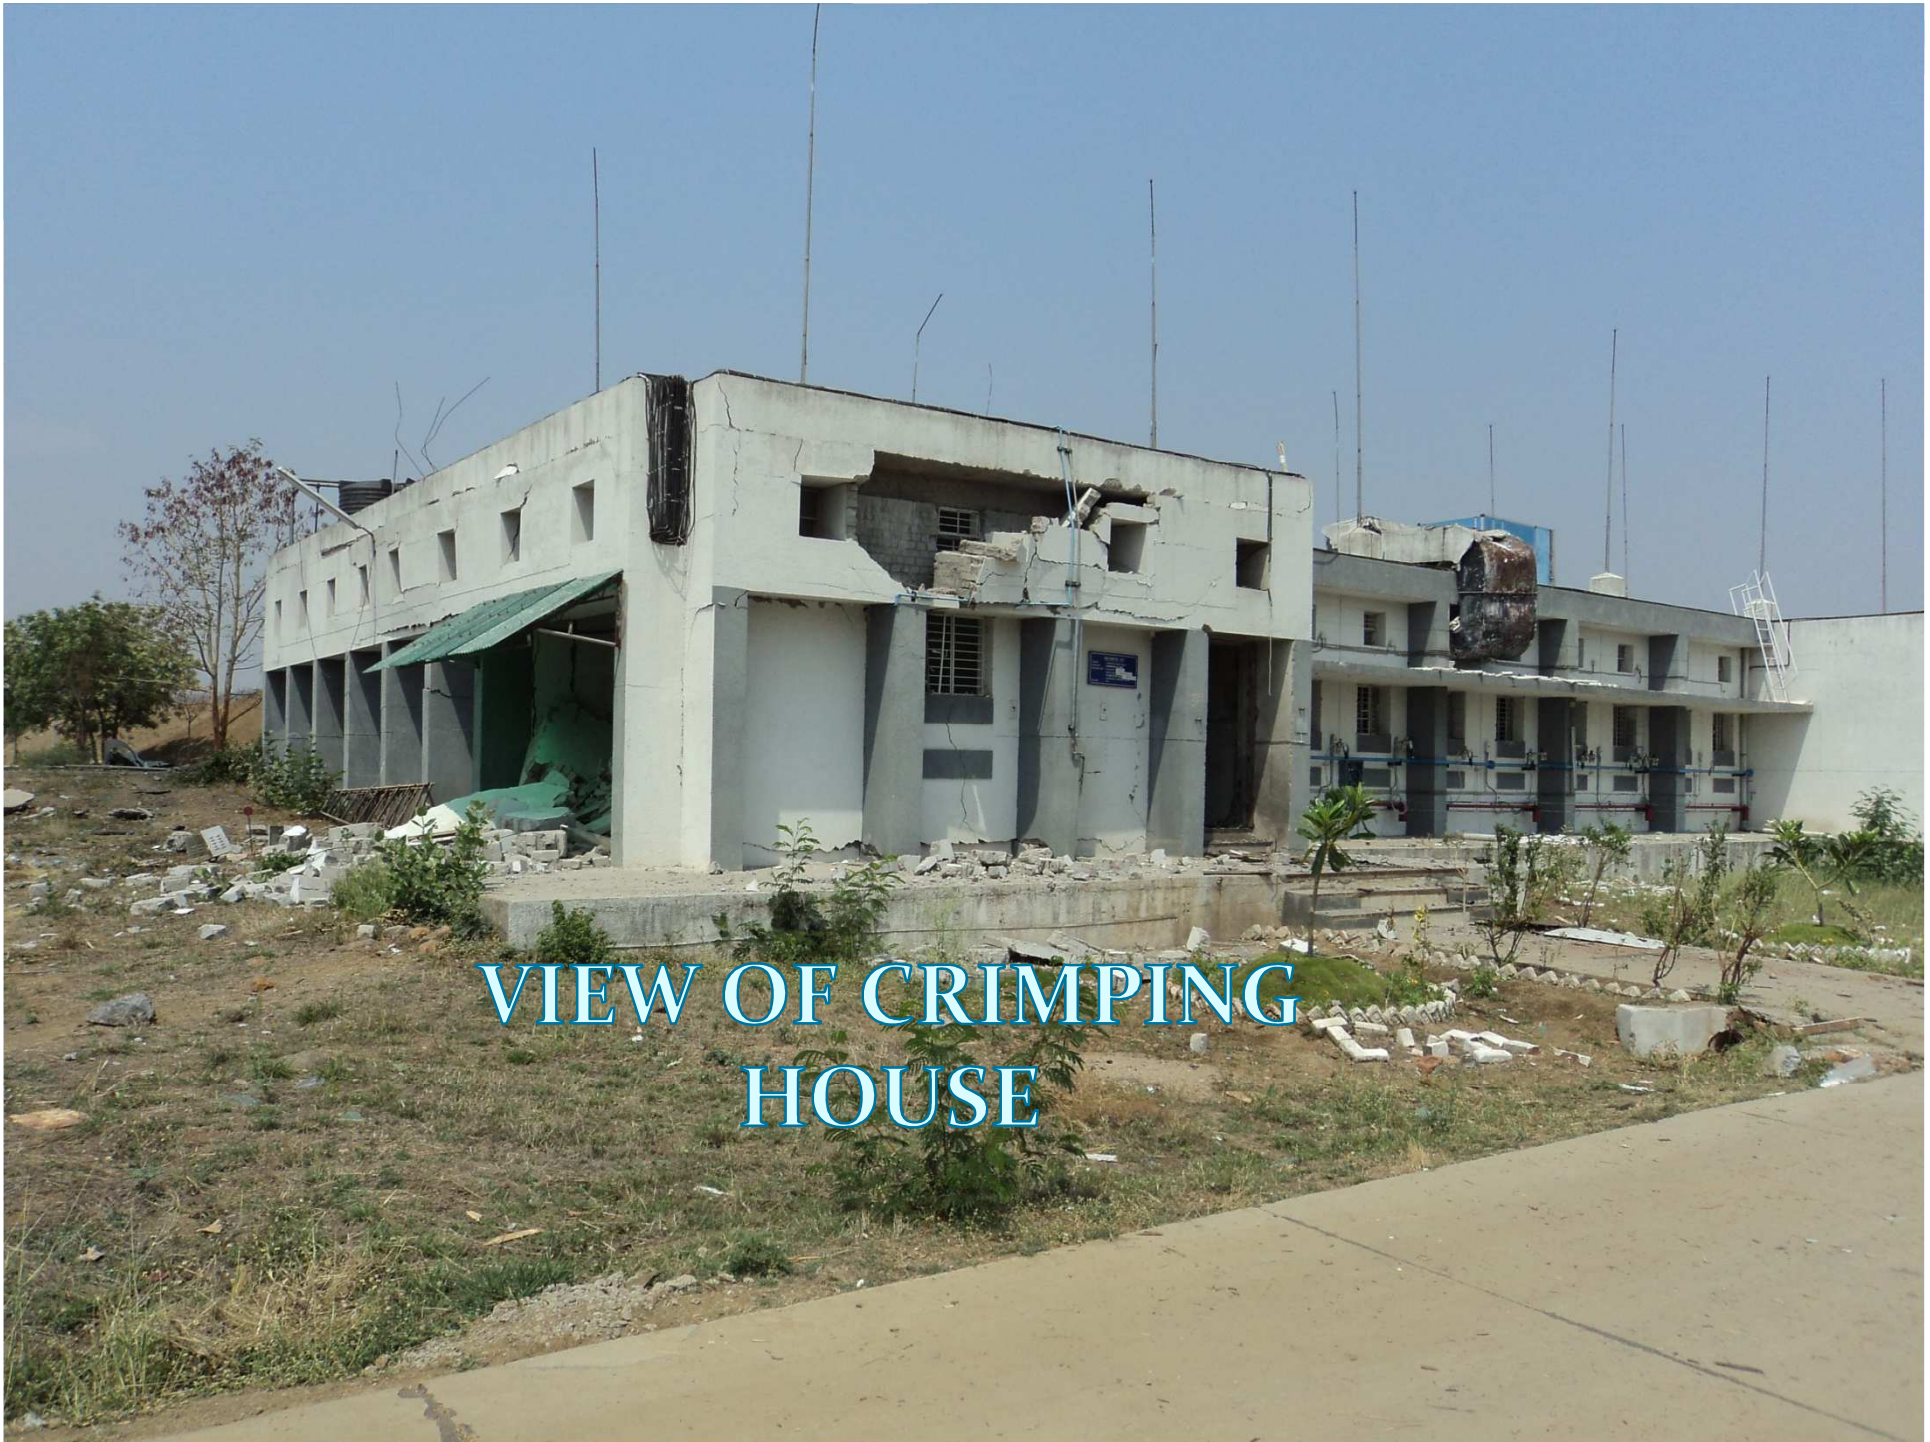
VIEW OF CRIMPING
HOUSE

DOOR ENTRANCE TO
FILLED SHELL ROOM
