A SERIES OF PRESS INCIDENTS

2013-12-12

Austin Detonator s.r.o.
Vsetín / Czech Republic

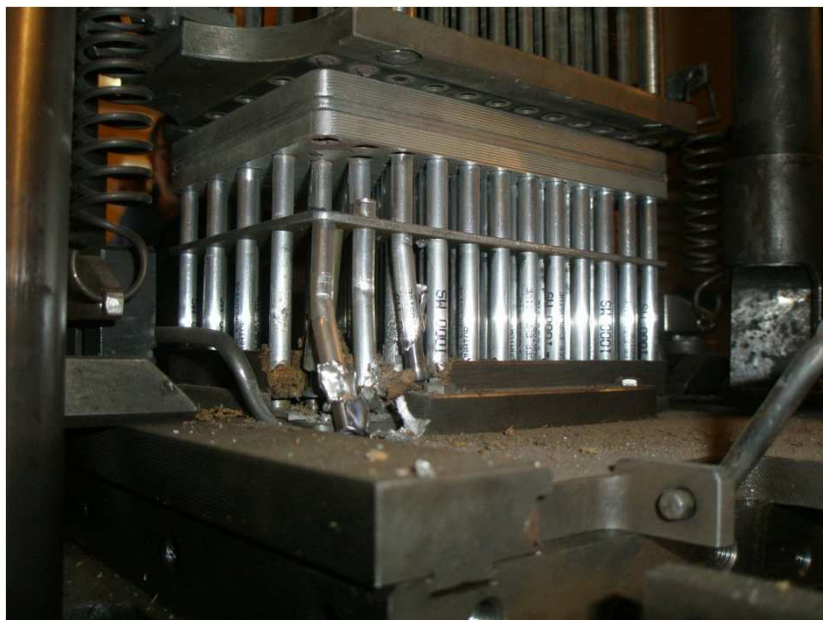
X = 3

X detonators detonated

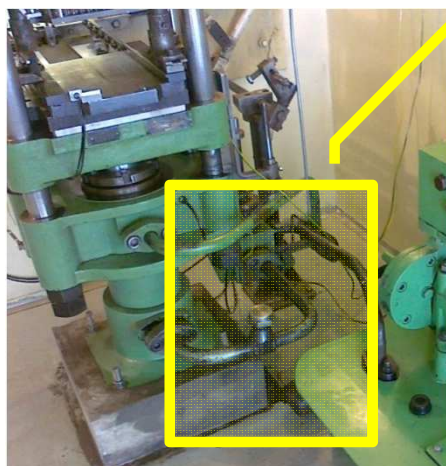
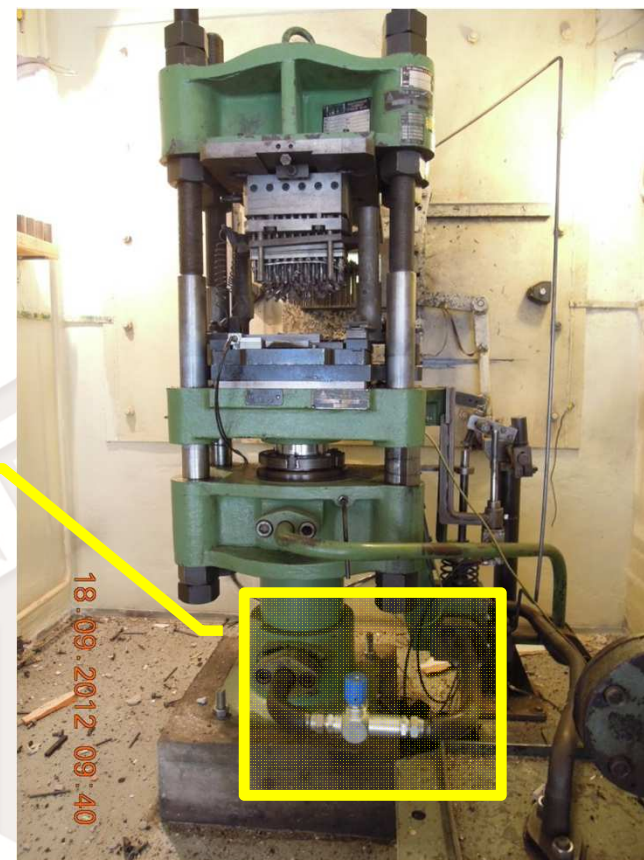
- ◆ **by coincidence** after the first explosion **we replaced** the „old design“ valve of hydraulic unit to the „new design“ valve **to save press time** during reverse running.

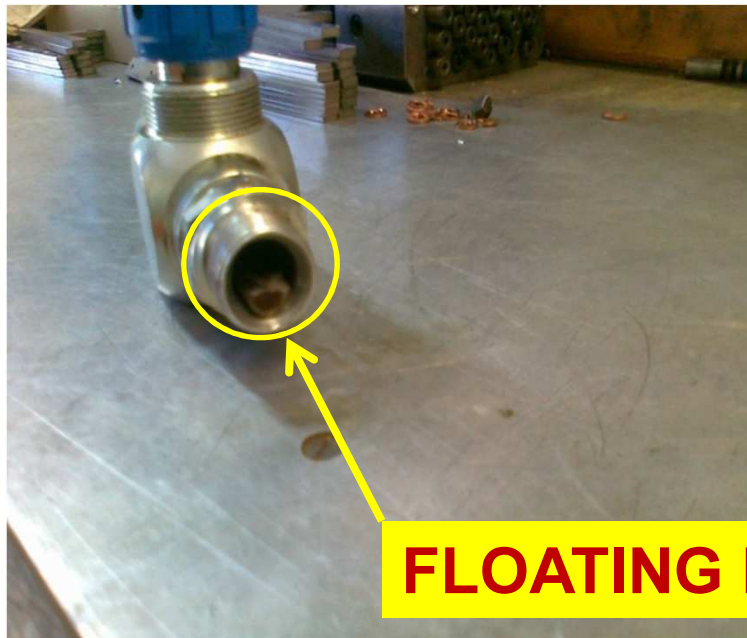
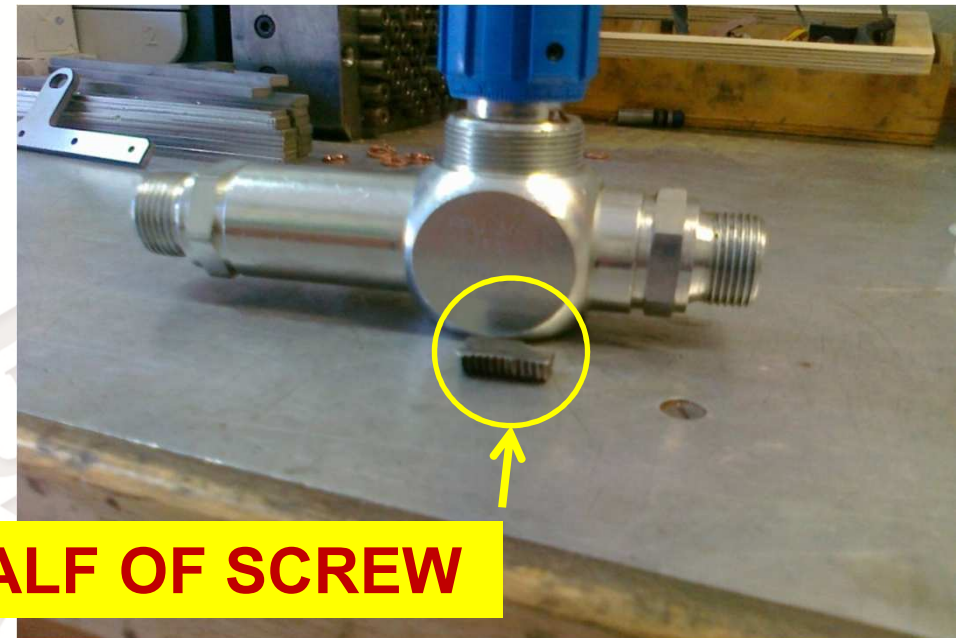
FLOATING HALF OF SCREW

- ◆ Down to hard work we observed after the third explosion that **half of a screw blocked** the „new design“ valve in the hydraulic unit.

- LOST SCREW
- INNER DIAMETER of SHELL (STEP 18)

- **Explosion stopped once we had:**
 - removed lost screw,
 - reinstalled the old design valve
 - slightly widened the inner diameter of shell to reduce friction between shell and delay element.
