# EXPLOSION DURING THE OPERATION OF DOSAGE OF PRIMARY EXPLOSIVE

SATURDAY, June 30th 2012 at 22.15

***Company Facility:***  
Factory of Santiviáñez (Bolivia)  
Dosage of primary explosive (70% Lead Azide and 30% Lead Styphnate) building (D05)

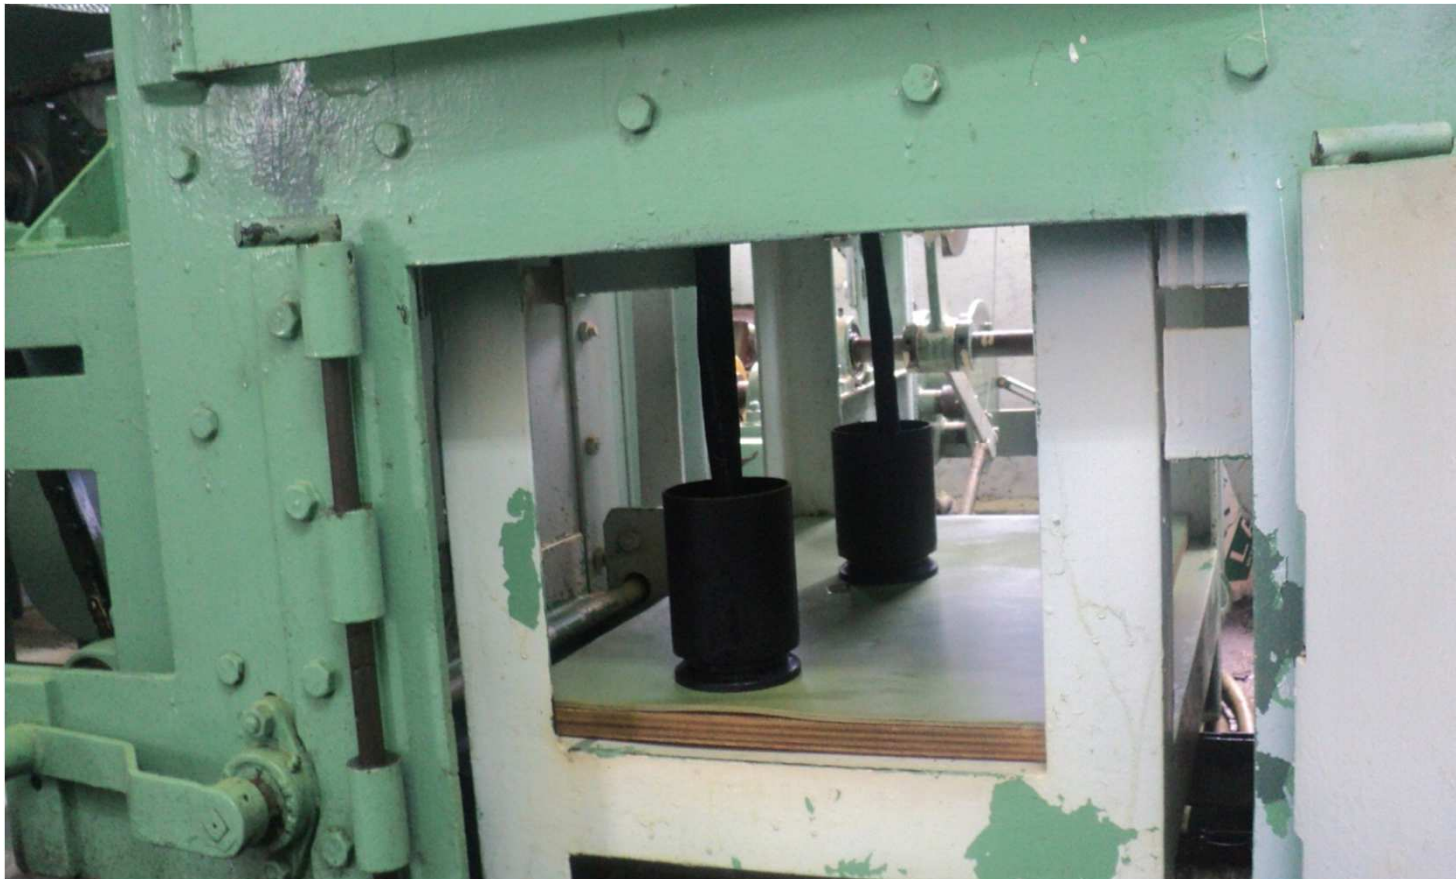
At 22:15, the operator of the post was performing the daily final cleaning of the machine. At the very moment of starting to remove the second container from the surface of the machine on which it was placed, it detonated.

This second container had approximately 40 gr of explosive and picked up the finest dust. It is also notable that this second container was located further from the position of the operator than the first container that had already been removed.

In this picture, taken after the accident and with some corrective actions already implemented, the relative position of the first and second container can be seen from the operator's point of view.

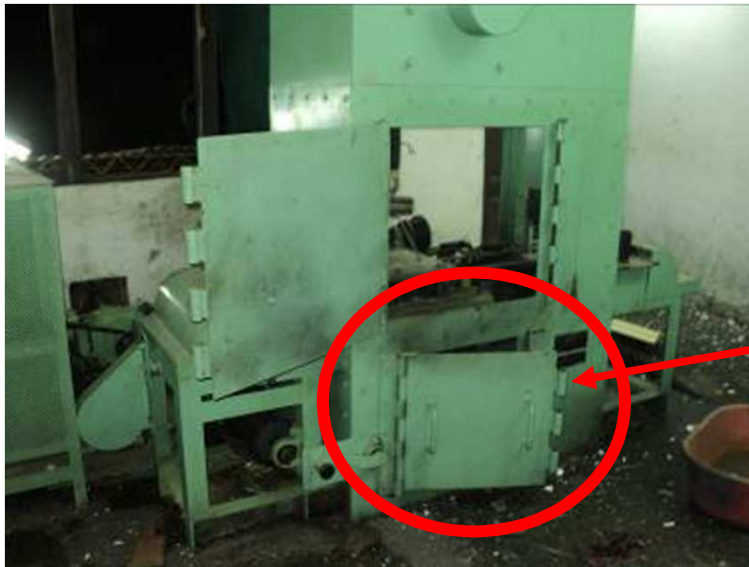
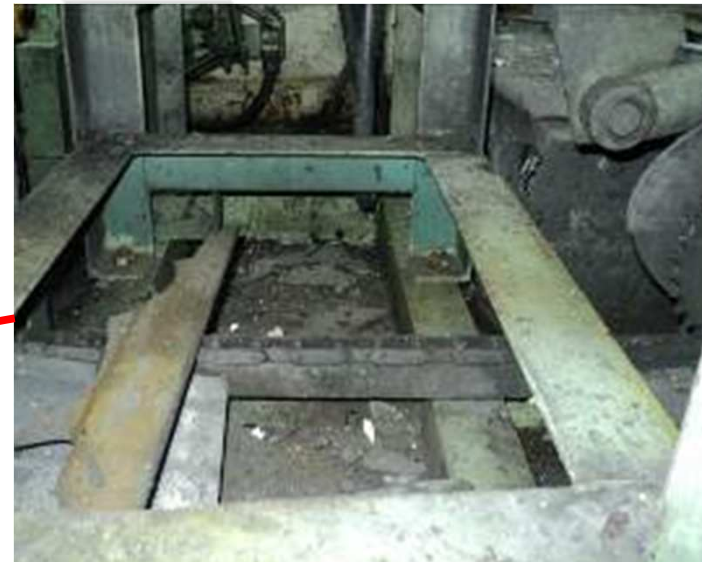
At the place of the accident, it became a proven fact that the most damaged spots were those where primary explosive waste had built up, particularly:

- Stainless steel funnel through which primary explosive waste travelled to the container placed on the lower part of the machine.
- Surface on which the container with the primary explosive was placed.

- The container that detonated was the one that picked up the finest dust and became coated on both inside and outside walls with the primary explosive.
- The surface upon which the container and the explosive were placed was not completely smooth but showed a certain degree of roughness.
- The place where the container was located did not allow the operator to have a good visibility of the object he was to remove and also forced him into a position that did not favour a good balance of his body, thus increasing the likelihood of making mistakes.

From these hypotheses it can be deducted that the operator, not having good visibility of the container, did not take in the presence of fine dust next to its base.

Then, the operator dragged the container creating friction between its base and the surface on which it was supported.

The energy engendered by the friction was over the threshold and ignited the dust present on the surface.

In order to avoid the impregnation of the surfaces of the container with dust, it will contain a certain amount of water that will minimize the presence of dust.

The surface upon which the container was located was changed to a smooth, soft, antistatic surface.

The amount of fine dust created in the operation was decreased by performing a pre-sieving of the primary explosive. This diminished the presence of dust on the surfaces of the equipment.
