# AIR OVEN ACCIDENT INVOLVING PYROTECHNIC COMPOSITION

Dr. N.V. SRINIVASA RAO  
PREMIER EXPLOSIVES LIMITED  
HYDERABAD; A.P; INDIA

## **ABSTRACT**

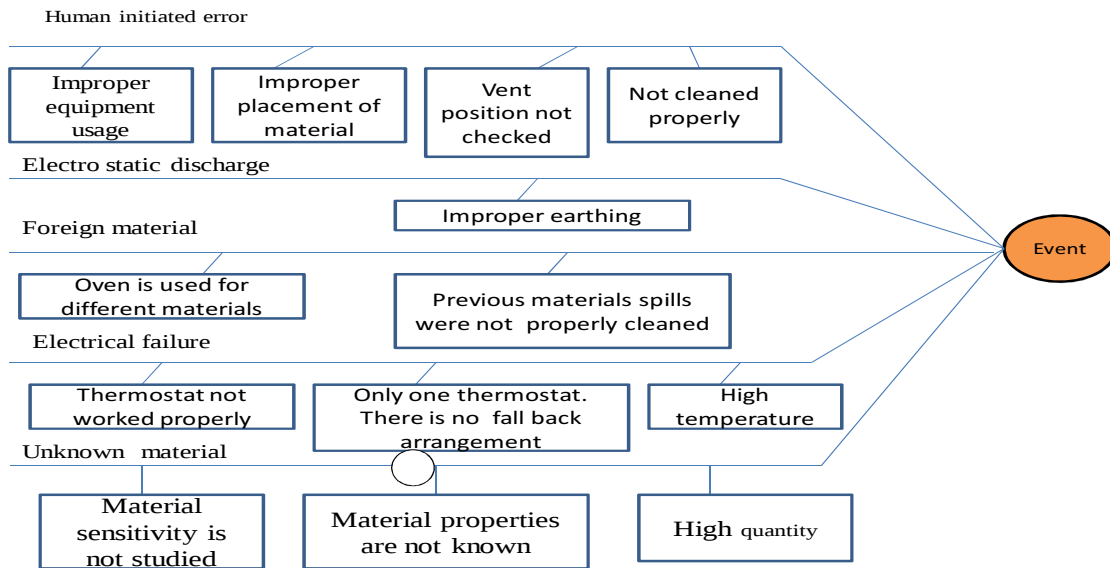
The participants after visiting the remnants and discussing the incident identified various undesirable aspects and basing on those a model has been made as shown in figure. 1.

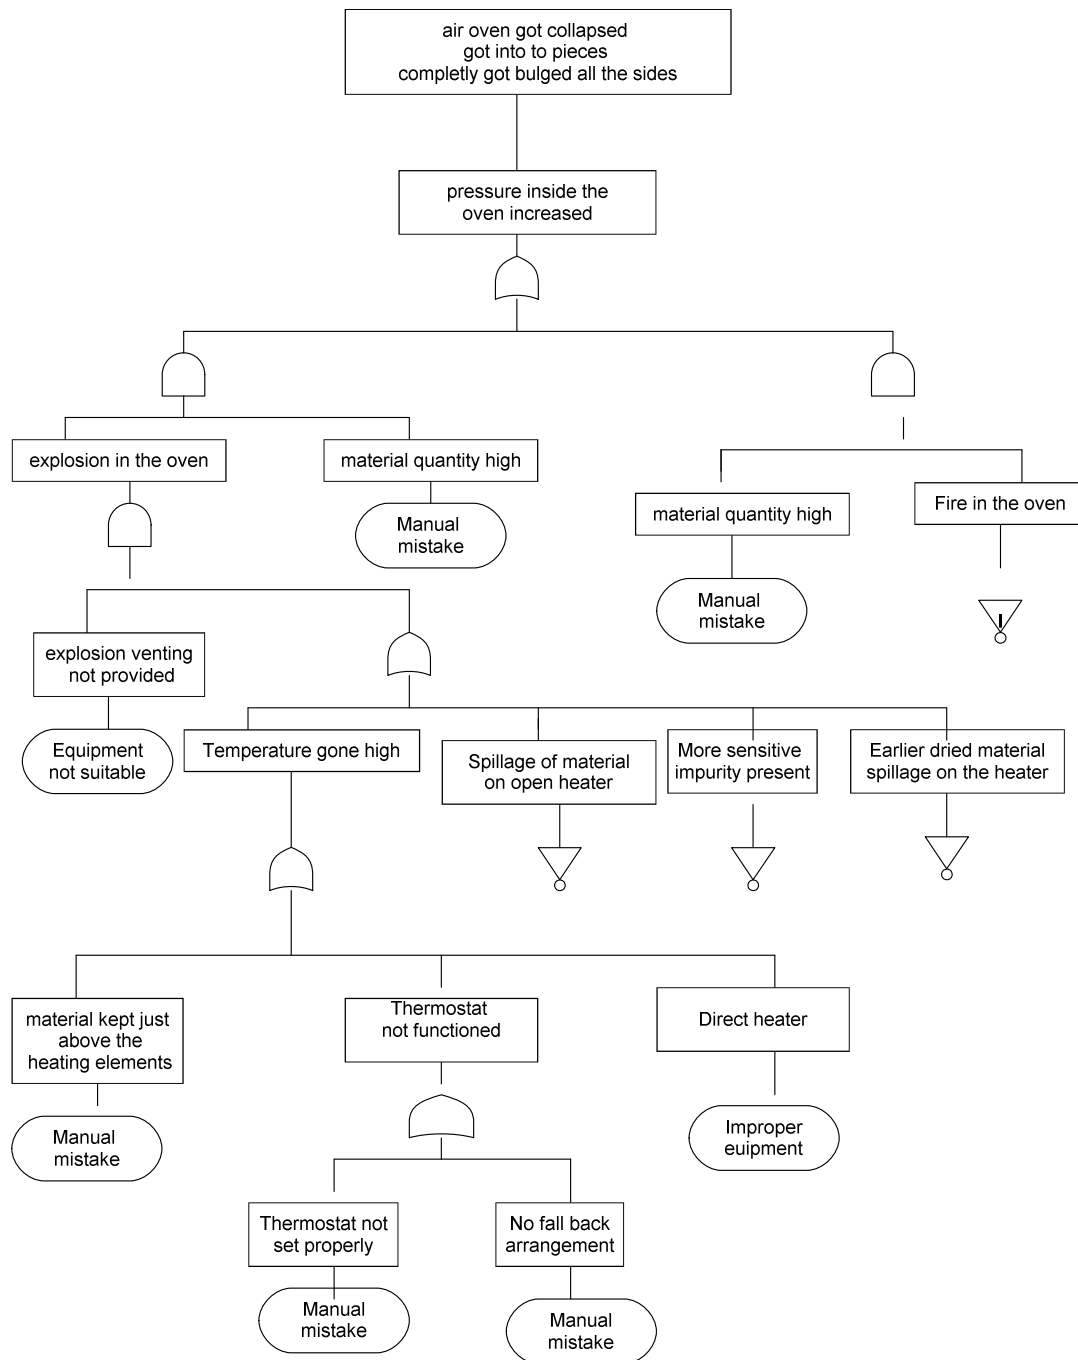
\_\_\_\_\_ TREE-1 \_\_\_\_\_

The above fault tree shows various reasons that might have caused the incident

With the available data and the analysis the most probable reasons appear to be manual mistake, faulty equipment or/and systems failure.
