## INVESTIGATION REPORT

**INCIDENT  
NOTICE NO.**  
**IN15-09**

**INVESTIGATION  
REPORT NO.**  
**IR846**

- a. **Company name:** Austin Powder Argentina
- b. **Company facility:** HMX Plant, Rafaela, Santa Fe, Argentina
- c. **Process outline:**

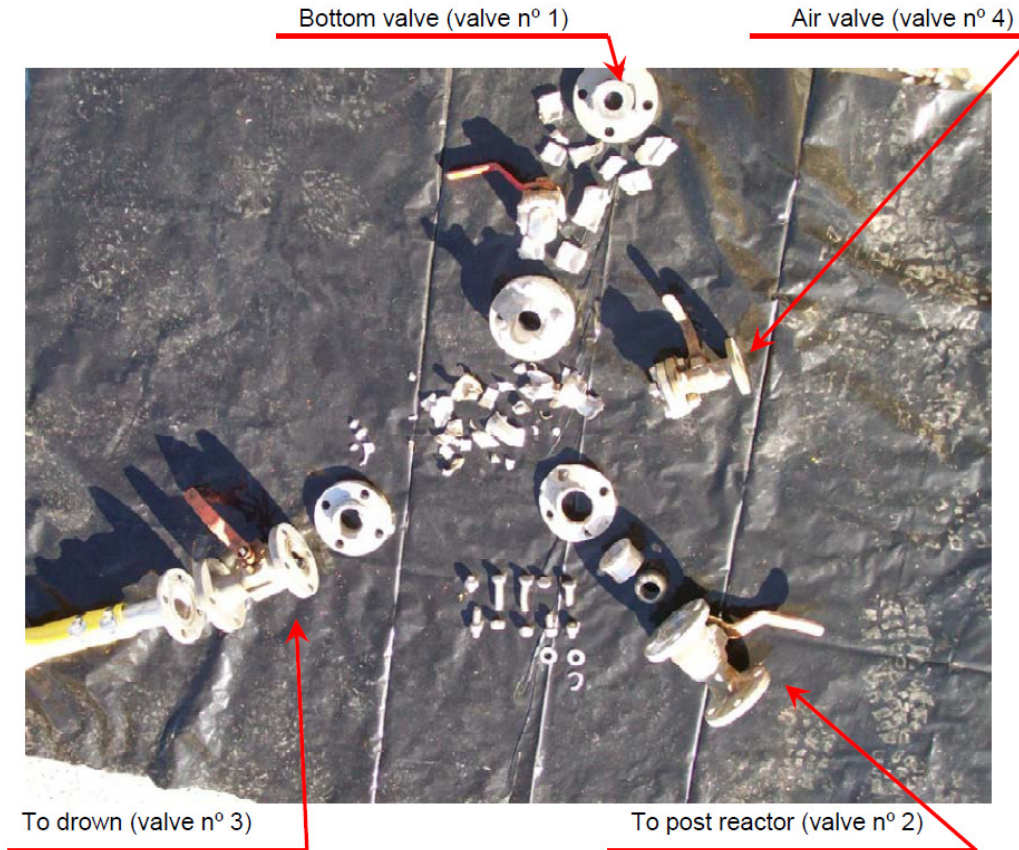
The damage to the valves is shown below.

The explosion did not propagate beyond the valves and is thought to have involved a very small quantity of material.

The discharge pipe and 3 valves were damaged. The entire material damage was small. There was no damage to buildings or structures. There were no other health or environmental effects.

The investigation revealed that operating procedures were followed at all times. The most likely causes were either impact or friction on the by-products that form during the process.

Impact may have been caused by small metal particles from inside the piping that were accelerated by the air used to clear blockages in the pipe as the suspension was transferred for separation/filtering

When the operator turned a ball valve, an ignition by friction of accumulated by-product in the inside surfaces of the valves/connecting pipes is also possible.

- a. The reactor outlet was enlarged and metal piping was replaced with a reinforced plastic hose (less confinement and to mitigate the consequences in the event of reaction/explosion).
- b. The compressed air line has been removed completely.
- c. The total number of valves has been reduced and all ball valves were replaced with diaphragm valves which will involve less potential for friction on any deposited product.
- d. Routine maintenance procedures have been improved to reduce the potential for deposition of product in lines and valves.
