# Explosion of Primary Explosive during Weighing Process

Detonator Plant, Kayaku Japan Corporation  
Miyazaki, Japan

## 1. Brief description of the accident

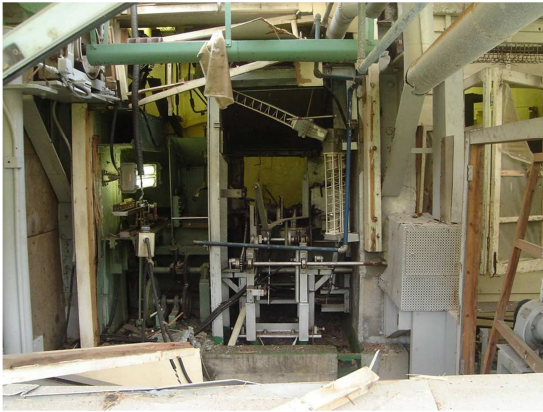
6.2 Damages: The weighing device, chain-conveyor, lights, ceiling, window, and roof of the weighing room and insertion device, chain-conveyor, lights, and window of the insertion room were damaged.

(2) Weighing and insertion room: Partially destroyed (See Photos 1 and 2)

Photo 1: Outside View of the weighing room      Photo 2: Outside view of the insertion room

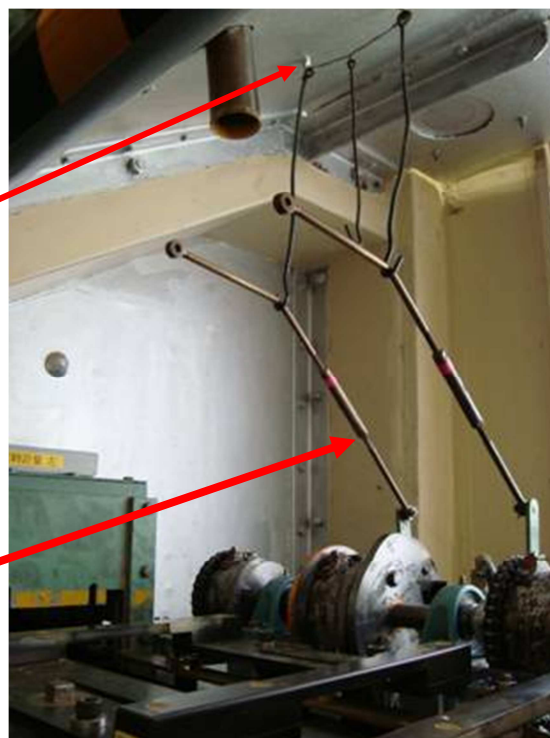
Figure 2: The hopper arms assembly

The investigation and Fault Tree Analysis showed that the explosion was initiated at the weighing device and suggested impact from a falling object as the most probable cause.

On examination one of two bolts (about 6mm diameter, 20mm long and weighing about 32g) that is attached with a ring under the steel cover of the weighing device was found on the floor. These bolts were used for suspending the two arms of the weighing device during routine cleaning by the operator. The arms are attached to the hopper and move back and forth during the weighing operation. 80% of the cross-section of the fallen bolt had rusted away causing it to fall onto the plate of weighing device which initiated the primary explosive. (See Figure 2 below)

Location of the bolts from which the arms are suspended during cleaning. The photograph also gives an indication of the inaccessibility of the bolts which made it difficult to detect their condition.

The hopper with the primary explosives is gripped between the two arms which move during the weighing operation. Note the weighing device would be directly beneath the bolts.

- a. The bolts on the weighing devices were removed.
- b. The method for cleaning the weighing device was revised as a result of the bolts being removed.
- c. All other processes in the plant were checked for unnecessary parts (bolts, nuts and so on).
- d. We knew about the bolts above the weighing device and planned to incorporate appropriate protective measures. However, there was no action taken. To be honest nobody expected these bolts could cause an explosion and did not check them for corrosion. As a result of this incident we revised our inspection standards and schedules especially for old equipment with special emphasis on corrosion.
- e. Wherever possible, non-corrosive materials must be used for critical parts and equipment.
