**Sierra Chemical Company**  
**Mustang, Nevada**

Investigation Report into an incident on 7<sup>th</sup> January 1998 on the cast booster plant by  
The US Chemical Safety and Hazard Investigation Board (CSB)

Report No. 98-001-1-NV

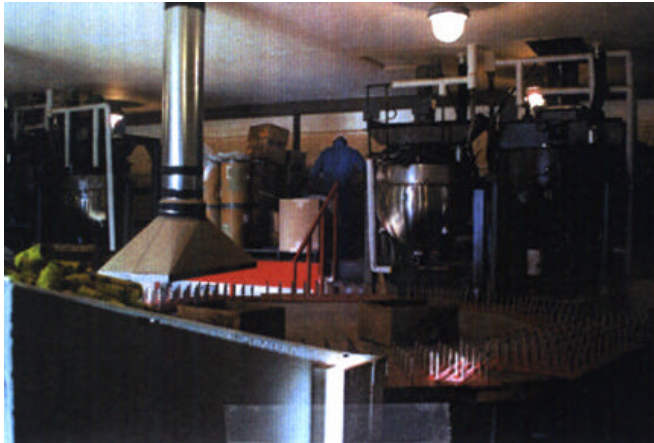
Figure 3

Booster Room 2, shown in Figure 3, was approximately 40 feet wide by 40 feet long and had been put into operation about four months prior to the explosions. A platform along the north wall of Booster Room 2 had an 8-inch, reinforced, poured-concrete floor supported by steel I-beam. Workers placed materials in the center of the platform between two independent melt/pour production lines.

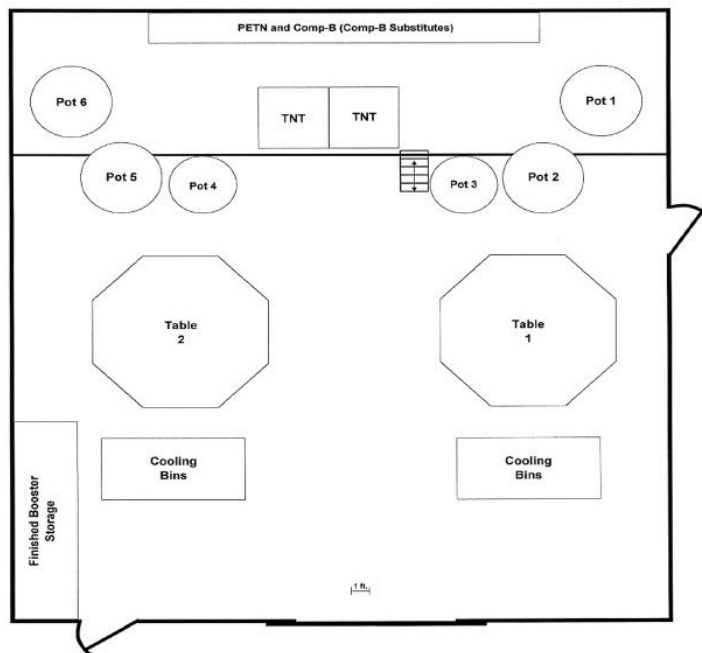
Figure 4

Pots 2 and 5 were used to make the base mix consisting of TNT, Comp-B, and PETN. Pots 3 and 4 were smaller, were used to make Pentolite from PETN and TNT, and were mounted in an I-beam support structure located directly in front of the raised platform. All mixing pots were equipped with gauges that indicated steam jacket temperatures and explosive mixture temperatures to aid operators in controlling the process. Each pot had an exhaust line to carry any dust or vapor from the pots outside through a series of particulate filters. The mixing pots in Booster Room 2 and the location of explosives between the pots are shown in Figure 4.

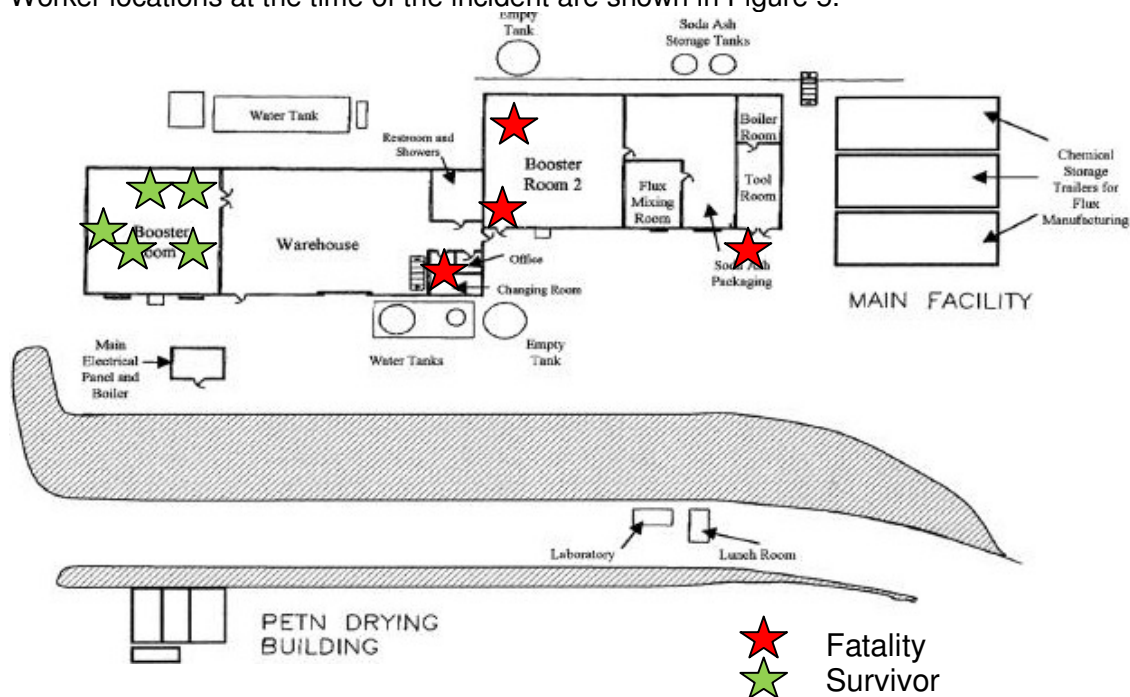
Figure 5

At 3:00 p.m. on January 6, an operator for the west side of Booster Room 2 left work early, leaving 50 to 100 pounds of melted explosive base mix in pot 5. He mentioned this to the other operator in the room, who later checked and saw the explosives in pot 5. Explosives manufacturing operations began the next morning, January 7, shortly after 6:00 a.m. in Booster Room 1. Two teams of two workers each had finished mixing operations for the first batch of the day and were beginning to pour. A fifth worker was also working in Booster Room 1, packing the finished boosters from the previous day. The operator for the west side of Booster Room 2 arrived at work, and at about 7:30 a.m. visited Booster Room 1 to greet his fellow workers who were pouring boosters. He talked briefly with a Booster Room 1 operator about a pouring pitcher he had returned to that worker's locker in the change room, and then left at about 7:35 a.m. The supervisor arrived at approximately 7:40 to 7:45 a.m., stopped in Booster Room 1 for about 5 minutes, then rode to the nearby gravel pit in a backhoe with another worker. Besides the operator assigned to the west side of Booster Room 2, there were three other workers in or near Booster Room 2. The suspected locations of the four workers are consistent with the locations of human remains found during the investigation. Worker locations at the time of the incident are shown in Figure 5.
