# Incident at waidhan, India

## **Brief Description of the Incident**

- ▶ A massive explosion at Waidhan Industrial Estate involving bulk emulsion plants of M/s IDEAL Industrial Explosives Ltd and Rajasthan Explosives and Chemicals Ltd. Several other neighboring units had also suffered extensive damages
- ▶ The explosion occurred at 1845 hrs on 5<sup>th</sup> July 2010
- ▶ 18 persons were killed, 6 missing and 42 injured

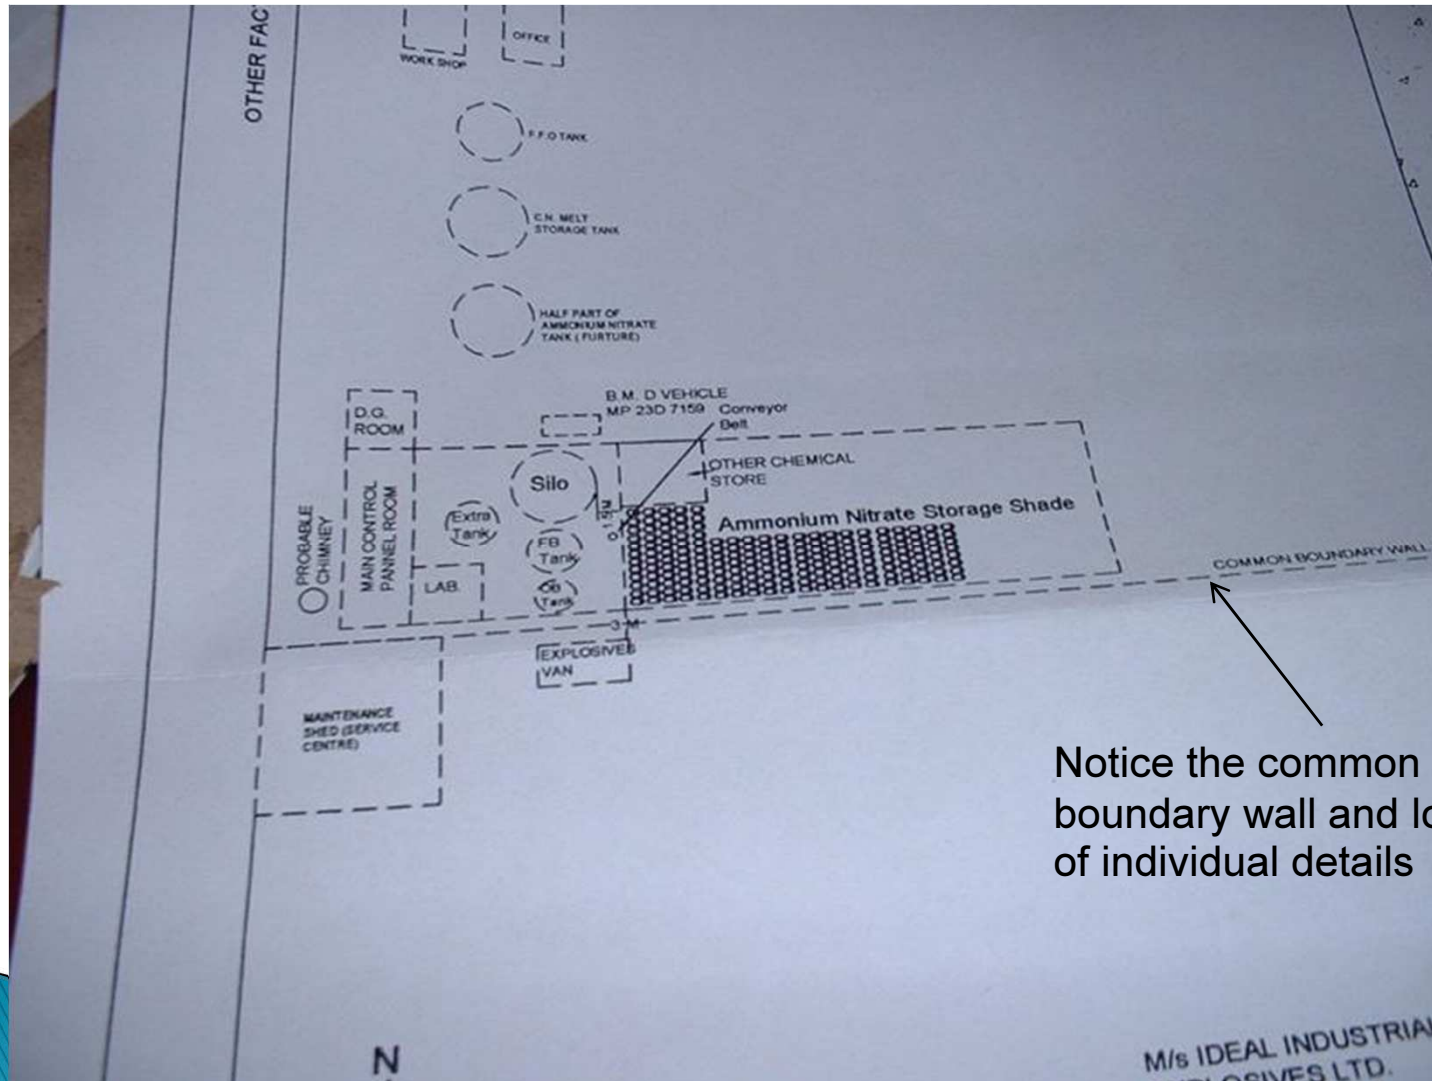
# Layout of IDEAL and RECL Units

- ▶ Maximum damage was along the common wall between IDEAL and RECL
- ▶ The entire bulk matrix plant of RECL was totally destroyed except its security guard room
- ▶ The bulk matrix plant of IDEAL did not suffer damage
- ▶ Adjoining plants of Bharat Explosives, Humepipe factory, Blastech India suffered damage
- ▶ Up to 350 m from location of accident, asbestos roofing of several units were blown away

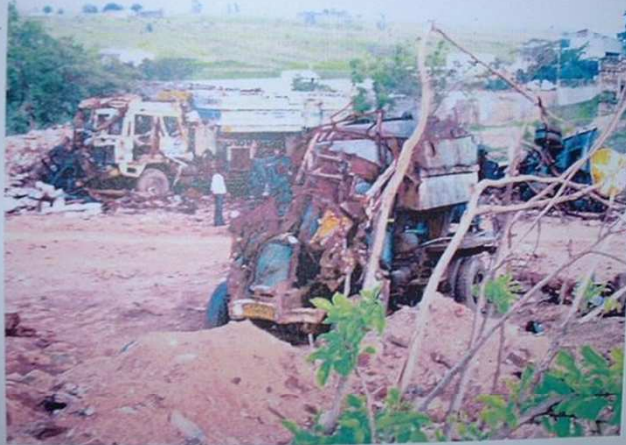
PHOTO 8

BLAST EFFECT OF EXPLOSIVE VAN EXPLOSION

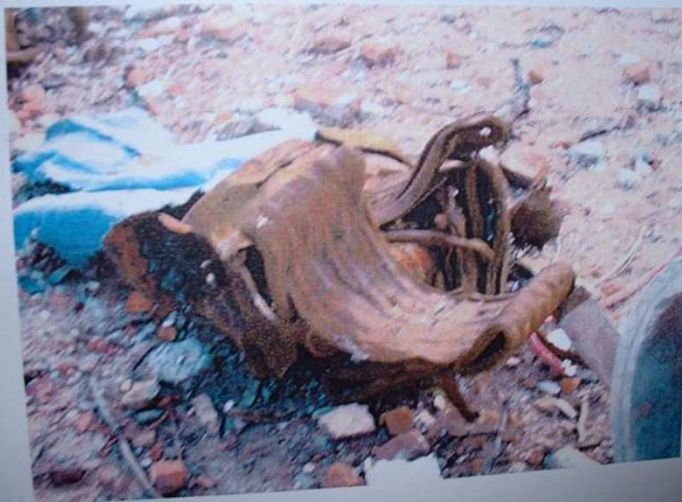
PHOTO 10

ON ACCOUNT OF BLAST

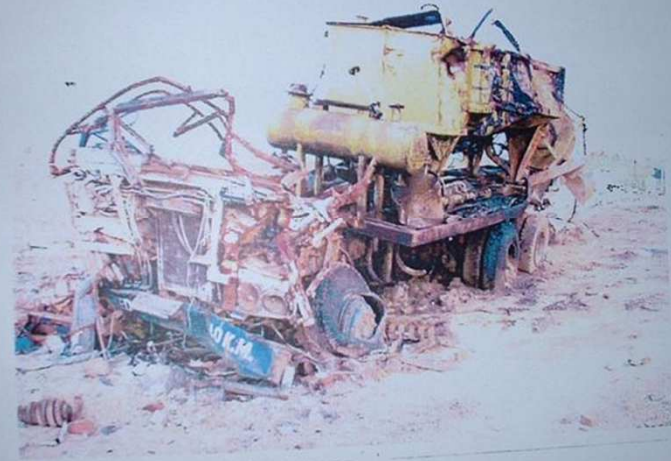
PHOTO 5

RECL DAMAGED BMD SYSTEM LOADED WITH NON EXP MATRIX VEH NO. UP 65 1565 PARKED NEAR AN STORE

- Although the truck getting loaded from the silo was totally destroyed still the matrix it contained was non explosive in nature
- *Reasonable conclusion - BMD not a source but received full force of blast due to close proximity to AN storage*

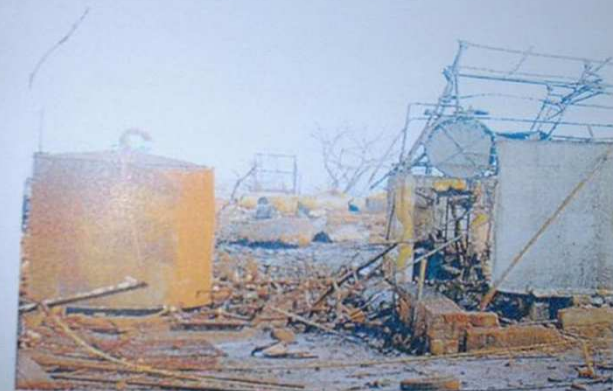
Photograph-11 Splashes of matrix in M/s Bharat Explosives P. Ltd.

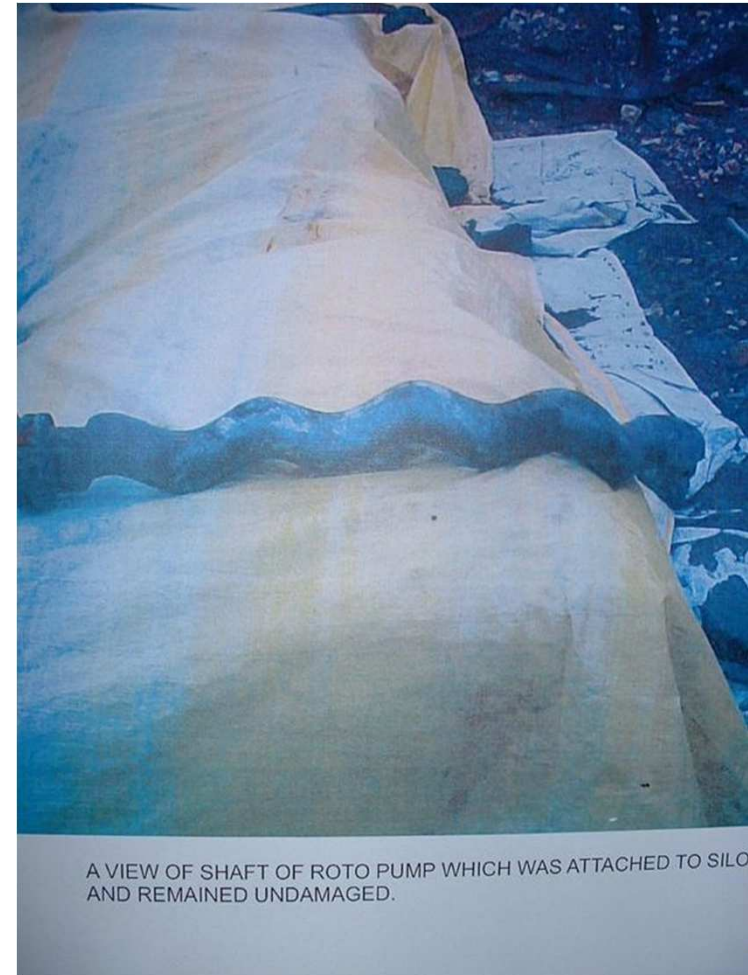
## ► Scenario A: Initiation due to malfunctioning of roto pump

- At the time of explosion, pumping of matrix was going on from silo to bulk truck, hence dry running is not the cause. There was no overpressure seen as indicated in the high and low pressure switches installed in the pump line. The hopper of the rotopump was 30 cm below the outlet of silo
- The matrix being pumped proved to be nonbooster sensitive when tested and hence it was not explosive in nature
- Shaft of the rotopump was recovered intact from field - hence explosion would not have taken place within the pump
- *Reasonable conclusion - pumping by rotopump of matrix is not the source of initiation or cause of explosion*
