# **Explosion in an HMX plant**

**- SAFEX Closed Day Incident Session -**

**Martin Held**

**XVII SAFEX Congress  
Istanbul, May 25th – 28th**

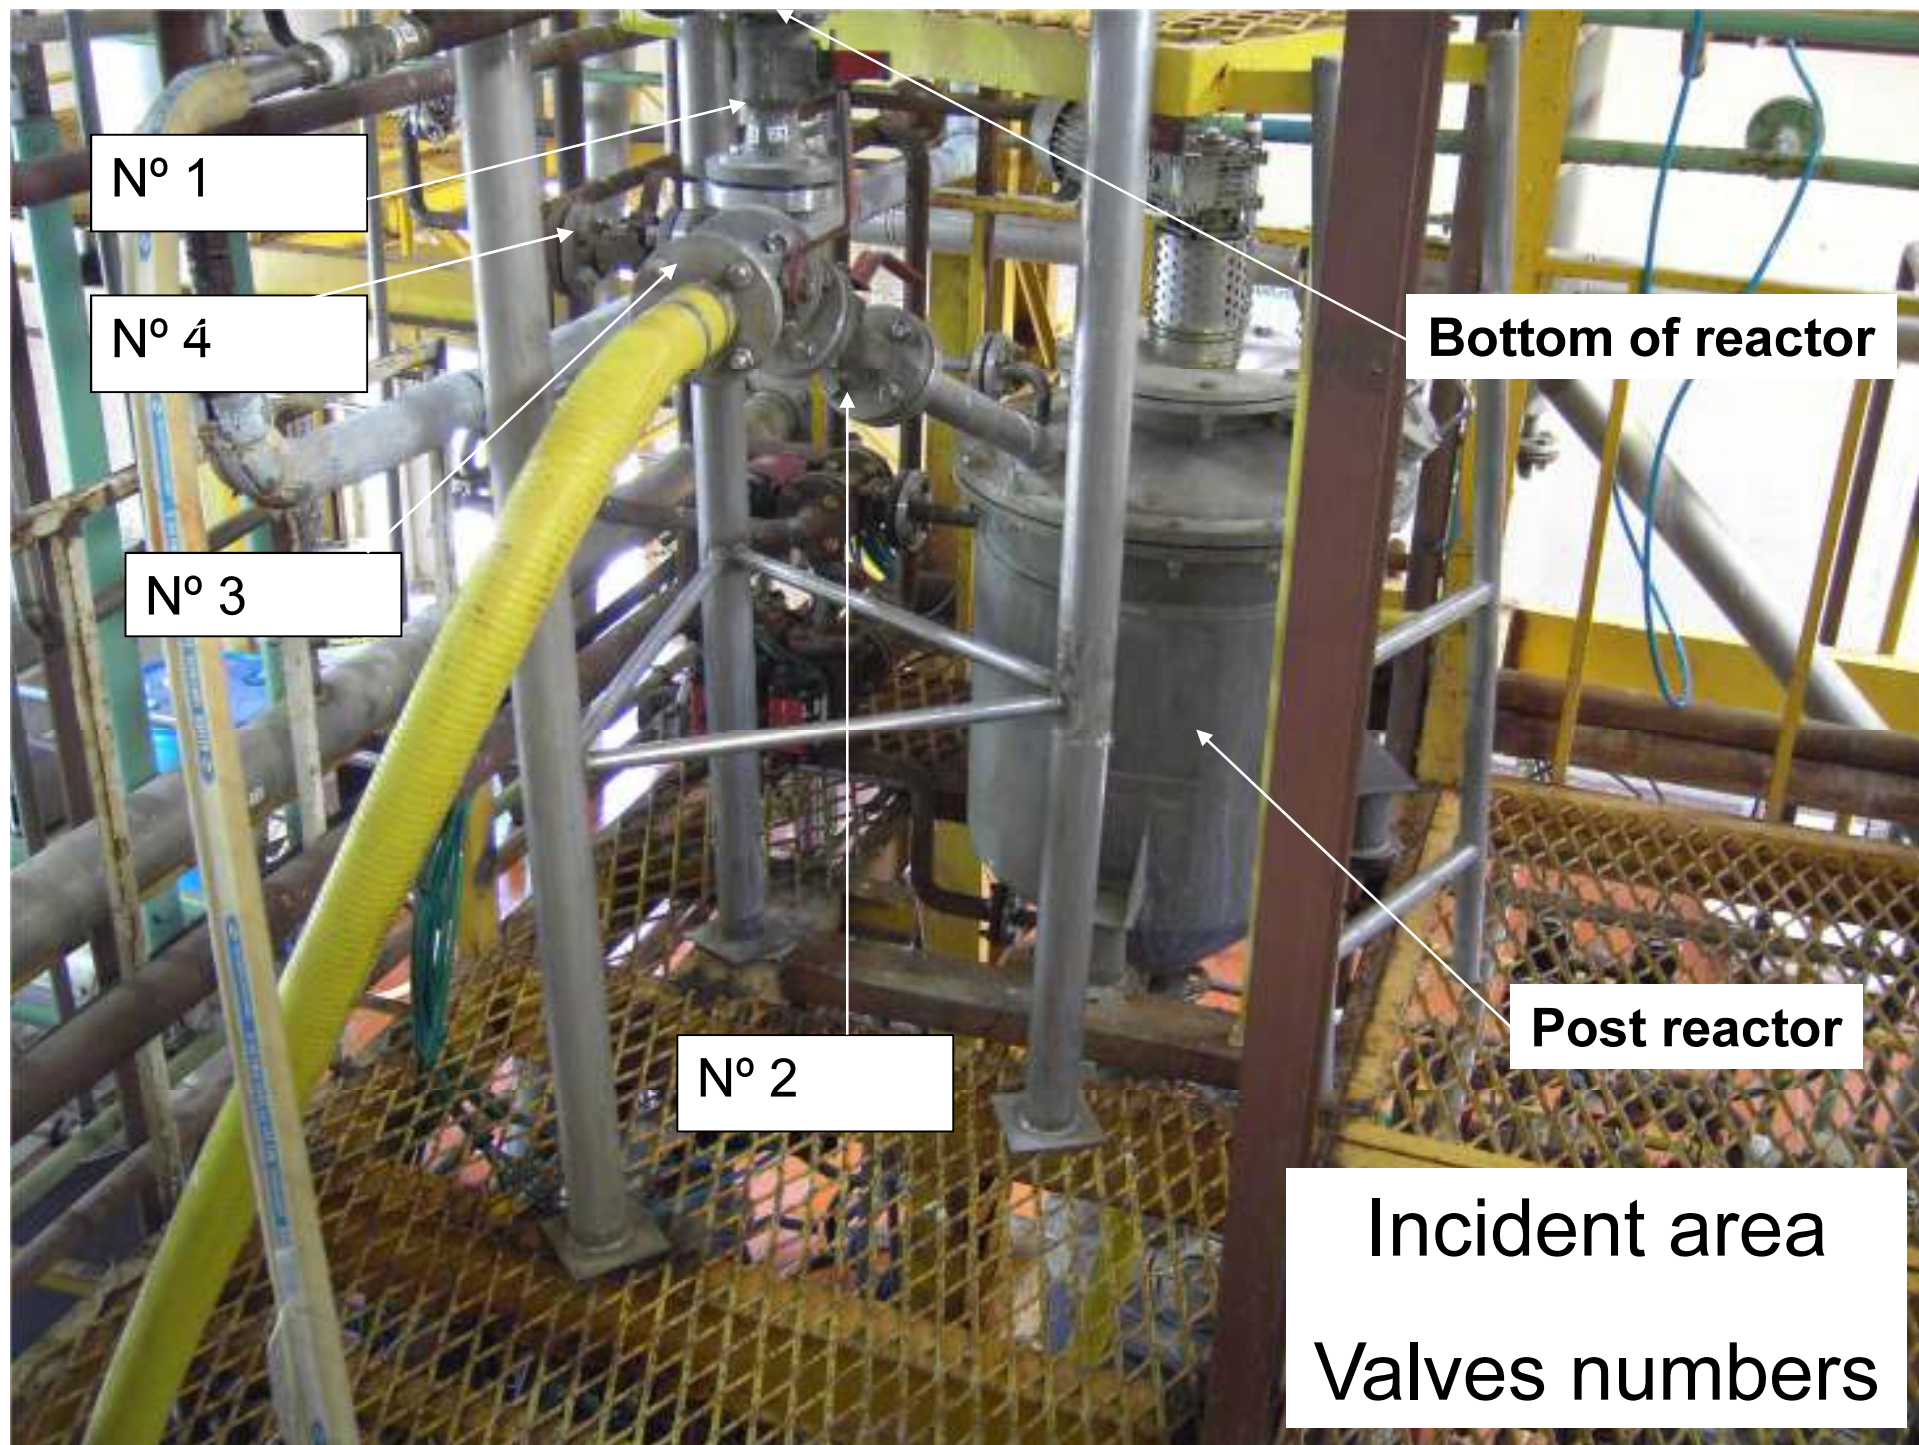
Valve N° 1:  
The sphere  
was damaged

Pieces of pipe

Valve N° 3:  
Dilutor tank  
Minor damage

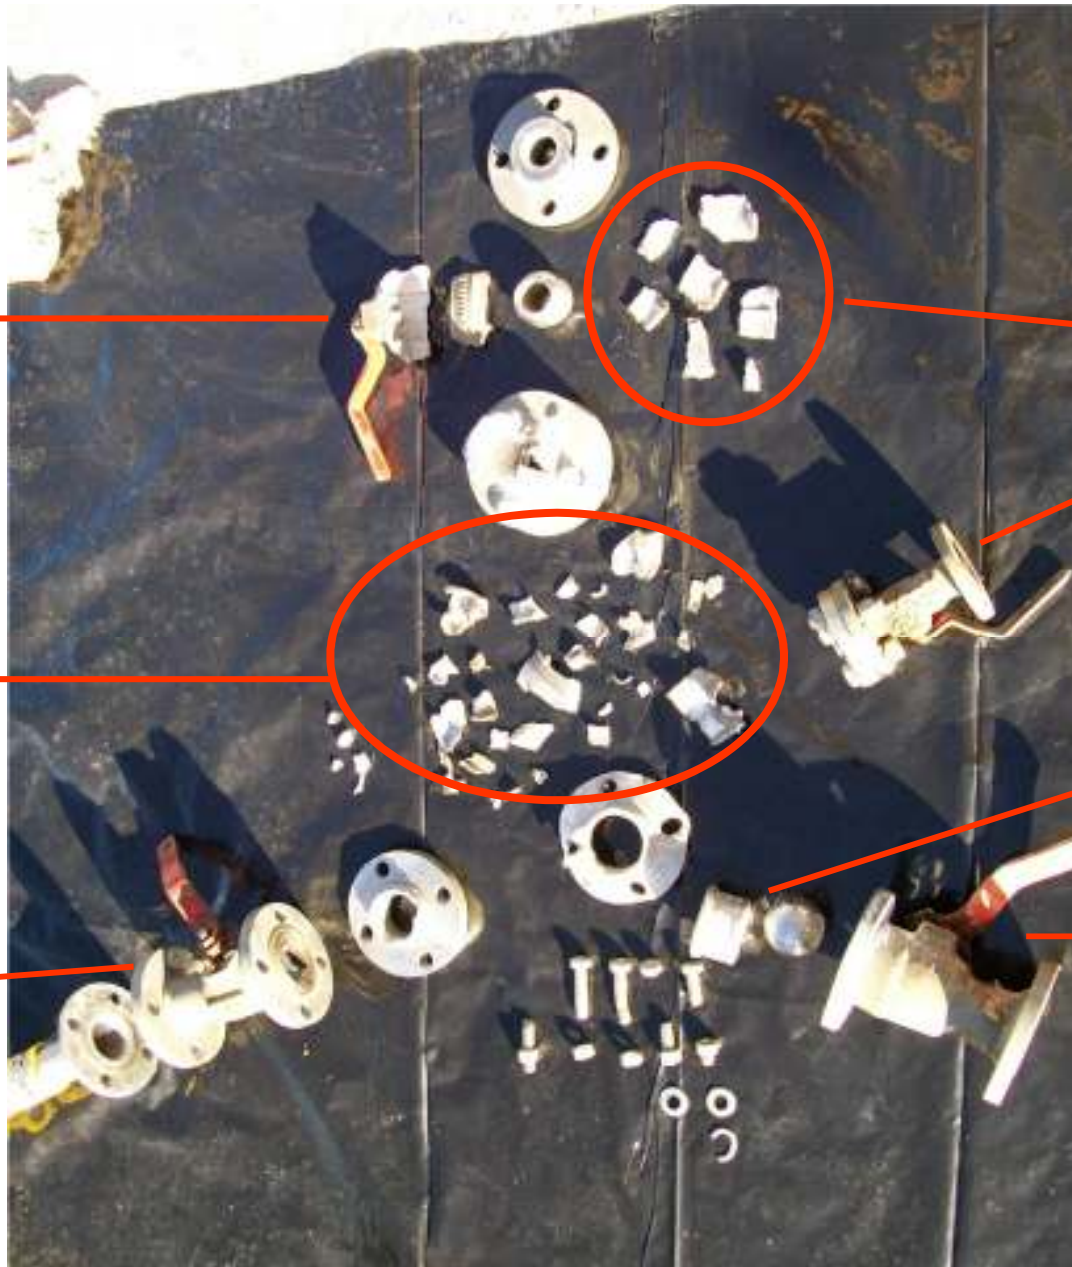
Pieces of Valve  
N° 1

Valve N° 4: Air  
Minor damage

Sphere from  
Valve N° 2  
Minor damage

Valve N° 2:  
Post reactor  
Minor damage
