# U.S. CHEMICAL SAFETY AND HAZARD INVESTIGATION BOARD

# Incident in Sierra Chem. Co. 1998

4 fatalities and 6 injuries in  
booster plant explosions

Report No. 98-001-1-NV

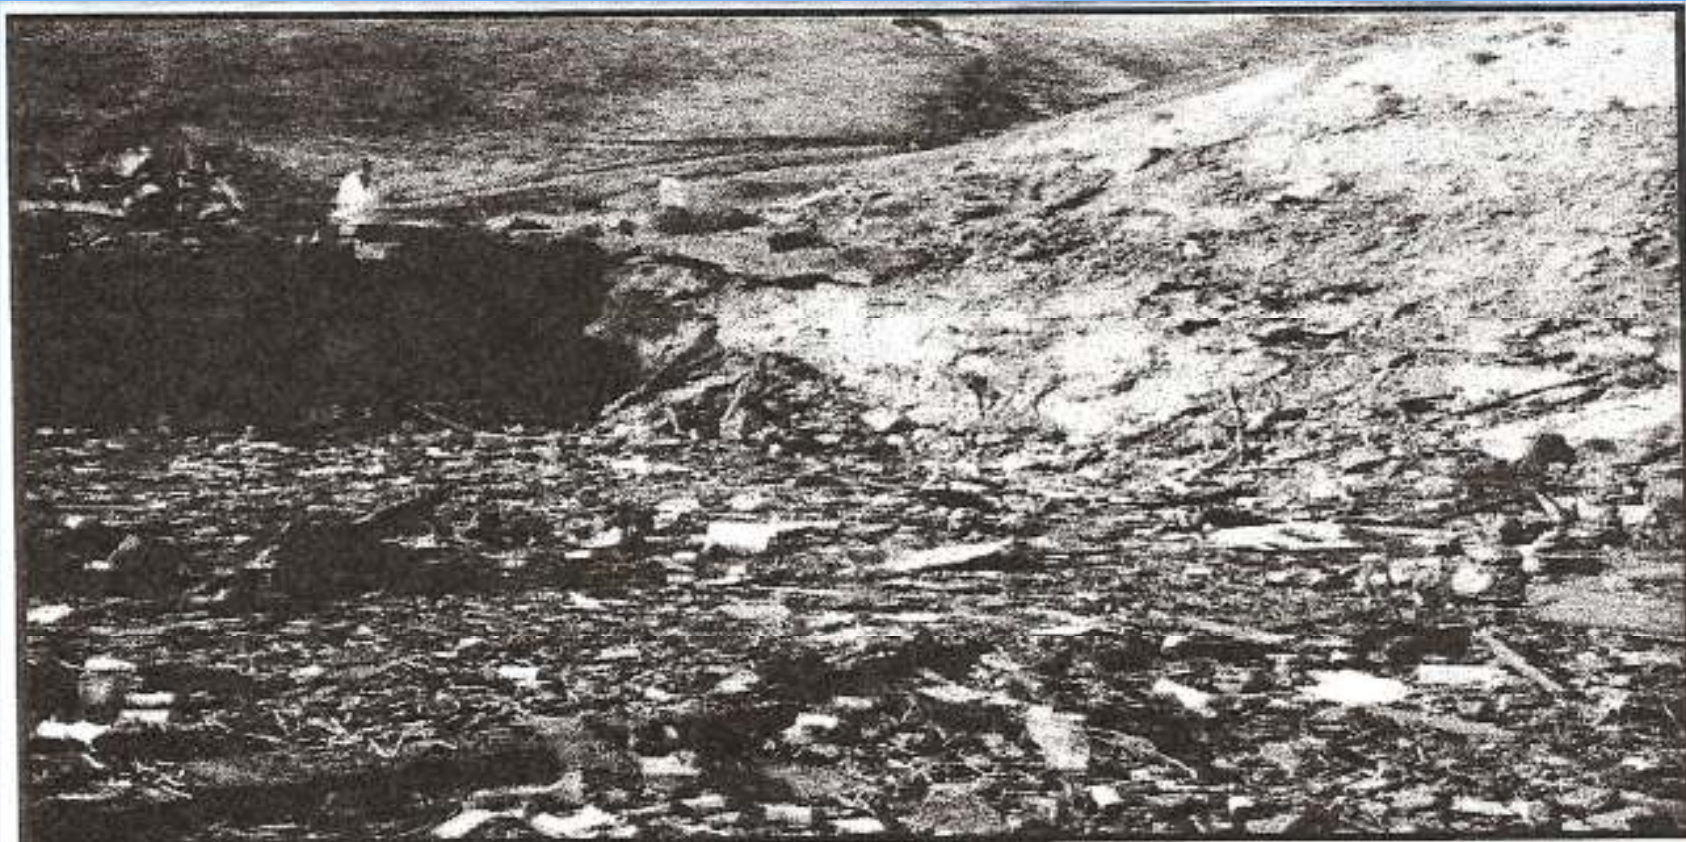
**Figure 8. Booster Room 2 After Explosion**

- Seismological records from 4 stations
- Statements from witnesses
- Debris field
- Equipment and building damage analysis
- First explosion in BR 2, second in PETN building

- Pot was left overnight with 50-100lbs of mix
- Solidified overnight
- Next day operator started stirrer without checking pot.
- Bottom of stirrer initiated the mix by friction, impact or shearing.
- PETN building hit by debris causing second explosion

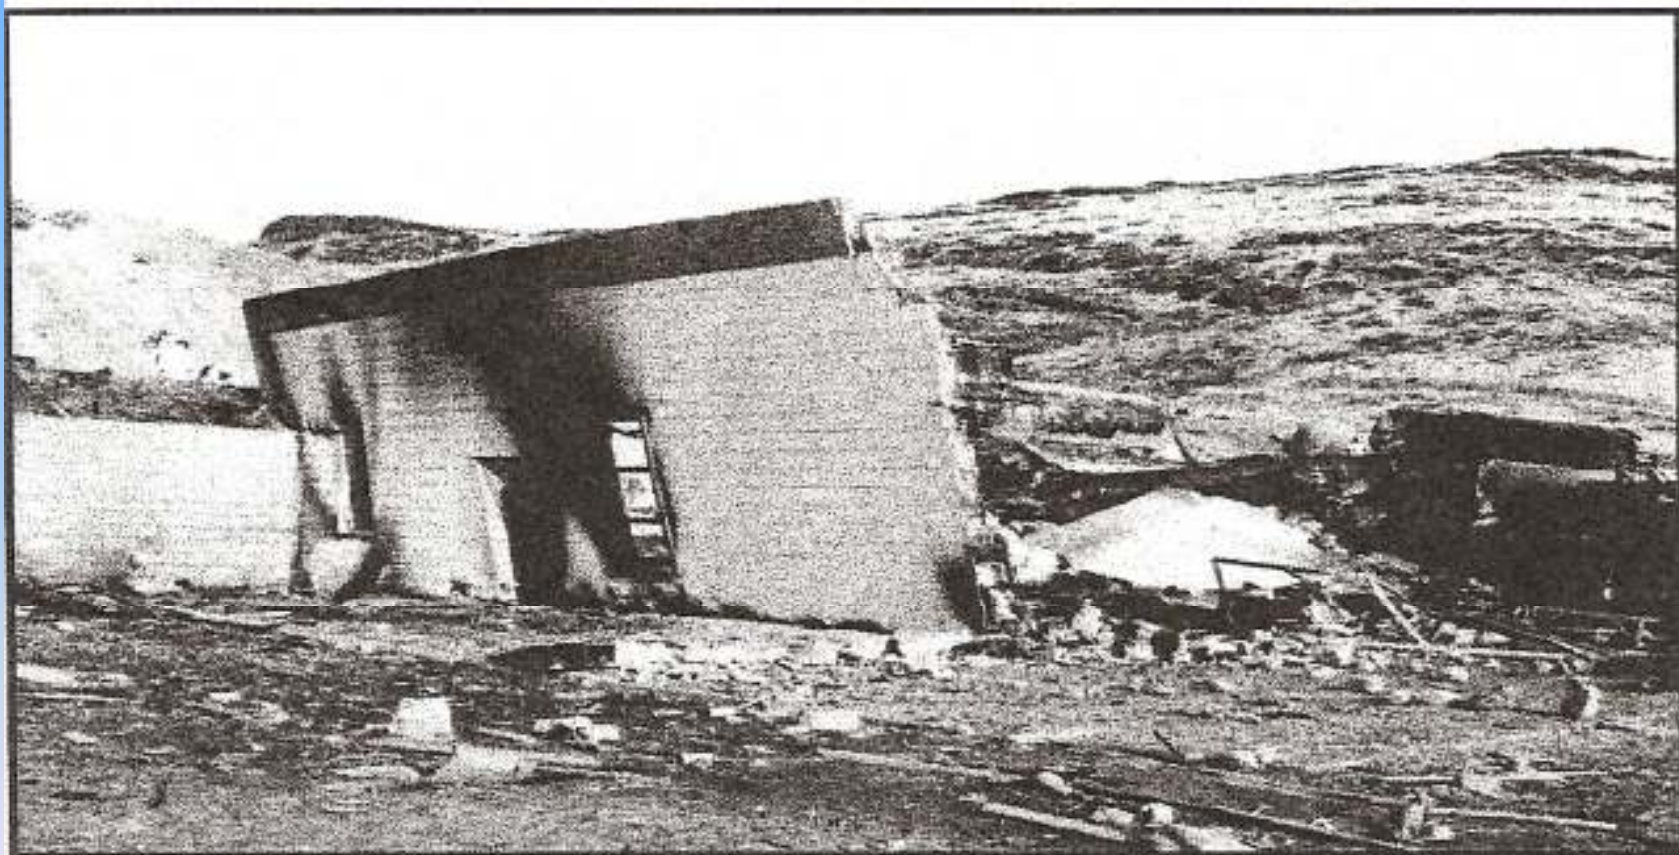
**Figure 7. Booster Room 1 After Explosion**

- 6 am - plant start up in room 1
- 8am - 4 personnel in or near room 2 for start-up
- First explosion
- Seconds later explosion in PETN building
- 5 personnel trapped in room 1 but survived
- Crater 40x60x6ft where PETN building had been

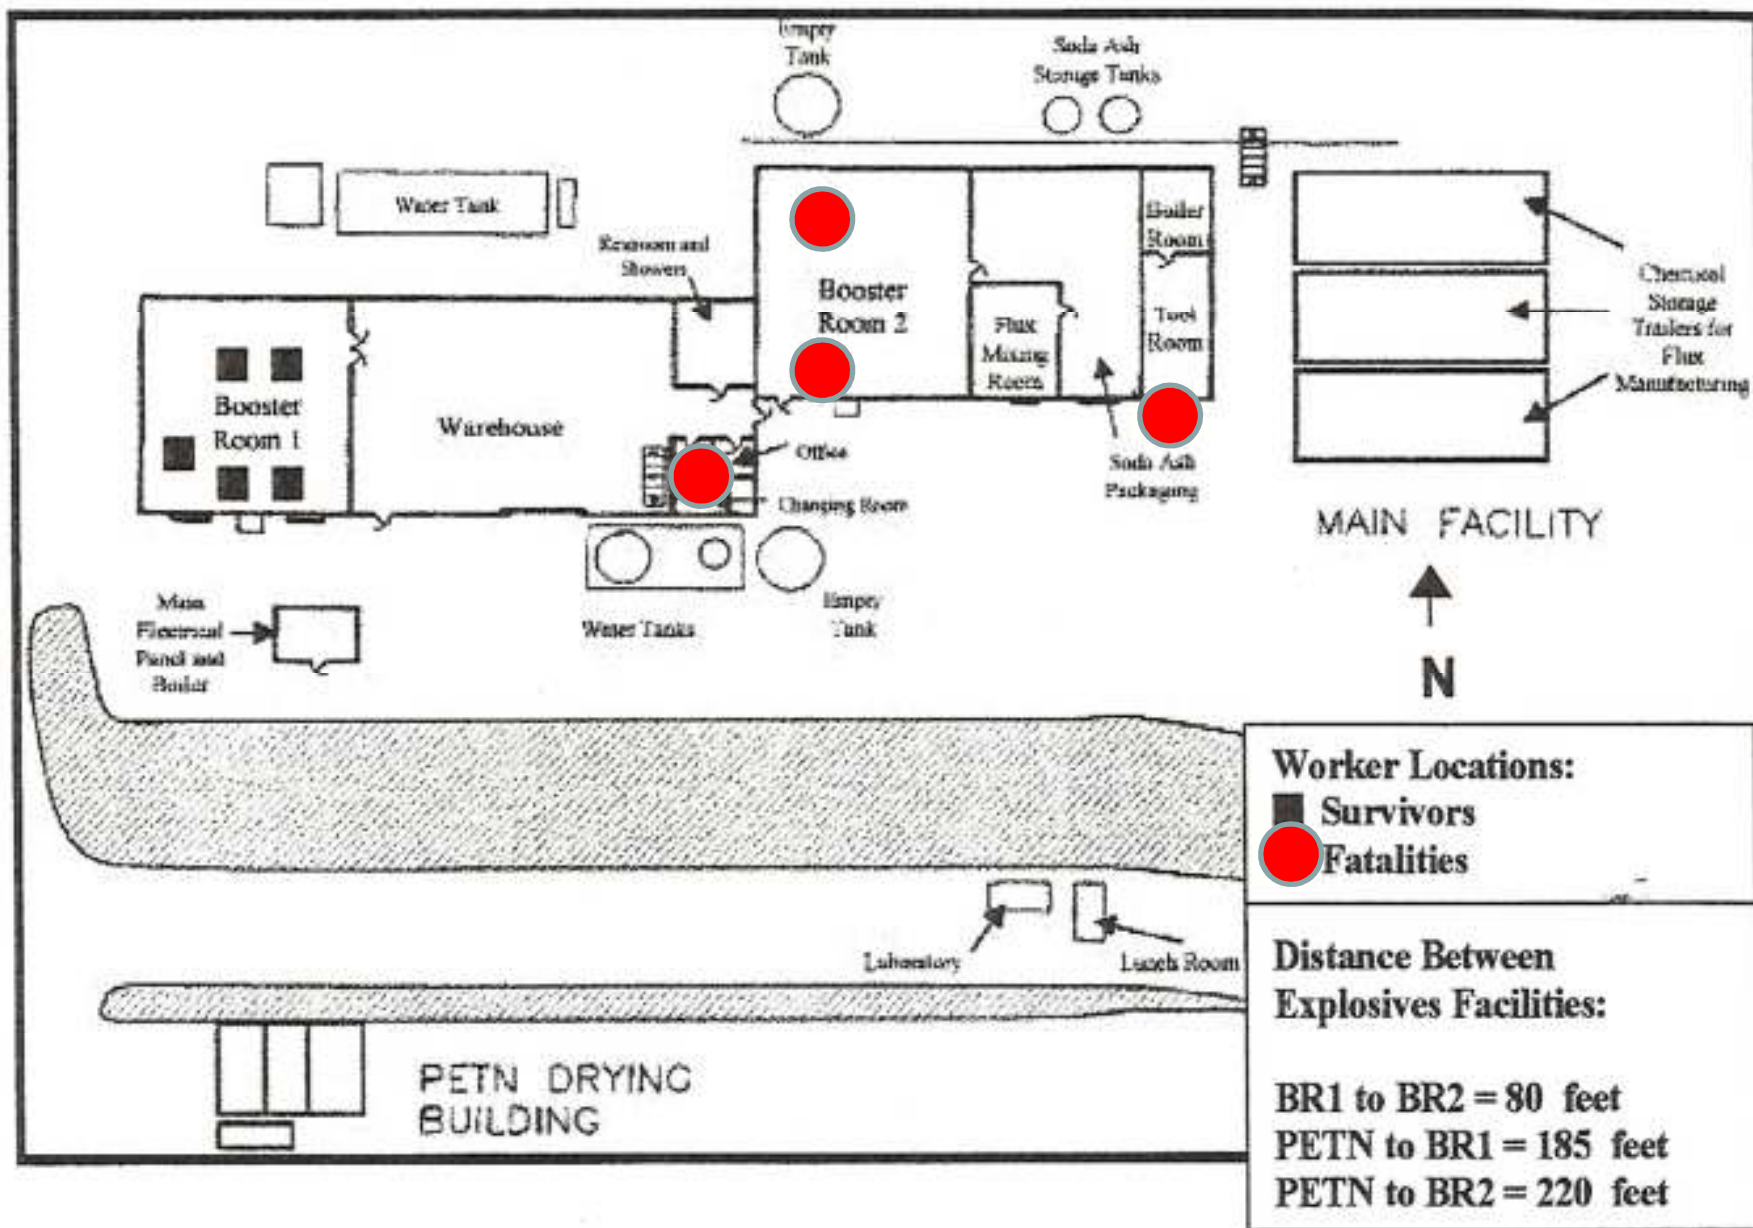
**Figure 3. Layout of Production Facilities**  
(not to scale)

- Buildings at Sierra were not located at safe distances from each other in order to prevent the propagation of an explosion from one building to another
- Building construction was inadequate.
