# Lorena Packaged Emulsion Plant Explosion, 11 November 2004

# Prefatory note

The Packaged Emulsions Plant located at Lorena, Brazil was completely destroyed by the explosion that occurred on November 11, 2004. As a result of this, very little direct physical evidence of the causes of the explosion survived.

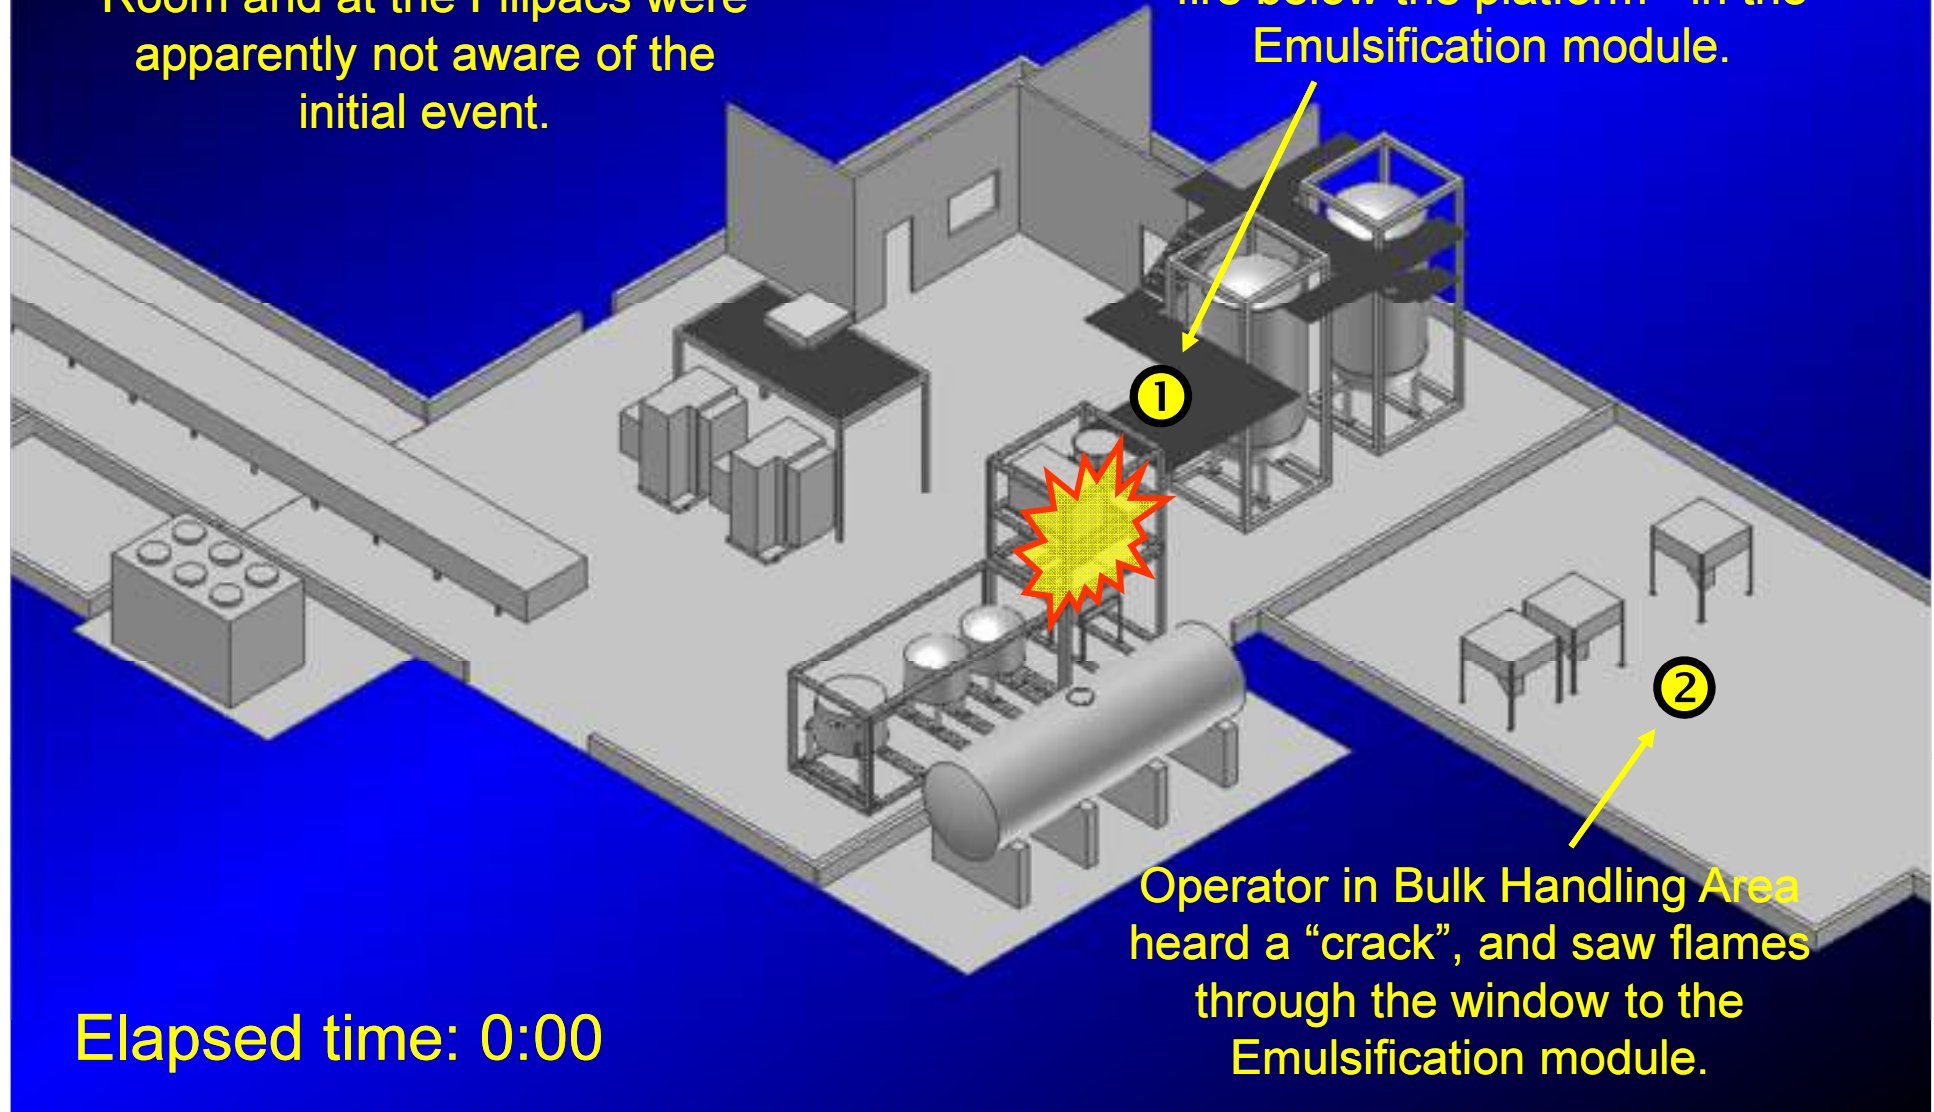
Operator on Mezzanine level saw a “bright, sharp, yellow fire below the platform” in the Emulsification module.

Operator in Bulk Handling Area heard a “crack”, and saw flames through the window to the Emulsification module.

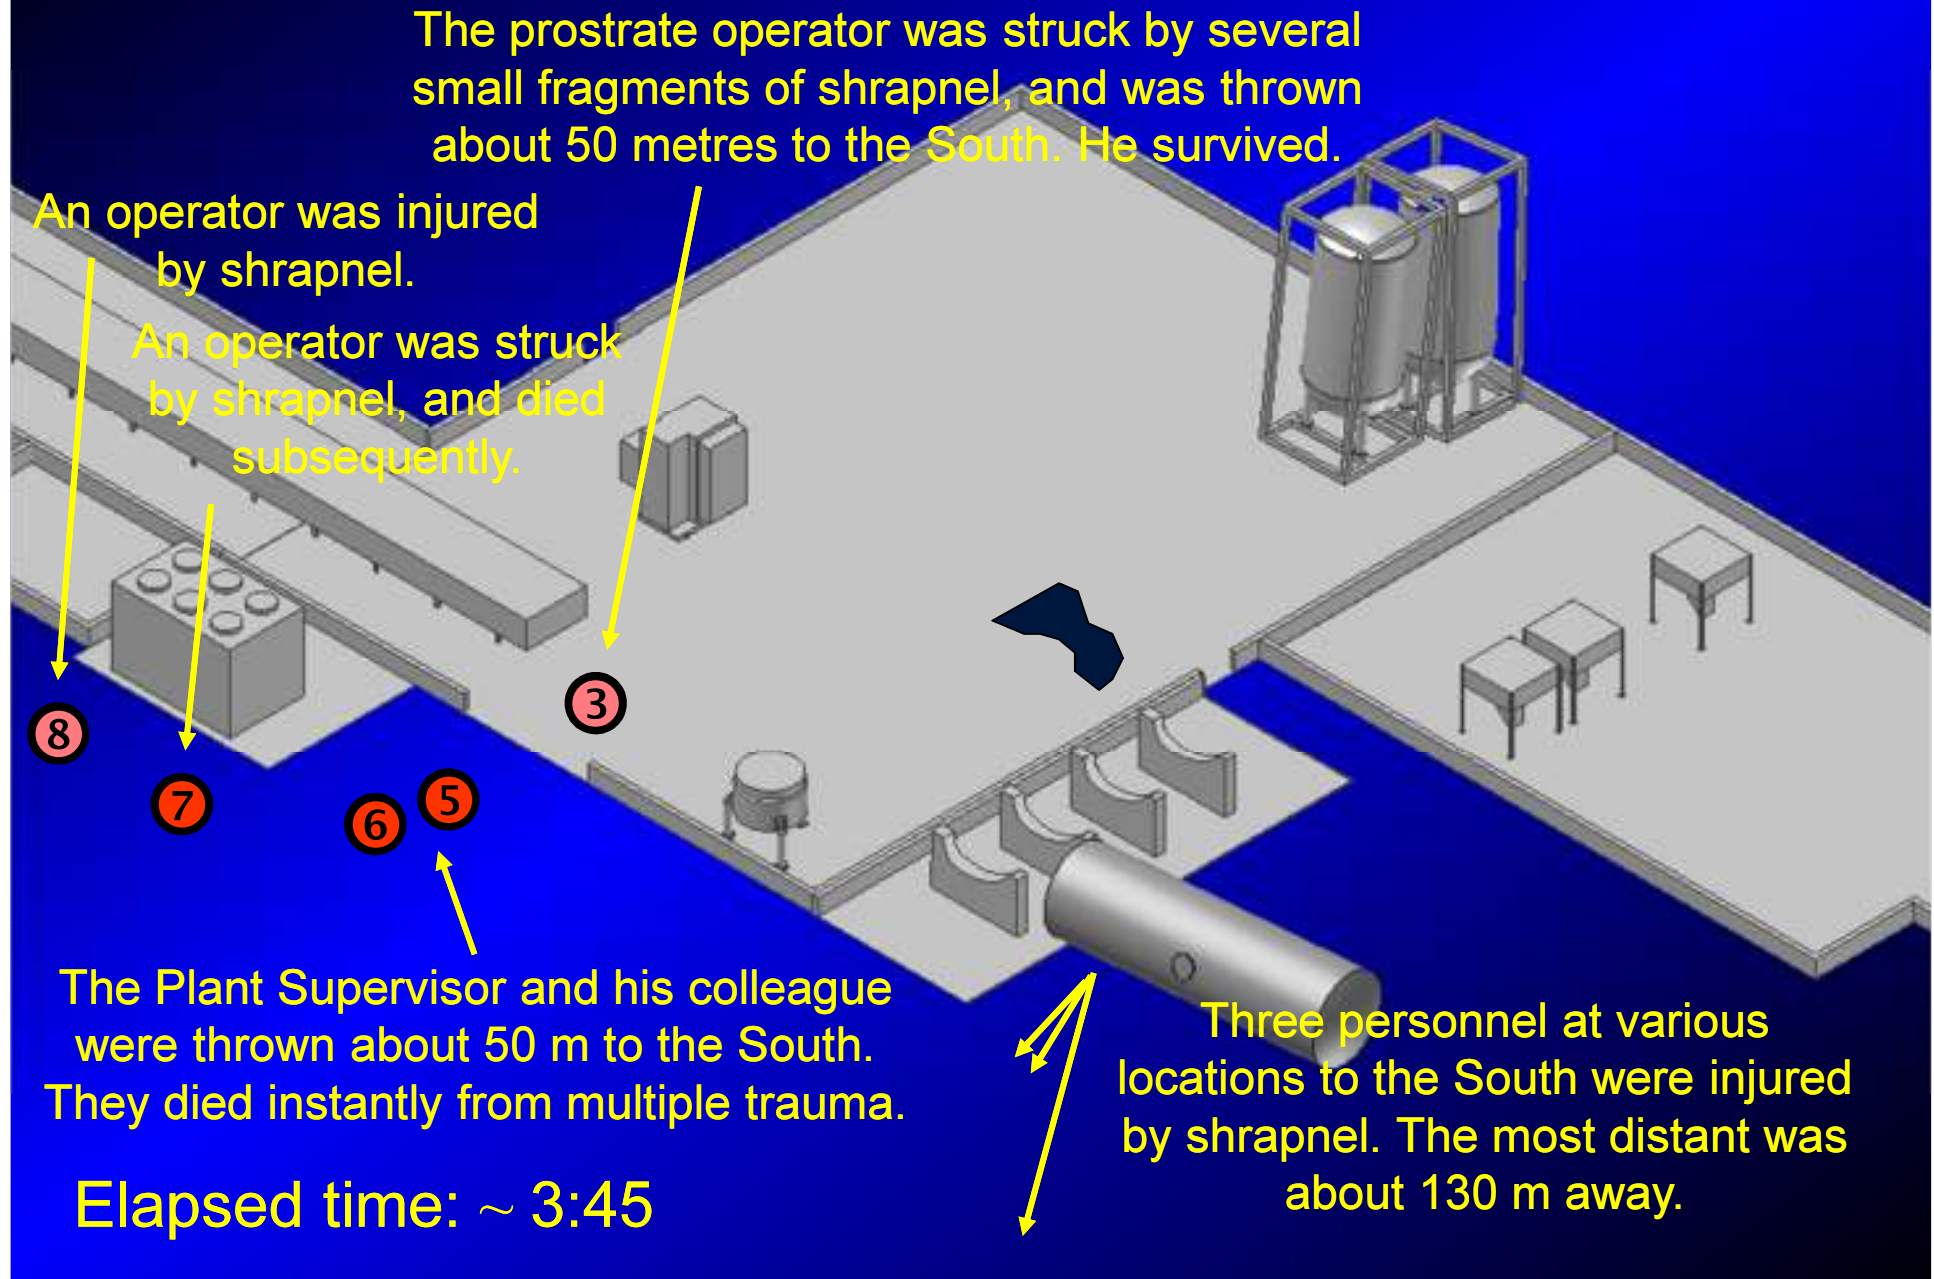
The prostrate operator was struck by several small fragments of shrapnel, and was thrown about 50 metres to the South. He survived.

The Plant Supervisor and his colleague were thrown about 50 m to the South. They died instantly from multiple trauma.

Three personnel at various locations to the South were injured by shrapnel. The most distant was about 130 m away.

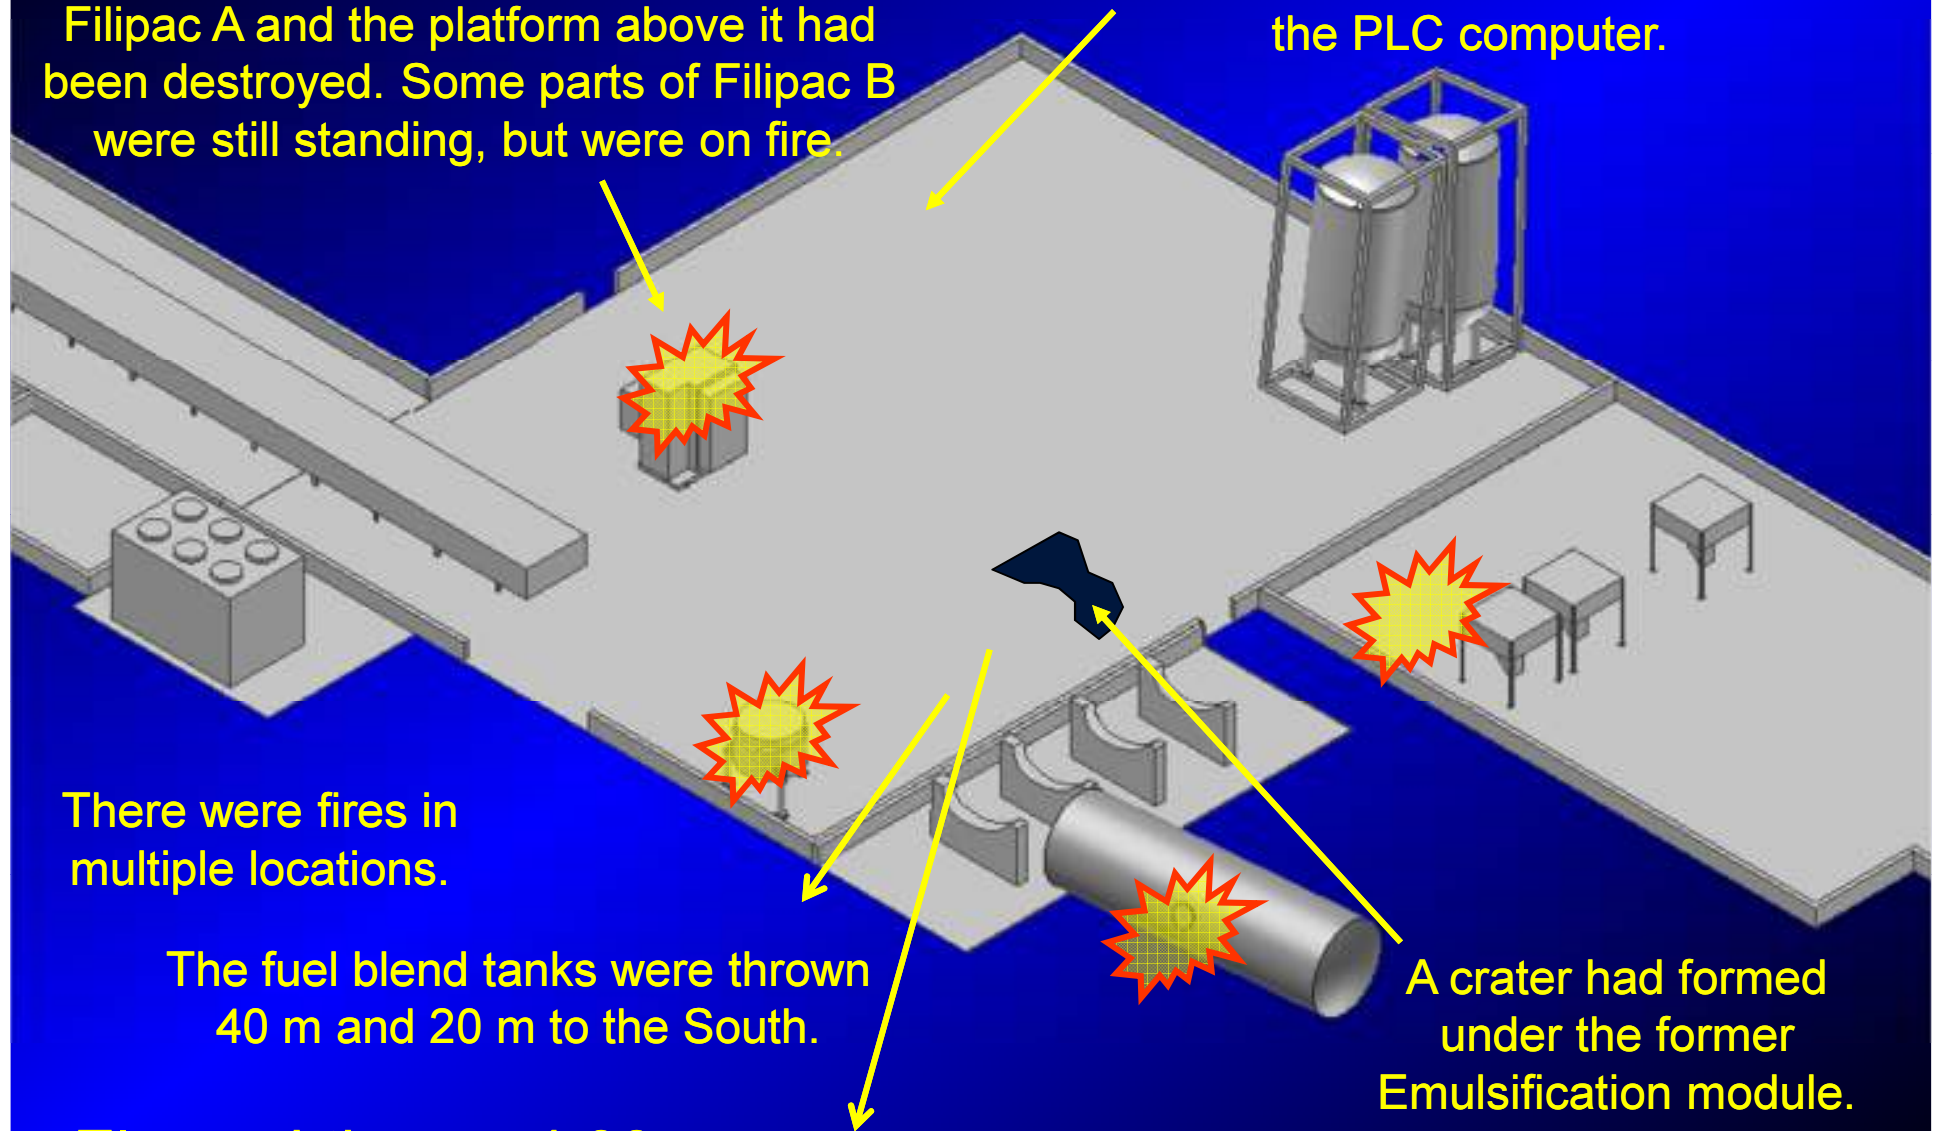
Filipac A and the platform above it had been destroyed. Some parts of Filipac B were still standing, but were on fire.

The Control Room was destroyed. No data could be recovered from the PLC computer.

The fuel blend tanks were thrown 40 m and 20 m to the South.

A crater had formed under the former Emulsification module.

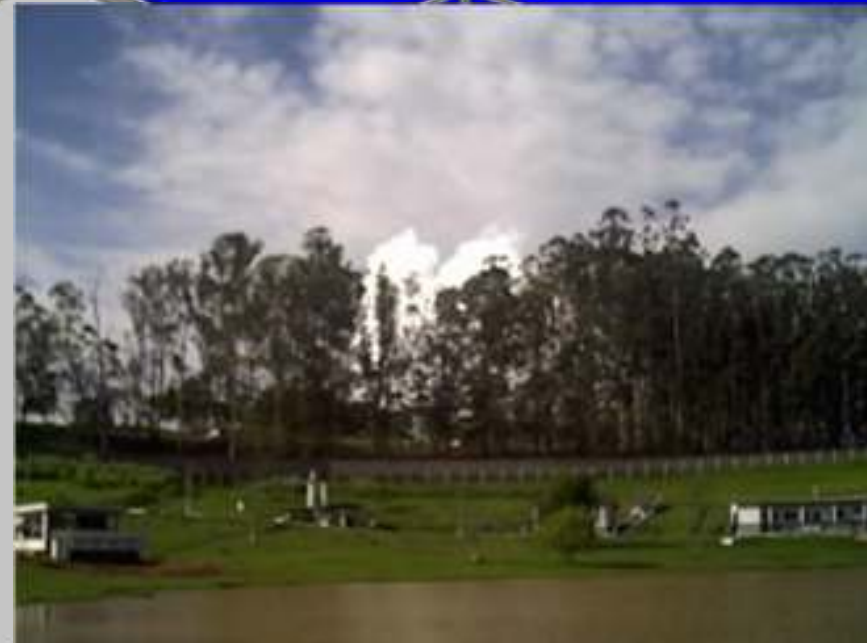
After burning for about 15 minutes, the remains of Filipac B exploded.

The fireball was photographed from a position about 400 m to the North East.

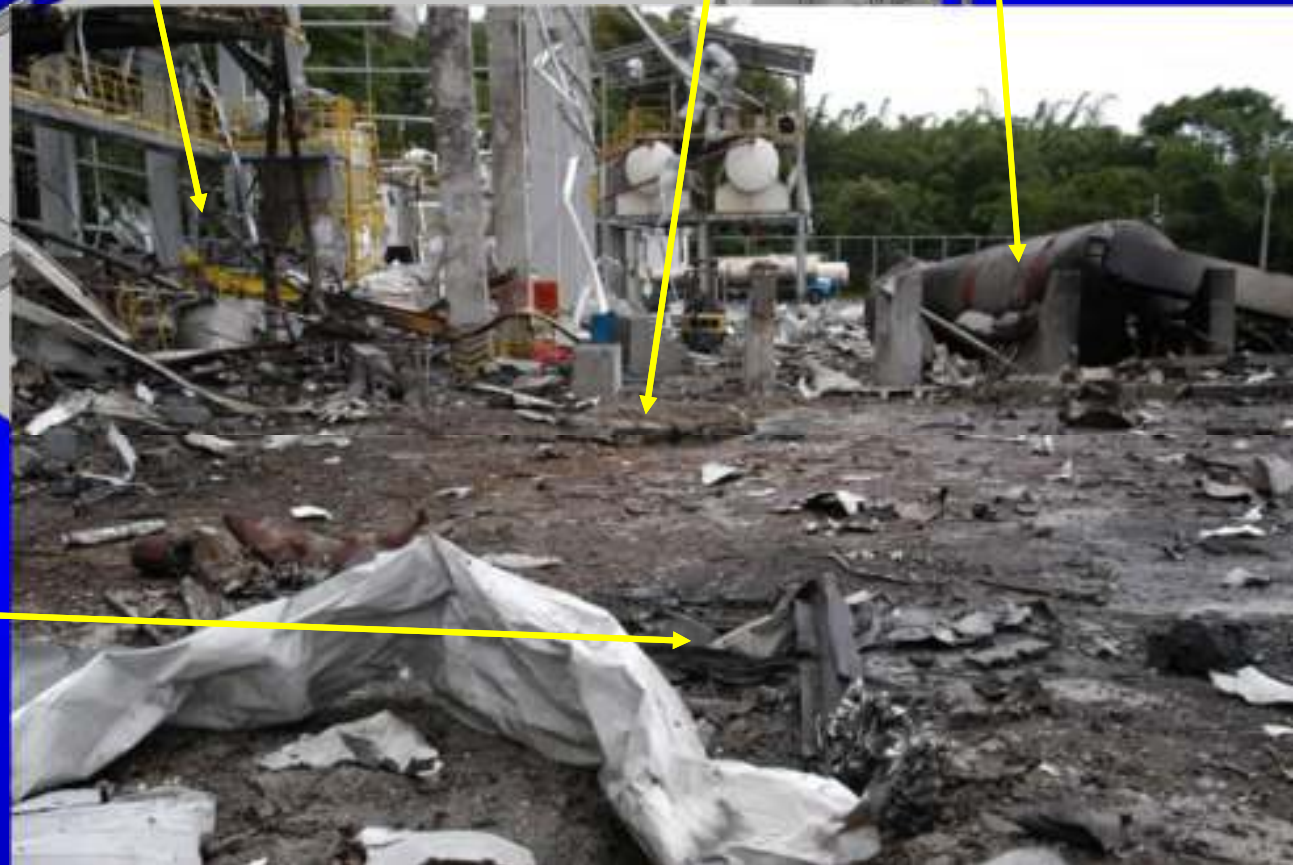
The remains of the Bulk Handling Area.

The crater underneath the Emulsification module.

The remains of the Emulsifier tank.

The remains of the Filipacs.

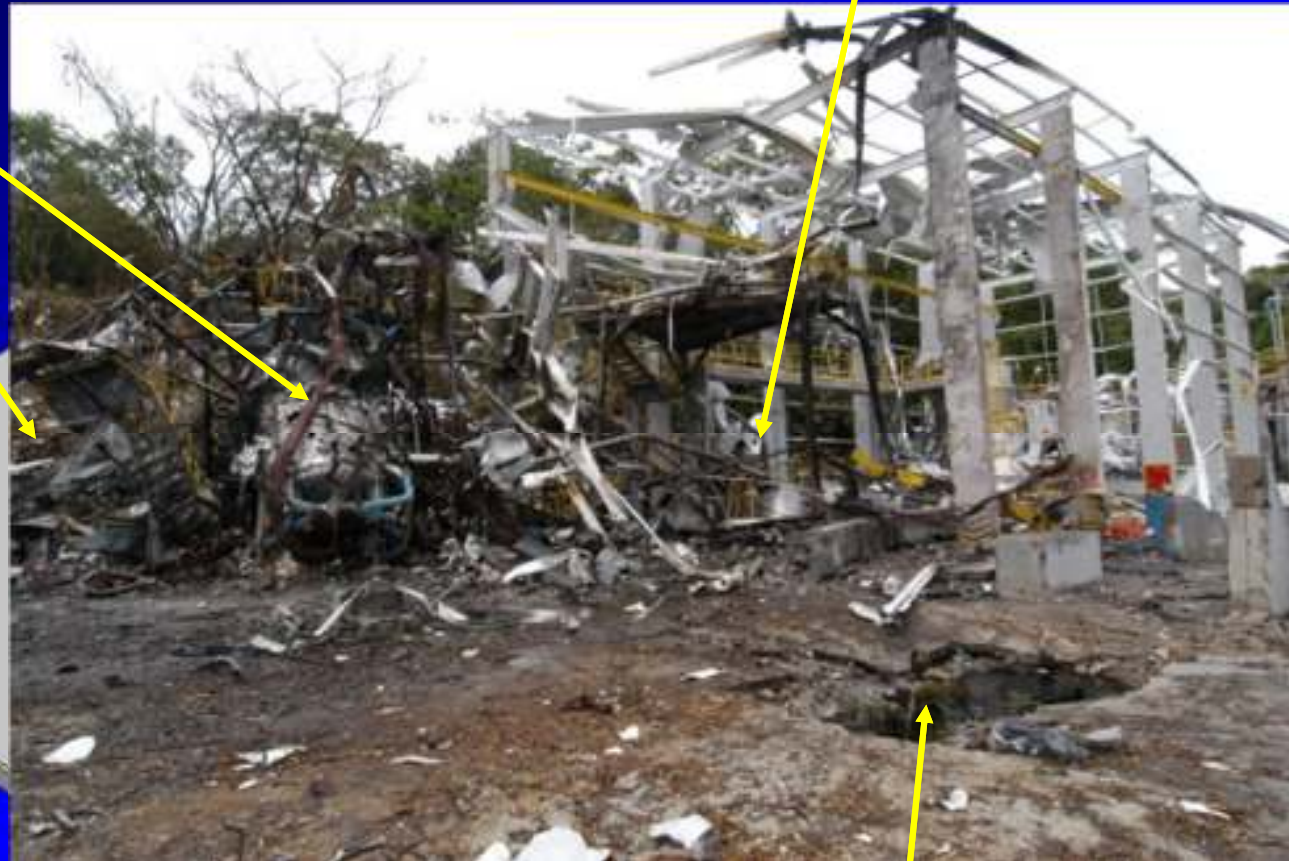
The remains of  
the solution tanks.

The remains of  
the Laboratory.

The remains of the  
Bulk Handling Area.

The crater underneath the  
Emulsification module.

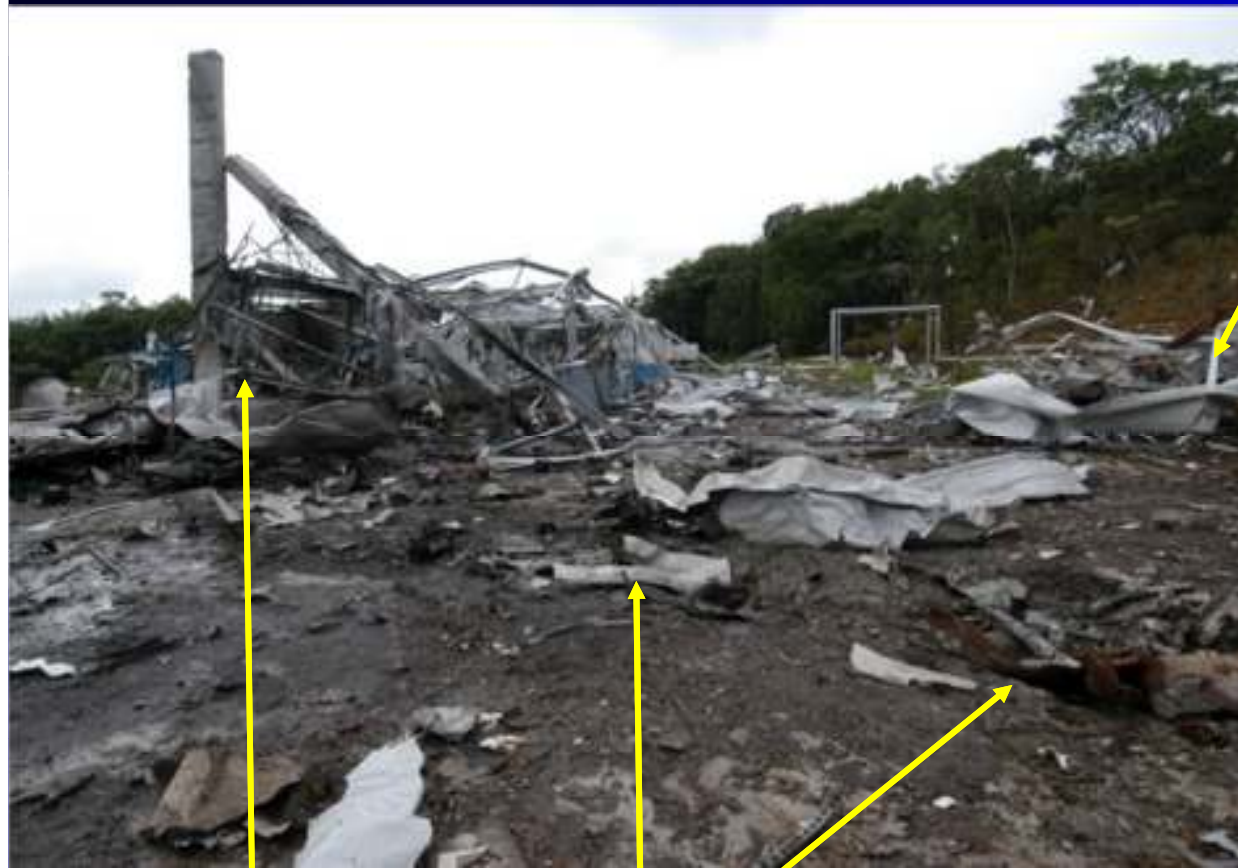
The remains of  
the Cooling  
Bath corridor.

The remains of  
the Filipacs.

The remains of the  
Control Room.

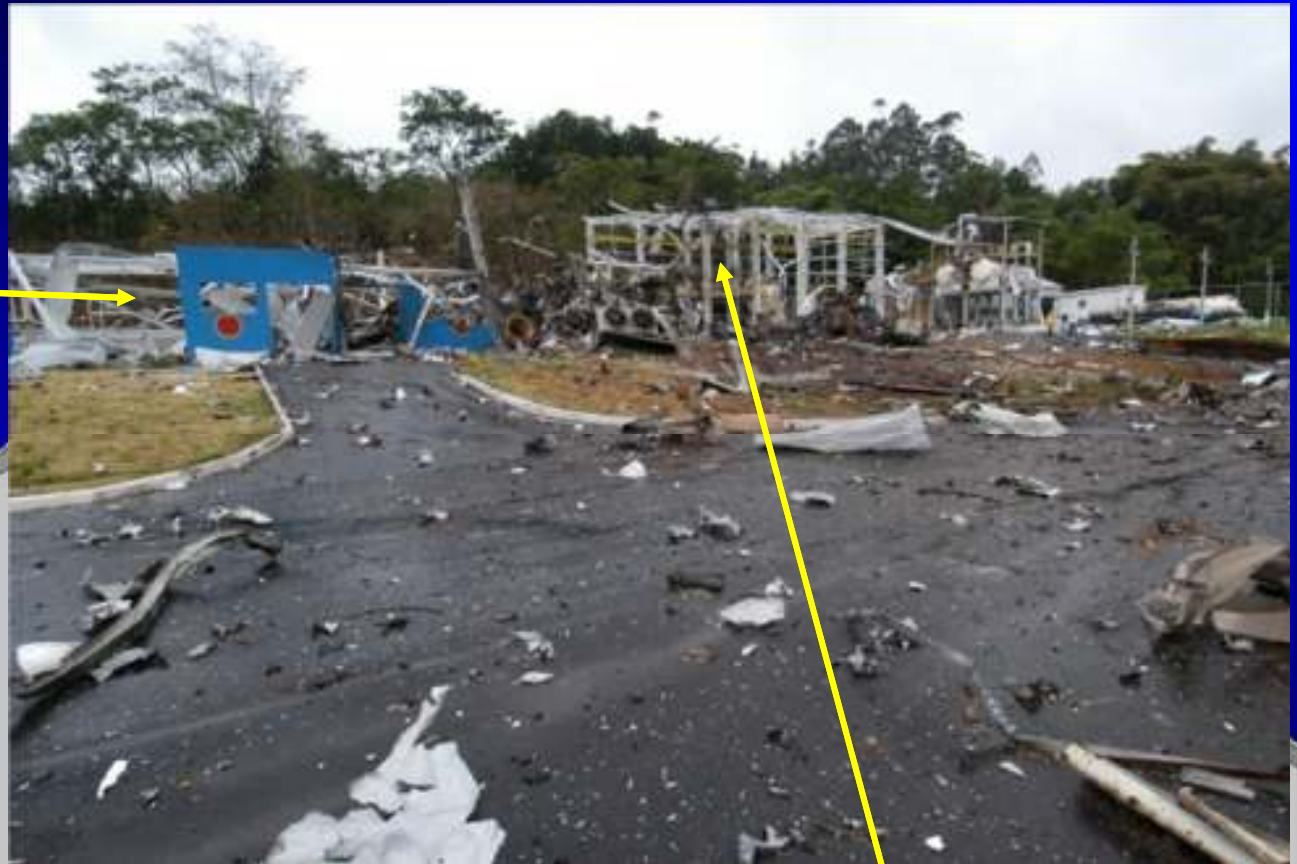
The remains of the  
Cooling Bath corridor.

The remains of the  
Bulk Handling Area.

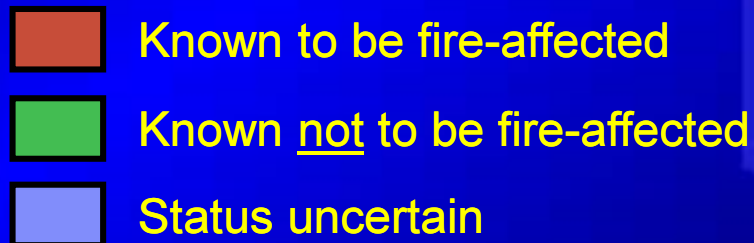
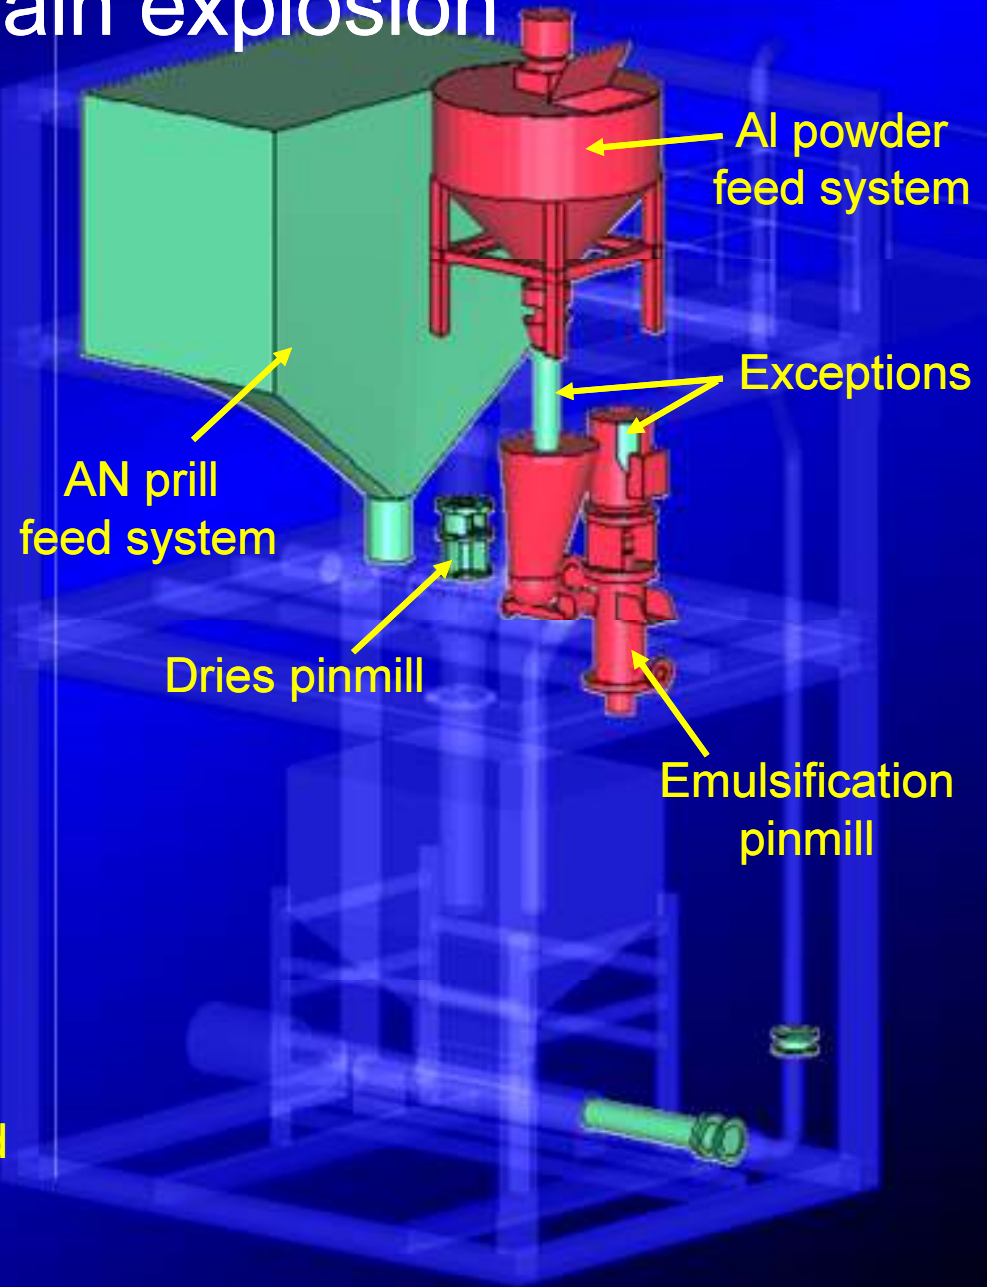
- The fire had engulfed
  - all of the aluminium powder feed system *except* for the connecting pipeline.
  - all of the Emulsification pinmill *except* for one fragment of its motor casing.

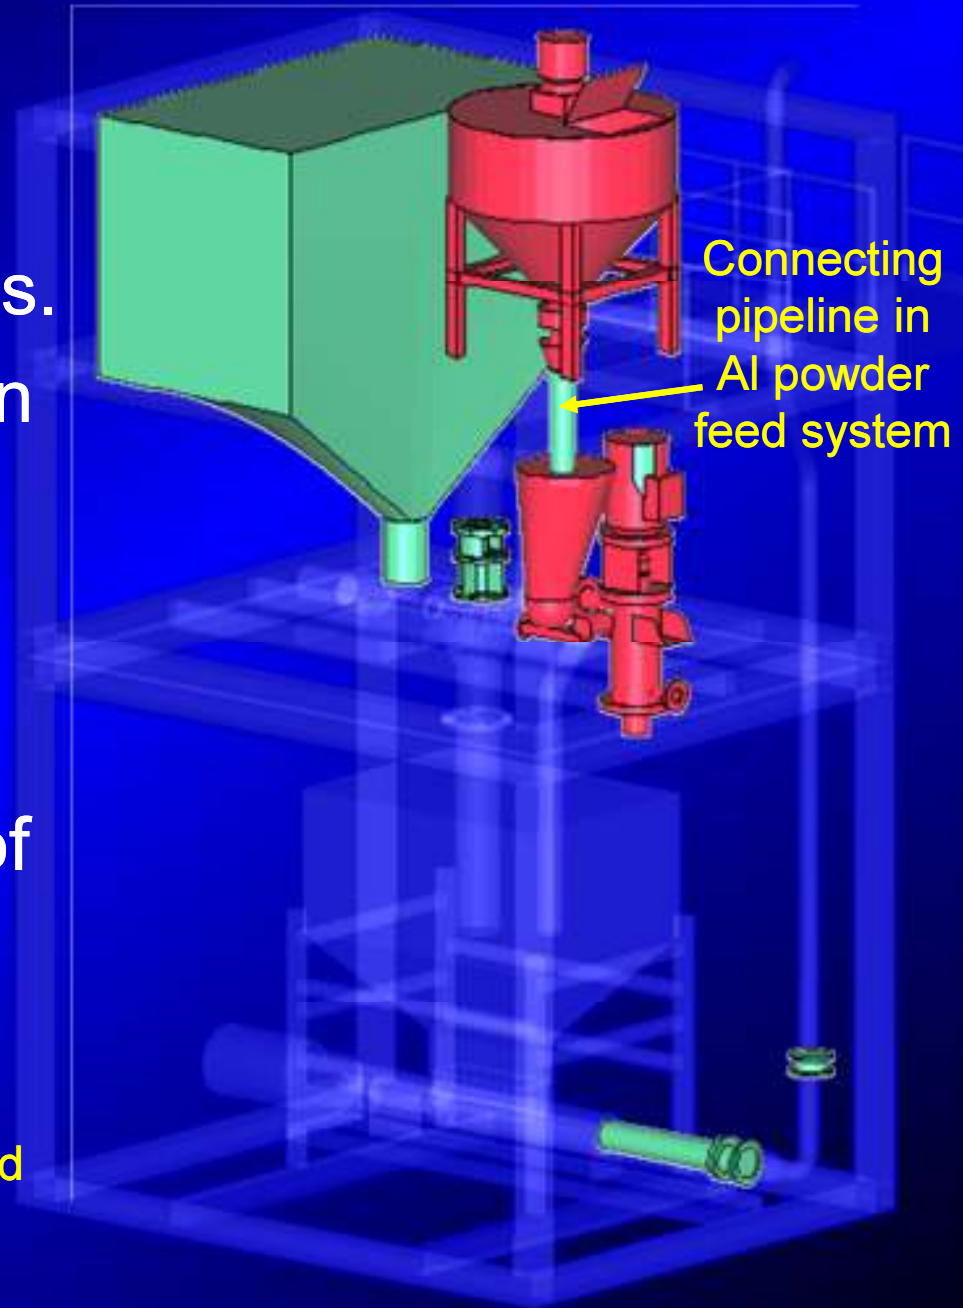
- These two exceptions showed other anomalies.
- The pipeline was thrown in the exact opposite direction to the rest of the items in the Al powder feed system. It had acquired traces of green paint.

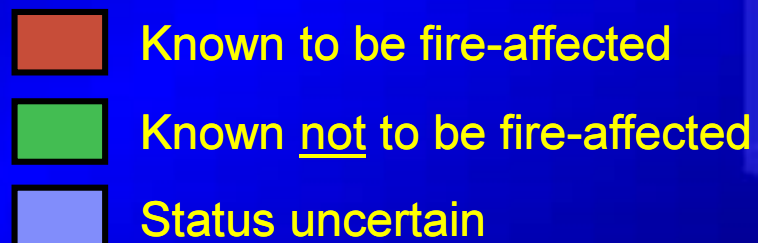
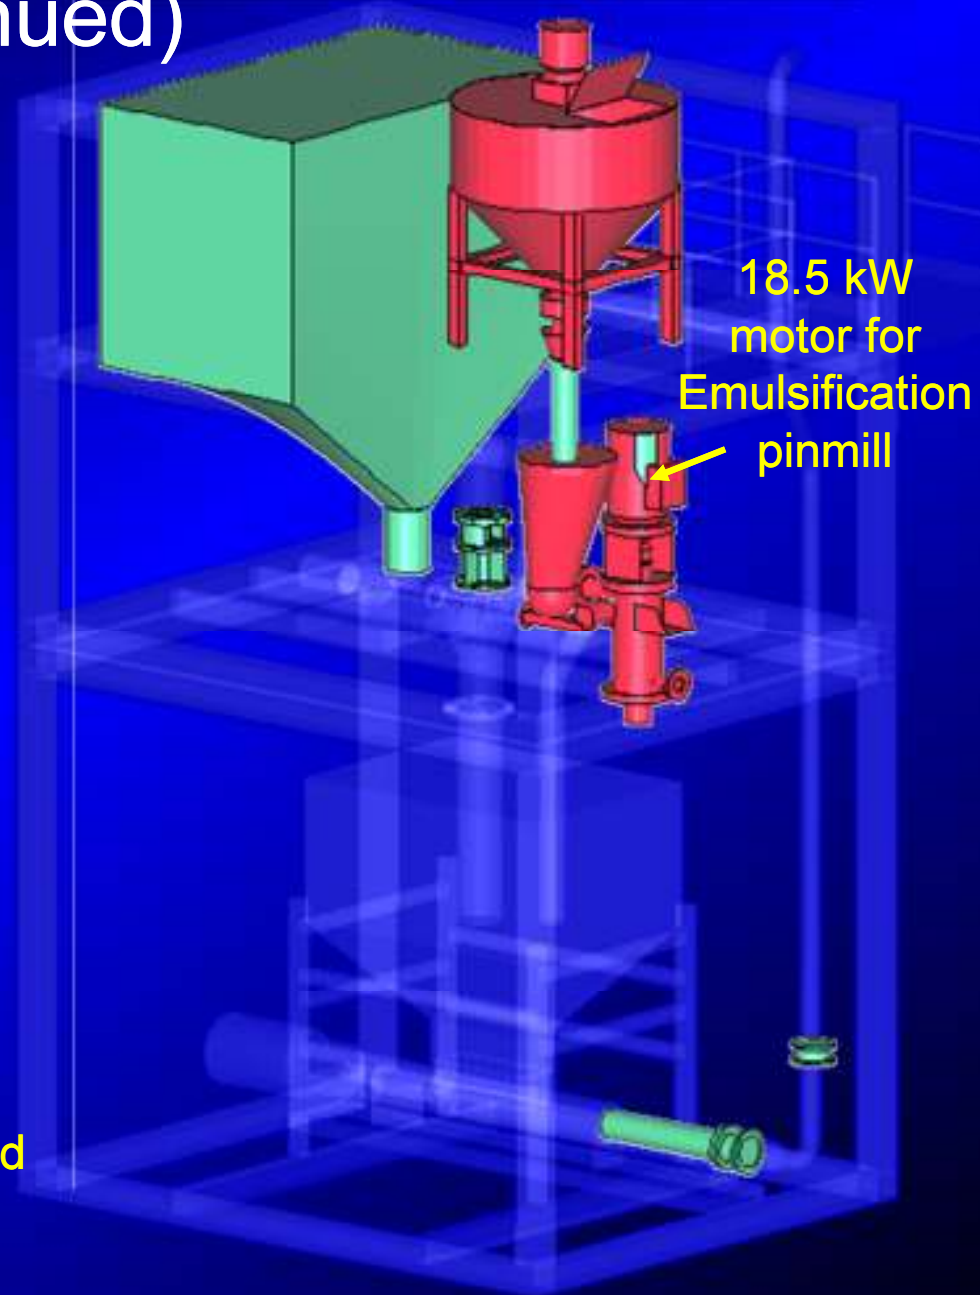
- The fragments of the 18.5 kW motor casing were scattered widely, being thrown as far as 225 m in all directions.

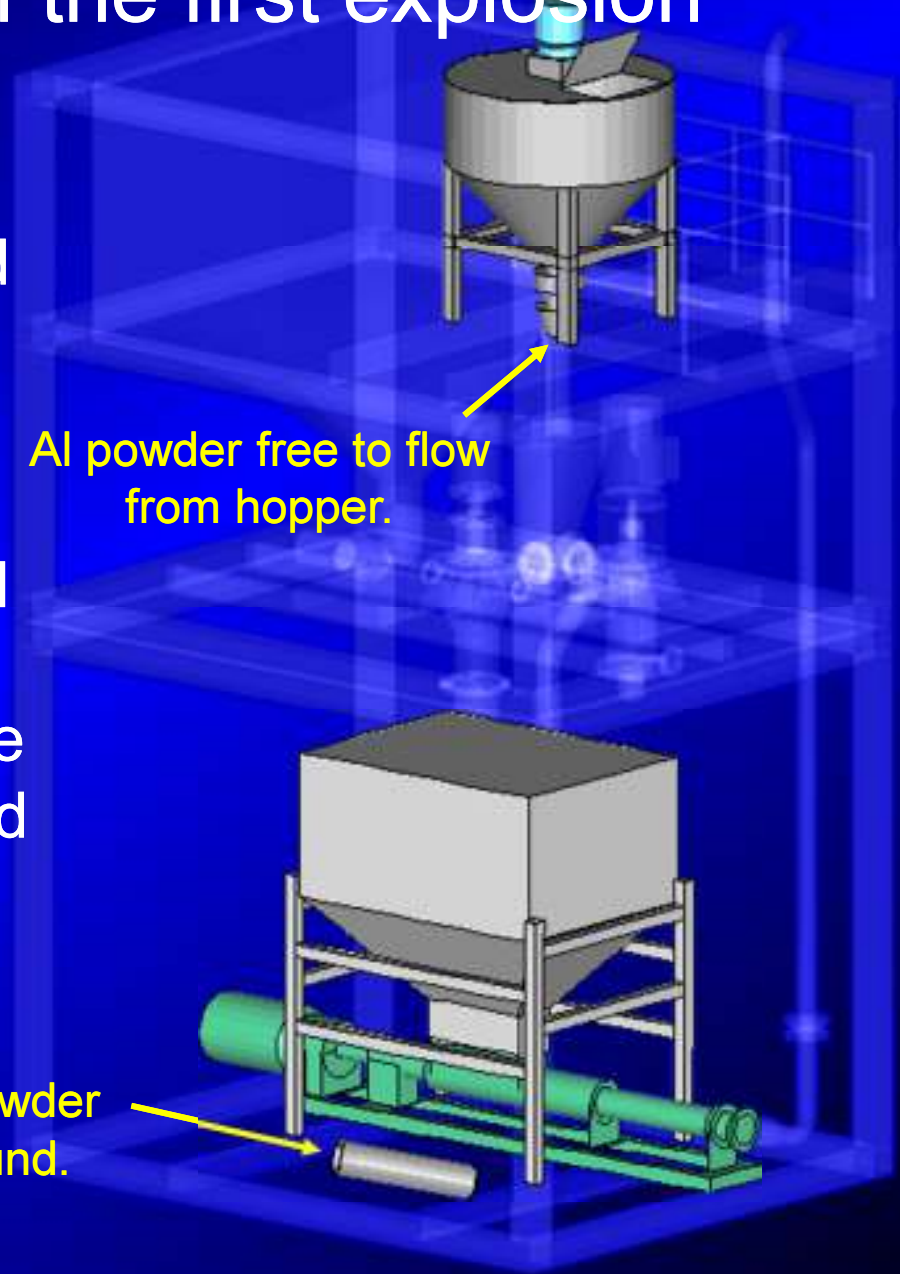
- It is inferred that:
  - The connecting pipe had fallen to the floor, and was lying next to the (green) PC pump.
  - Its dislodgement allowed aluminium powder to flood the area around the Emulsification pinmill and to fuel the subsequent fire.

Al powder free to flow from hopper.

Connecting pipeline from Al powder feed system fallen to the ground.

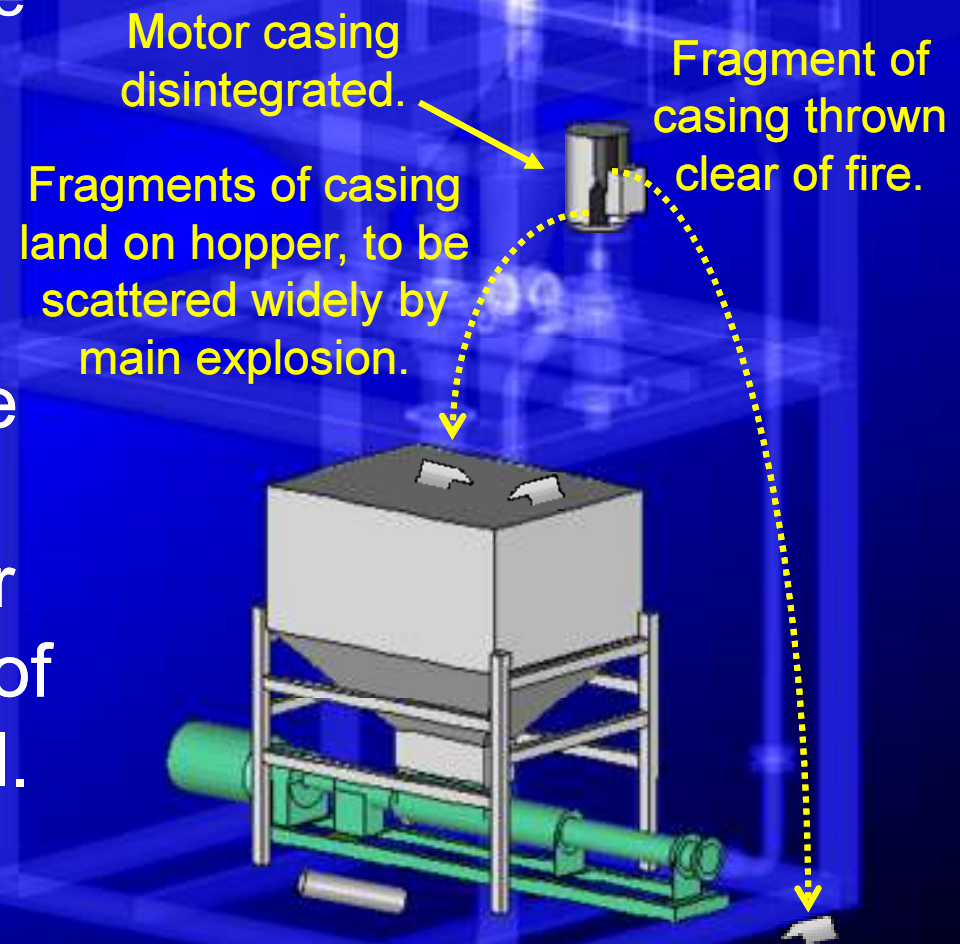
- It is inferred that:
  - The cast iron casing of the motor had disintegrated, and fragments were lying on top of the hopper and on the ground.
- It was concluded that the first small explosion had occurred either inside, or very close to, the motor of the Emulsification pinmill.

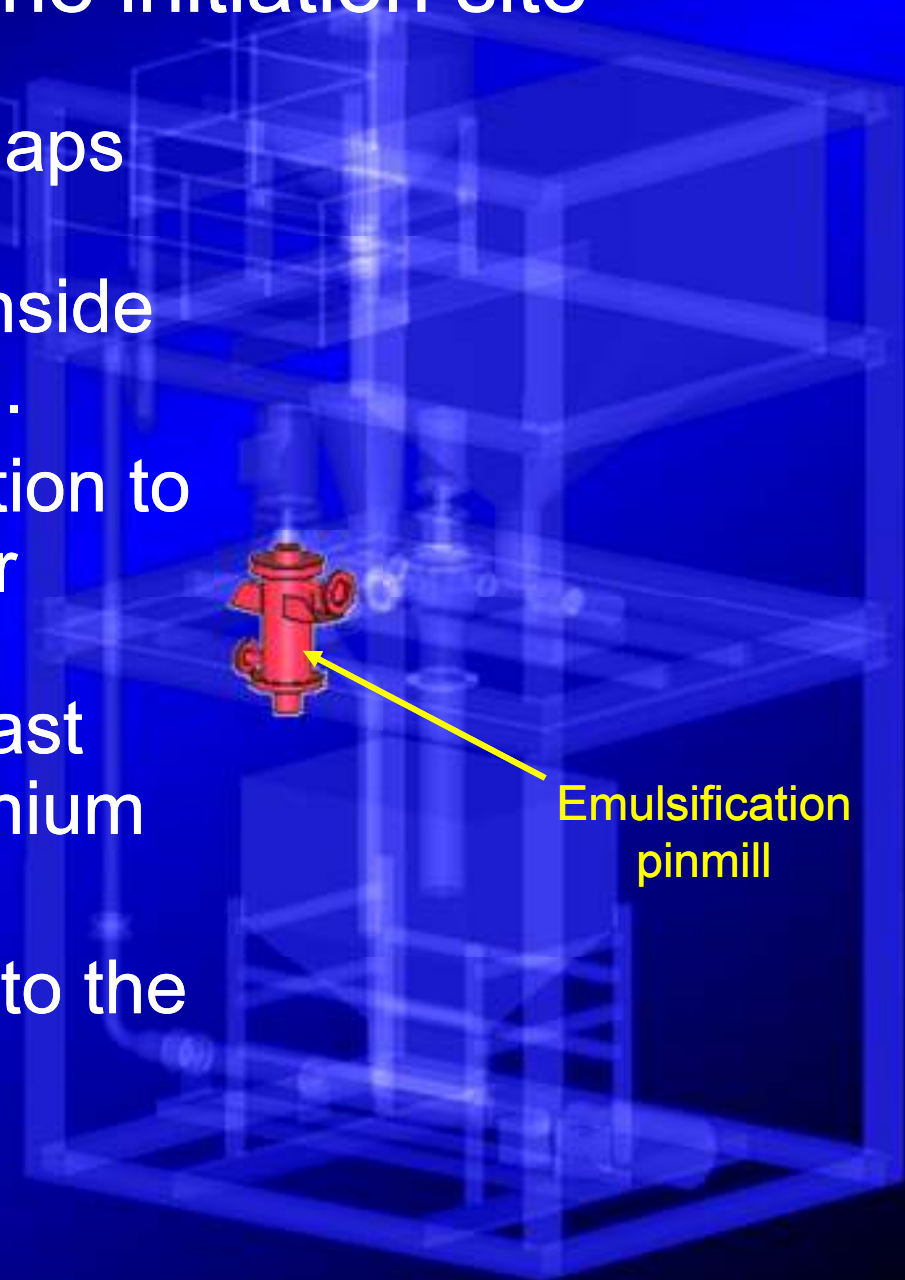
- The debris distribution maps indicated that the main explosion likely started inside the Emulsification pinmill.
- It is inferred that a transition to detonation occurred after about three minutes of engulfment in a fire at least partially fuelled by aluminium powder.
- The mechanism leading to the transition is not known.

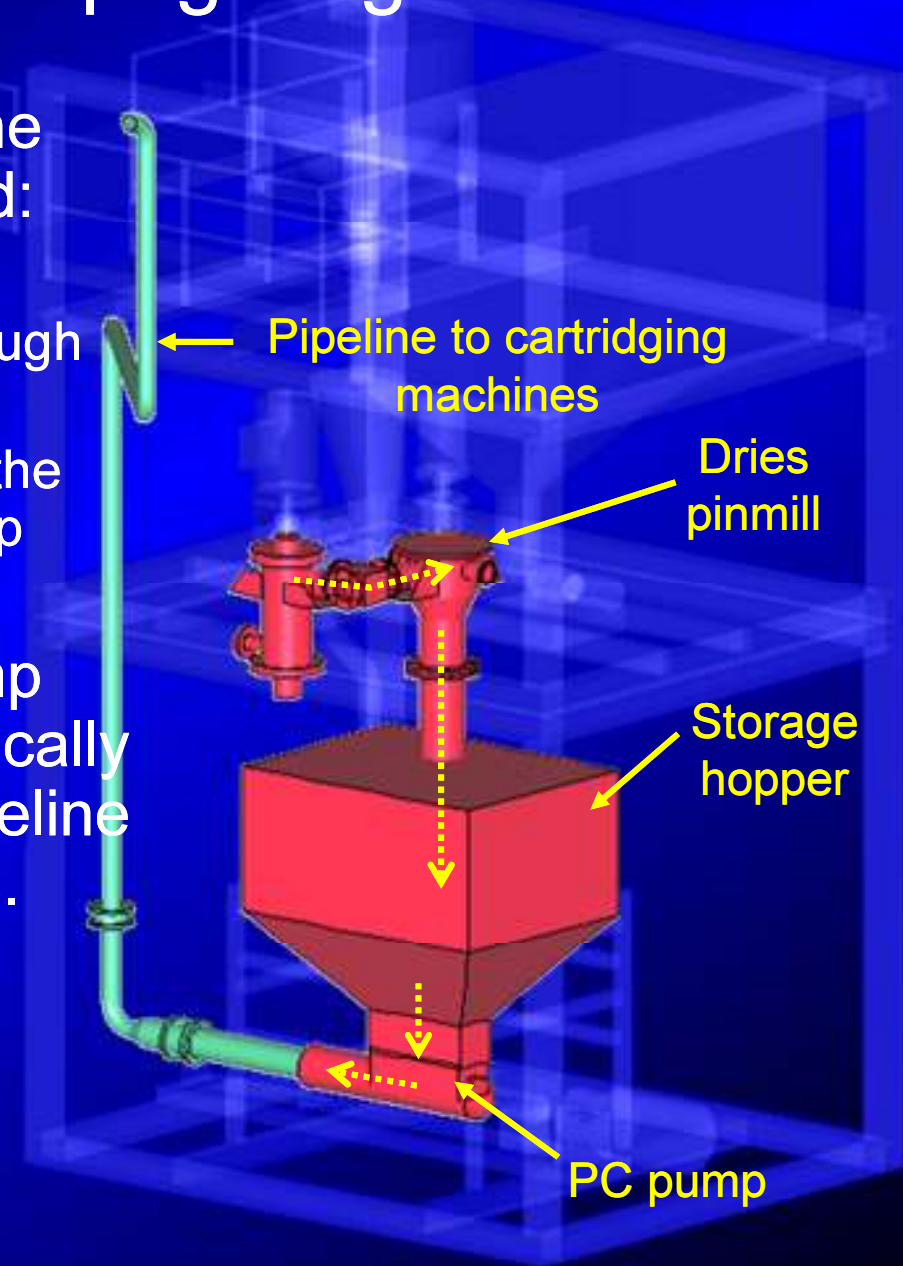
- The debris indicated that the detonation then propagated:
  - through the 3-way valve
  - into the top of and down through the Dries pinmill
  - through the hopper and into the inlet chamber of the PC pump
- The detonation did not propagate through the pump stator, nor did it sympathetically initiate the matrix in the pipeline to the cartridging machines.

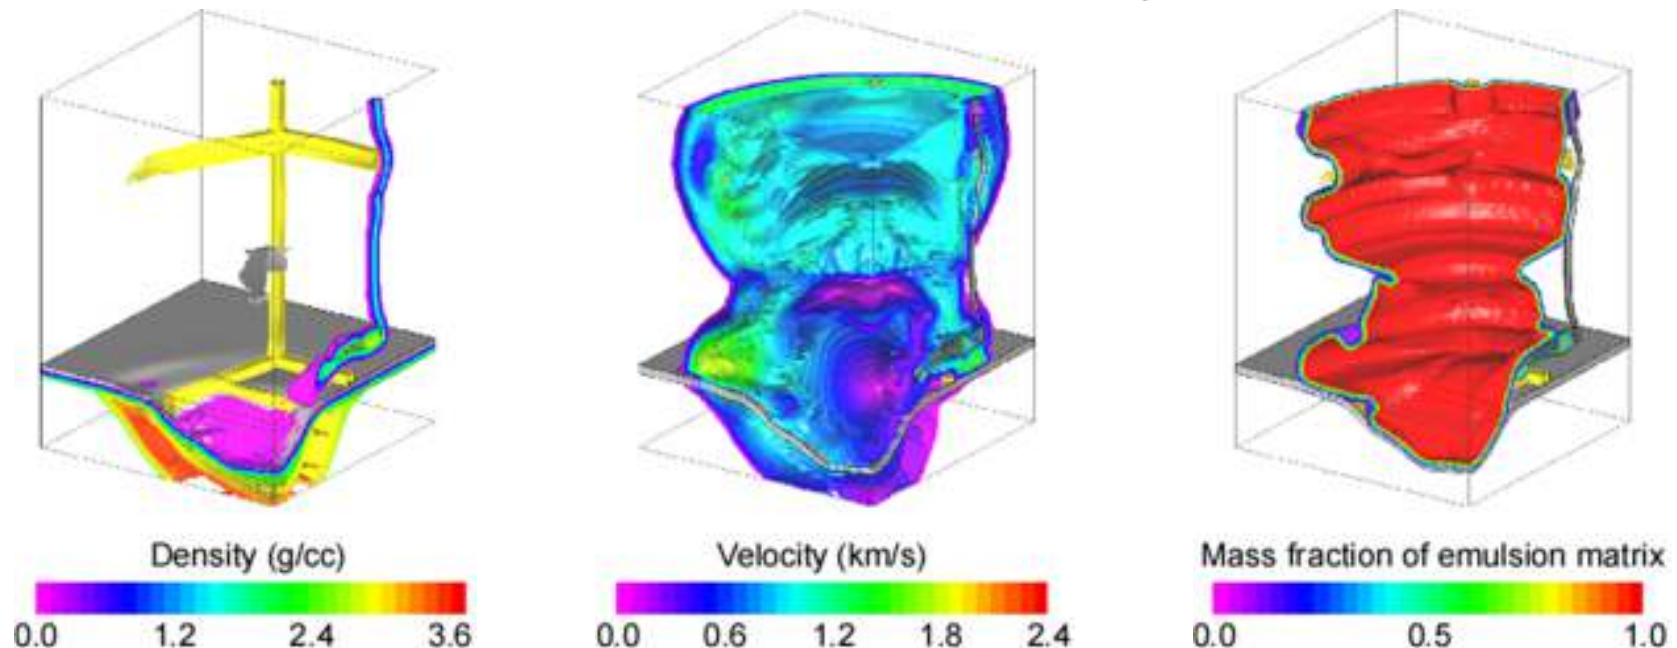
- The DFEM code LS-DYNA was used to simulate the explosion for different assumed masses of emulsion matrix in the emulsification module.

Quarter-space model with symmetry planes through PC pump and hopper, shown 1.5 milliseconds after initiation of 200 kg emulsion matrix.
