# Lorena Packaged Emulsion Plant Explosion, 11 November 2004

# Prefatory note

The Packaged Emulsions Plant located at Lorena, Brazil was completely destroyed by the explosion that occurred on November 11, 2004. As a result of this, very little direct physical evidence of the causes of the explosion survived.

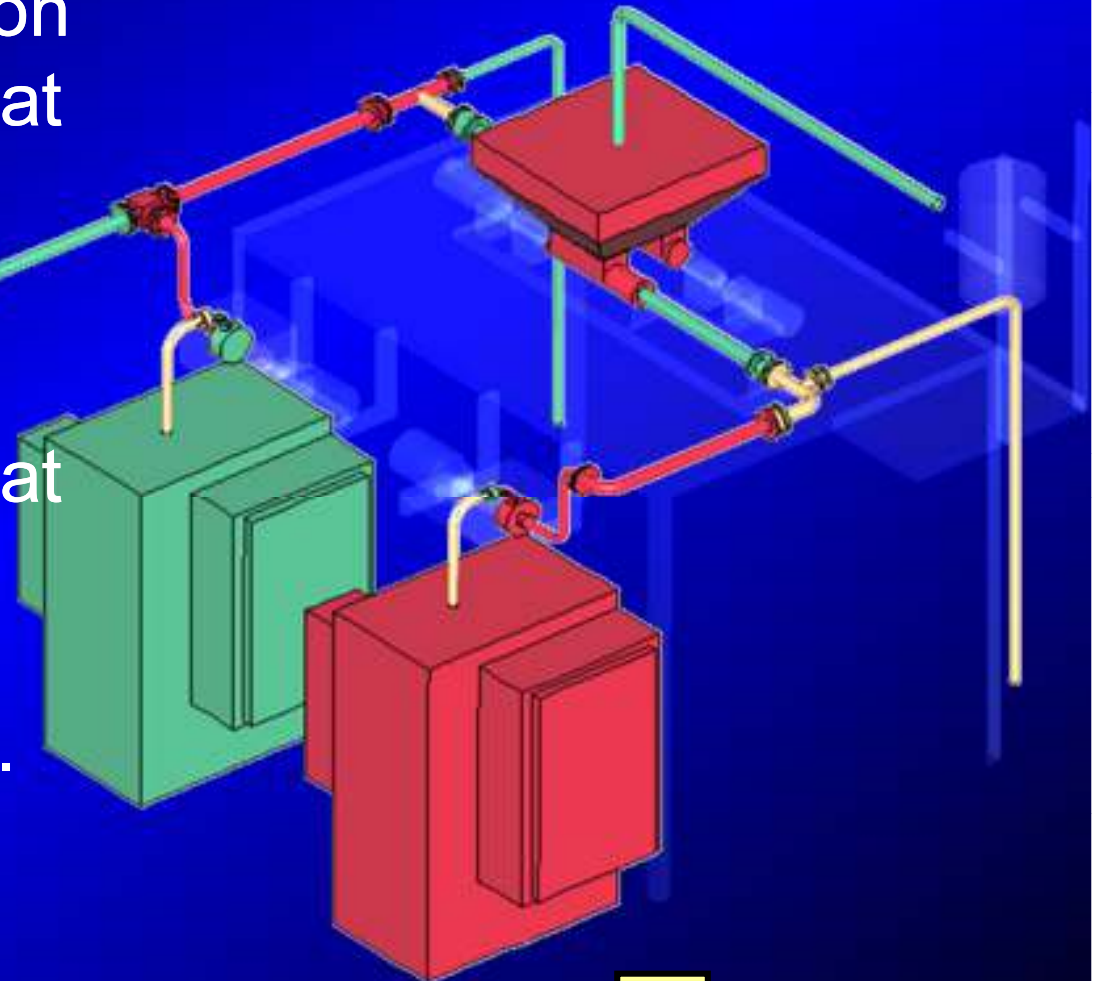
- The debris distribution maps established that several detonations had occurred in this region.
- However, regions that had detonated were interspersed with regions that had not.

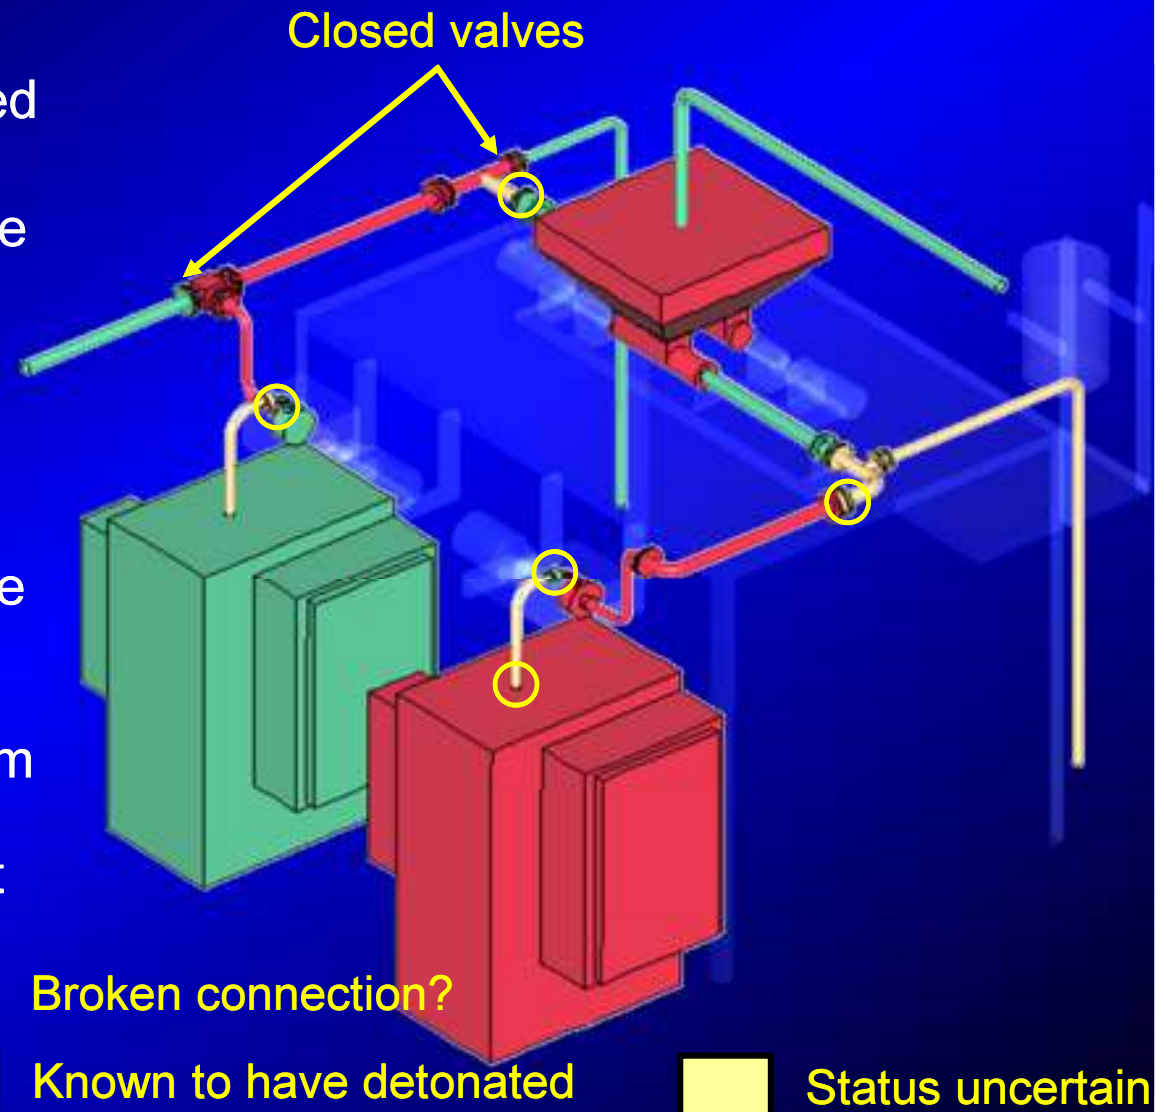
- Two of these interruptions were obviously due to closed valves.
- It is inferred that some of the connections must have broken prior to the onset of each sympathetic initiation, and undergone relative displacement.
- This means there must have been a time delay (of about 10 ms or so) between the arrival of the blast wave from the emulsification module and the onset of initiation at each site.

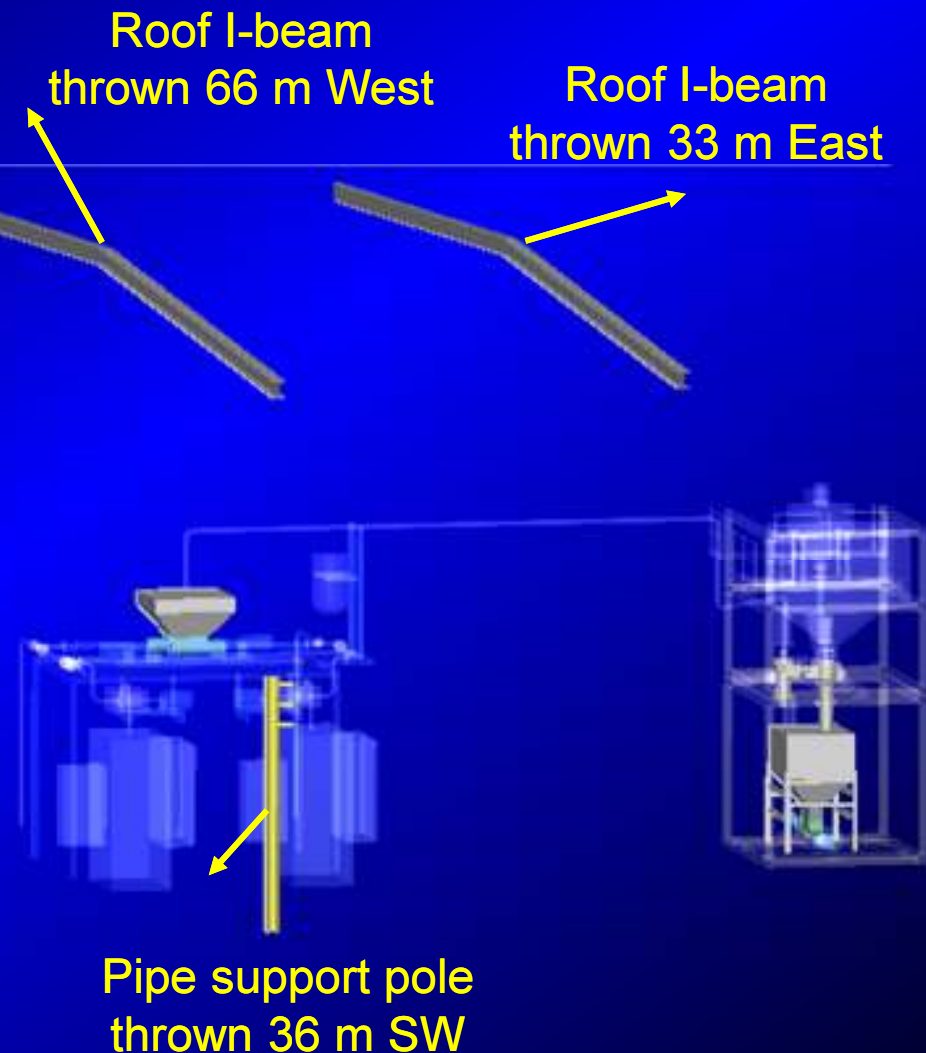
- The relative contributions from the explosion centres at the Emulsification module and above the Filipacs were determined by analysing the throw directions of several structural items.
- It was concluded that about 25% more matrix exploded above the Filipacs than at the Emulsification module.
- Since the latter was previously estimated to be about 200 kg, the former was estimated to be about 250 kg.

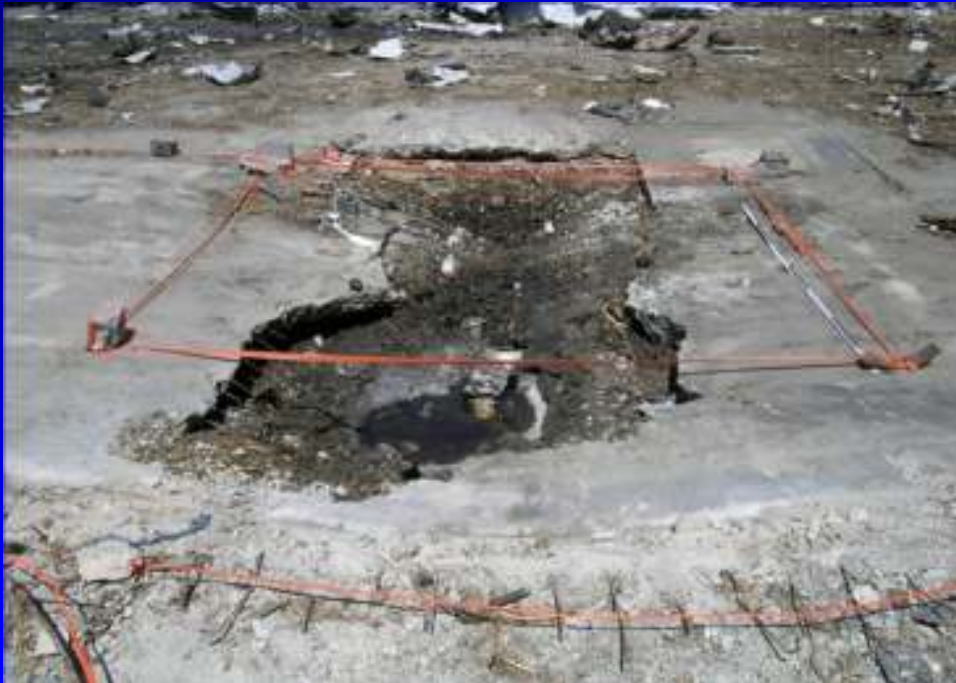
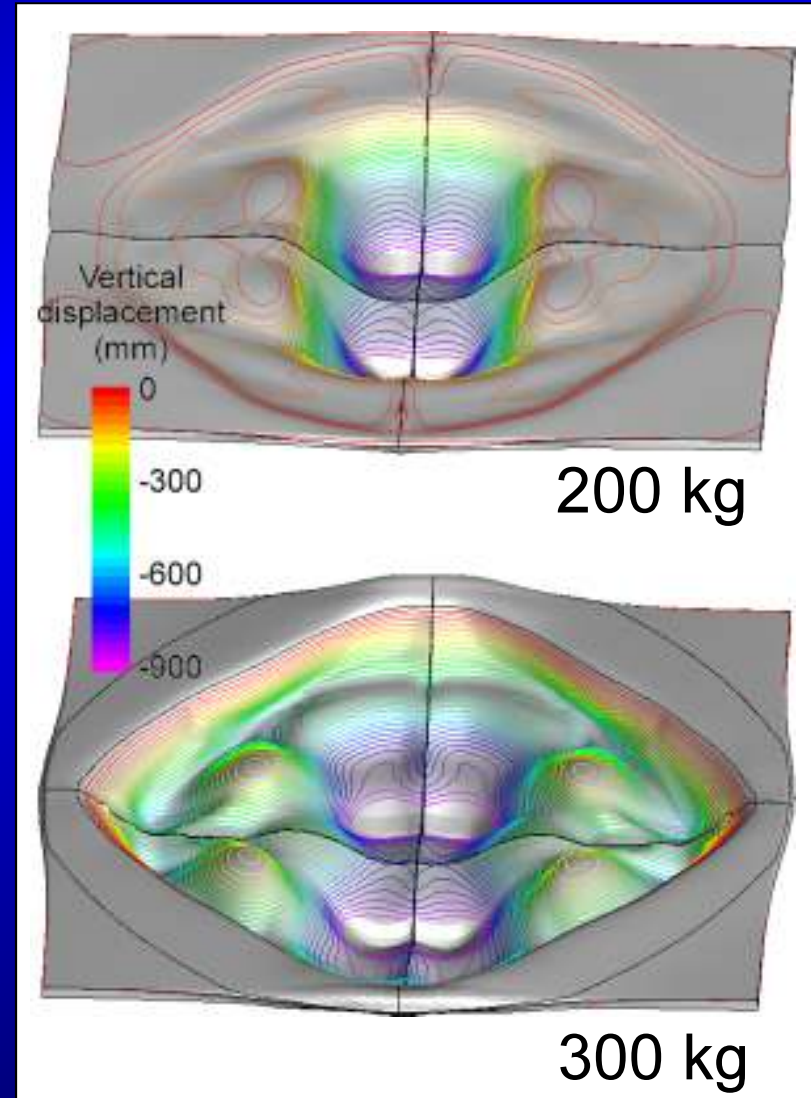
- The best simulated match to the size and shape of the crater under the Emulsification module was for an assumed explosion of 200 kg emulsion matrix.

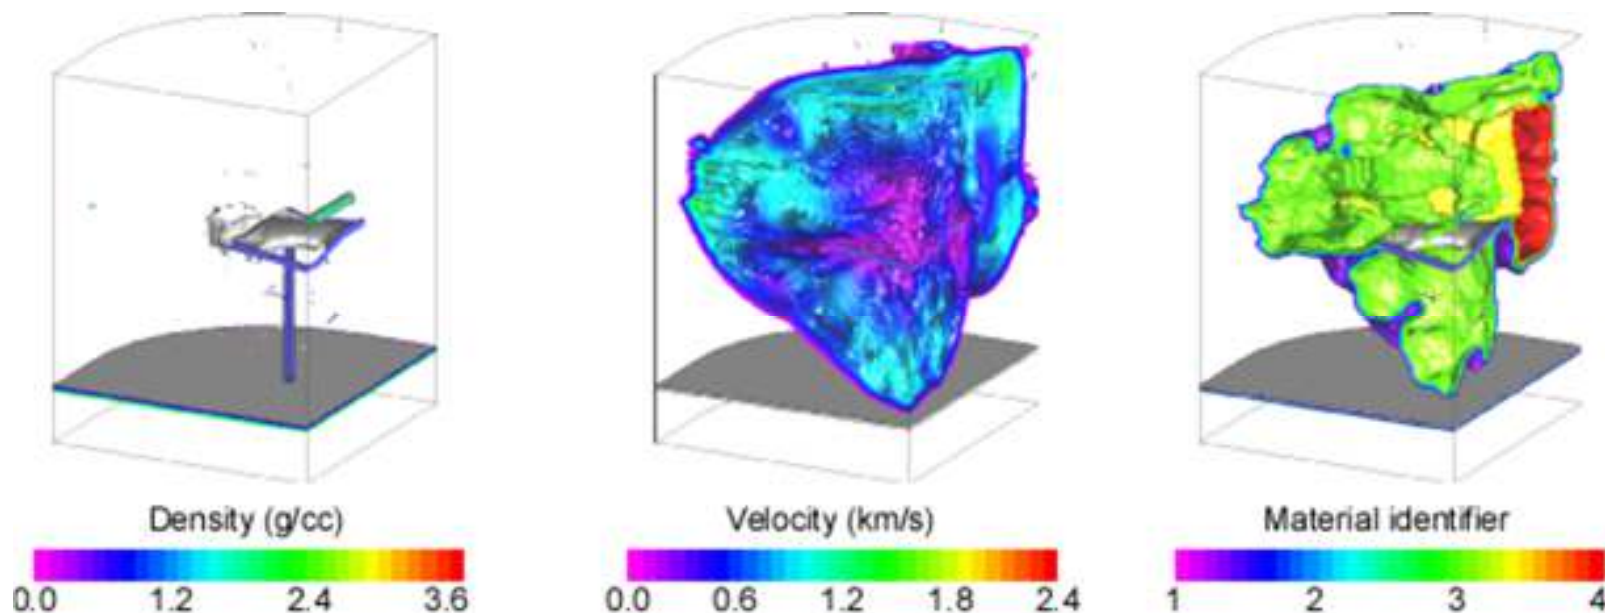
- The DFEM code LS-DYNA was used to simulate the explosions above the Filipac machines for different assumed masses of emulsion matrix and for different delay times between the assumed initiation sites.

Quarter-space model with symmetry planes through hopper, shown 2.5 milliseconds after initiation in the hopper and sympathetic initiation in the Gasser mixer.

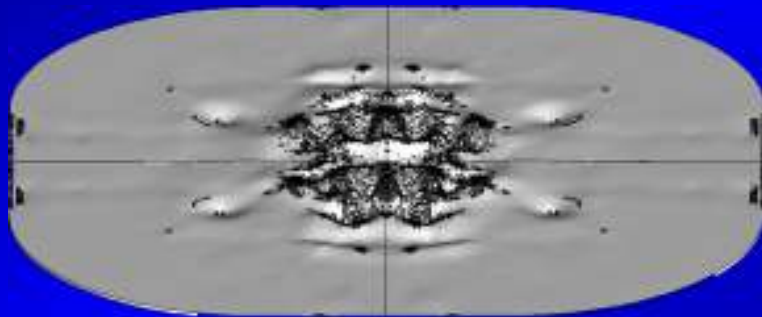
Simulated crater

- The simulations were inconclusive, indicating that the blast wave had been too weak to fracture the concrete floor, but that the observed damage was most likely due to shrapnel impact and penetration.
- The order of the separate sympathetic initiations could not be determined.

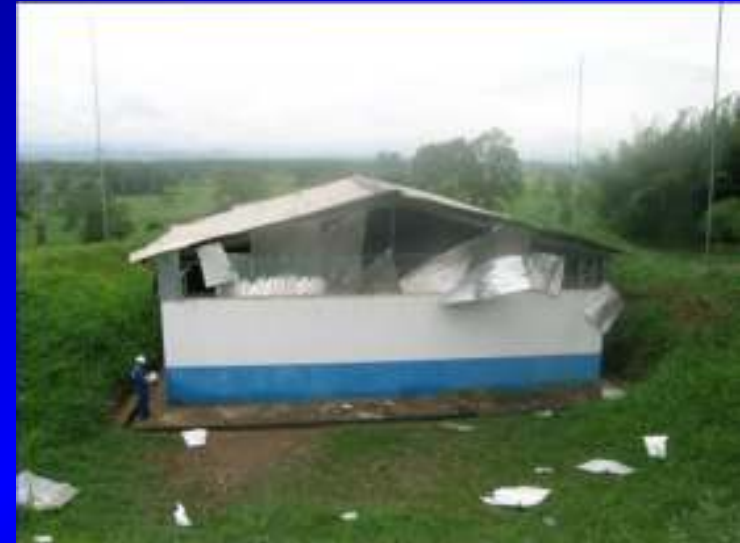
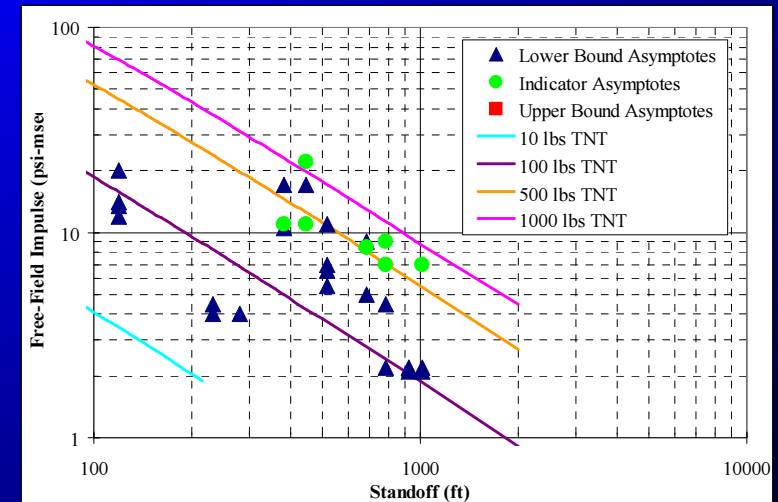
- Baker Engineering and Risk Consultants, Inc., analysed the blast-induced damage to surrounding buildings.
- They estimated a total explosion yield of 270 kg TNT equivalent, corresponding to an explosion yield from about 360 kg AN-based explosive.
- This is in reasonable agreement with the 450 kg total derived by the independent analysis of crater formation and throw of structural items.
