# Watergel Plant Detonation

## Gladstone - South Australia

### May 2006

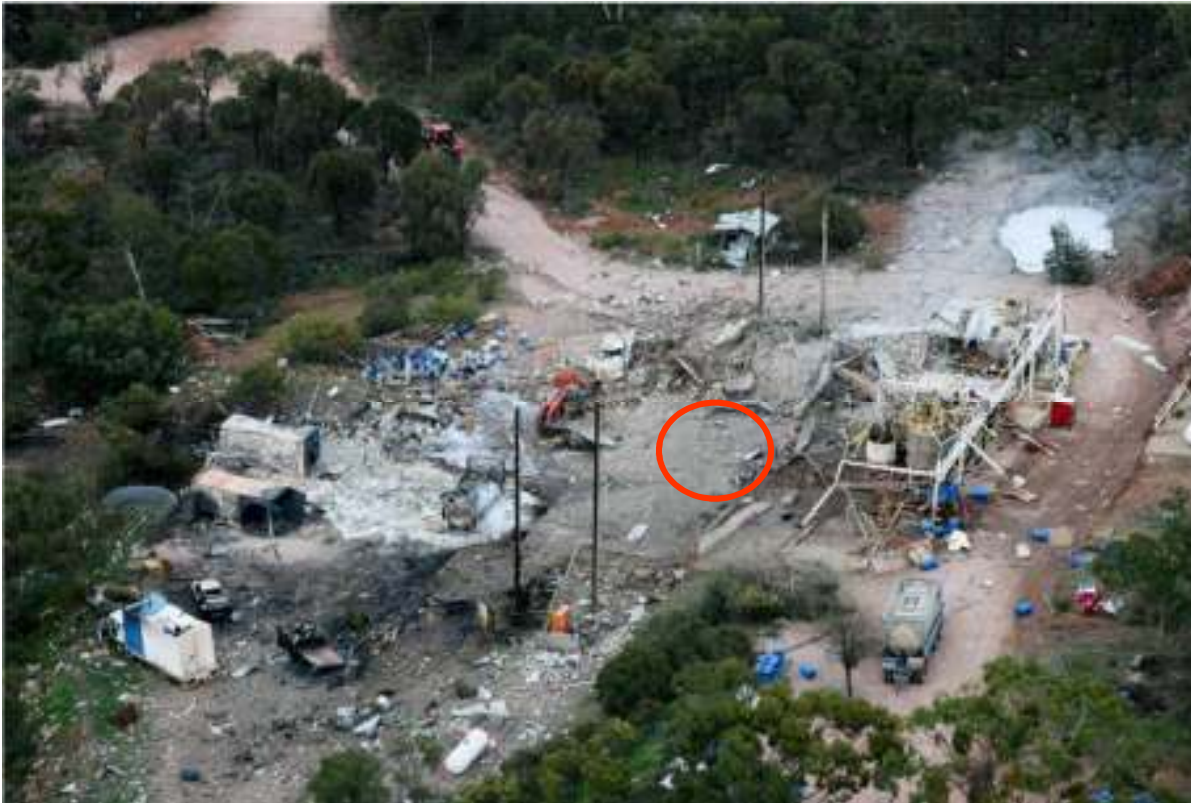
Evidence at the scene suggest the explosion took place in the area shown below, with a crater under the site of the pre-mix hopper.

- South Australian authorities have still not released an official report on their investigations.
- The site has been released back to Quin in August 2007.
- The evidence on the site is consistent with the full order detonation of the contents of the pre-mix hopper.
- The movement of material appears to be radially away from the area of the pre-mix hopper as centre.

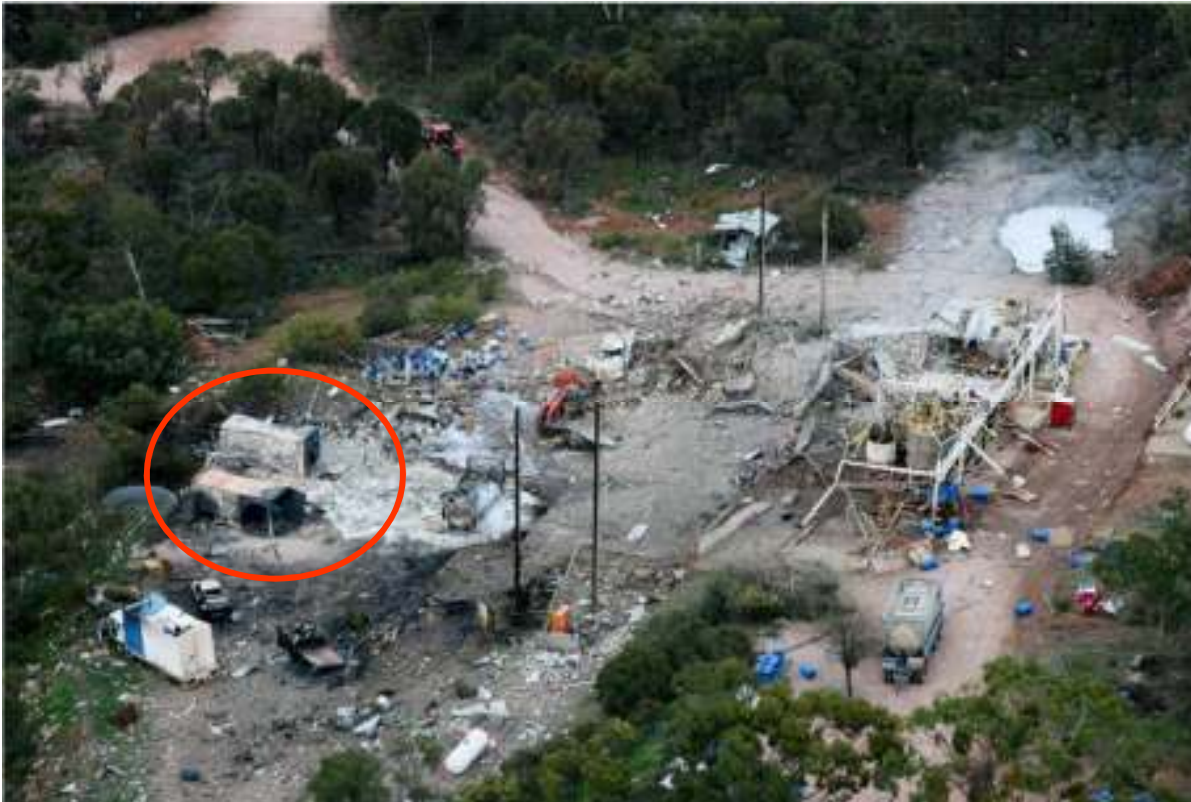
The explosion triggered an intense fire in the nearby storage magazines where TNT castings were stored

- Knock-on explosion of the nearby 5t TNT would have increased the number of casualties, and would have greatly complicated the subsequent investigation
  - *Minimise explosive inventories around manufacturing plant.*
- The electrical power to the site was lost and then reinstated just prior to the blast
  - *Ensure plant powers down in a safe fashion and cannot restart without intervention.*
