## *AEL ignite...* SAFETY AND HEALTH

## DETONATOR PRIMING – IT'S SERIOUS!

# Priming Incident Details

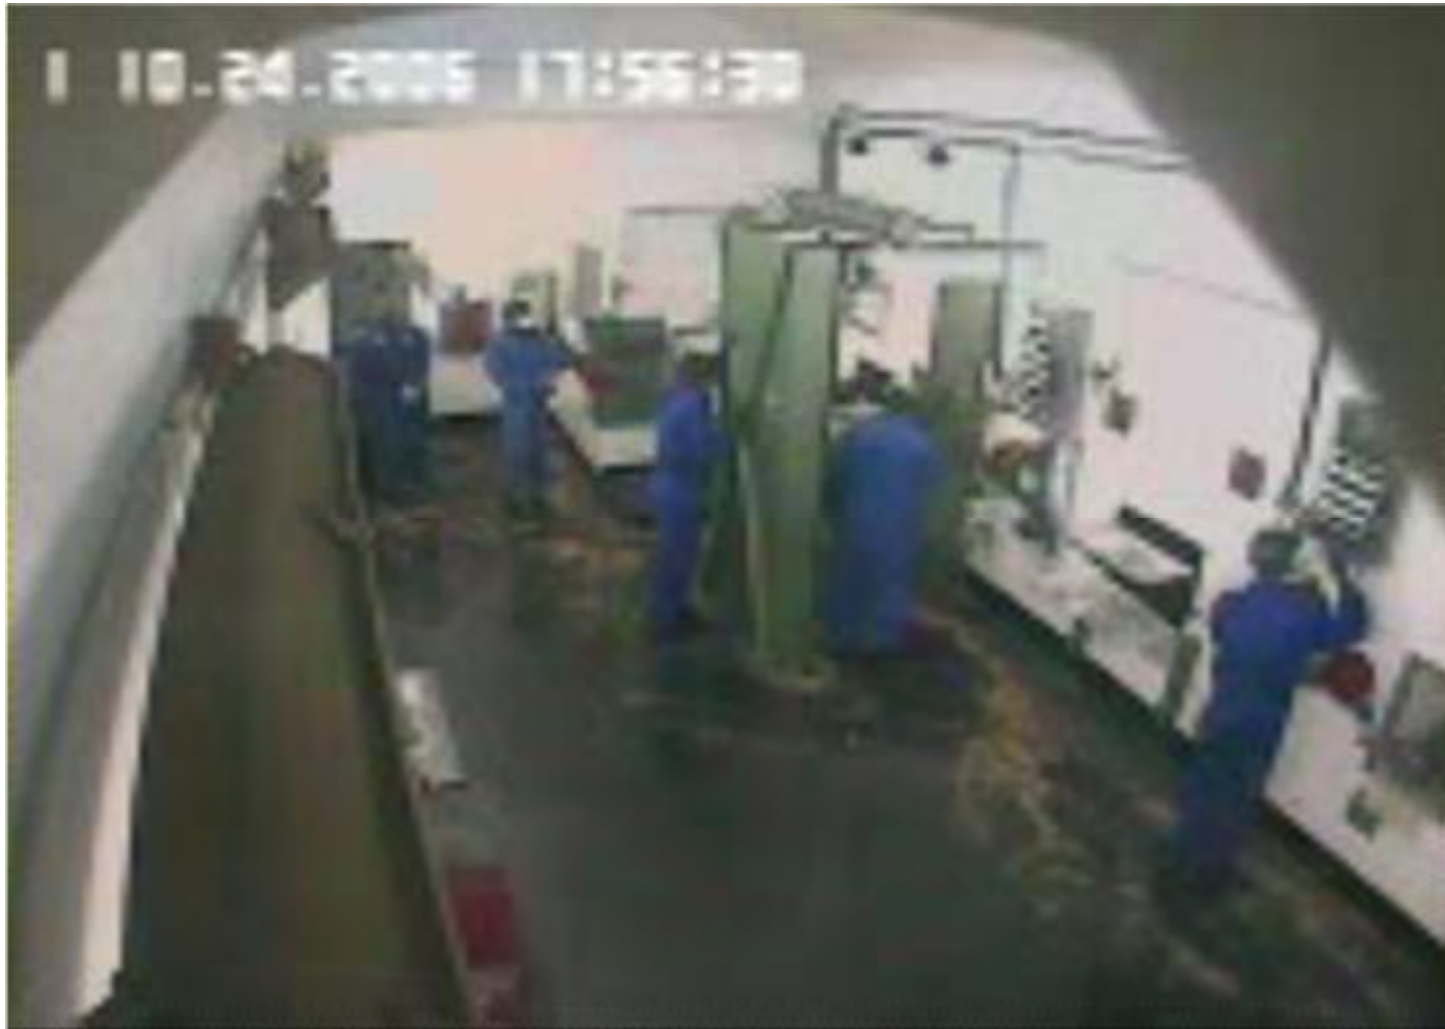
# Priming Incident Details – Just Before the Detonation

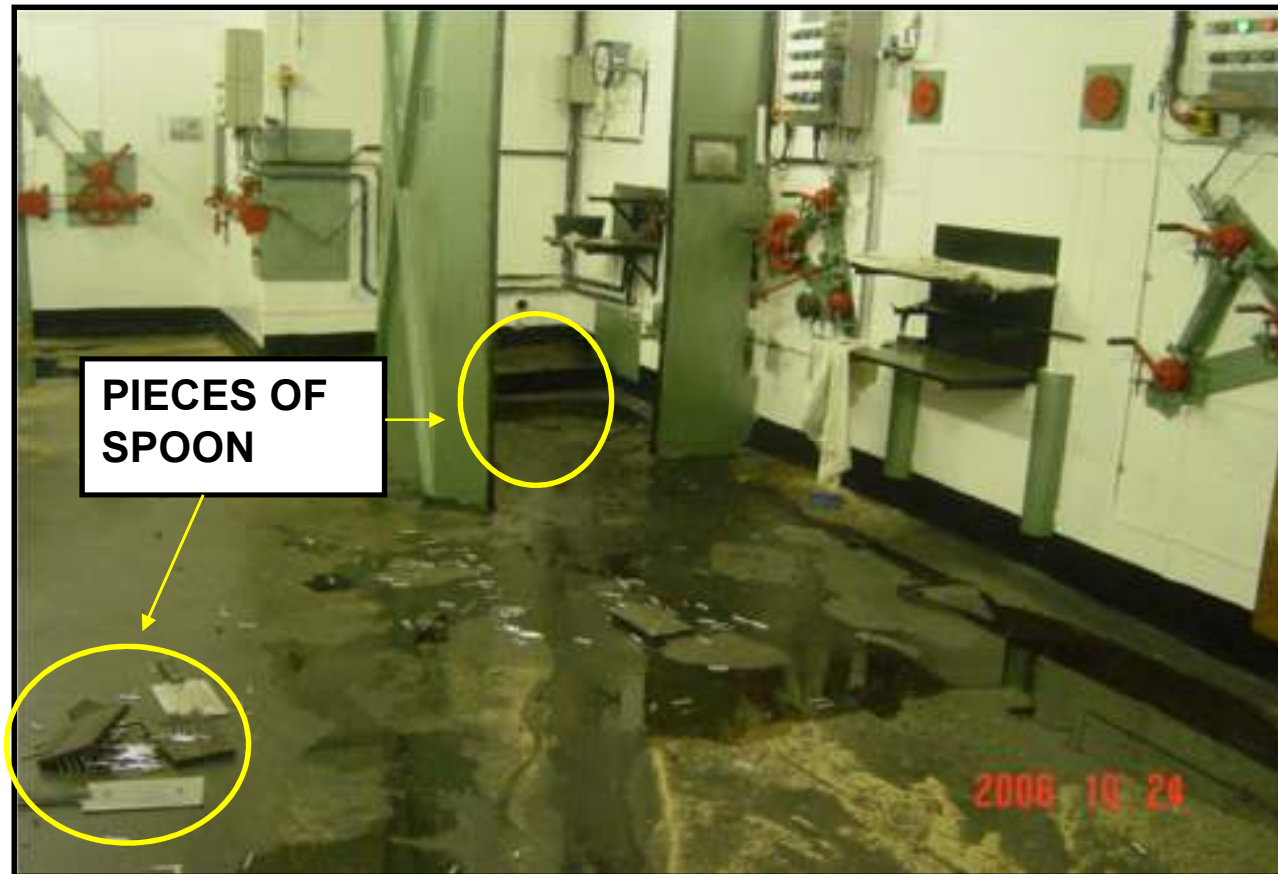
- There was extensive damage to the lead azide / lead styphnate priming cubicle and the employee sustained a severe wound to his left arm requiring his left arm to be amputated.
- He also suffered shrapnel wounds to his left side of his body.

# Priming Incident – Damage to Cubicle ( Inside )

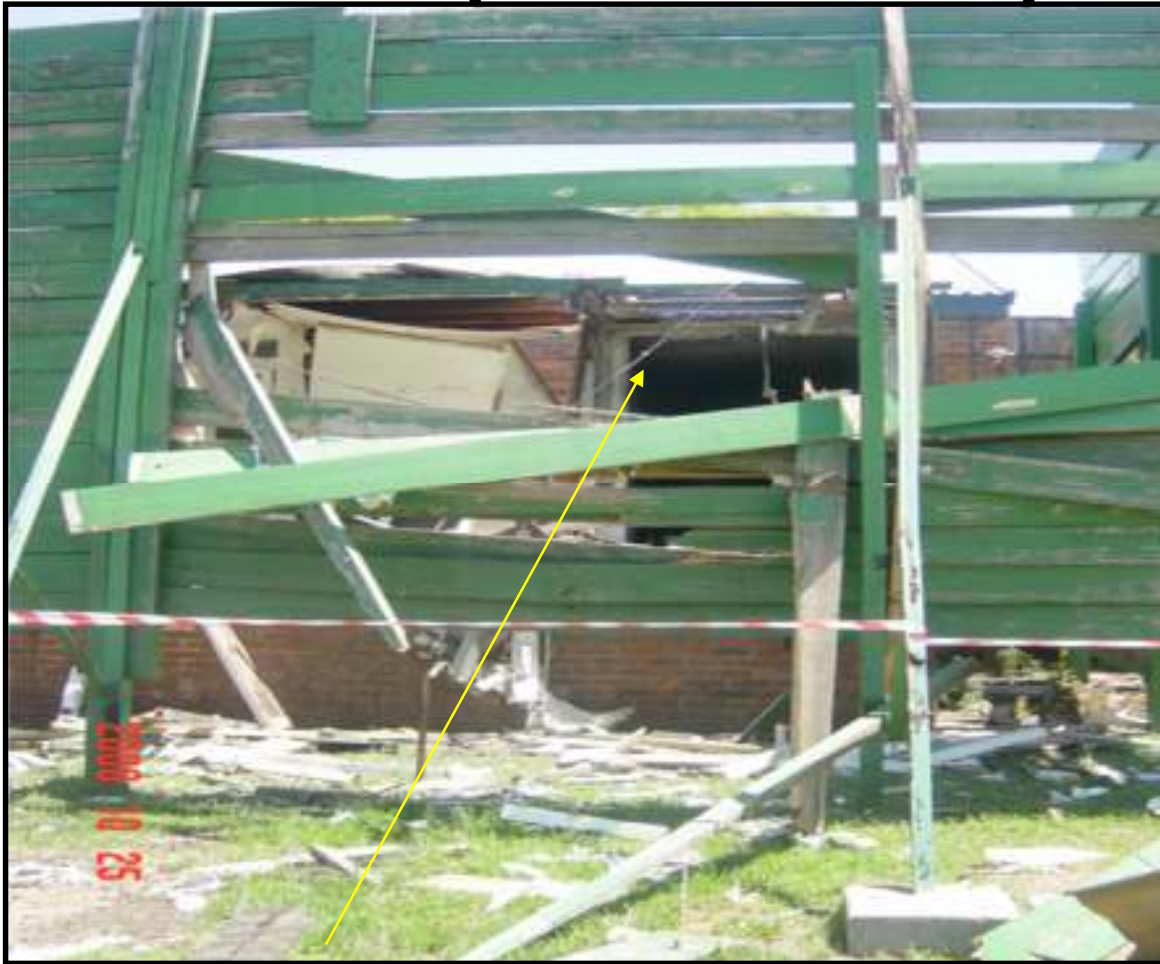
# Priming Incident – Damage to Cubicle ( Backside )

LARGE HOLE CAUSED BY THE EXPLOSION

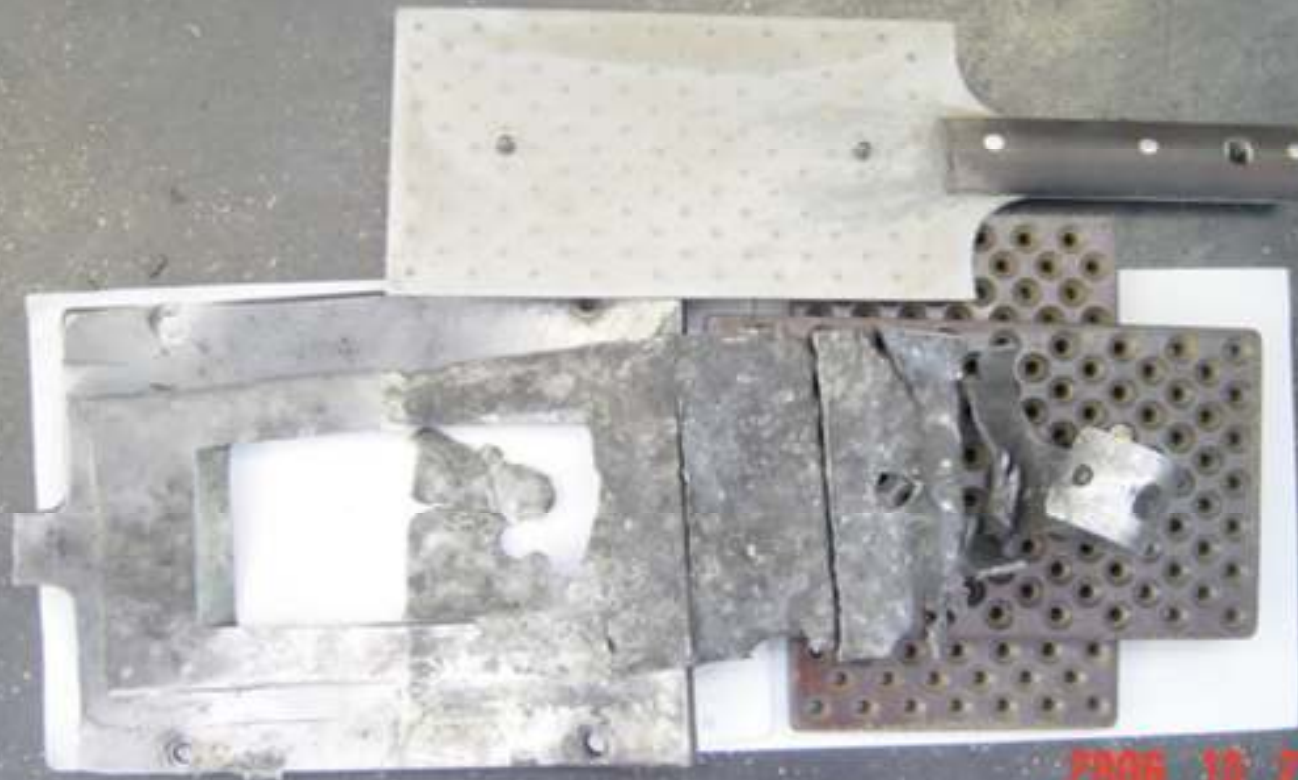
2006 10 27

- Employee was about to prime, accidentally entering the priming cubicle manually and not via the introduction system.
- This resulted in the spoon impacting on loose lead azide/lead styphnate (on the base plate) causing it to detonate.
- The detonation propagated to the spoon of tubes and the hopper of lead azide / lead styphnate.
- As the shutter was open the employee was exposed to the blast resulting in his injuries.

THE RECOVERED PIECES OF THE SPOON REASSEMBLED ON THE RECOVERED BASE PLATE WITH A STANDARD SPOON AS REFERENCE.  
( THE BLOCKS ARE PURELY FOR SUPPORT )

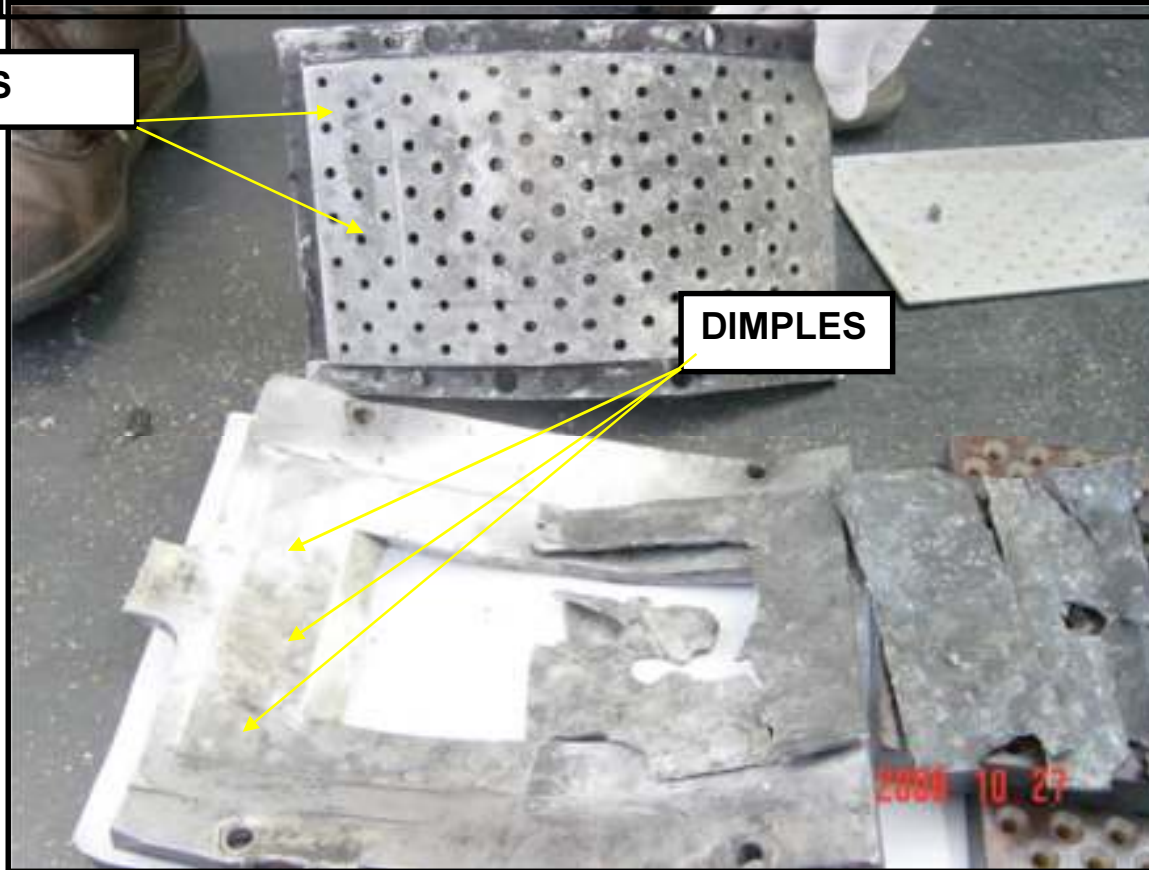
THE RECOVERED PIECES OF THE SPOON AND BASE PLATE WITH THE PRIMING PLATE. THE DIMPLES ON THE BASE PLATE CORRESPOND WITH THE HOLES IN THE PRIMING PLATE.

THE PIECES OF SPOON WITH THE PRIMING PLATE ON TOP AND A STANDARD SPOON AS A REFERENCE
