## TRANSPORTATION INCIDENT – ANFEX TRUCK FIRE

# **ANFEX Truck Incident Details**

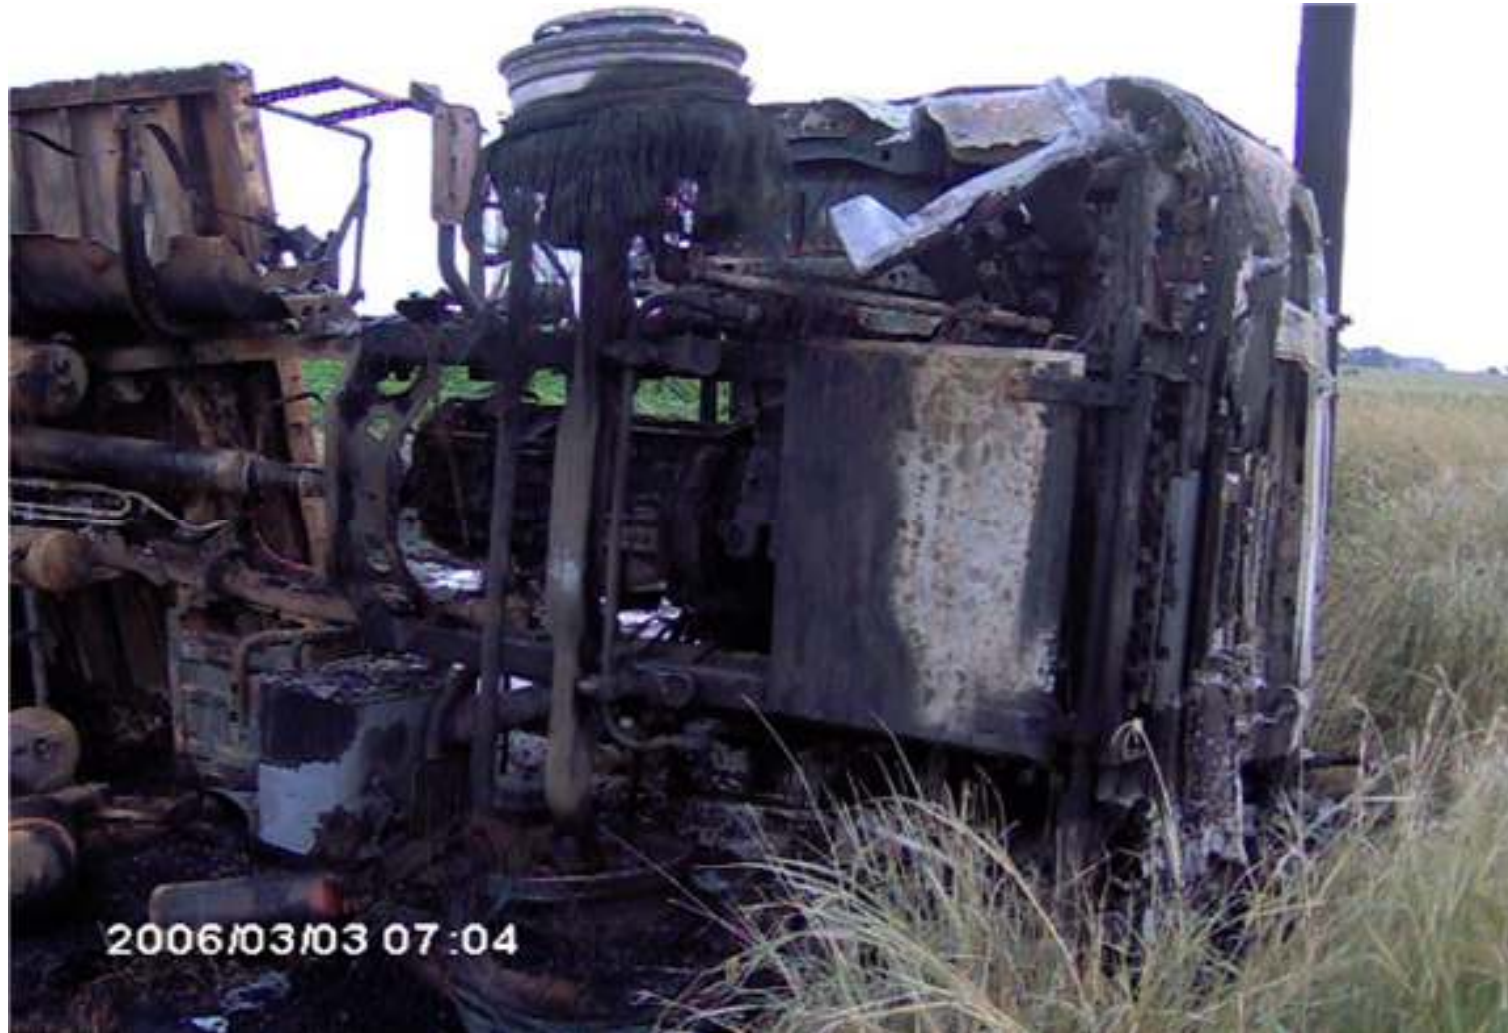
# ANFEX Truck Incident Scene

- The truck was burning, fire department responded as well as many people in the surrounding area gathered around the incident scene to see what was happening.
- This included a Farmer who lived close-by.
- The truck was fully loaded with AEL product ( 20 tons ANFEX ) and the fire destroyed both the horse and trailer as well as the product which was loaded in the enclosed trailer.
- Truck was basically left to burn out.
