LEARNINGS FROM WUERGENDORF ACCIDENTS IN 2002

**Presented at
SAFEX May 2005**

EXPLOSIONS AT WUERGENDORF IN 2002

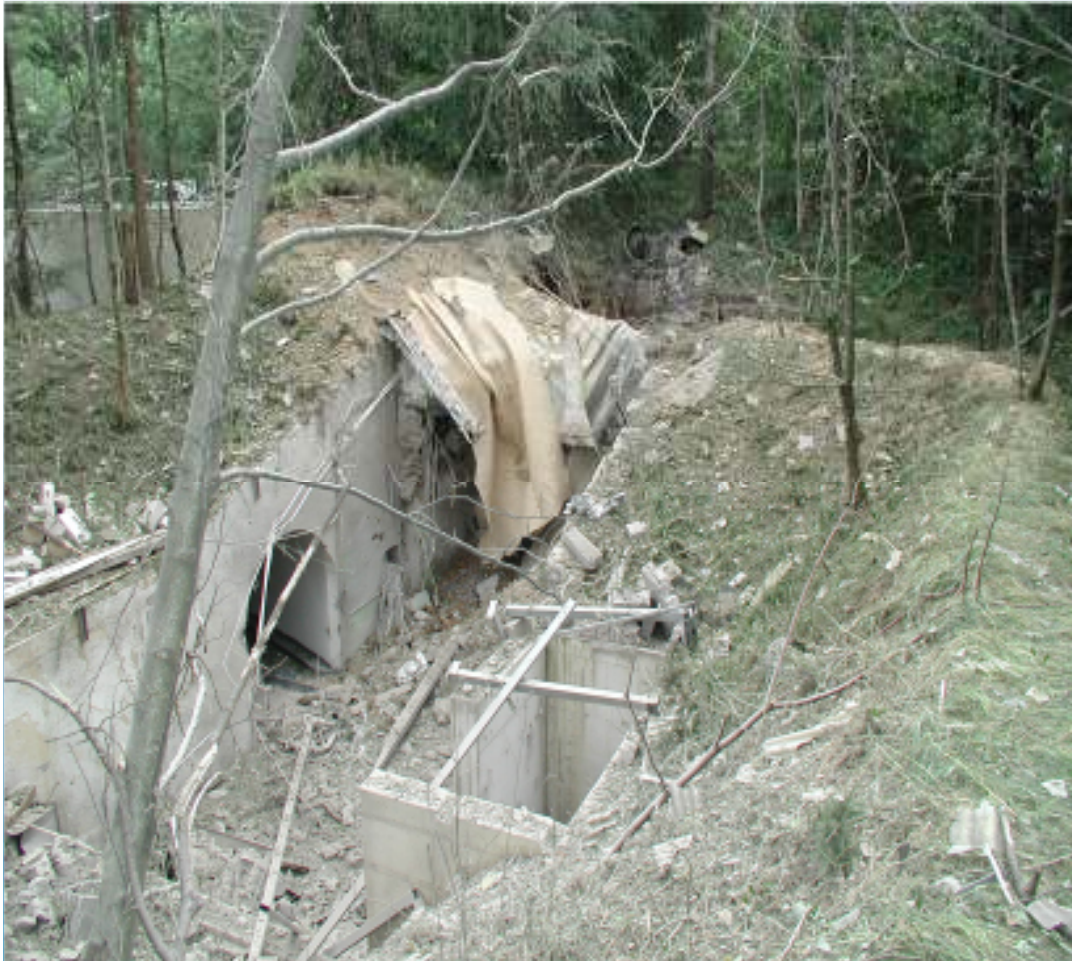
Above transfer tunnel

- Building 49: Dynamite small diameter Packaging Machine: Rollex
- Machine exploded while employee was in room; around about 90 kg of Dynamite
- Possible causes: Foreign body introduced to either Auger or table
- Consequences: one fatality, Machine and Building destroyed

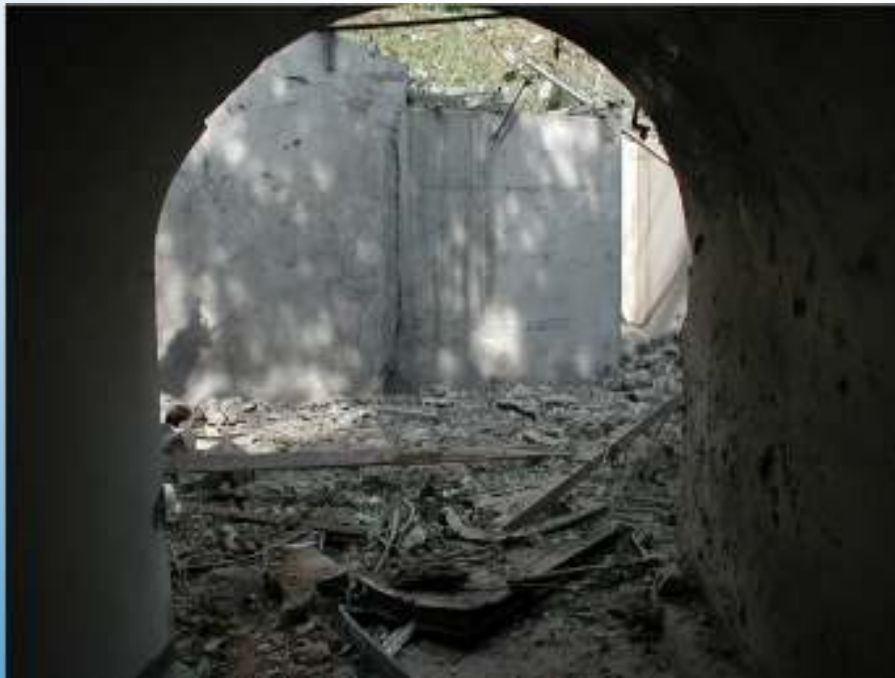
Entrance to cartridging room

- Occurred in a dynamite cartridging room (Rollex Machine)
- Approx. 90 kg NG explodes
- **One Fatality**
(Bruno Itschner,
 - 36 years - married, no children
 - 10 years' experience
 - 2 years in NG on Rollex Machine))
- **No other casualties** - fortunate as debris (broken concrete, steel, earth, etc.) rained down over adjacent operating areas
- **Extensive damage** (projectile and overpressure) in immediate area to equipment, building and roadways, up to 120 metres from blast.
- **Machine in 2000 pieces**

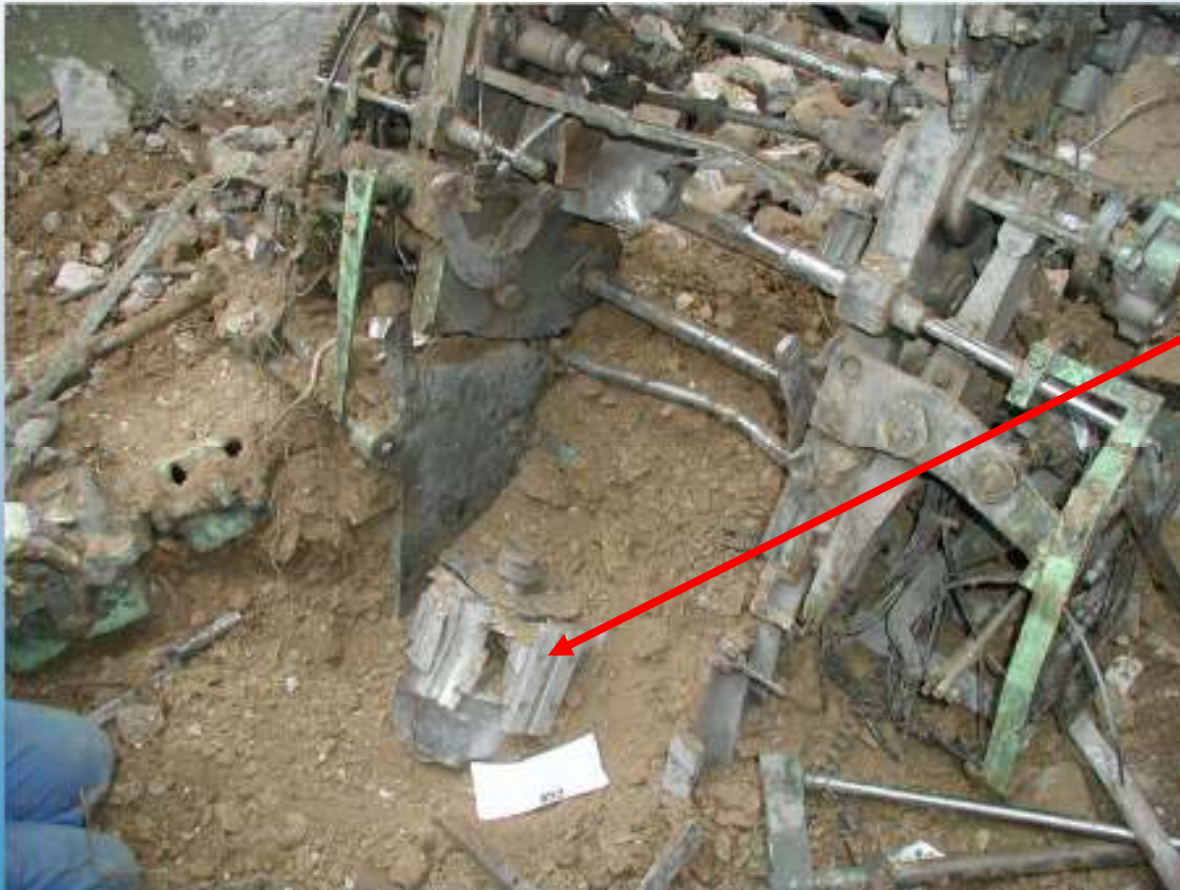
Revolver

2 cartridges insite

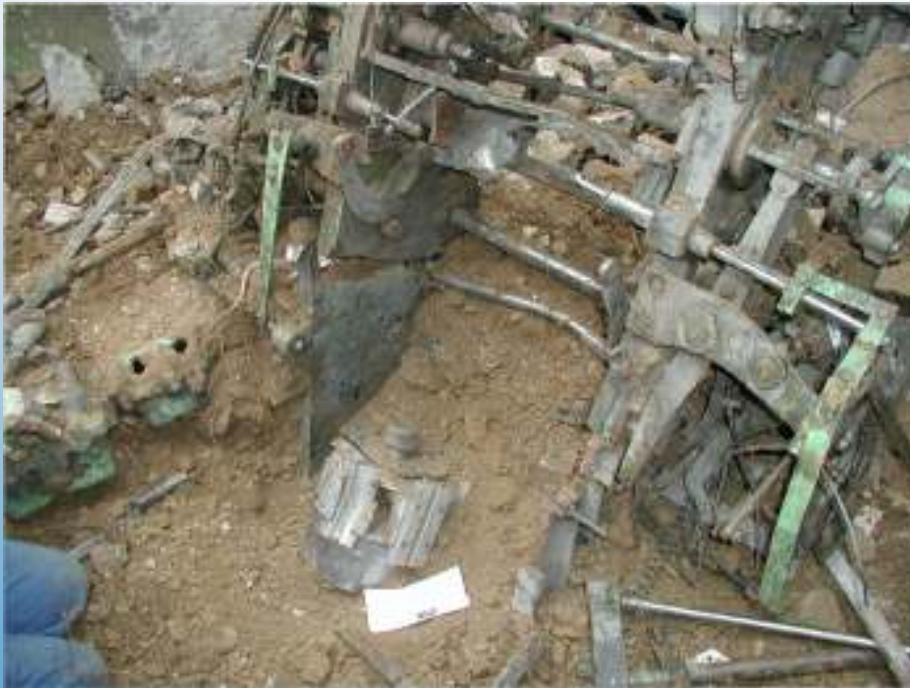
Searching for machine components

Management and employees at the factory not mindful of

- Design philosophies and operational intent of their operation
- Basic associated safe systems of work

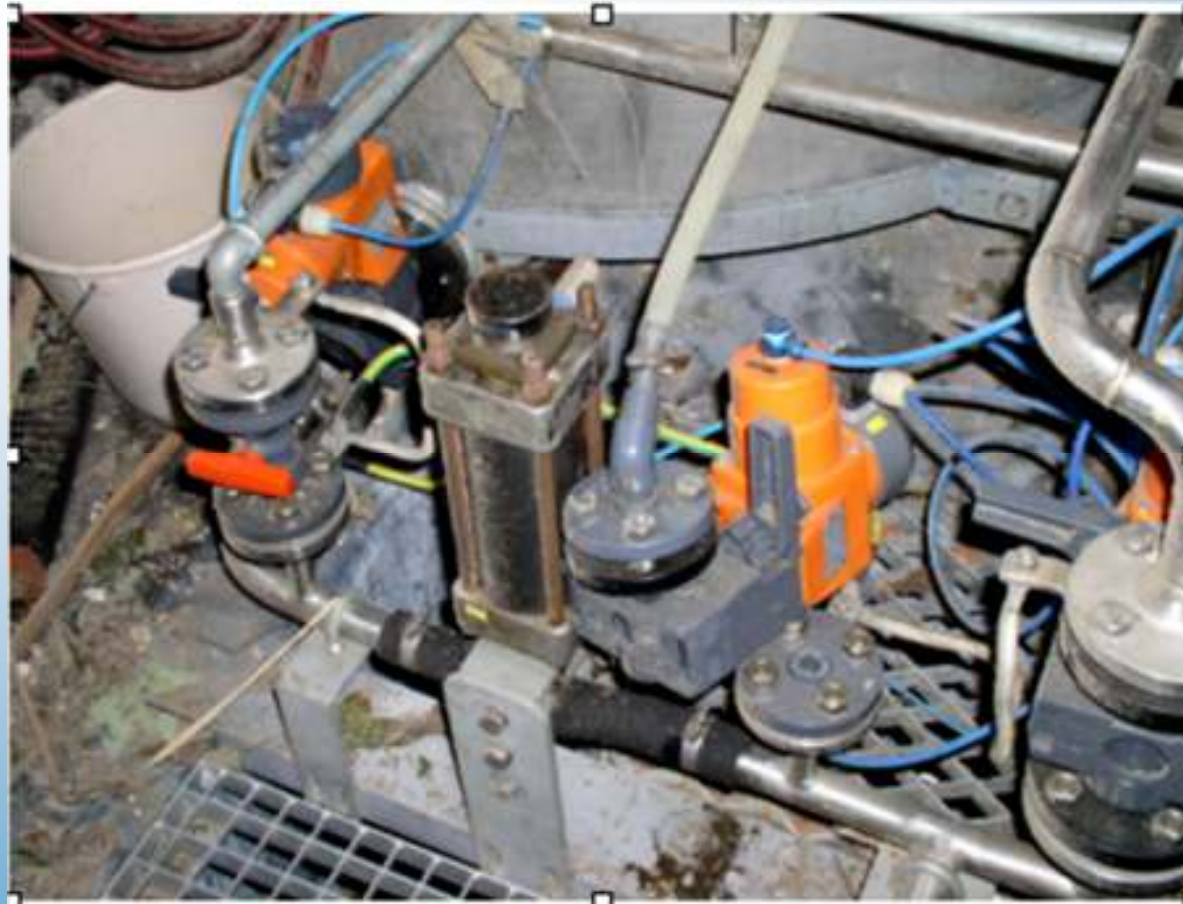
BALL VALVES

- Building 207: Third wash process of EGDN.
- Explosion in building after production start over a weekend, around about 60 kg of EGDN.
- Possible causes: friction in ball valves of the EGDN transport; Vacuum forced EGDN to collapse.
- Consequences: Building and machinery destroyed.
- Last event prior to the explosion was the commencement of NG transport to the storage house which involved the remote opening of the valve.

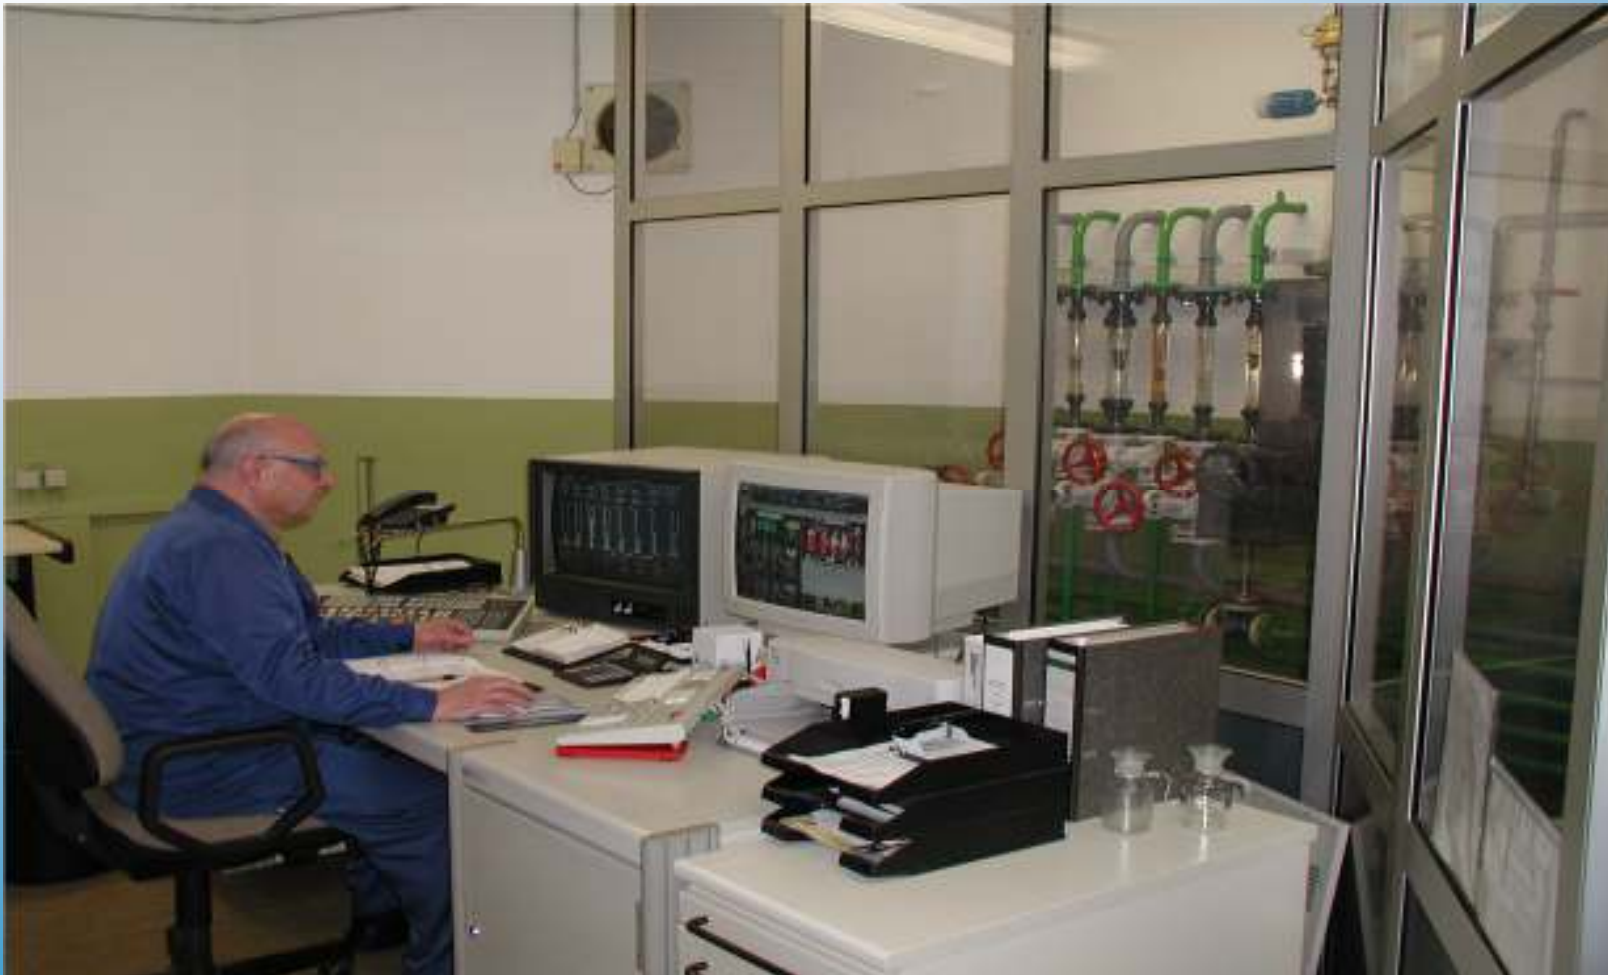
No damages

Only minor flying bricks

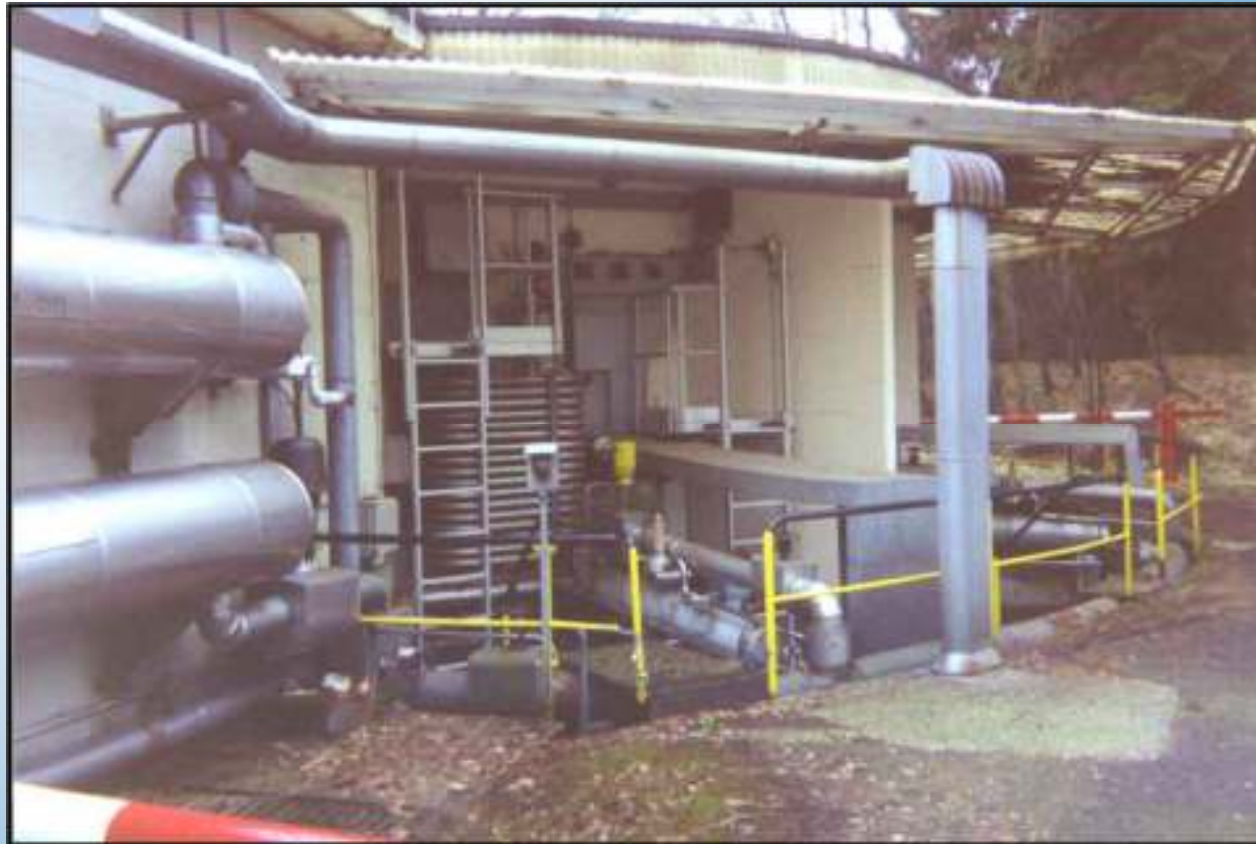
Building 200 (one of two Nitrators & Related Equipment)

Safety issue:
Acidic nitroglycol
in centrifuges
(appr. 1 - 2 kg)

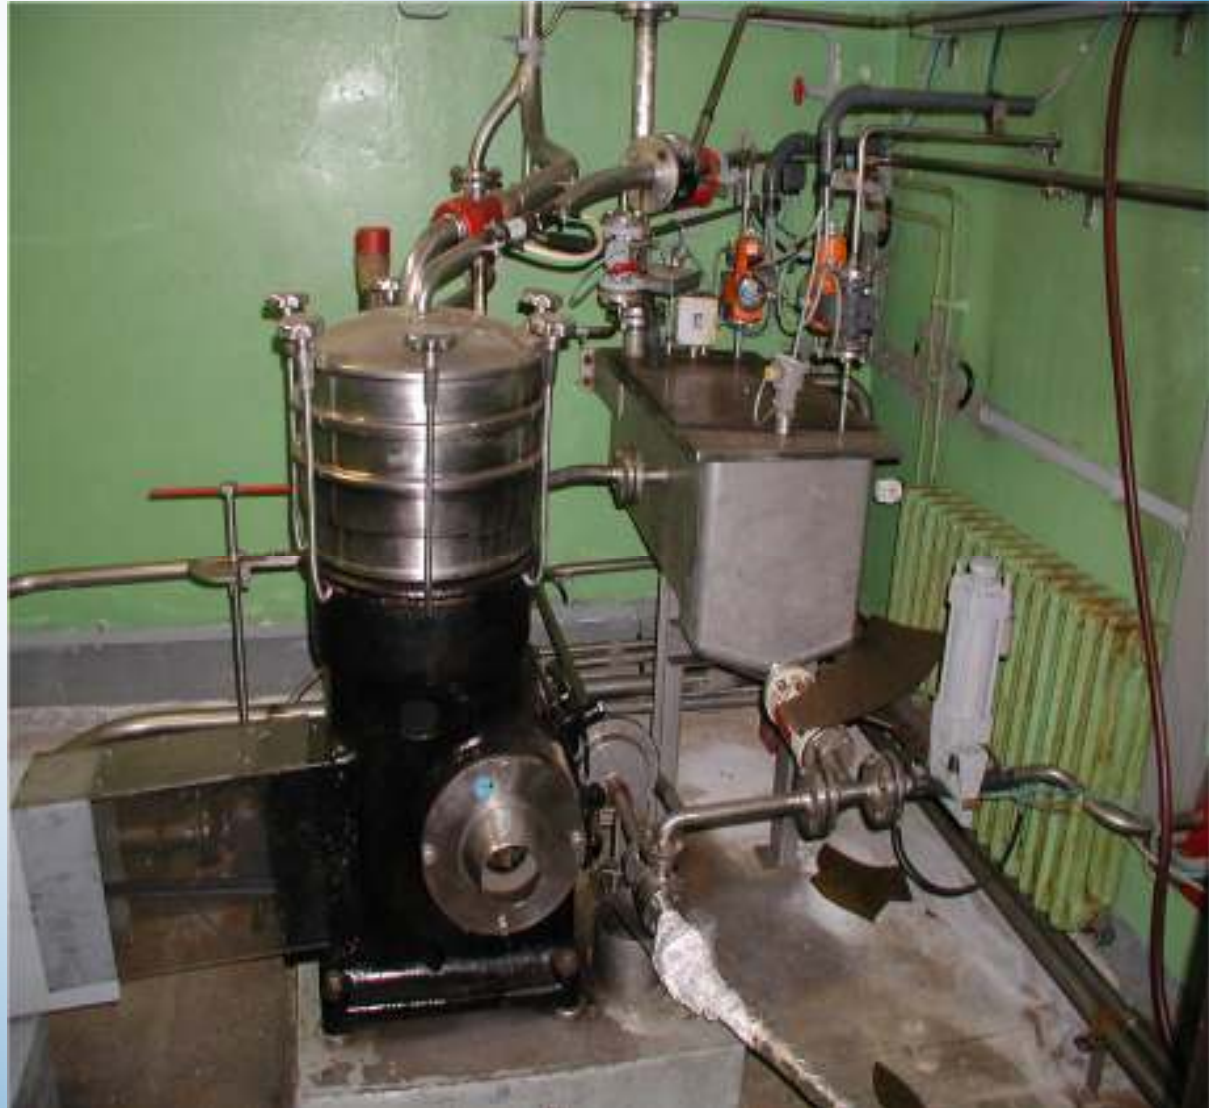
**Wash Building
204 after
explosion**

**Safety issue:
Disposal of
nitroglycol
contaminated
material (liquid/
solid) in a bund**

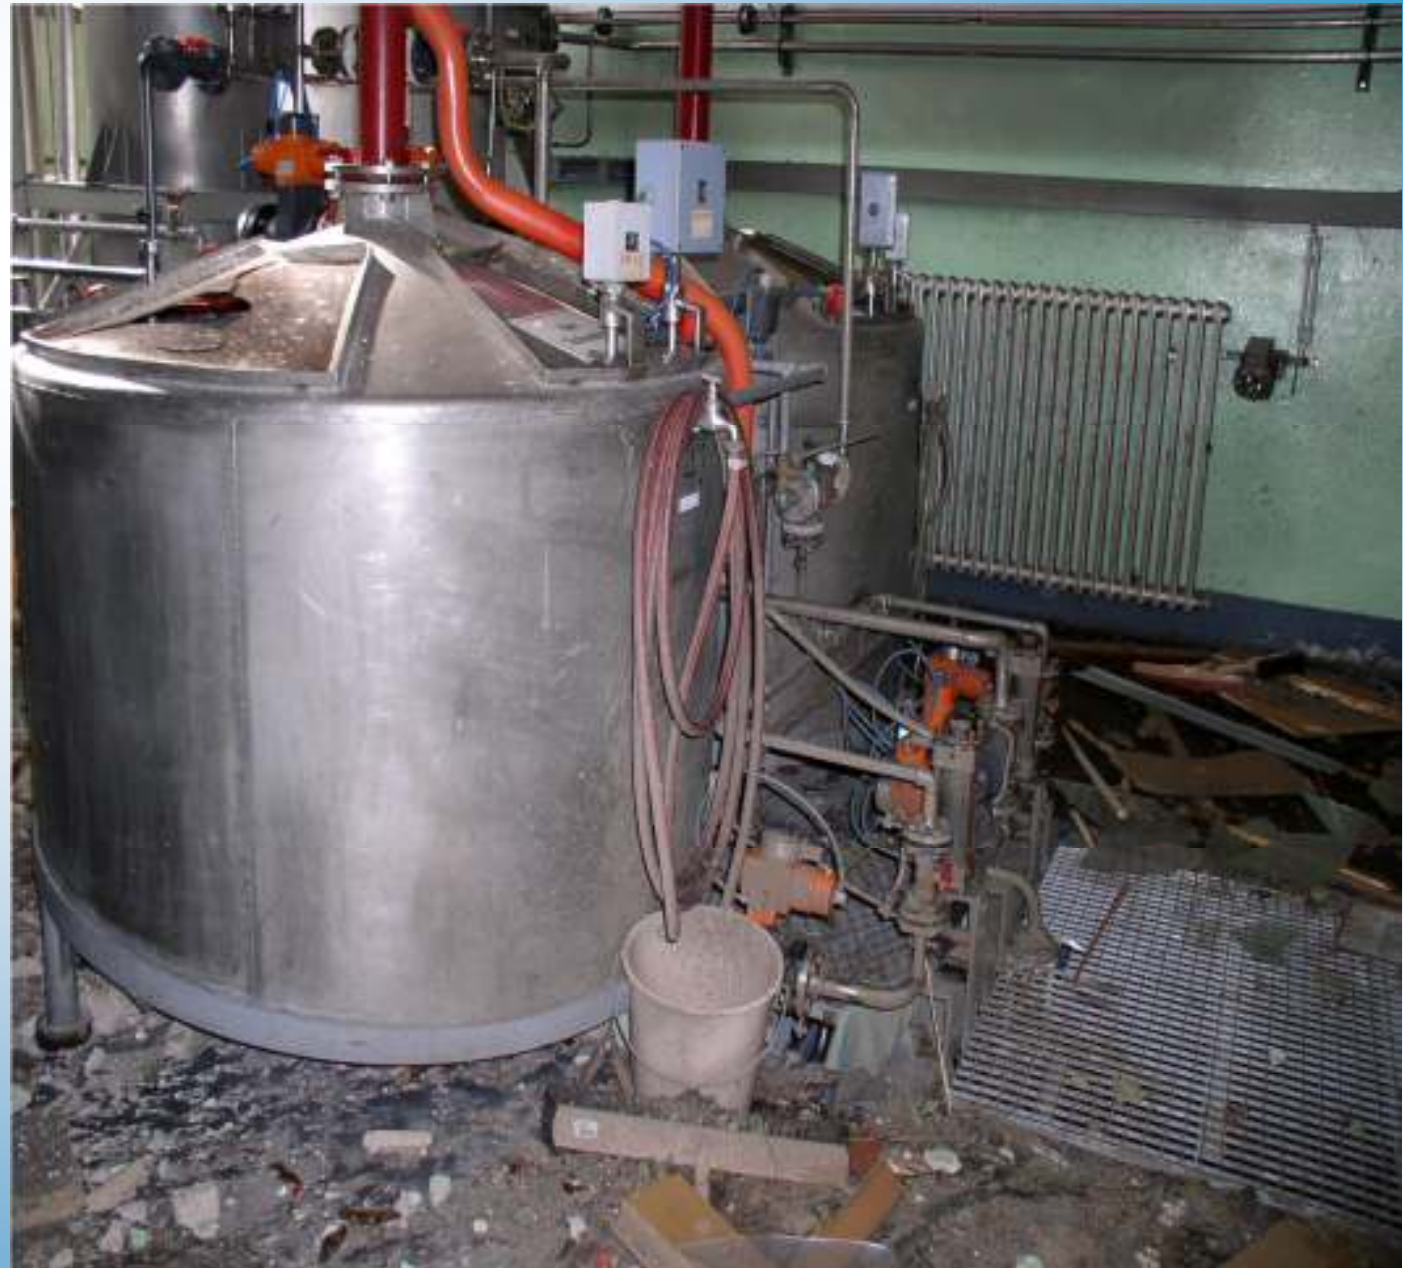
**Testing Vessel
Building 208**

**Safety issue:
approx. 400 kg
nitroglycol in
vessel**

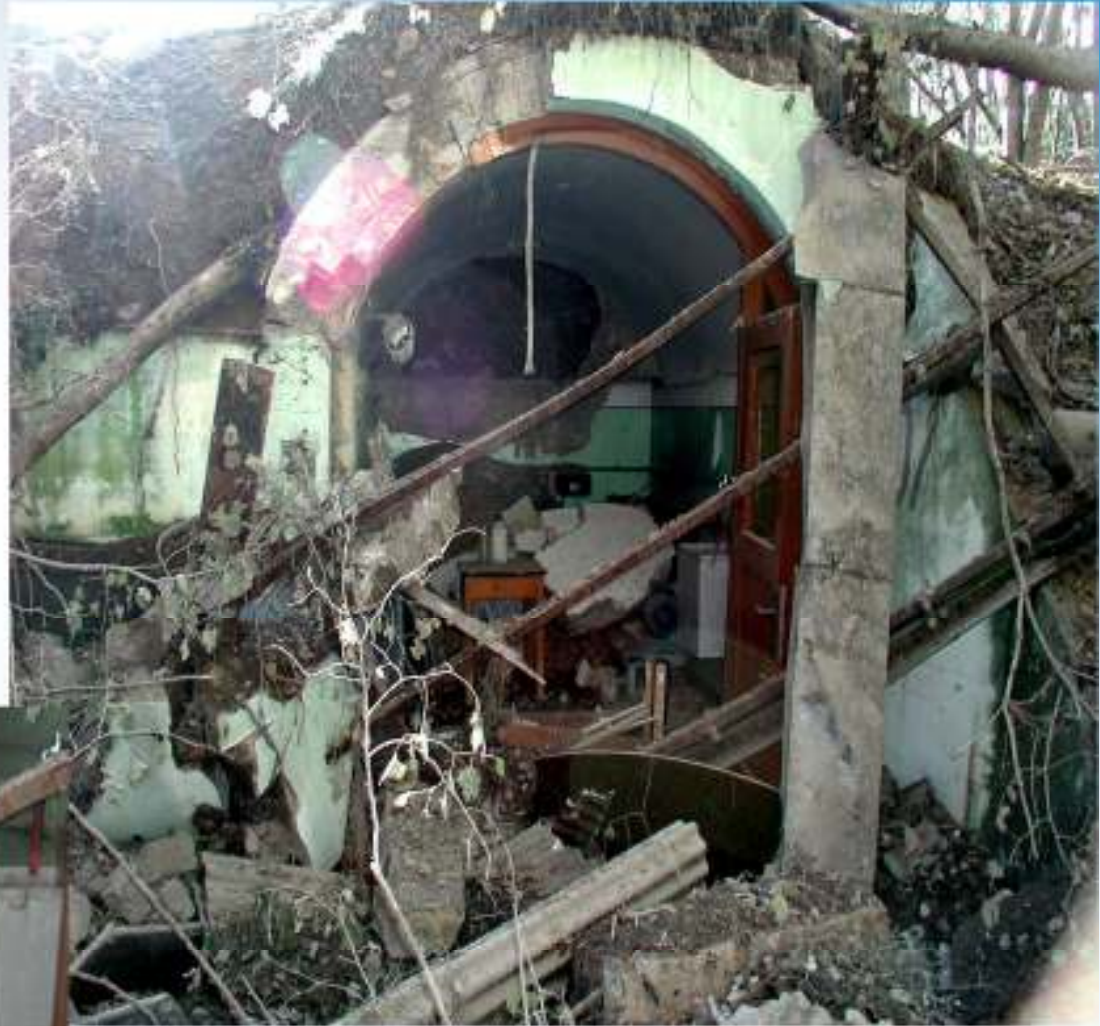
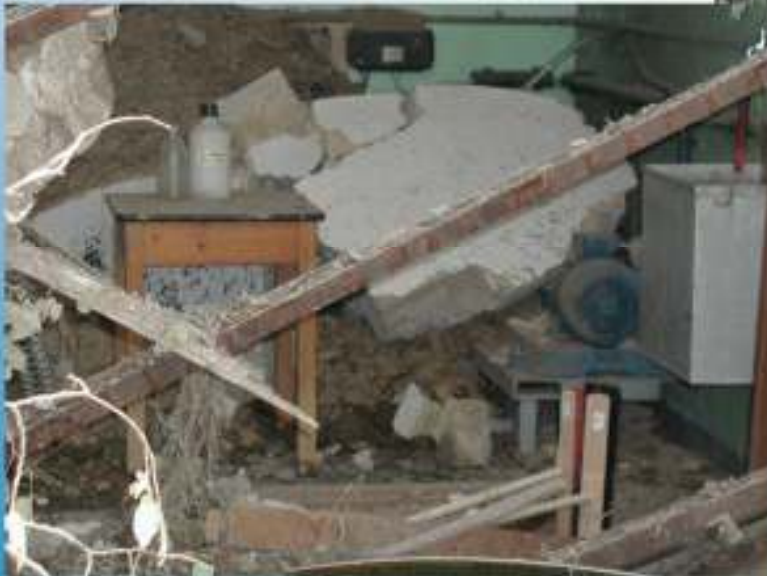
Pump Building 207.1
Partly damaged

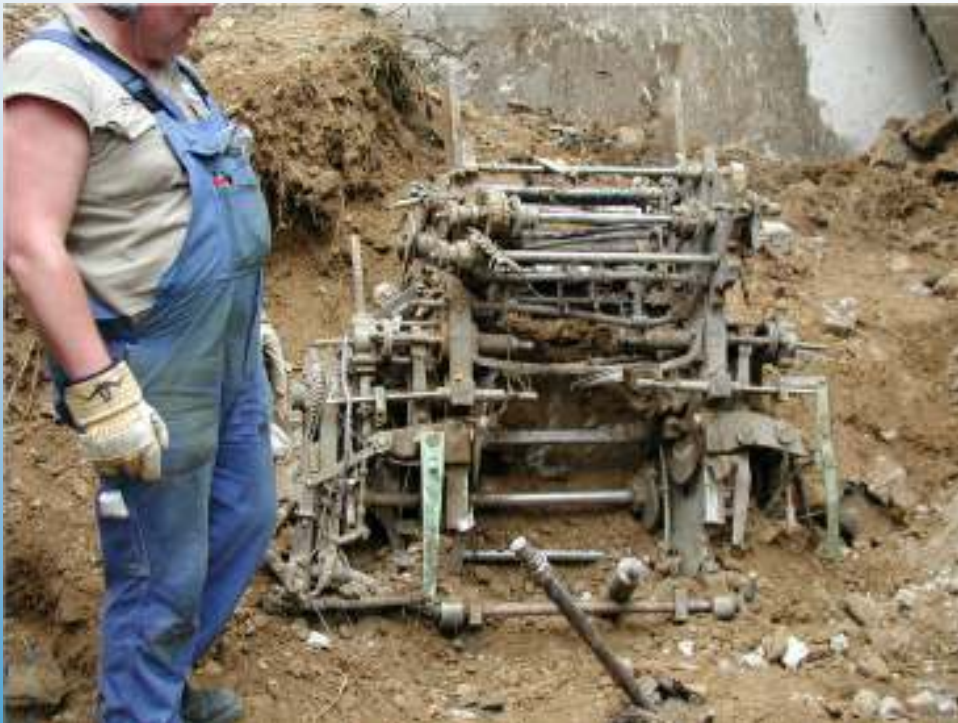
**Turrent and frame of Rollex
cartridge machine**

Extensive action list (36 items) from investigation covering:

- previous audit action close-out
- site procedures
- safe operating procedures
- process safety (BOS)
- hazard studies
- protection systems
- remoting high risk operations
- re-training
- reinforce adherence to standards
- formal review of completion prior to re-start

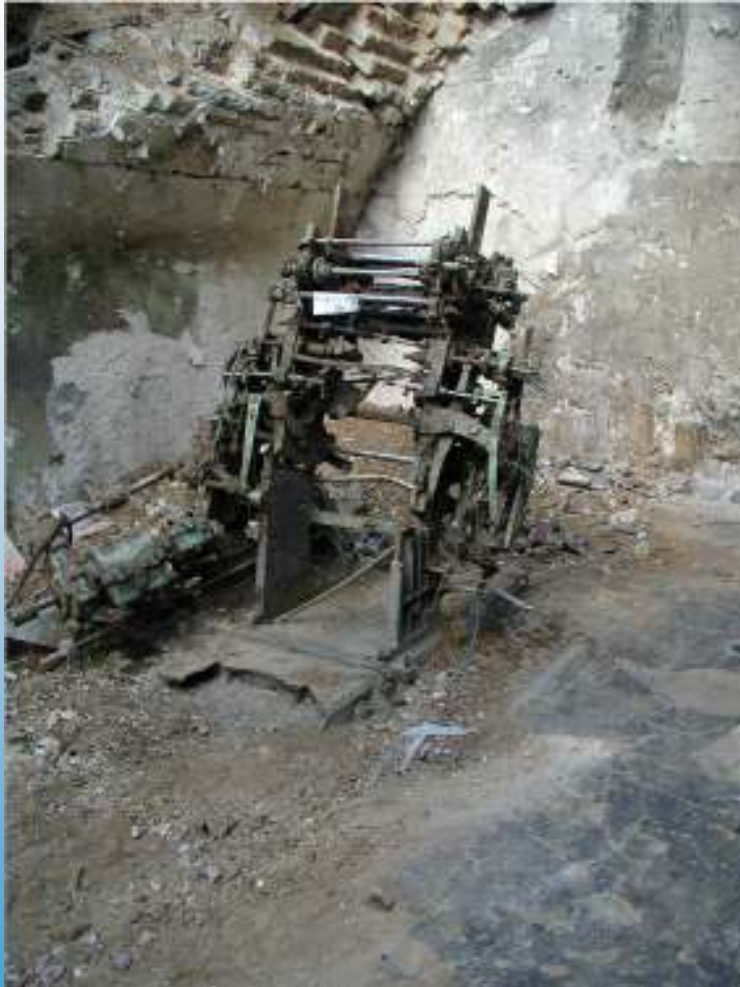
Frame of Rollex machine was covered with 2 metres of debris
