Powder GmbH

Heinz Krätschmer

Deflagration of
Nitrocellulose
in the Lab

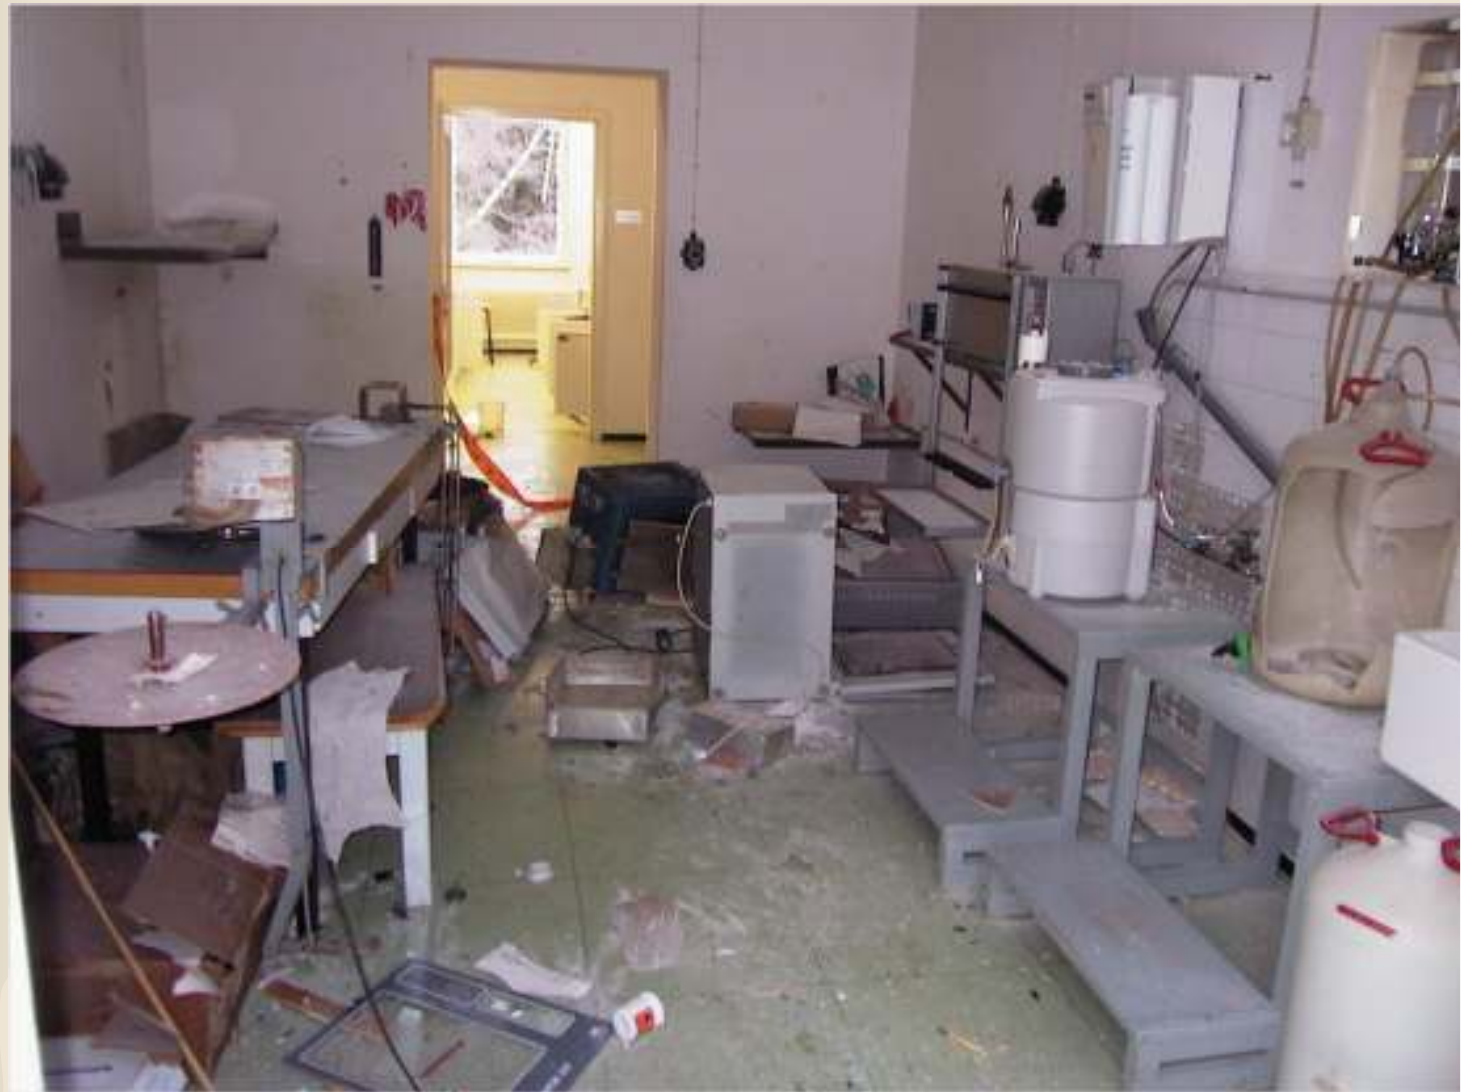
Room #11

- ◆ no people injured
- ◆ room #11 extensively damaged
- ◆ rooms #10 and #12 and ceiling of the building damaged
- ◆ most windows of lab building broken
- ◆ some smaller damage in the lab
- ◆ total cost app. \$ 180,000

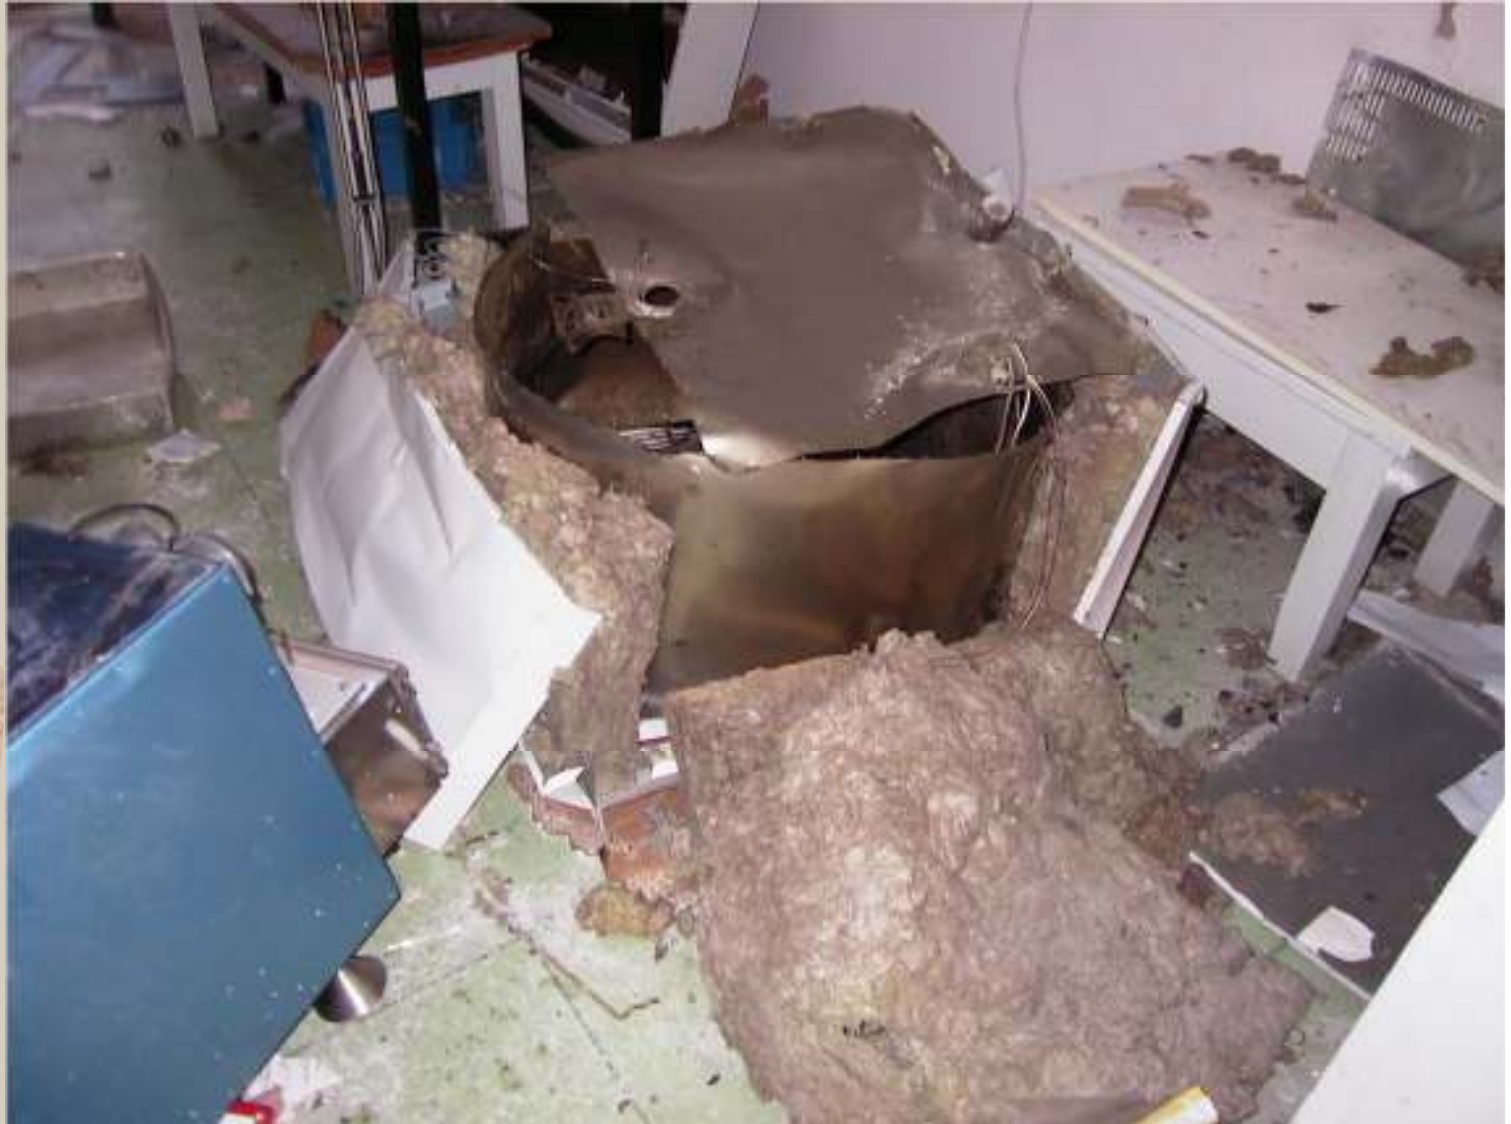
Room #11 convection oven

- ◆ *no overheating, temperature checked some minutes before, thermal fuse 80 °C (176 °F)*
- ◆ *no electrical defect according to examination by expert*
- ◆ *identical oven showed homogeneous temperature dispersion*

- ◆ *adaptation of a separate building for drying and further processing of NC*
- ◆ *drying process remote controlled*
- ◆ *special drying oven with hot water heating and explosion proof ventilation*
 - *oven temperature 30-35 °C (86-95 °F)*
 - *NC dry after 20 hours*
- ◆ *stainless steel drying trays*
- ◆ *excess of dry NC is destroyed*

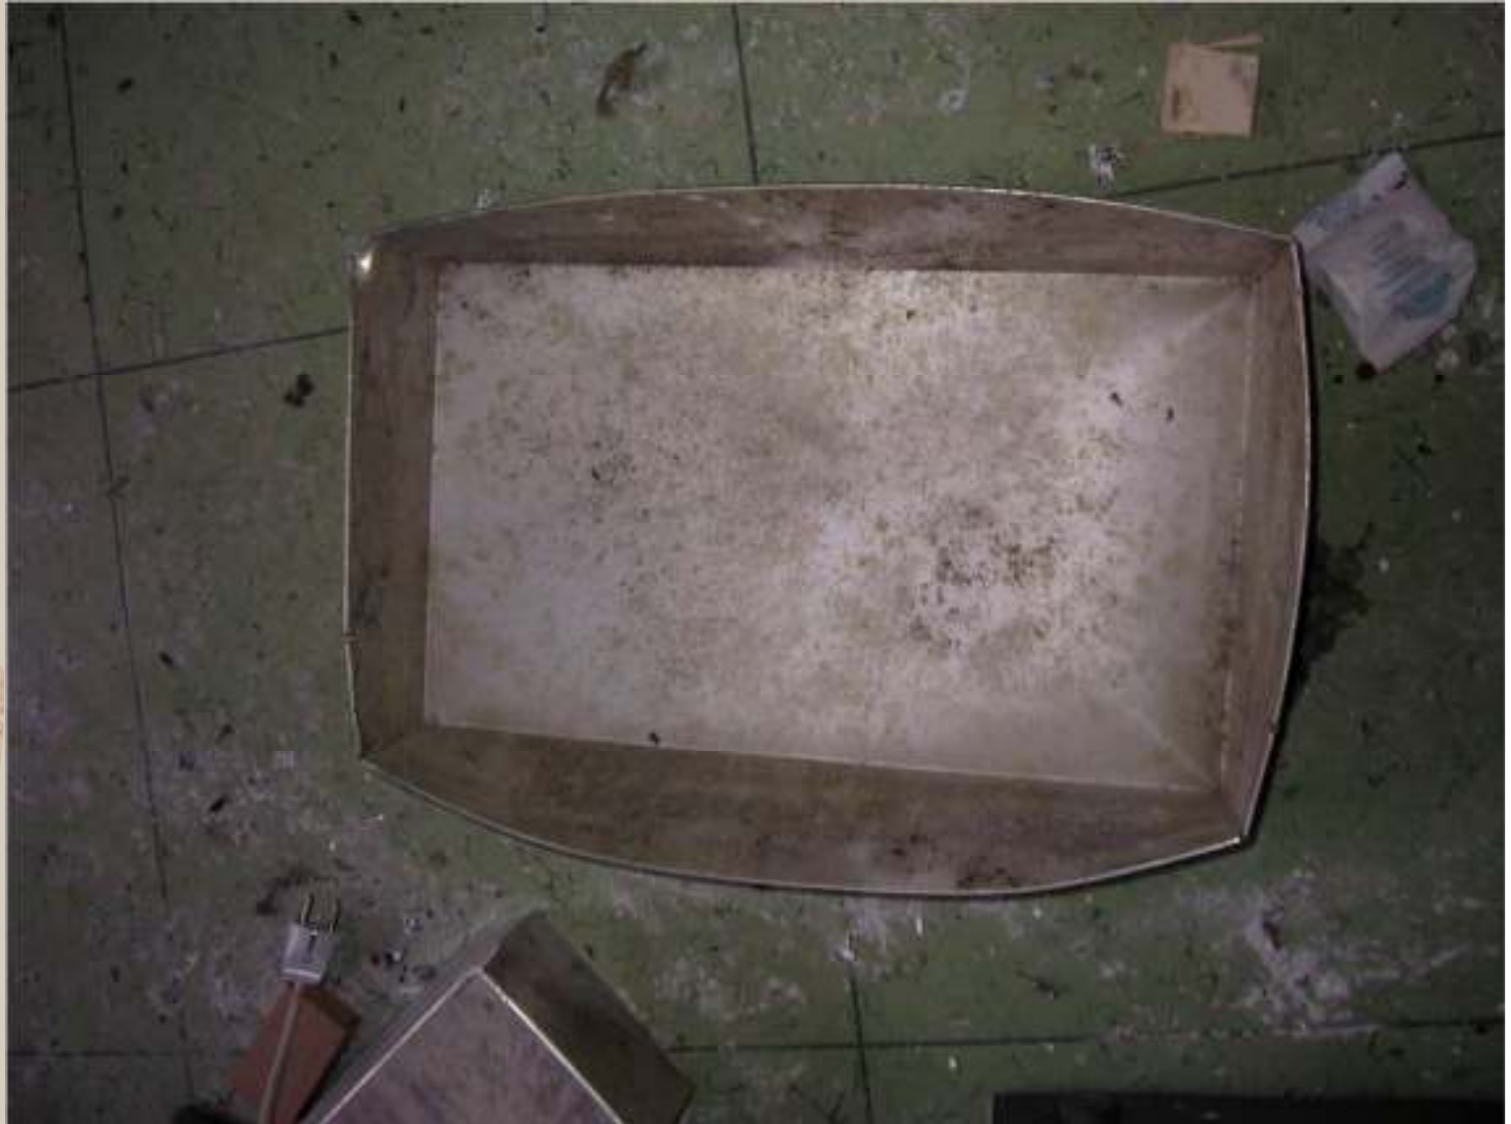
Room #11 drying tray

- ◆ Investigation of thermal stability of the NC batch showed a decrease in stability when stored on aluminum trays at elevated temperatures
- ◆ traces in the drying tray show some evidence of a starting explosion
- ◆ manufacturer of NC reduced shelf life of NC type to one year, but did not inform us
- ◆ batch used was app. 2 years old
