# Explosion during primary explosive process

Presented by Tsuyoshi MURASHITA  
ASAHI KASEI CHEMICALS CORPORATION  
JAPAN  
May 27 2005

XV CONGRESS SAFEX INTERNATIONAL

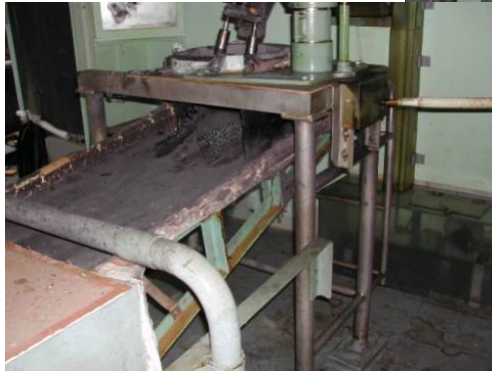
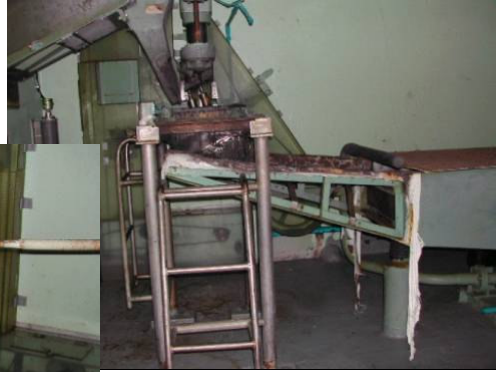
Granulator

## Damage

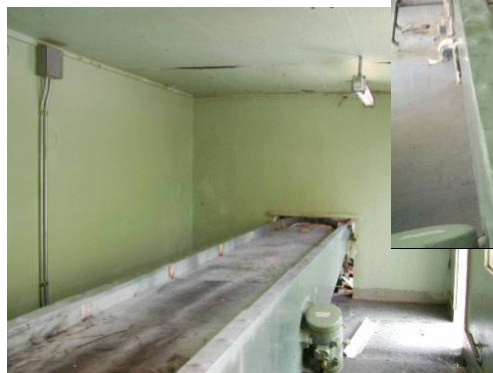
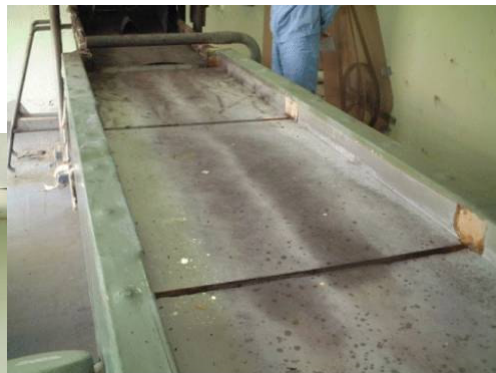
dry conveyor

## Damage

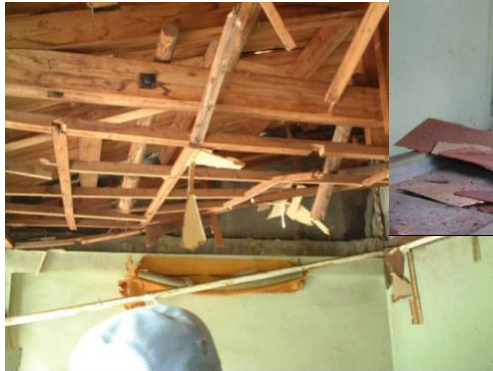
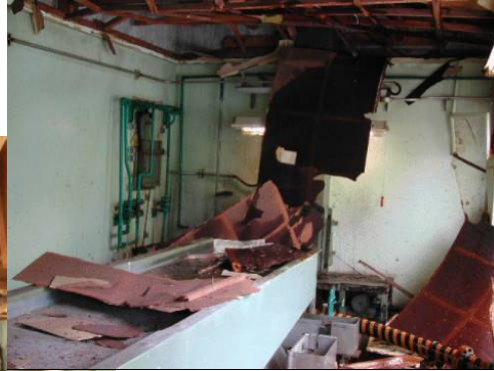
□ d dry conveyor  
and ceiling

## Damage

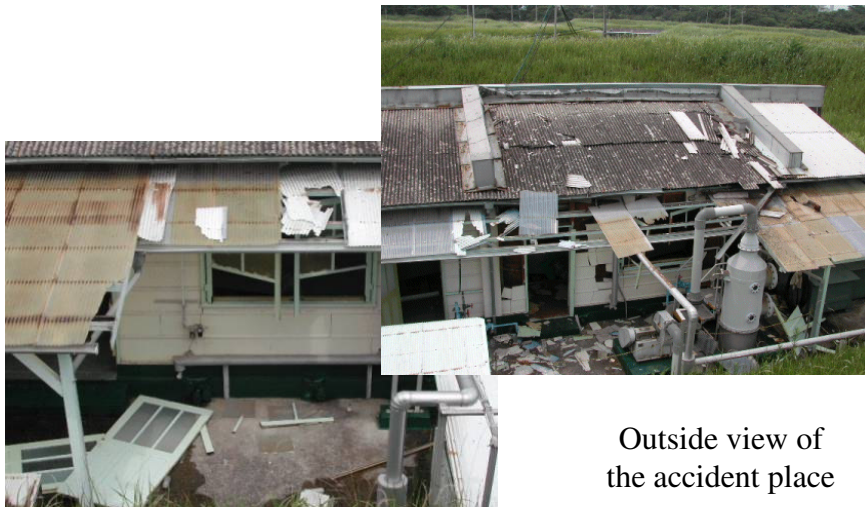
Outside view of  
the accident place

## Damage

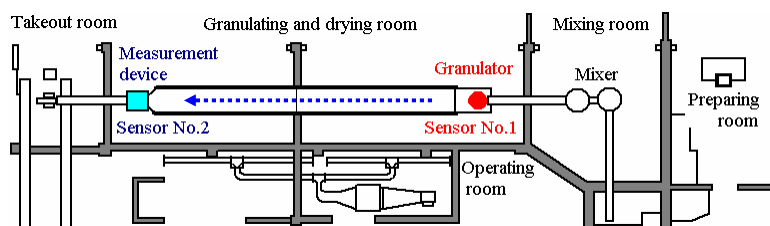
- The ignition occurred around granulator.
  - Remained the detected signals in the control unit
  - Initiation sensitivity property of DDNP powder

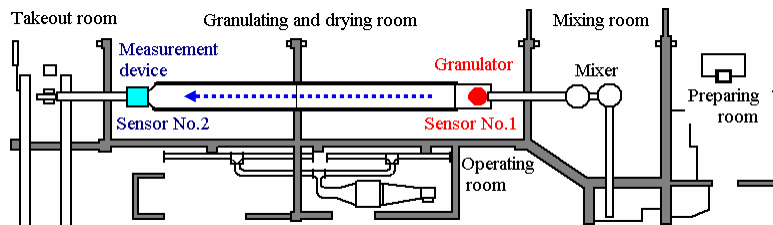
- The fire propagated to DDNP powders on the conveyor.
- The status of combustion was changed to deflagration and finally detonation occurred.
