# Explosion during primary explosive process

Tsuyoshi MURASHITA  
Detonator Plant, Miyazaki, Japan

## 1. Brief description of the accident

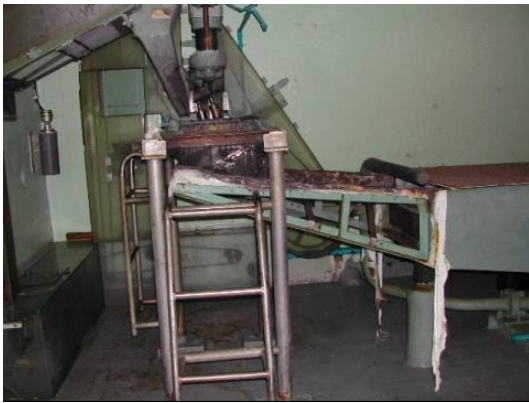
Photo.3 Granulator

6.2 Damages: The granulator was burned by the combustion and the dry conveyor was damaged by detonation of primary explosive. Windows, walls and roofs of the granulating and drying room were also damaged.

(2) Granulating and drying room: Partially destroyed (See Photos 3 and 4)

As a result of the analysis, we estimated that Wet-primary explosive ignited around the granulator, then the fire propagated to primary explosive on the dry conveyor. The state of combustion was changed to deflagration, and finally detonation was occurred.

(2) Wet-primary explosive in granulator burned out. The surface of equipment around the granulator and on dry conveyor near granulator was caked with soot.
