Decontamination of the SmartDet Manufacturing Facility (RL26)

Kaylee Baker; AECI Mining Explosives; Modderfontein, Gauteng, South Africa

This paper deals with the methodology used to decontaminate the facility for the purpose of a change of licence of the explosive facility.

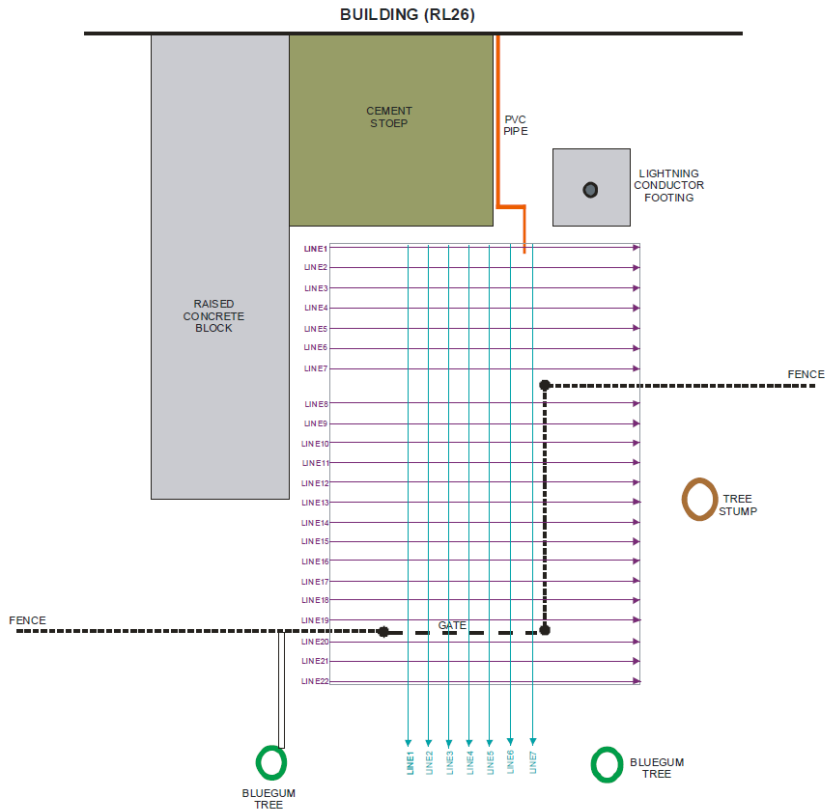
Figure 3: Schematic of RL26 area, given by the CSIR (van Schoor, 2012)

In 2012, the Council for Scientific and Industrial Research (CSIR) conducted a ground penetrating radar (GPR) survey at the RL26 facility. The aim of the survey was to detect possible subsurface storage or drainage structures that may have been constructed several decades earlier during the development or operation of the facility. No reliable subsurface utility maps or records were available to confirm the presence of such structures in the area of interest. The only visible evidence that such a structure might exist is the PVC drainpipe that originates from inside RL26 and extends a couple of metres away from the building where it disappears into the ground (see Figure 3).

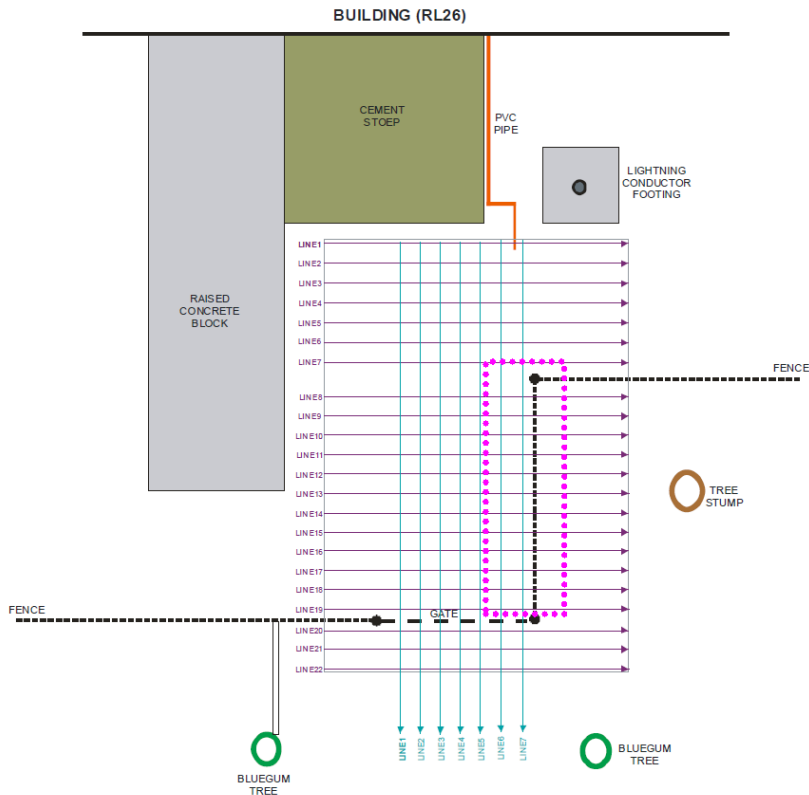
Figure 4: Schematic of RL26 area indicating possible location of French drain, given by the CSIR (van Schoor, 2012)

Results from the ground penetrating radar indicated that a pipe existed that extended approximately 1.8-2.0m away from the edge of the cement area. Profiles also suggested the presence of a man-made dipping horizon between approximately 1 m and 2.5 m deep. These observations, although not conclusive, do provide some evidence for the existence of a French drain structure. If such a structure exists, it slopes away from the building. (van Schoor, 2012)

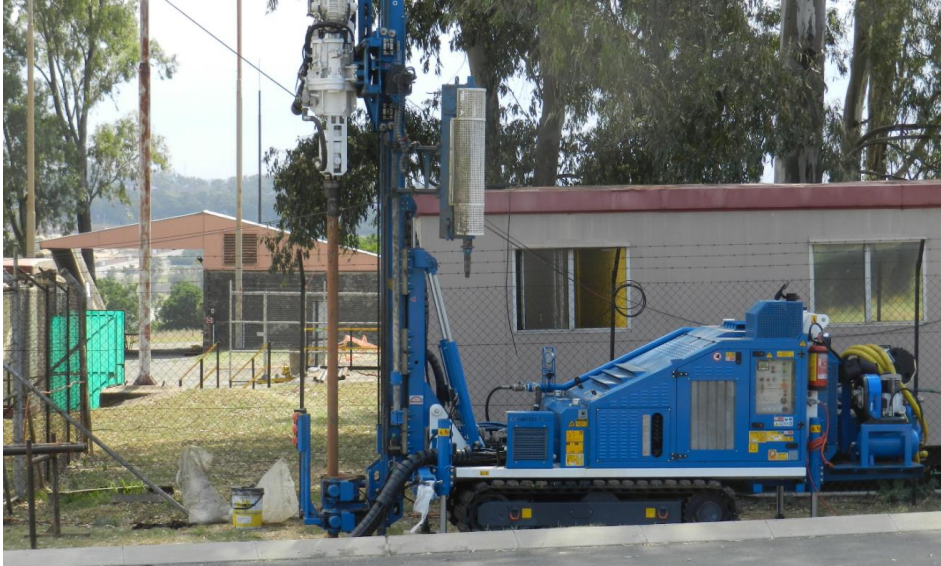
Figure 5: Drill Rig

A possibility existed that the lead styphnate had migrated through the ground. Due to this, the full extent of the area of contamination was uncertain. As such, a remotely operated drill rig was brought in to sample the area around the building. Drilling was done to a depth of 3m and samples of the ground were taken every 500mm. The samples were tested for the presence of lead and hot plate testing was also conducted. It was found that the contamination of the ground was localised to an area of 6.0 x 3.0m. Figures 5-8 illustrate the remote drilling and soil sampling.

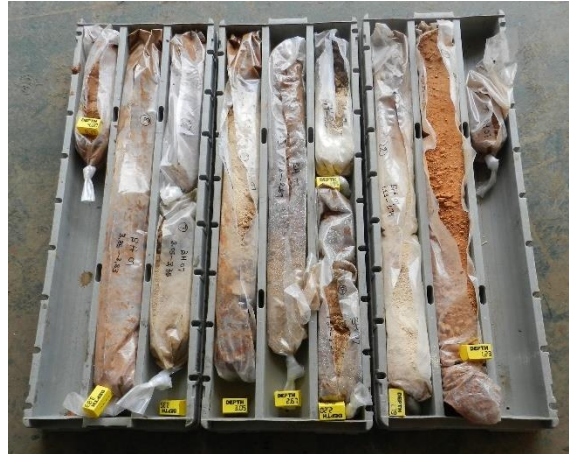
Figure 7: Soil samples collected at various depths

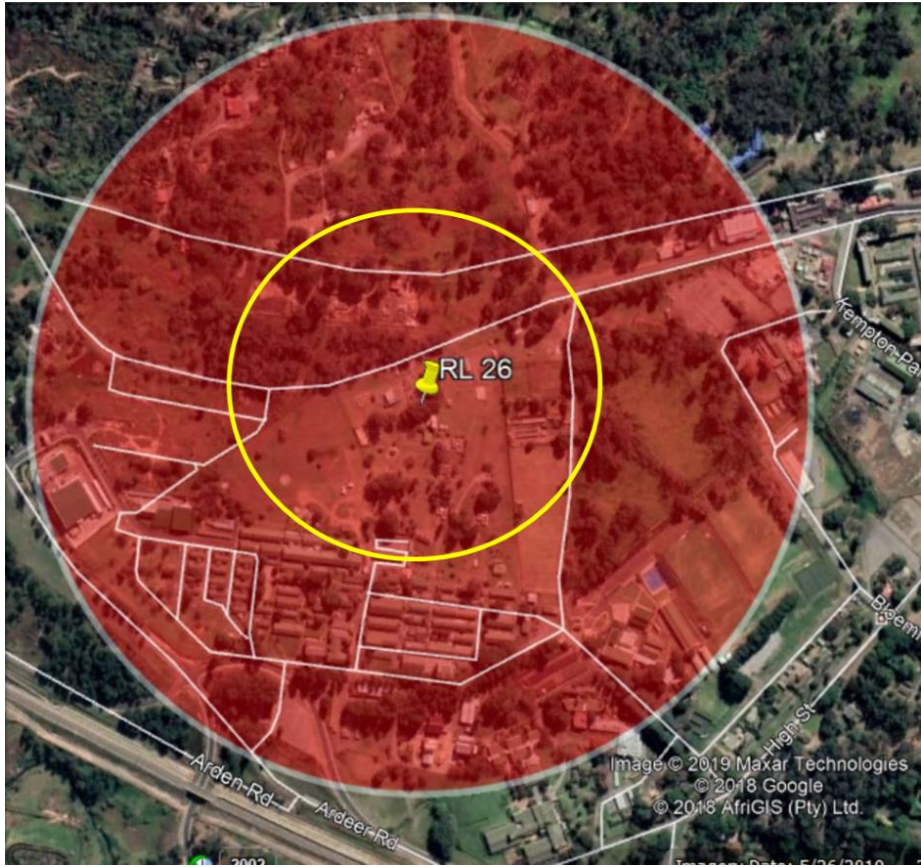
Figure 9: Exclusion and Perimeter Area

Blasting was planned for the week of 9th July to 13th July 2019, 10am to 2pm. As mentioned above, the blast area was determined to be 6m x 3m, as determined by ground penetrating radar and soil sample analysis. Legal requirements dictate that perimeter of 500m be set up. An exclusion zone of 200m was set up, based on the predictions given in the expert report (as mentioned above). The exclusion zone extended to approximately where the fence separating R&D offices from the R&D Test Range along its southern boundary is located. These are both shown in figure 9.

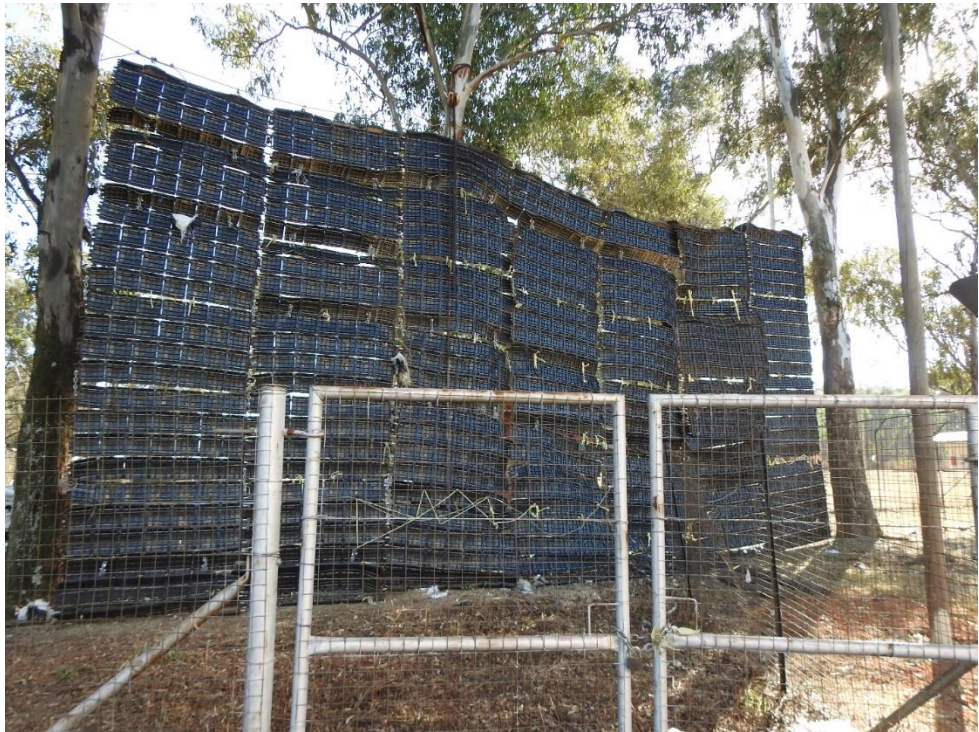
Figure 10: Blast barricade

Also to the south, a powder dryer plant was located 20m from the blast site and was vulnerable to impact damage on the profiled IBR sheeting that made up its walls and roof. To lessen the danger of rocks and other missiles being thrown to the south, a curtain of blasting barricades (as used on mines) was erected. The barricade was 6m high and 12m wide. It comprised heavy panels of thick plastic tiles with metal links between them fixed to a framework of steel cables (figure 10).

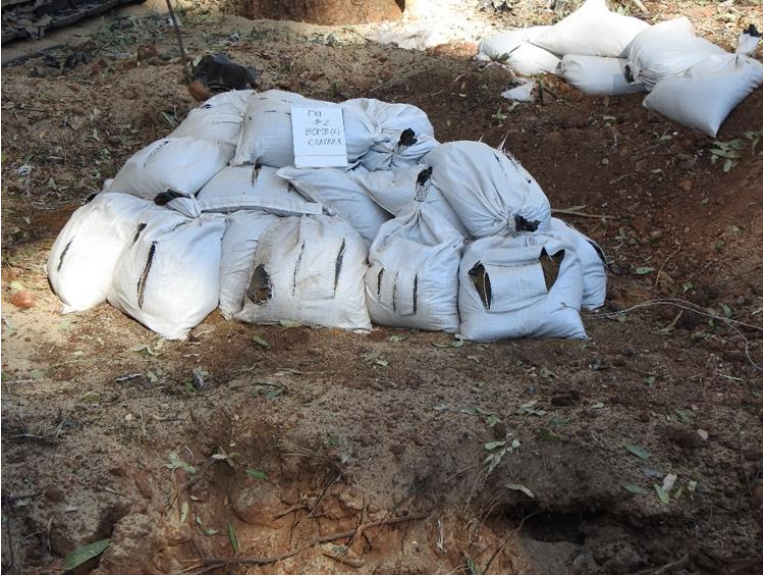
Figure 12: Dome of sandbags placed over 5kg charge to suppress blast noise

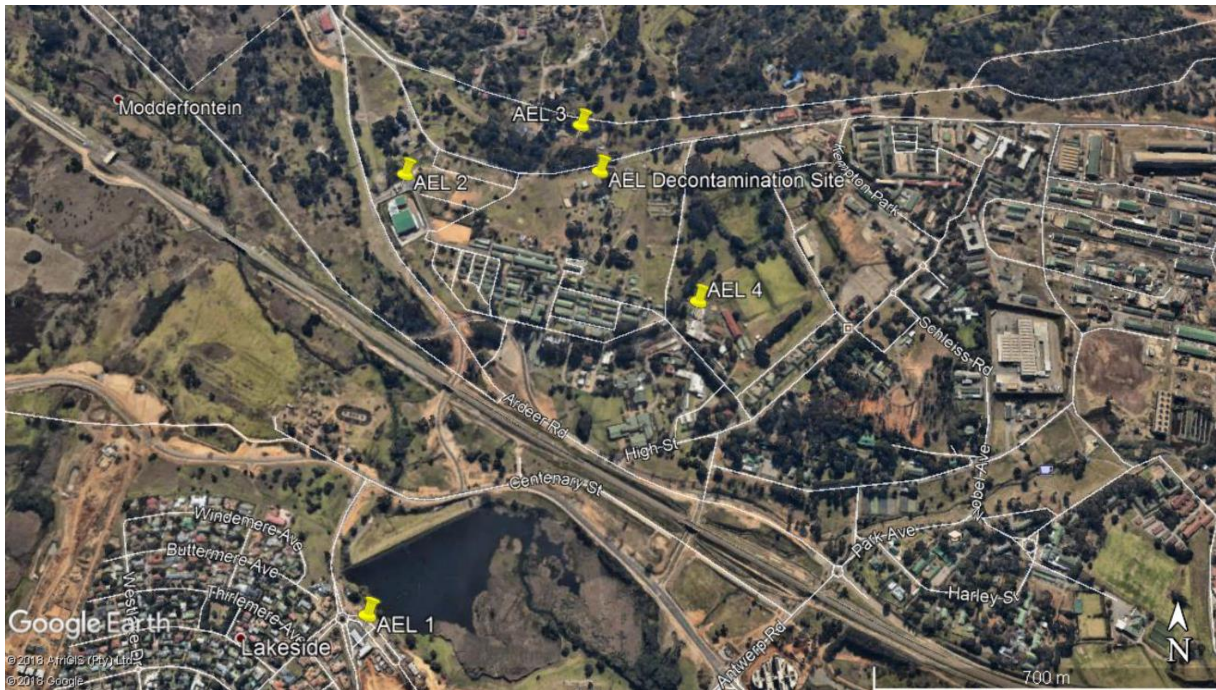
Figure 15: Location of monitoring stations

Four NOMIS Seismograph permanent monitoring stations were set up by a technical consultant to monitor blast induced ground vibrations and air blast at positions in near to the RL26 site. The positions of the four seismographs are given in table 2 and figure 15. (Burrow & Beattie, 2019)

All blasts registered an air blast reading at station 3 that exceeded the USBM recommended maximum level for prevention of human irritation (this area was evacuated prior to blasting). Four blasts registered an air blast reading at station 4 that exceeded the USBM recommended maximum level for prevention of human irritation. No blasts registered an air blast reading at stations 1 and 2 that exceeded the USBM recommended maximum level for prevention of human irritation. The results of all blasts can be seen in table 4. (Burrow & Beattie, 2019)

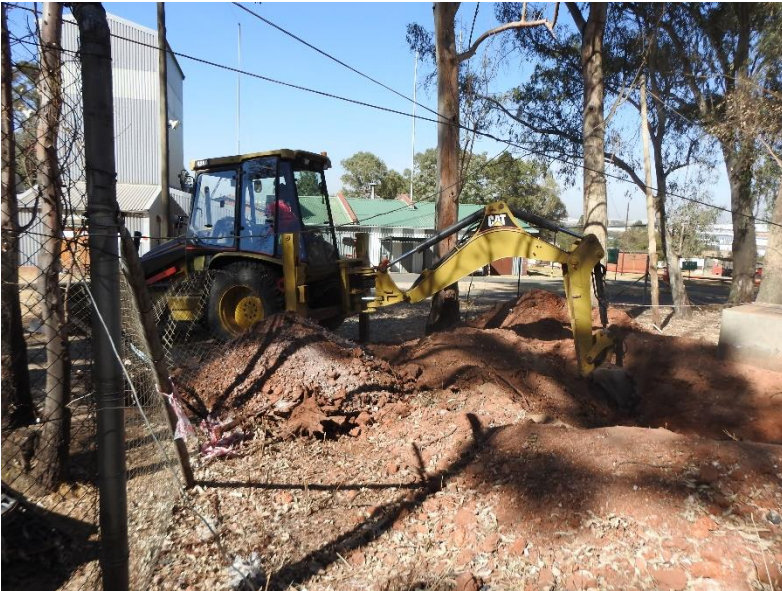
Figure 16: TLB clearing crater of loose material

After blasting was concluded, the blasted earth was removed from the craters. Additional digging was done with a tractor-loader-backhoe (TLB) until hard earth was reached in all directions (figure 16 and 17). Earth remaining between the craters has also been removed, thus leaving one large hole. No evidence of a French Drain was found. Additional soil samples were taken from the bottom and sides of the hole and of the sodium carbonate layer. These have been sent for analysis for lead.

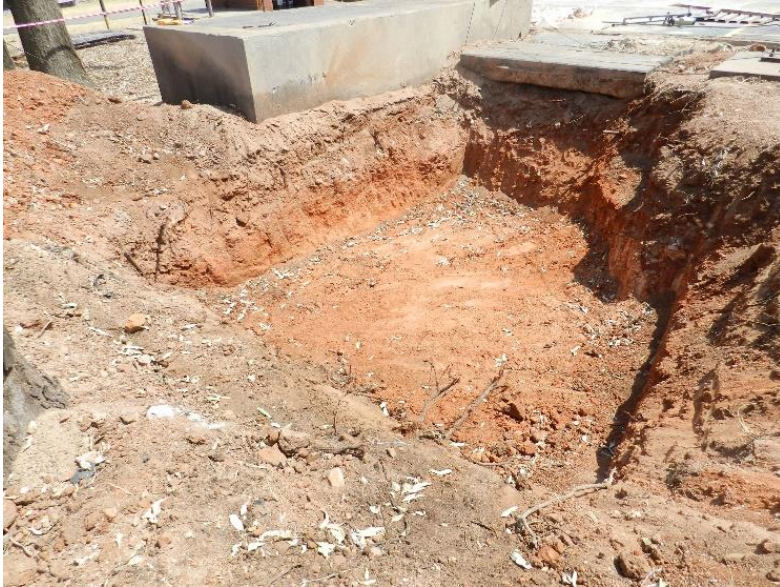
Figure 17: Single hole after cleaning
