Emanation of Nitrous Gases in Nitration Process
Río Loa Plant - ENAEX Chile

Abstract

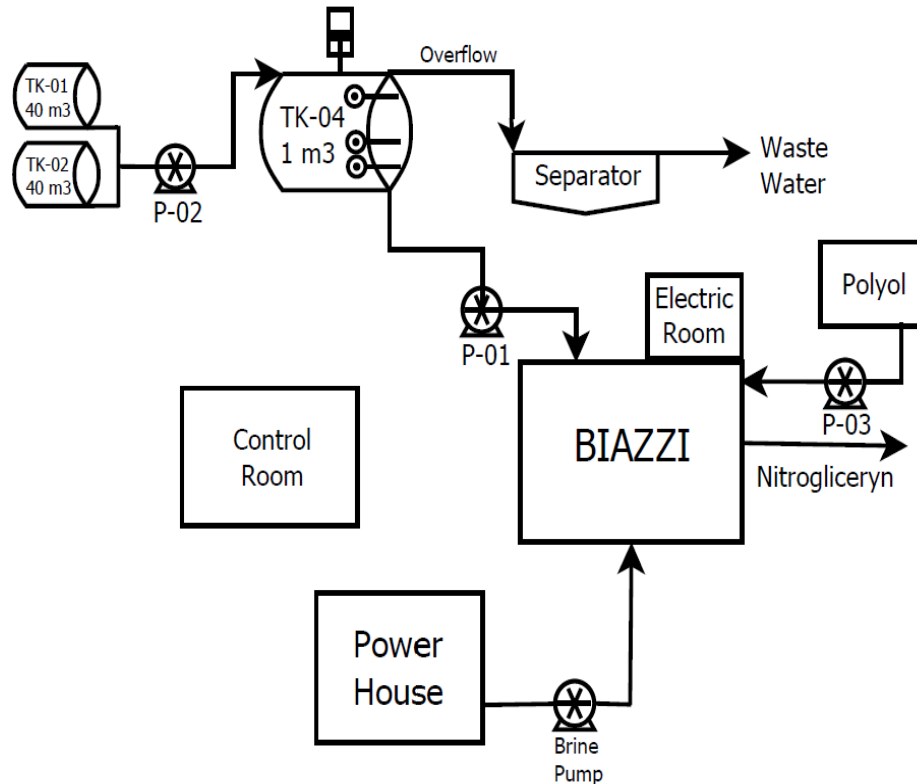
Figure 1. Nitroglycerin Nitrator Process

To operate the Nitroglycerin Nitrator, it is necessary to feed the reactor with mixed nitric acid and sulfuric acid. This mix is sent by pump N° 1 (see figure N° 1) from tank TK 04 to the reactor. Pump N° 2, sends the mix of acids to tank TK 04 from tanks TK 01 and TK 02 respectively, and located approximately 80 meters away.

- If the nitration process stops due to other problems, such as failure in the cooling brine pump or else a stop in the sodium hydroxide pump that maintains pH in the nitration process, and, at that point, pump P-02, which feeds mixed acid to tank TK 04 is working, does not stop when reaching the high level, as it does when there are no unexpected stops in the nitration process. In this case, the operator must physically go to the electric room and turn off pump P-02. If pump P-02 is not manually turned off, then the mixed acid would overflow through the tank TK 04.

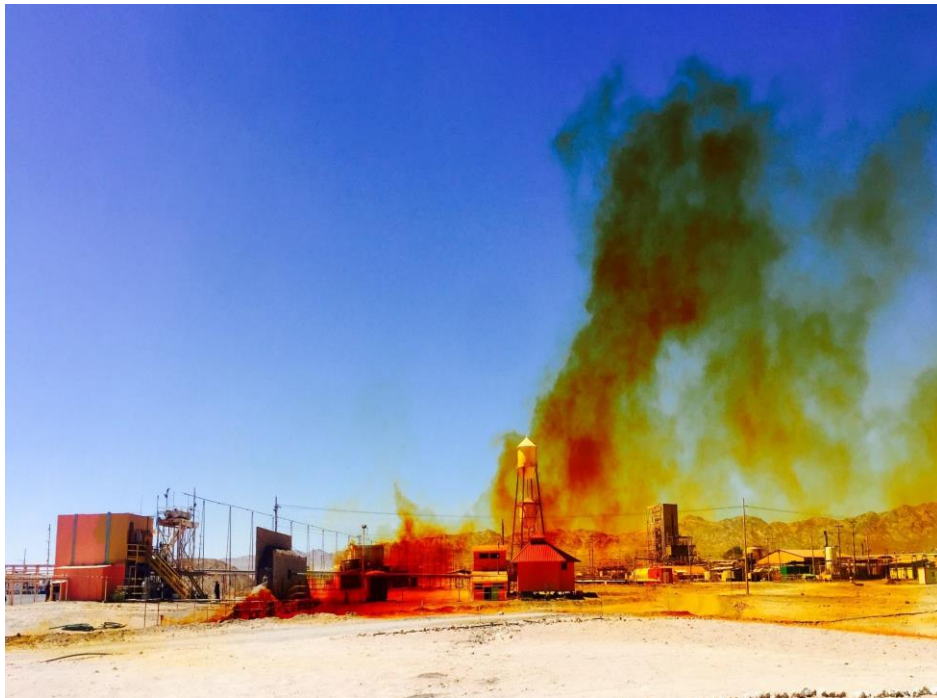
Figure 2. Emanation of Nitrous gases in the Separator

At that time, the nitroglycerin nitrator indoor operator sees on the computer screen that the signal of the level sensor was 100%, so he went to the electric room to stop pump P-02. It was then that the indoor operator realized that nitrous gases were being generated in the industrial wastewater tank. Therefore, he quickly went to stop the pump and, together with the outside operator, began to add water to the tank in order to control the gas emanation.

13. Two workers from the quality department saw the emanation of nitrous gases that was occurring in the nitroglycerin nitrator when they were heading to their offices, after finishing a quality control at the Starret house (see figure N° 2). They decided to stay in the sector, since the wind was carrying the nitrous gases in a different direction from where they were. Notwithstanding the above, a co-worker called them on the phone because all the quality area staff were evacuating their offices and going to the meeting points/security zone (EPP). Therefore, in order to get to that security zone, they had to pass through the gases, although these had already dissipated.
