## Reaction in Waste Container - Leading to Major Evacuation

Jari Henriksson, MSc, Oy Forcit AB; Hanko, Finland

### Abstract:

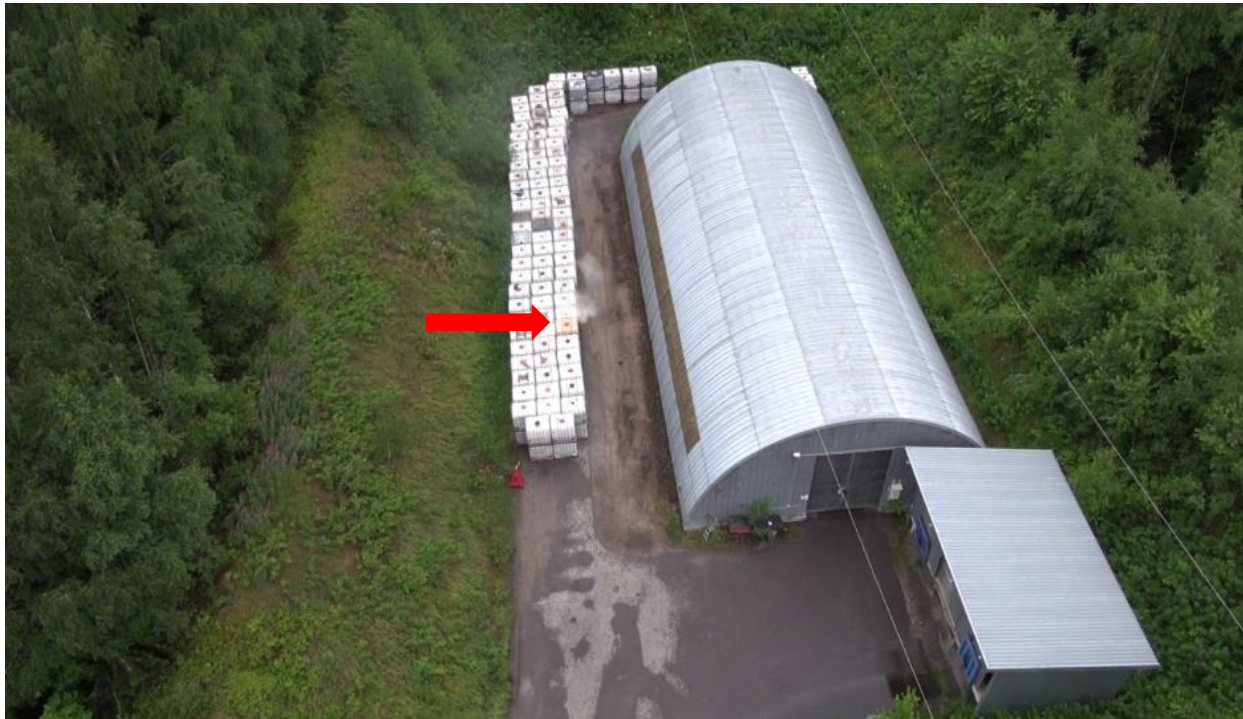
But - the situation was extremely tricky due to our lack of knowledge. We did not know the exact contents of the IBC. There had to be something generating energy – most probably ammonium nitrate that for some reason had started to decompose. The reason could be some sort of contamination. We did not know the origin of the IBC and how long it had been there. The IBC was in the middle of rows of IBCs placed wall to wall – totaling circa 200.

Figure 1. Storage building 312 (ANFO storage) and the placement of the IBCs – the IBC generating steam is marked with an arrow.

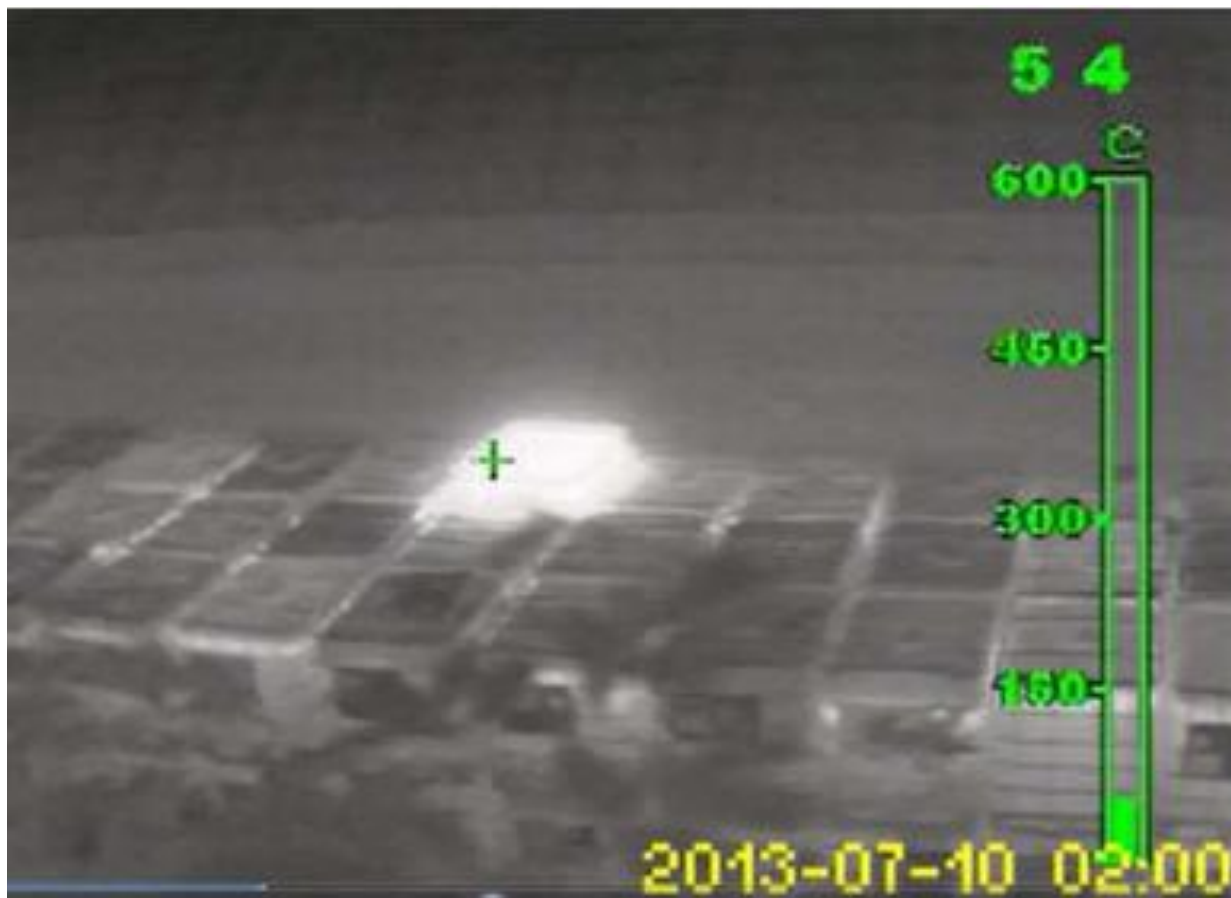
The fire department called for a drone that had an excellent camera but no thermal imaging capability. At that time neither the Fire Department nor the company had a drone. Since then drones have become more available – also on-site. One of the fire fighters climbed over the barricade to measure the temperature of the IBC – it was still below 100°C – at least measured from the top of the IBC. Because the flow of steam stayed about the same during the day and the steam remained white, we made the conclusion that decomposition rate of ammonium nitrate was still quite low, and IBC contained some water. The drone was flown over the IBCs on regular intervals to check the color of the steam.

Figure 2 Thermal image of the IBC – green cross indicates the IBC.

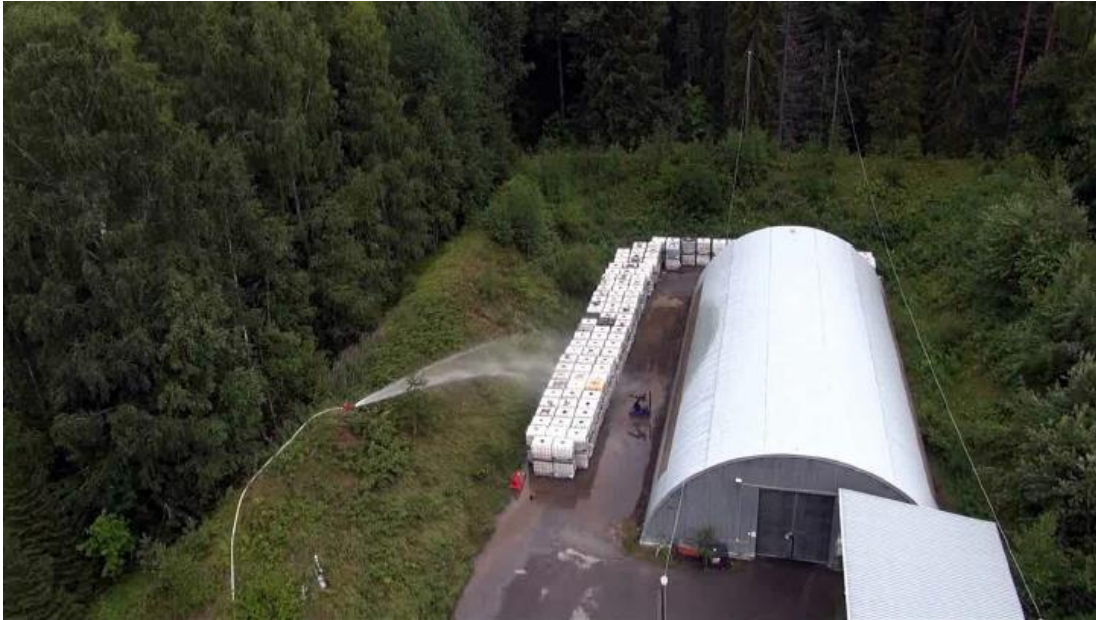
Figure 3. IBC is cooled with water

The plan was to get cooling water sprayed on the IBC first and when the Defence Forces robot arrived to punch a hole on the IBC and fill it with water cooling the reaction. This would most probably cease decomposition of ammonium nitrate. We deemed that there would be a high risk of detonation if we would move the IBC out from the row because there would be additional mixing that would likely increase the rate of decomposition. The IBCs were so close to one another that we also realized it would be impossible to move that one IBC from the row.

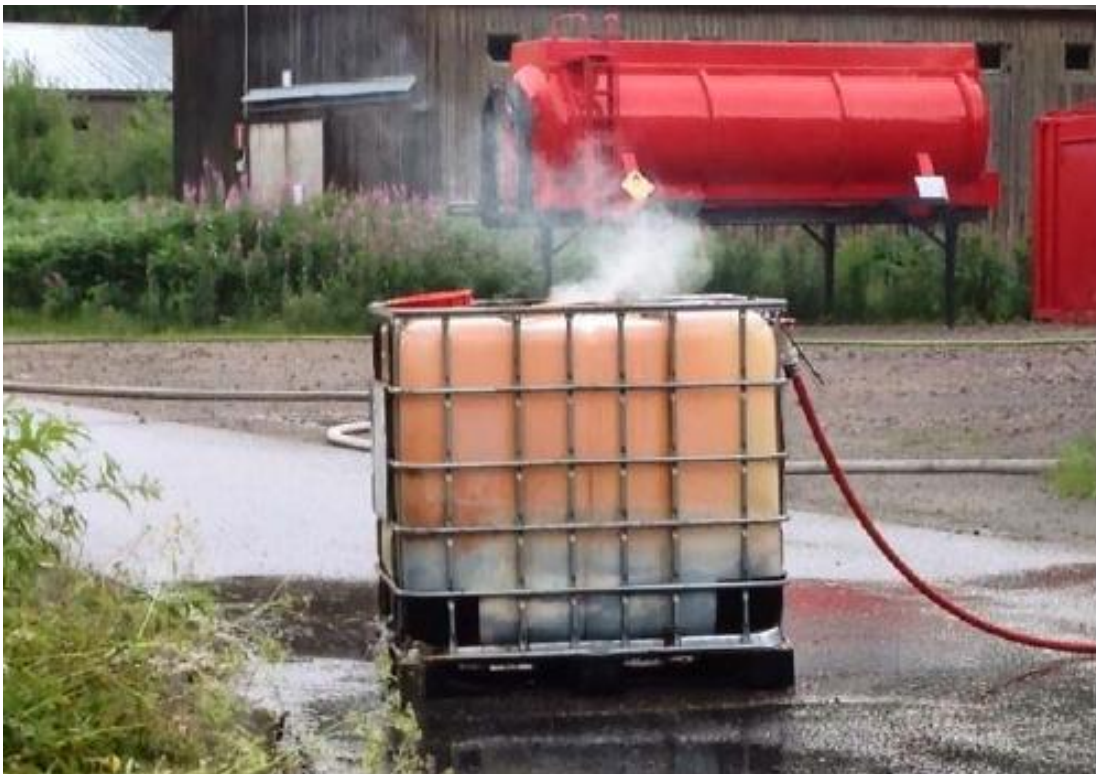
Figure 4. IBC transferred – water hose attached. Still just steam.

As the situation outside the gate seemed chaotic with the evacuation and media frenzy, inside everything was calm and professional. As soon as the Defence Forces robot was on site and the plan was set to action, the situation got better very quickly. The steaming reduced and eventually the fire department started to move the IBCs from the rows and nearing the reacting one. As the IBC was full of water it had cooled, it was moved, and the content emptied to several 50-liter plastic buckets –containing mostly a sludge of matrix and some mineral.

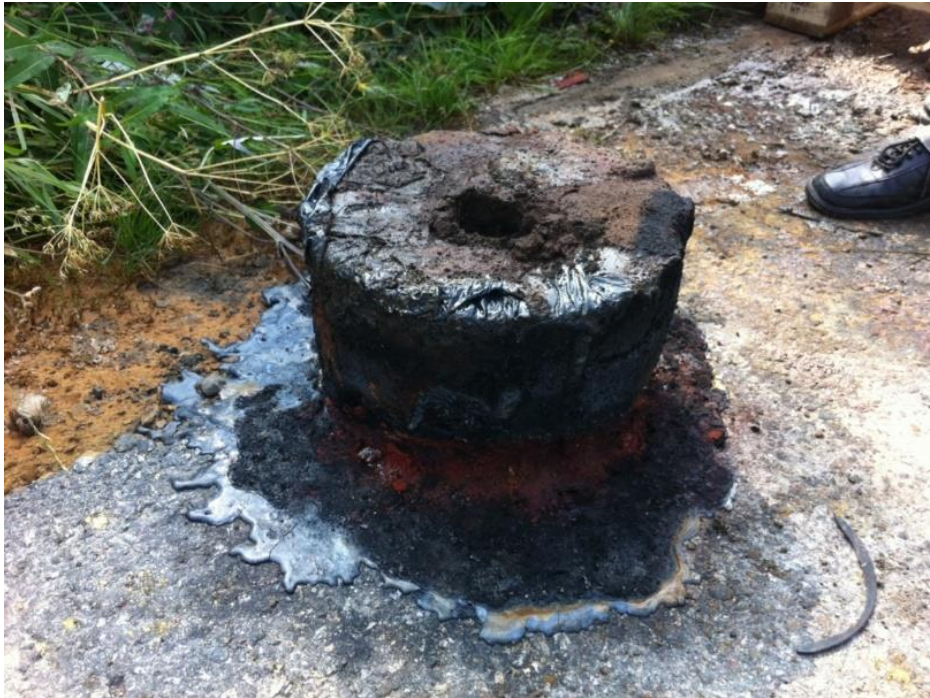
As we could now see the markings of the IBC it became obvious where the IBC came from and that the mineral was pyrite. Those familiar with reactive ground knew that in suitable circumstances ammonium nitrate decomposes in contact with fresh pyrite.

One 50-liter bucket containing mostly a mix of matrix and pyrite had continued to react during the night, see figure 5. There seems to have been relatively extensive amount of heat generated because the material and bucket ended up being quite charred. The material was studied very meticulously by hand – every bit was studied. The findings were somewhat alarming – there had been two RDX-based boosters (ca 25 grams each) inside the IBC. There were also filter bags (jute) and a lot of pyrite.

Figure 5. The 50-liter bucket with matrix and pyrite – clear signs of continued reaction
