# **Maxam Brazil Accident**

October / 2016

- Maxam Brazil, Cruzeiro Plant (Lead Azide production)
- Date / Hour: At 9:52 AM (local time) on October 13<sup>th</sup>, 2016
- Consequences
- 1 fatality (UAP coordinator) and 1 serious injury (maintenance manager).
- The plant was partially destroyed.

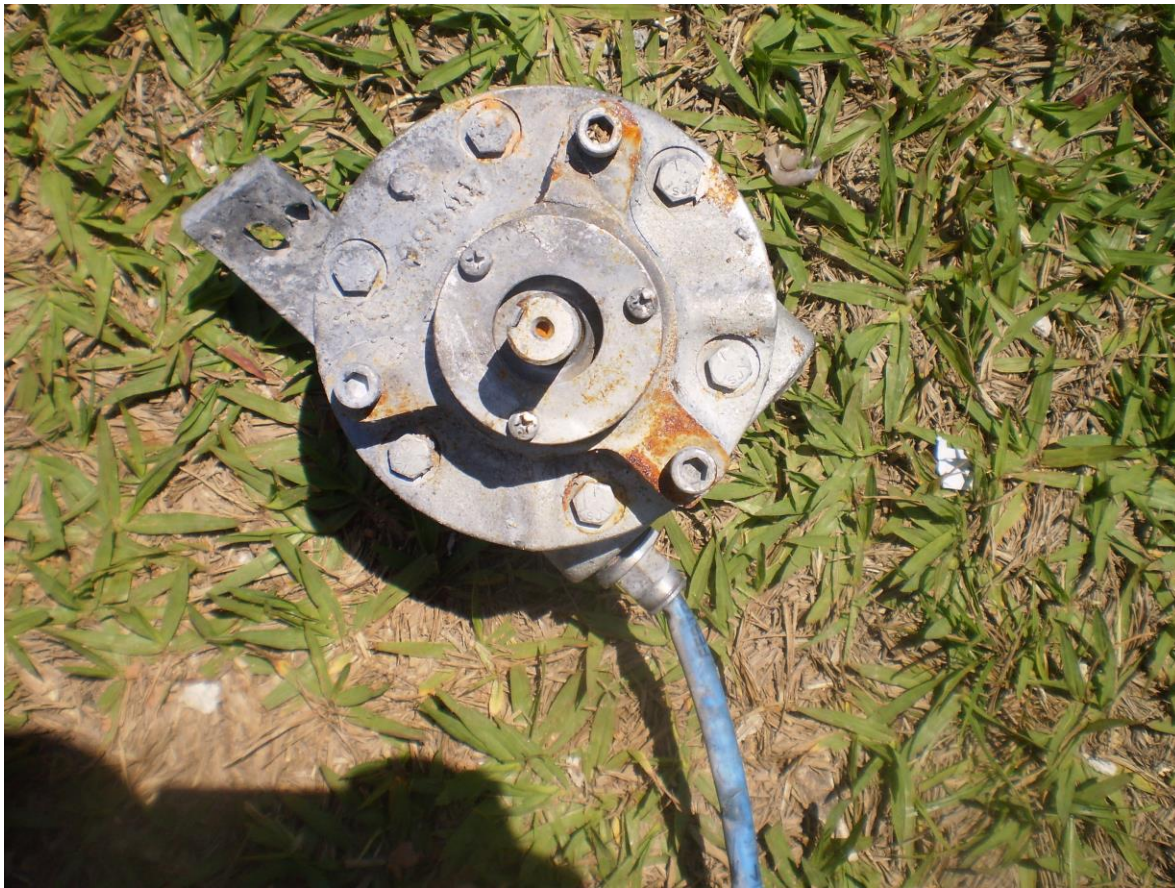
## New engine

On October 12<sup>th</sup>, 2016, a new engine (pneumatically powered) was installed to rotate the granulator stirrer. Here it can be seen after the explosion.

Some mechanical effect due to the stirrer. During the investigation it was concluded that the assembly had been correctly done. If this cause was to be ruled out, the remaining possibility pointed to the design of the process. It was proved that the engine of the original design had 0,5 CV of power, while the new one had 3 CV.

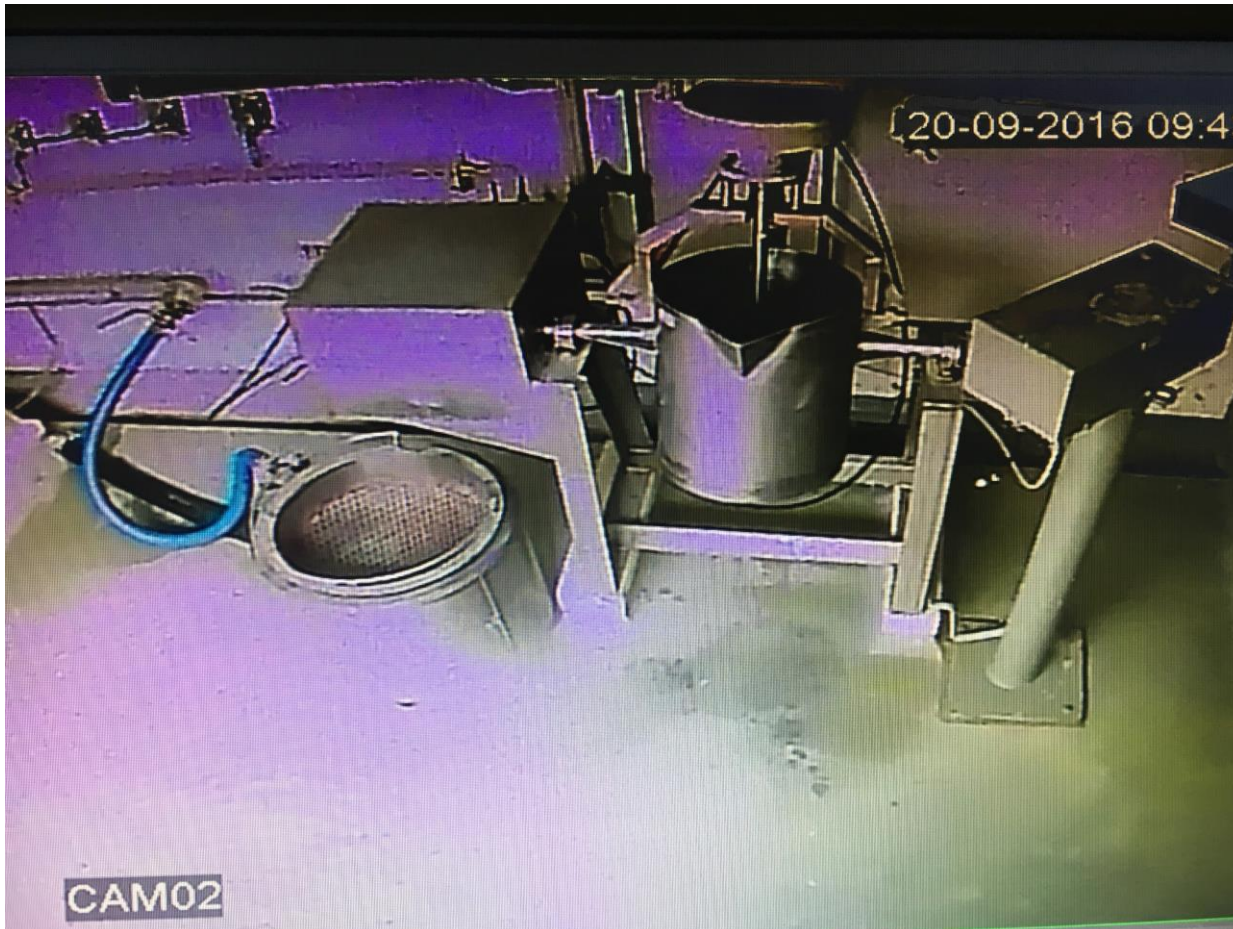
## Stirrer room

The tests performed had the purpose of finding the right working parameters for the engine. Speed of rotation.

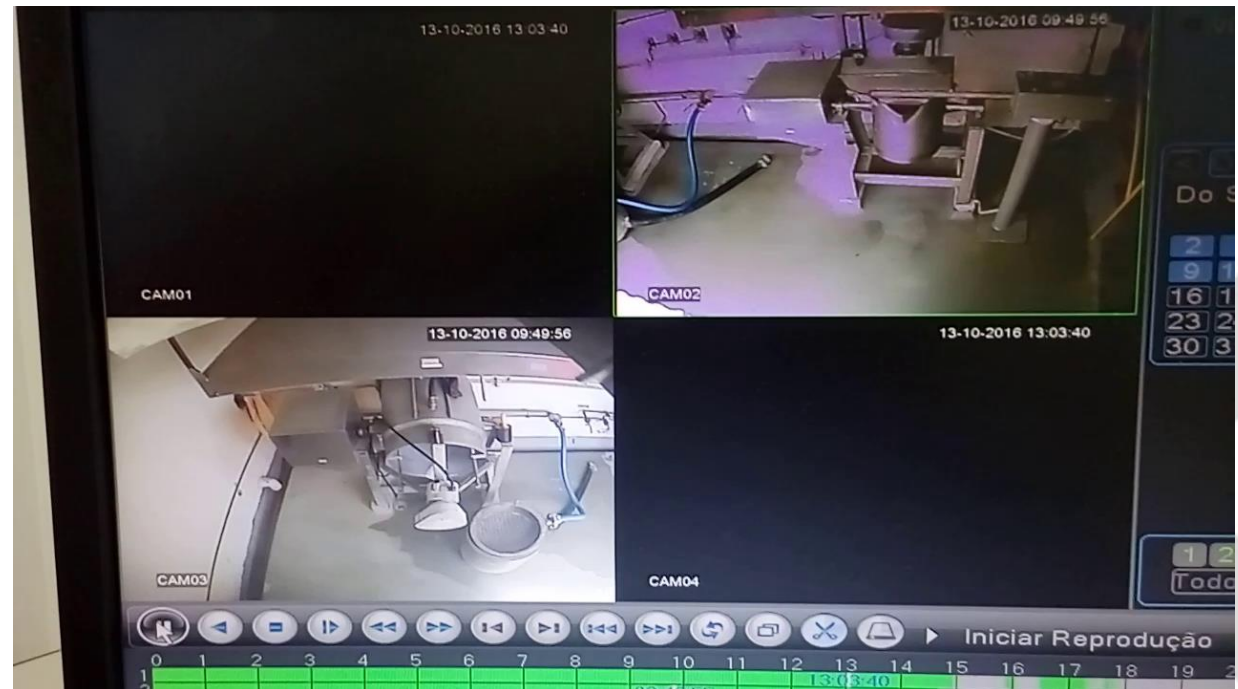
## Previous operations 2

Following standard operating procedure, 6 small containers of lead azide were poured onto the feeder (around 4kg). At 9:44 the water from the previous test was dumped into the floor.

At 9:48 the two plant operators loaded the granulator with Alcohol and Acetone and set the azide feeder into position.

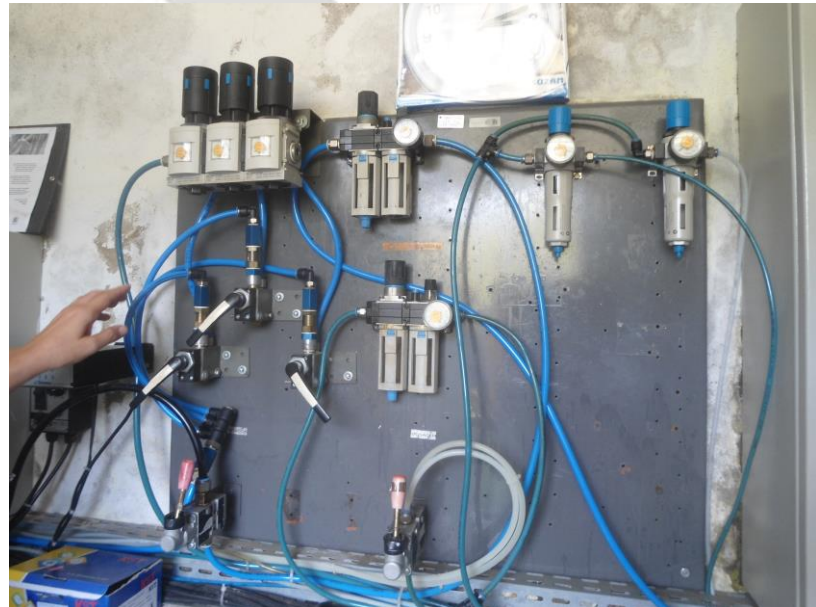
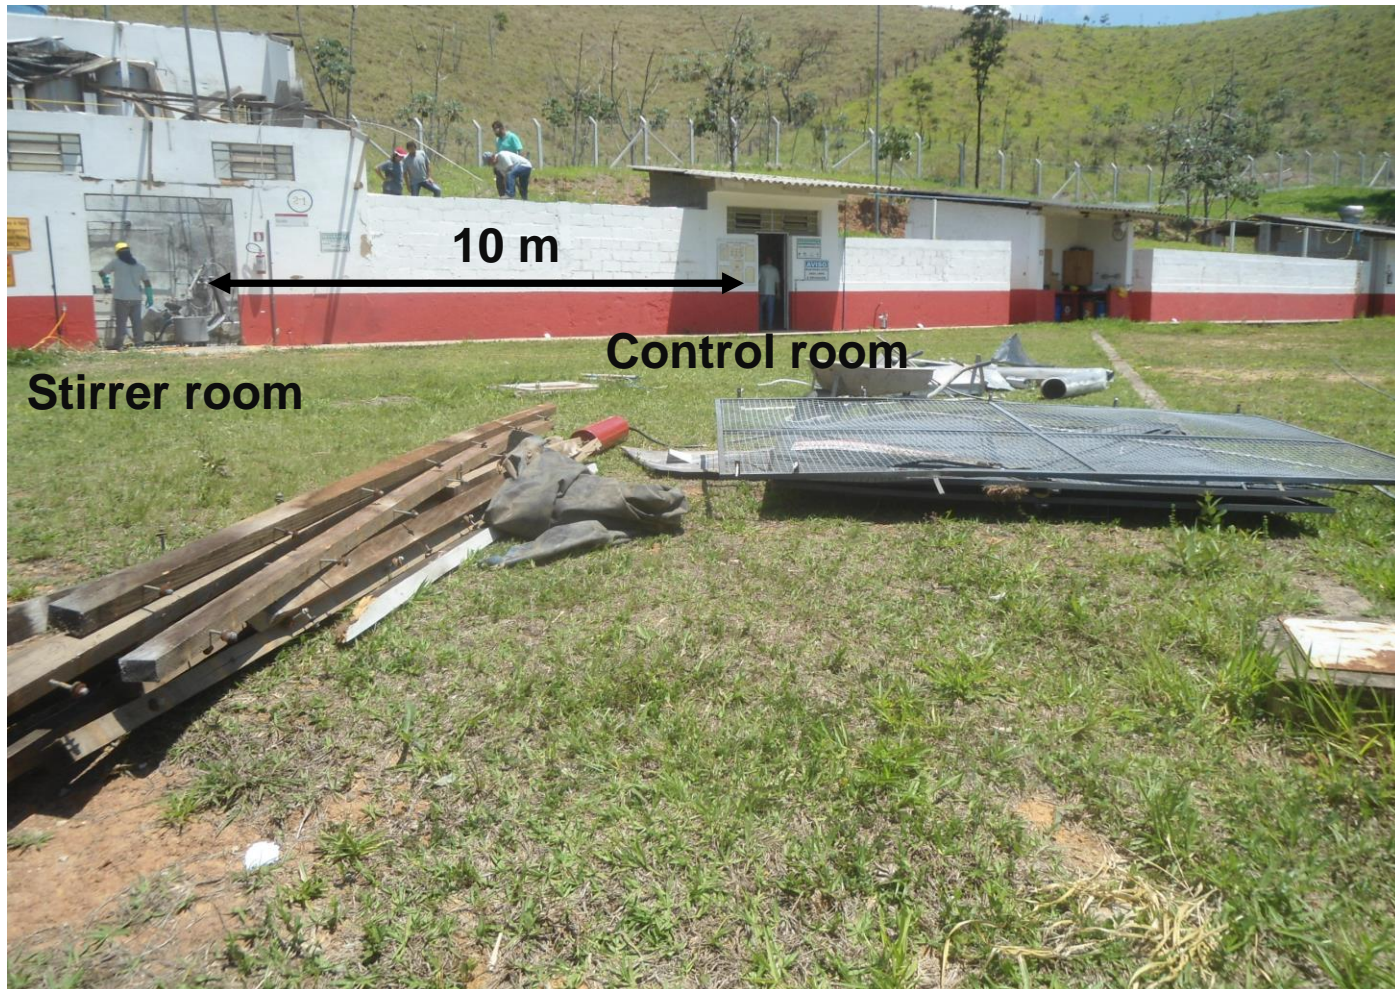
## Previous operations 3

At 9:49:53 the lead azide feeder dumps the explosive into the granulator, while the stirrer was already rotating at first speed. These actions (switching on the first speed and activating the feeder) were remotely performed from the control room by plant operator 1 (according to his own testimony). In that moment, plant operator 2 and the plant supervisor were with him. Also, the maintenance manager and the UAP coordinator were present near the control room, **although they started moving towards the granulation room, which is some ten meters away.**

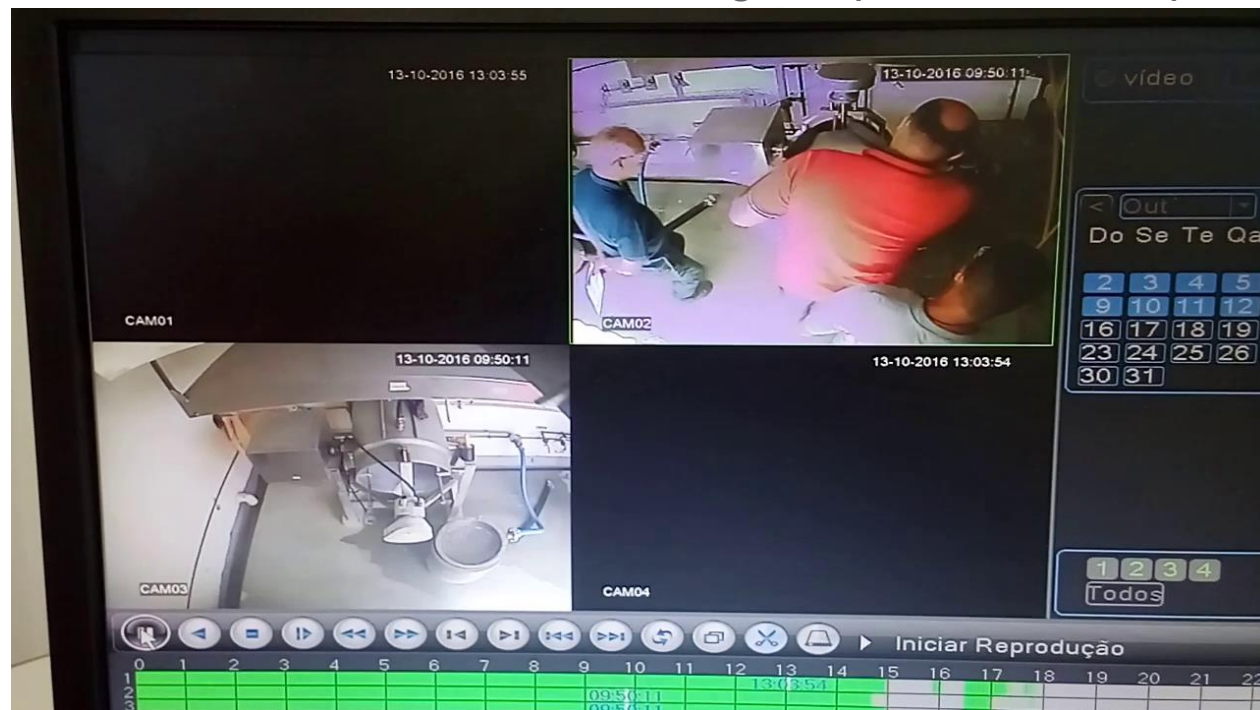
## Unsafe operations

These statements were in agreement with the video footage of the security cameras, where plant operator 2, the maintenance manager and the UAP coordinator could be seen **entering the granulation room after ten seconds**. The three persons were seen approaching the granulator and observing its inside while the stirrer was working. Plant operator 2, while being interviewed during the investigation, referred some unknown noise coming from the granulator. This noise had not been heard during the previous tests performed with water.

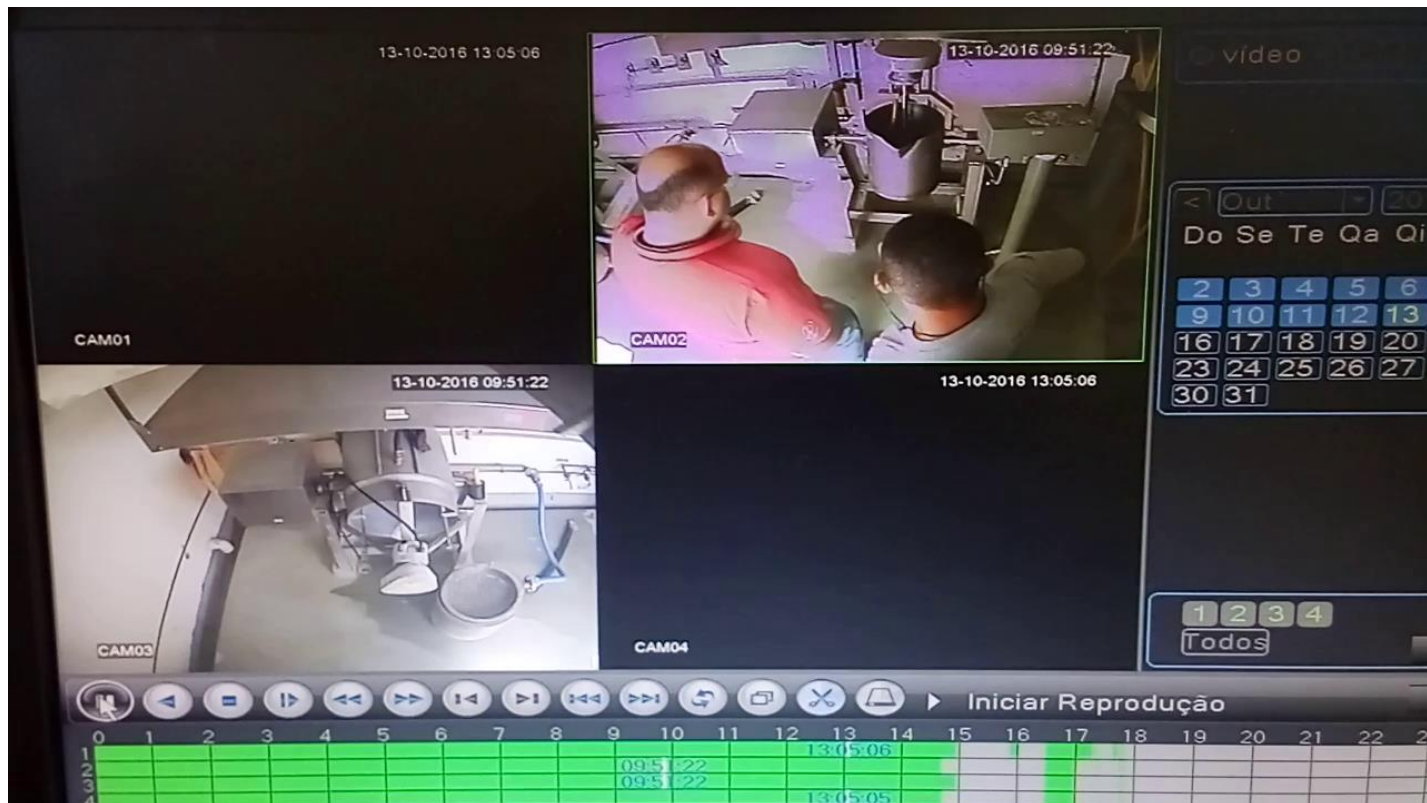
At 9:51:18 an increase in speed could be seen. Plant operator 1 stated that the command to increase velocity was given verbally by the persons inside the granulator room. In the video, the UAP coordinator could be seen approaching the granulator shortly after the increase had taken place, as it to inspect the result of the increase.

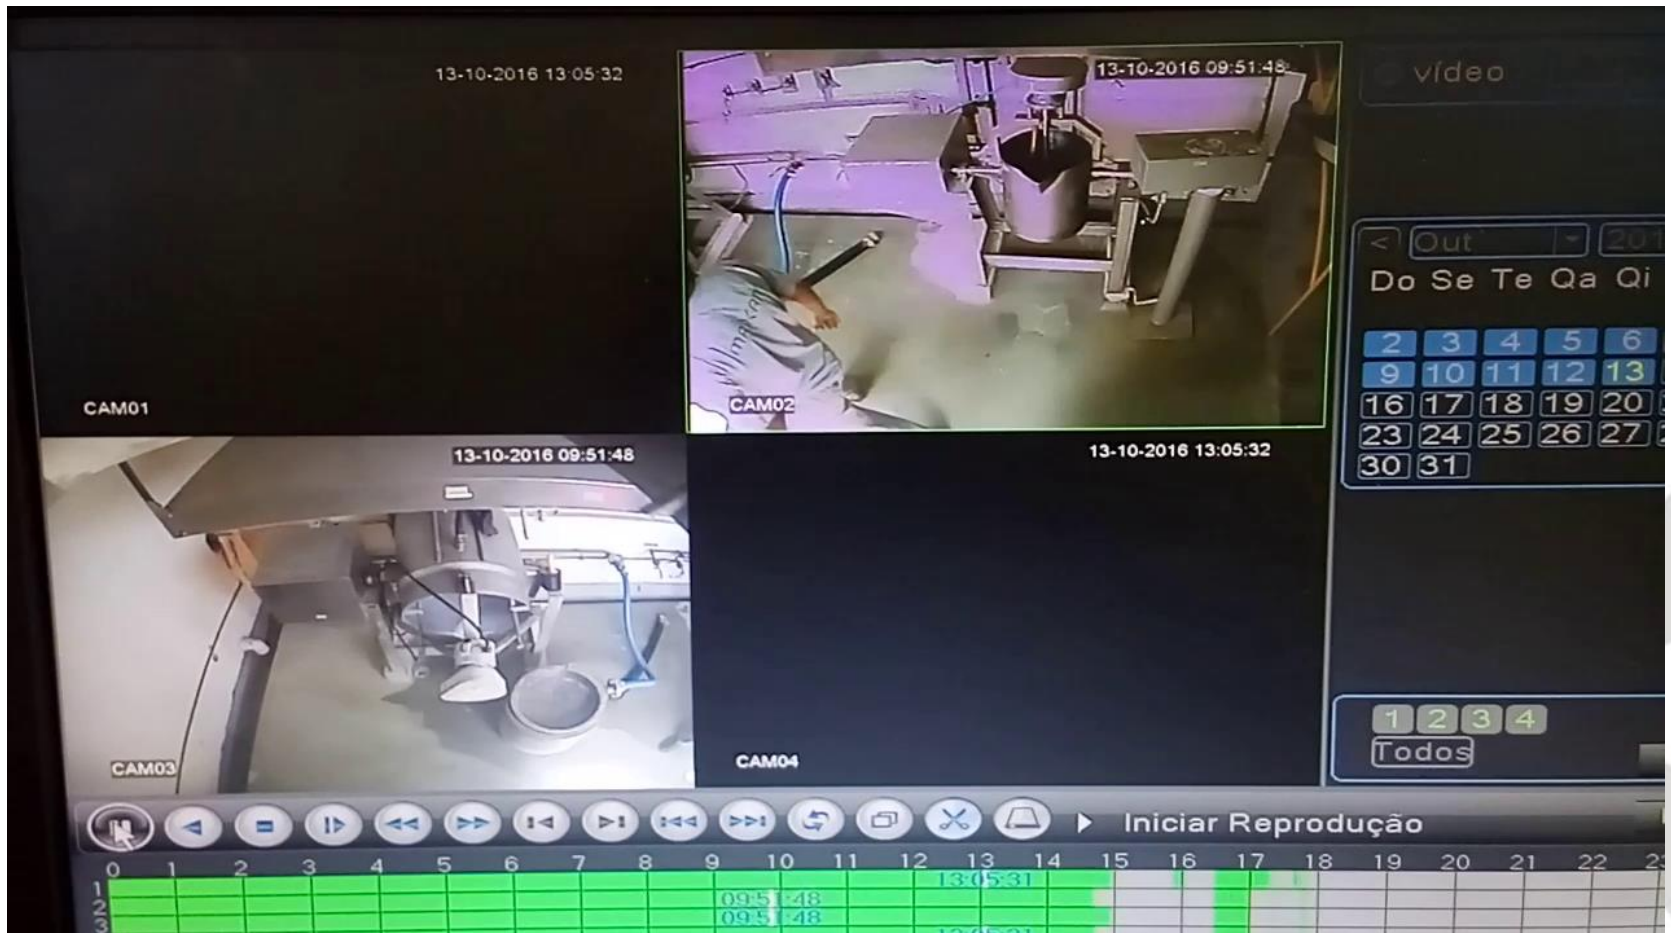
## Operator leaving stirrer room

At 9:51:49 (1 minute and 50 seconds after starting the process) plant operator 2 was seen leaving the granulation room.

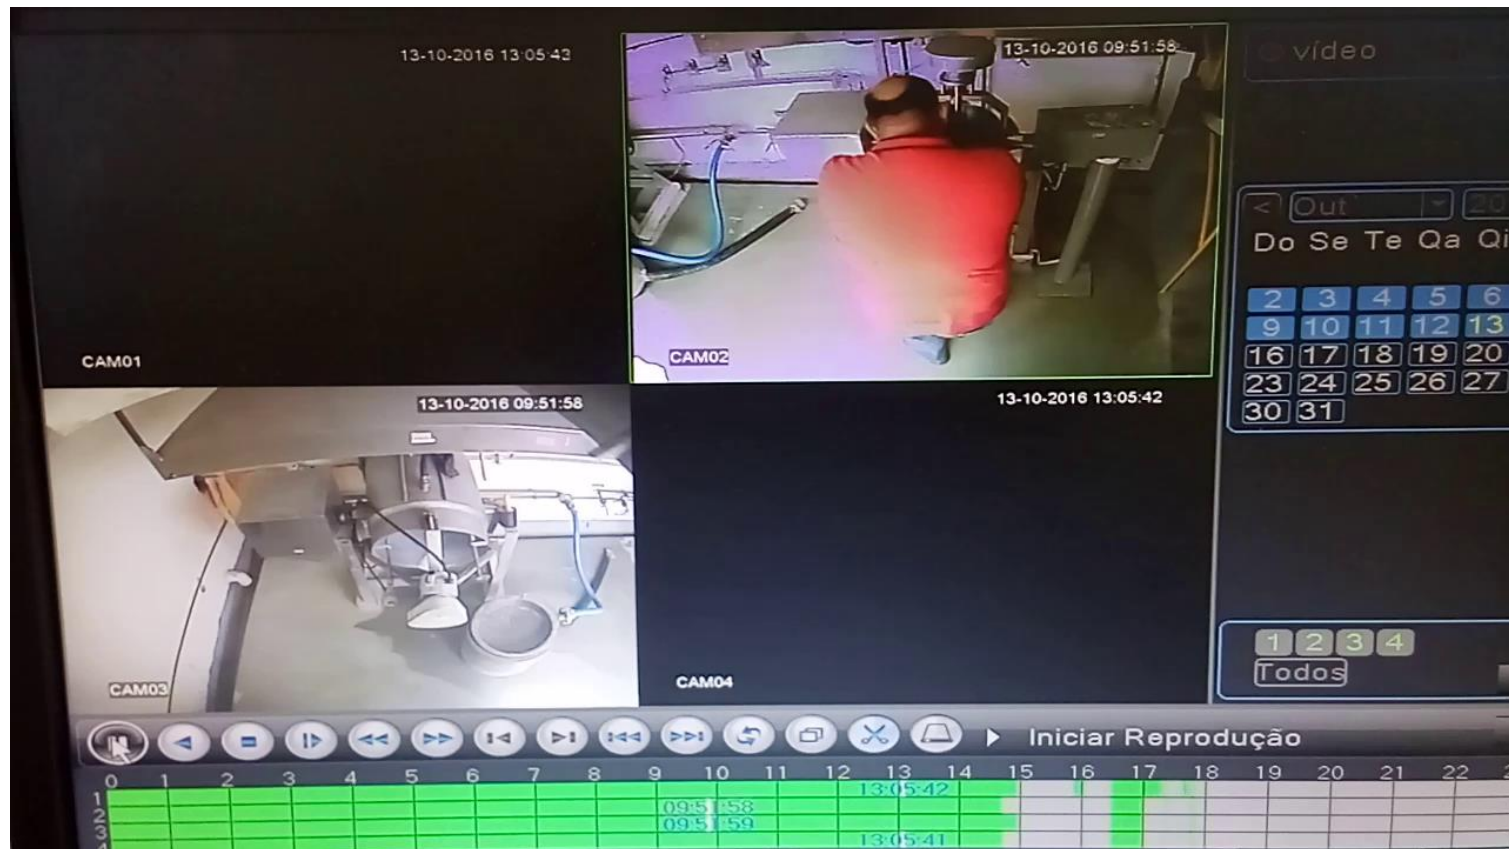
## Moment of explosion

Ten seconds after leaving the room an explosion took place. In the moment of the explosion, only the UAP coordinator could be seen in the room. He was approaching the granulator for visual inspection, exactly in the same manner as he had done after the second speed had been engaged.

In this new situation, the initiation of the lead azide could well be due to the possibility that the impact or friction of the blades of stirrer, against the grains of lead azide, were higher than the sensitivity threshold of the explosive for that mechanical stimulus.

This significant increase in the amount of energy transferred to the explosive in the last stage of the test was believed to be the immediate cause of the initiation.

And, if the knowledge of the team had not been enough to avoid an explosion during the tests, at least, issuing proper “Special Works” documents would have, for sure, avoided the presence of people in the granulation room during the movement of the stirrer.
