Angellala Creek Ammonium Nitrate Incident – 10 years on

By Geoffery Downs, Expert Panel

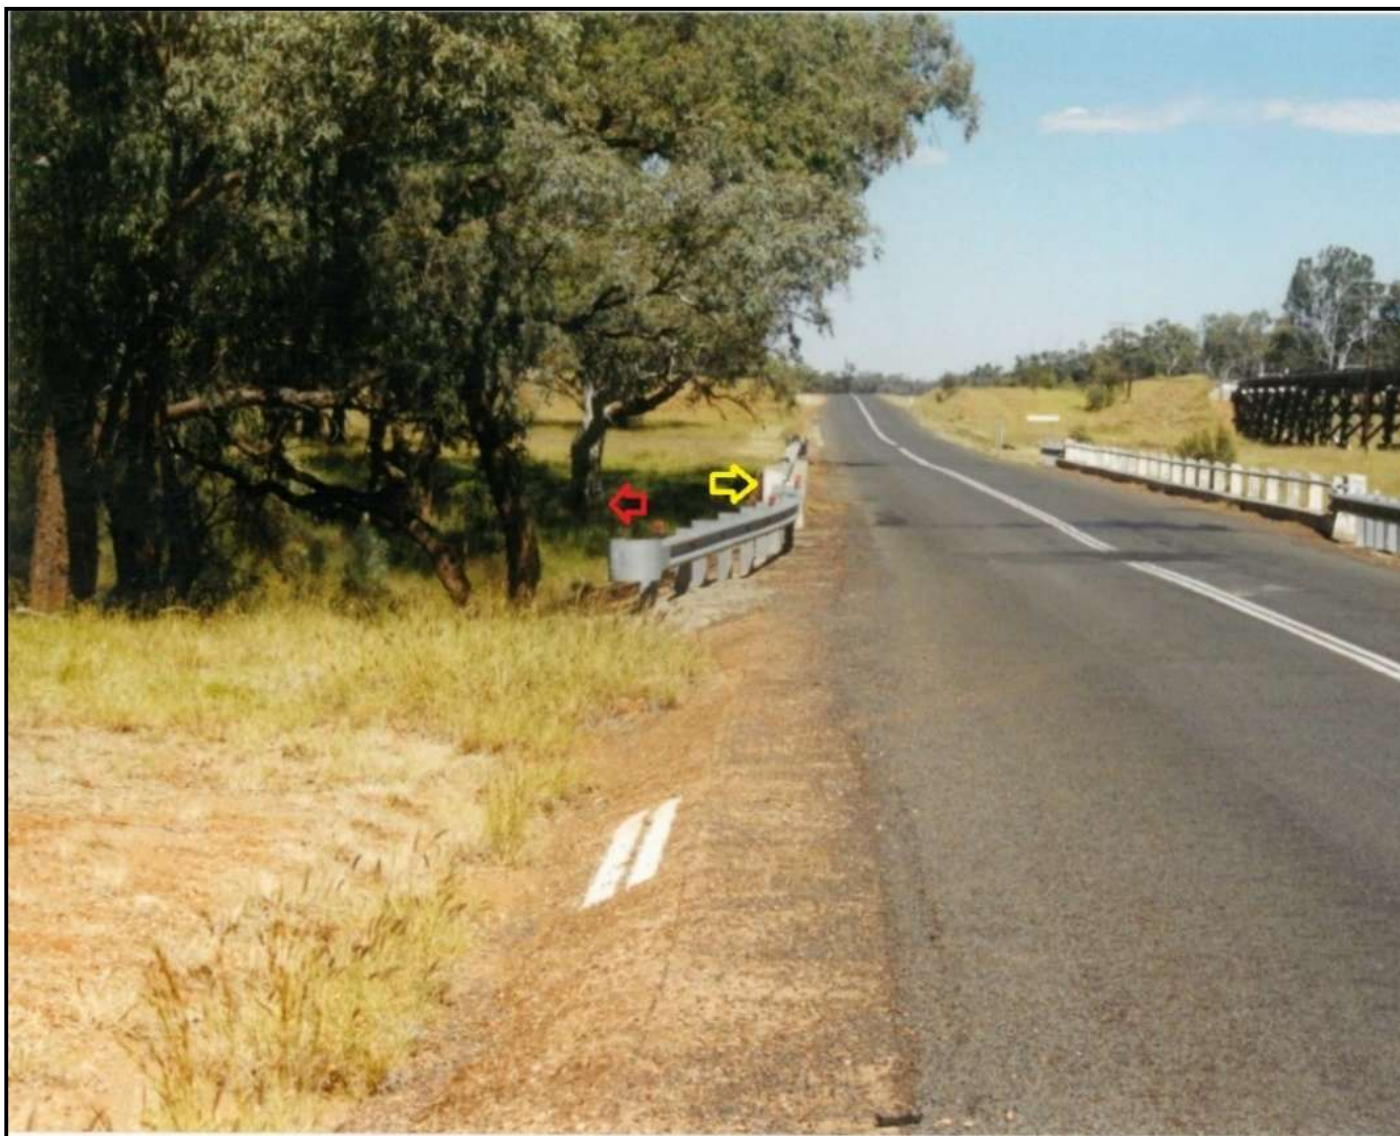
The vehicle was heading south along a straight section the Mitchell Highway. Picture 1 below shows the approach to the bridge at Angellala Creek in the direction of travel taken at an unknown time before the incident. In Australia, vehicles travel on the left-hand side of the road and hence the vehicle was travelling on the left-hand side of the road in the direction of travel and the focus should be on the left-hand side of the bridge.

The vehicle leaves the left-hand side of the road and proceeds towards the creek between the trees on the left-hand side, shown by the red arrow in Picture 1, and the railings of the bridge on the right hand side, shown by the yellow arrow in Picture 1. The vehicle continues through the Armco guard rail and into the dry creek bed. The prime mover and trailers jack knifed into the creek bed. There was a

Picture 1 – Angellala Creek Bridge prior to incident

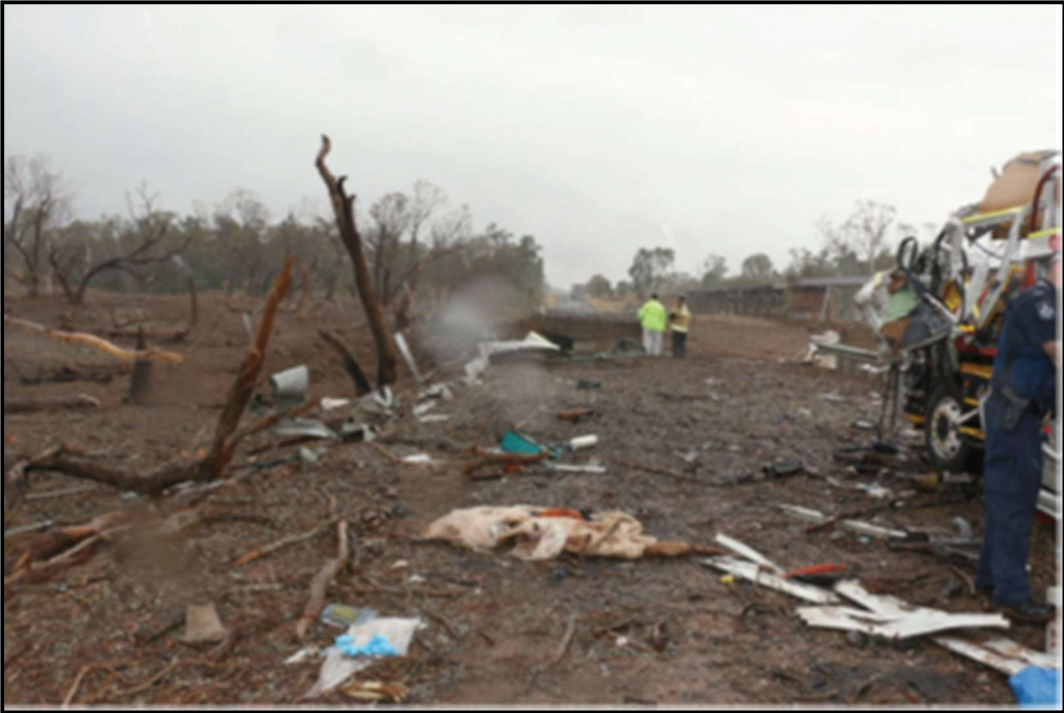
fire with explosions following. The Armco guard railing can be seen in Picture 1 before the incident. The guard rail was destroyed by the vehicle passing through it with the remains shown in Picture 2.

The point of entry between the trees and the bridge from roughly the same position as Picture 1 is shown in Picture 2 after the explosions. The two trees in Picture 1 are barely recognisable.

Picture 2 - Angellala Creek Bridge after the blast looking south

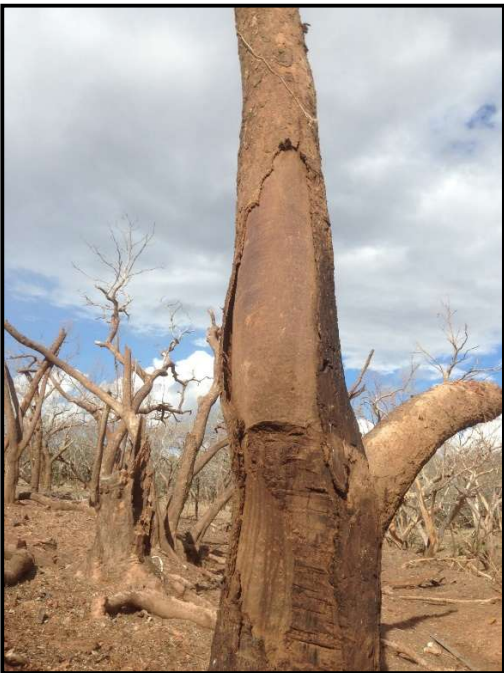
The tree identified in Picture 1 was sideswiped by the left-hand side of the trailers when passing through. The scar left on the tree from the prime mover and trailers passing through are shown in Pictures 3 and 4. The height of the scar is consistent with the vehicle height. Ammonium nitrate prill was found at the base of that tree.

Picture 3 – Scar on tree next to bridge

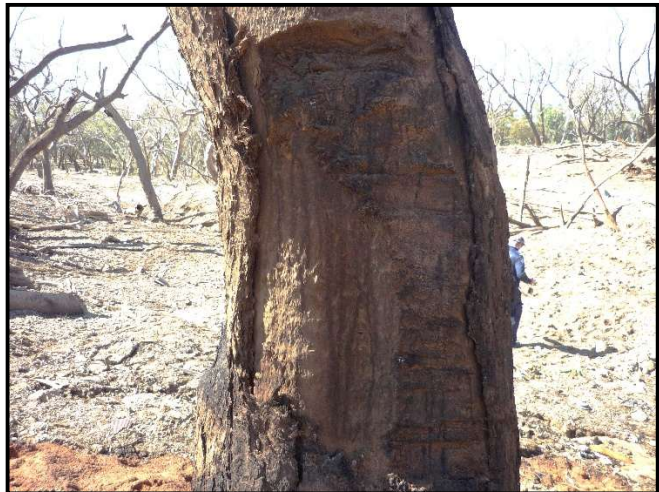
Picture 4 – Close up of scar on tree

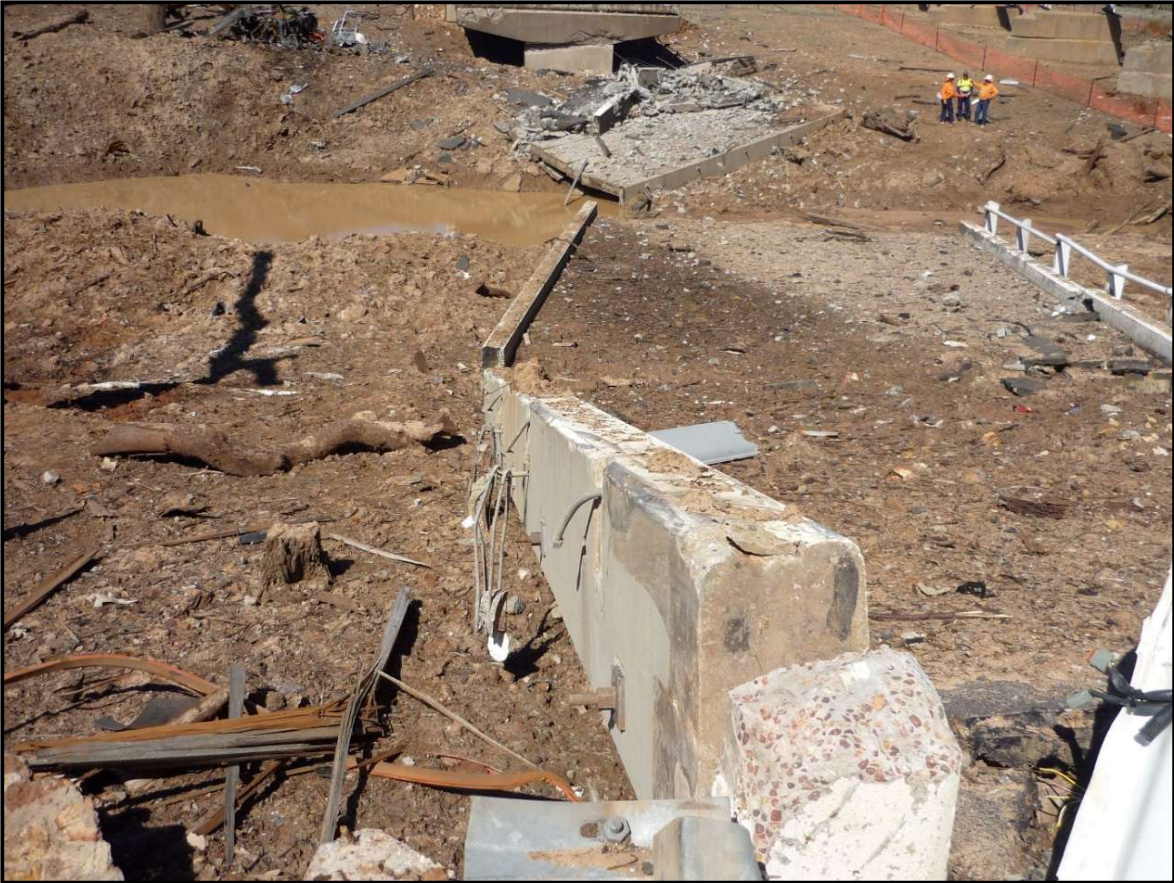
As seen in Pictures 5 and 6, the right-hand side of the vehicle appears to have mounted the left hand edge of the bridge and destroying the supports for the railings from the parapets as it proceeded. The concrete parapets show black marks resembling rubber from the tyres. If this was the situation, the vehicle would have the right-hand side much higher than the left hand side and the rig would be rotating anticlockwise. Note how the brackets for the bridge rail are bent in the opposite direction to the blast and the rail is gone.

Picture 5 - Parapets show black marks and the bent rail brackets

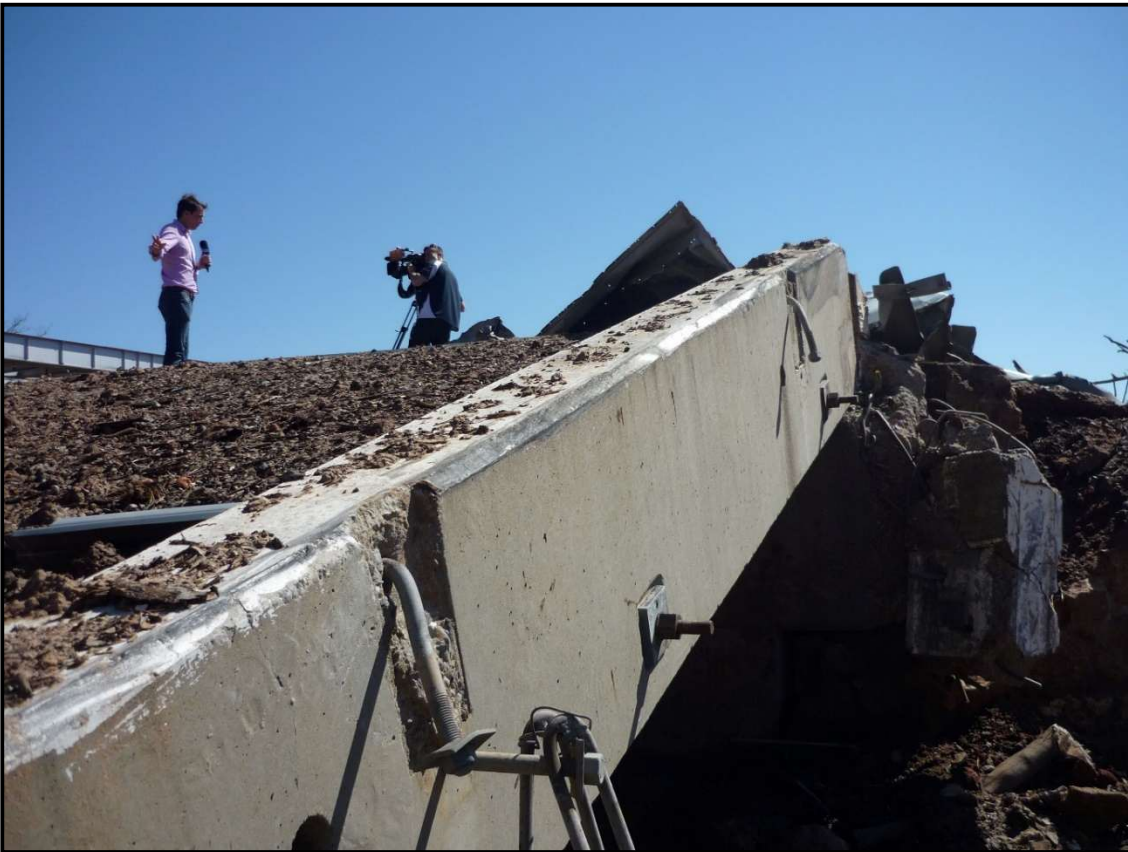
Picture 6 – Parapet with black marks and bent supports

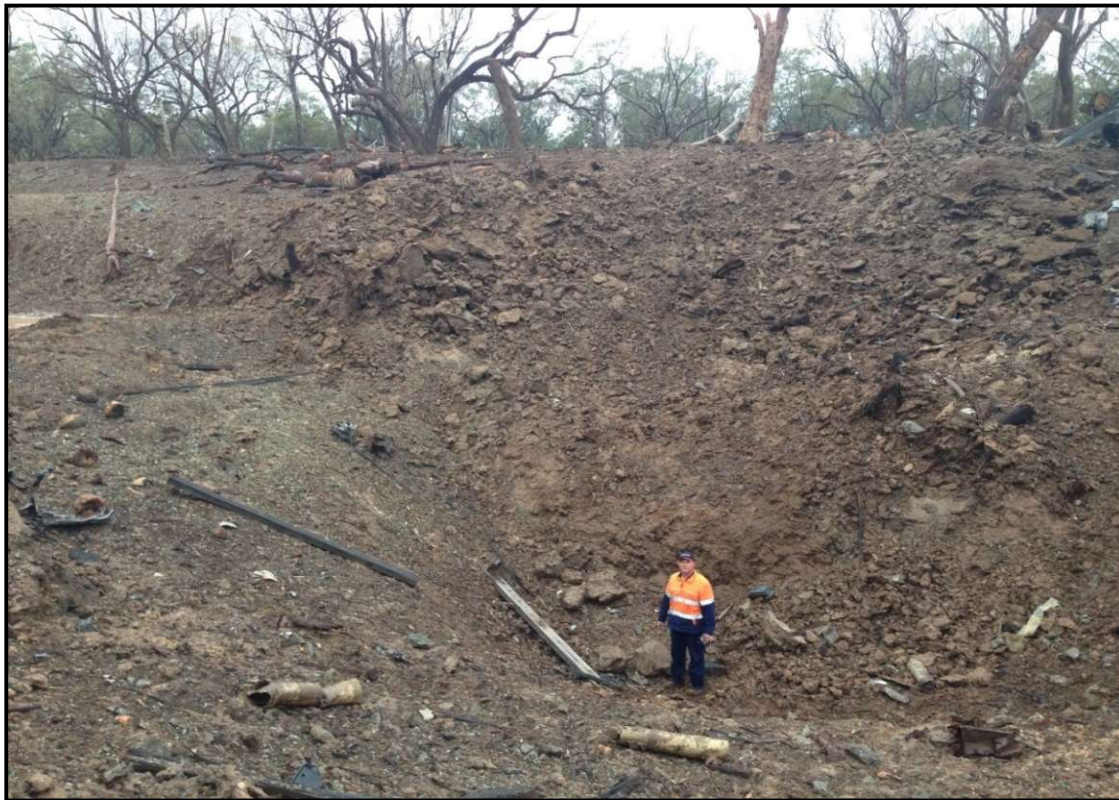
Two explosions were reported. The crater from the second explosion is presented in Pictures 7, 8 and 9. At the time of the incident, the creek and the countryside were very dry as seen in Pictures 7 and 8. A few days after the incident, it rained with lots of water in the creek. Picture 9 shows the crater full of water and that is the reason why water is seen in the creek, post incident, in many photos.

Picture 7 -Crater from north side of creek

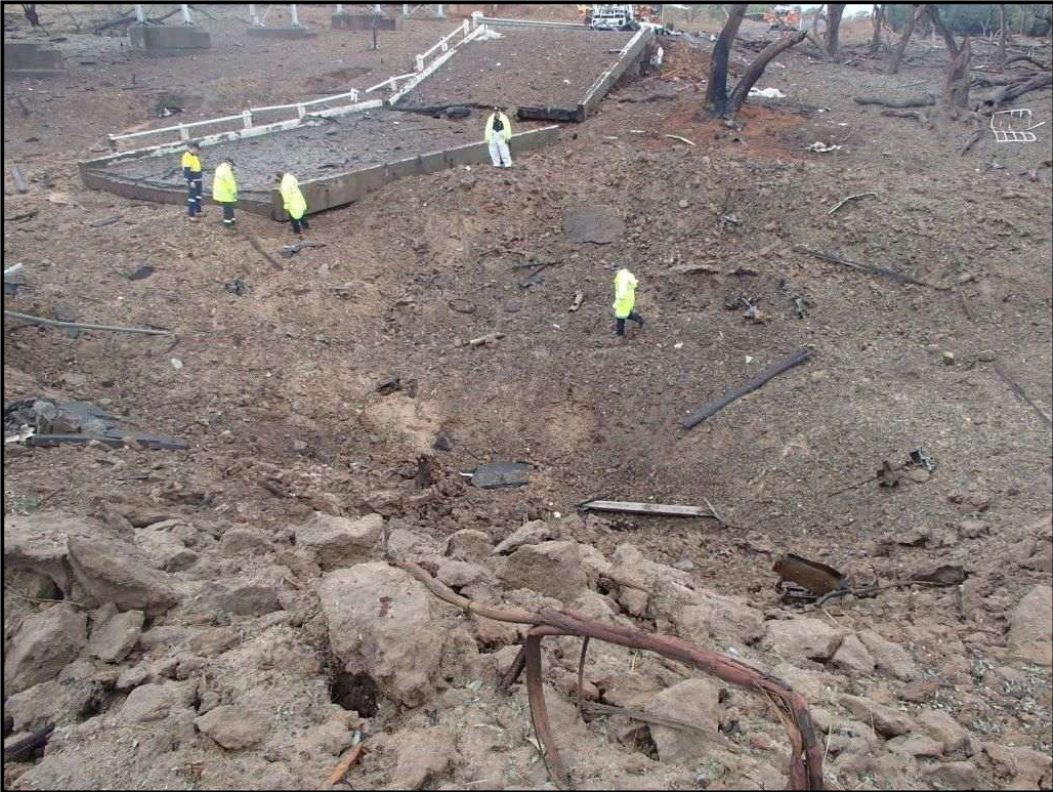
Picture 8 – Crater from south side of creek

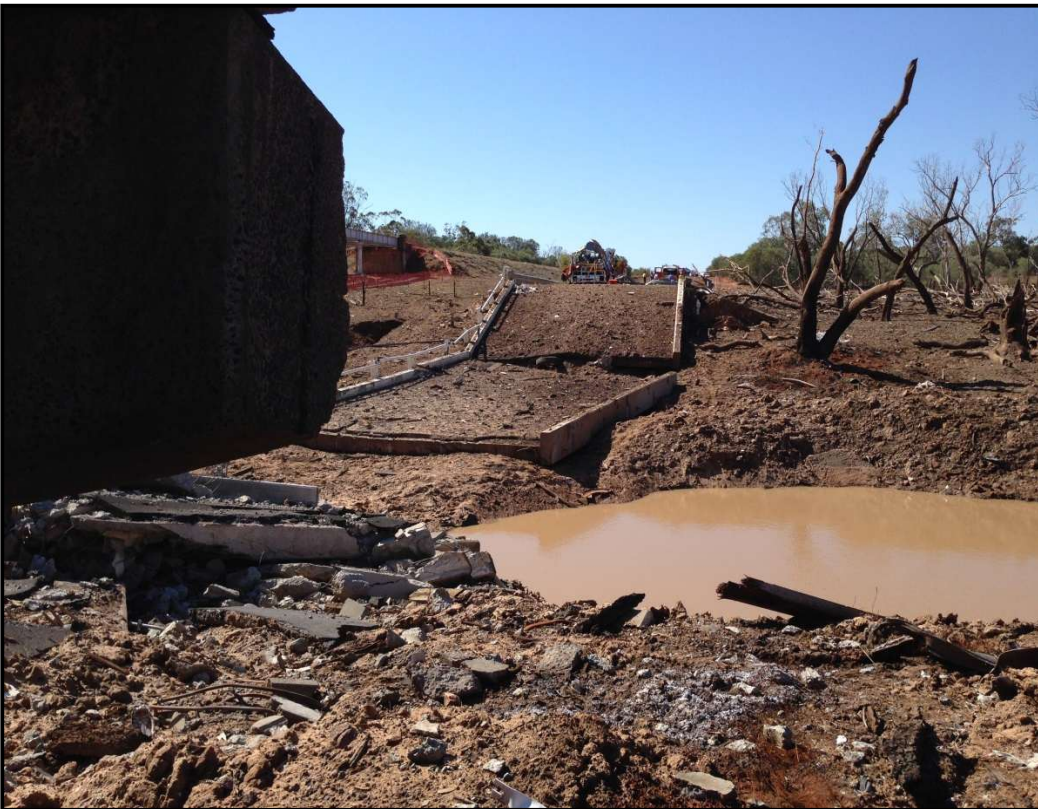
Picture – 9 – Crater from south side of creek after rain

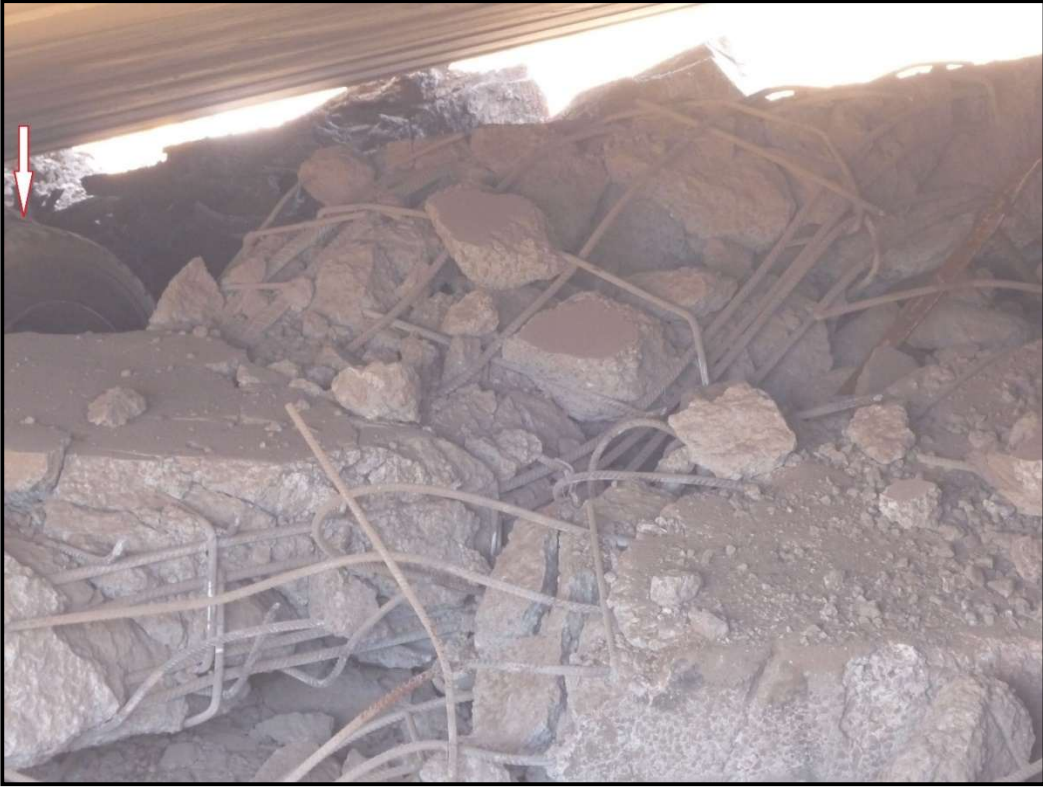
The wheels of the rear trailer can be seen in Picture 10 through the rubble under the bridge. There was a quantity of unconsumed ammonium nitrate adjacent to the wheels under the rubble. The wheels can be seen in the top left corner of the picture with an arrow pointing to its location.

Picture 10 - Trailer wheels

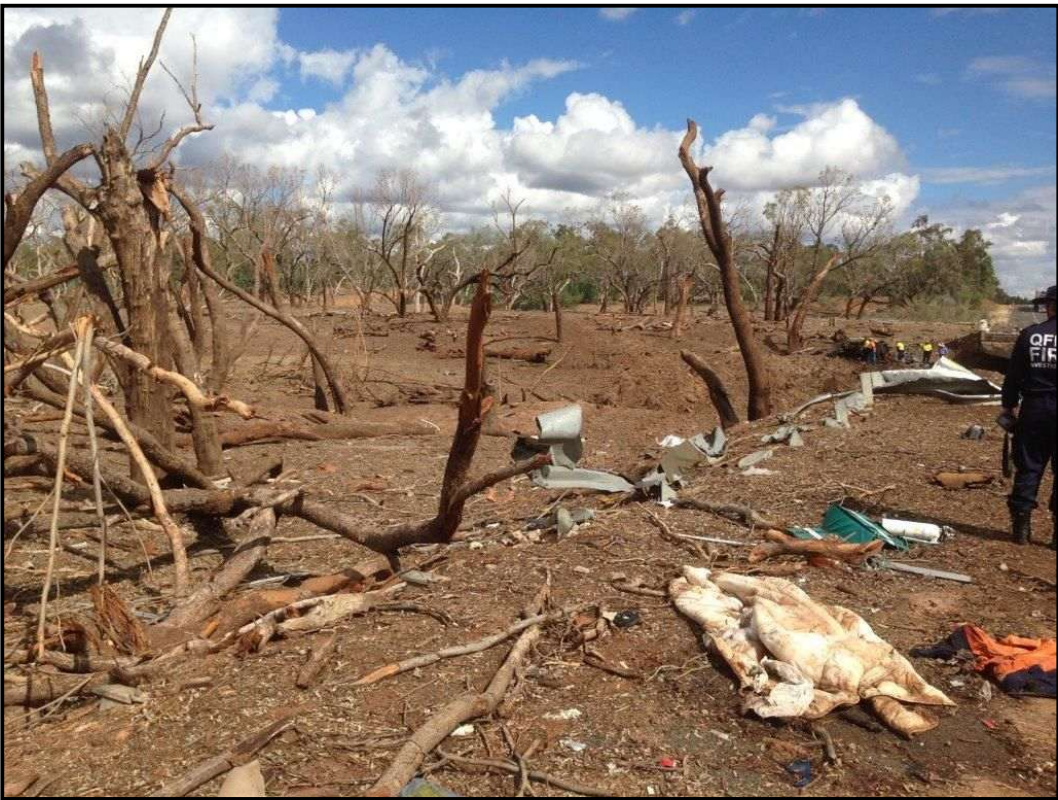
Picture 11 -

Picture 11 shows the general impact on the vegetation in the close vicinity. The remains of the prime mover are seen more clearly in Pictures 12 and 13. The remains are highlighted with a red circle in Picture 12. The blast projected the prime mover up onto the top of the embankment.

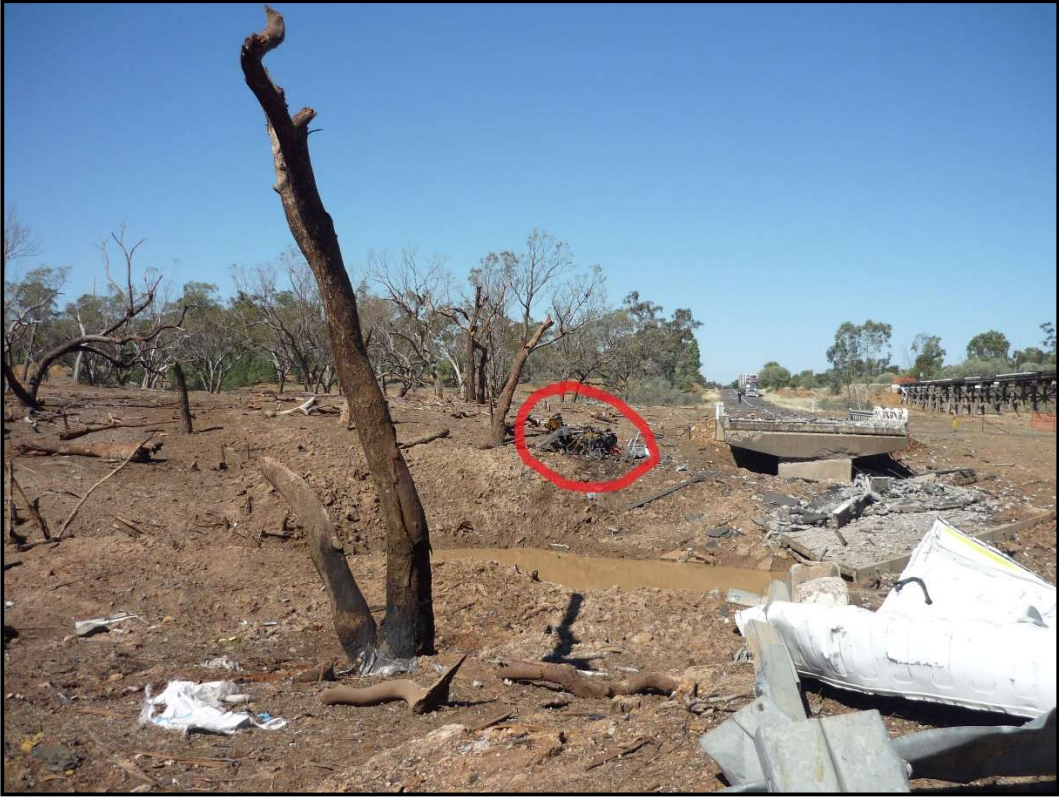
Picture 12 – Prime Mover after being projected to top of creek bank

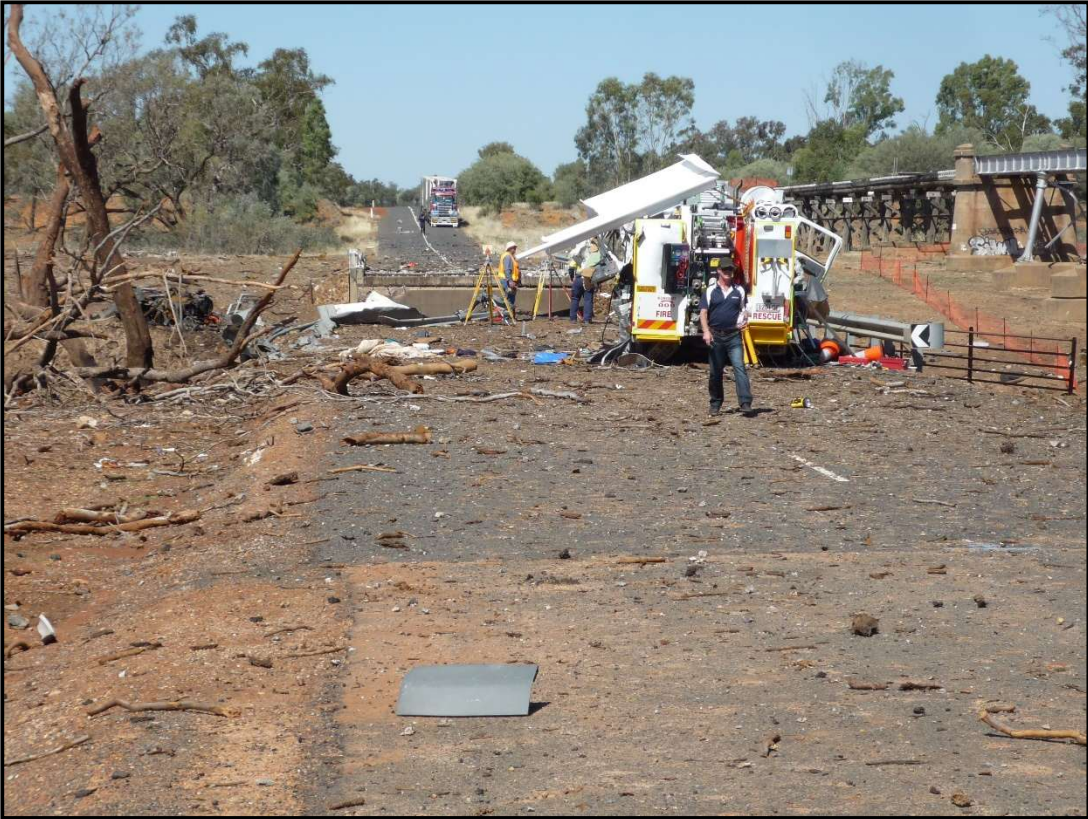
The area was littered with all types of debris. An example of the debris is shown in Picture 14. Aerial photos of the scene are also shown in Pictures 15 and 16.

Picture 14 – Debris around blast site

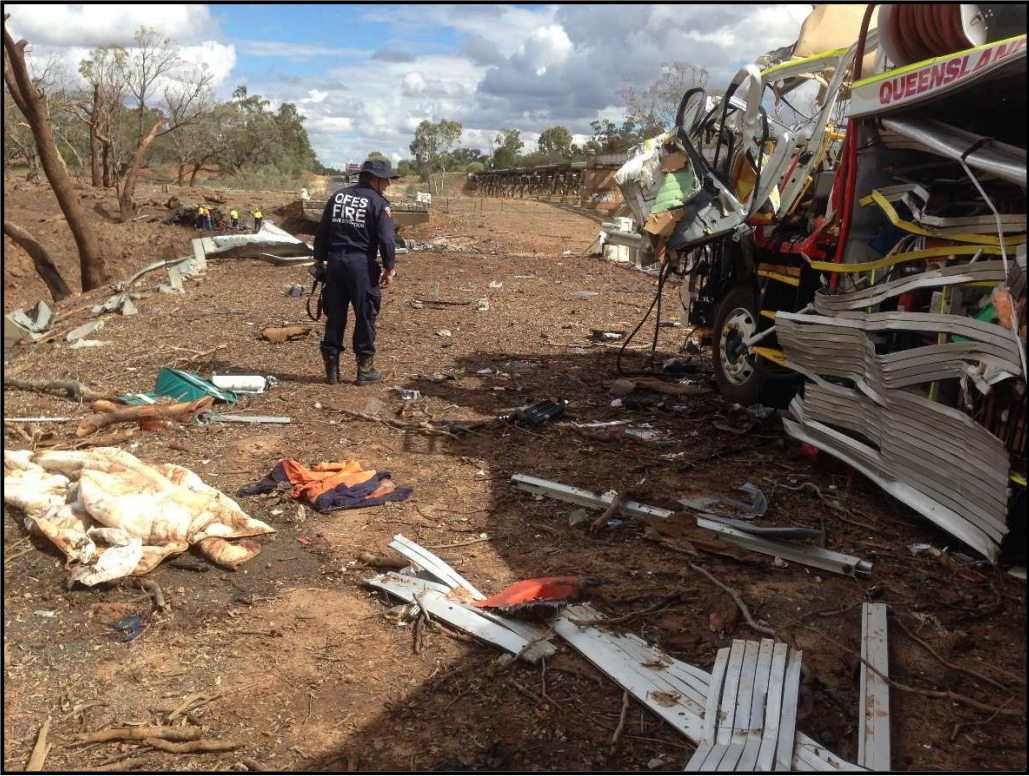
Everybody is amazed at the damage to the fire engine from the blast. However, there is more about this I wish to draw your attention to. In the foreground in Picture 17, there is a blanket and an orange safety shirt on the ground. The injured driver was receiving first aid treatment where the blanket is located. At the time of the explosion, all responders were attending to the injured driver and were crouching on the ground beyond the edge of the creek in the vicinity of the blanket. The blanket can also be seen in Pictures 2, 11 and 14. These pictures give more perspective, dimension and angles to the creek bed, banks and the edge of the creek to identify their location.

We can see the damage to the fire engine in Pictures 17, 18 and 19. The interesting observation is that damage to the fire engine has occurred above a certain height which is approximately at the height of the wheels. The tyres were not punctured and there is little evidence of damage under that height. This area below the dividing line starting at the edge of the creek was in the shadow of the blast wave.

Picture 17 – Site of first aid treatment for injured driver

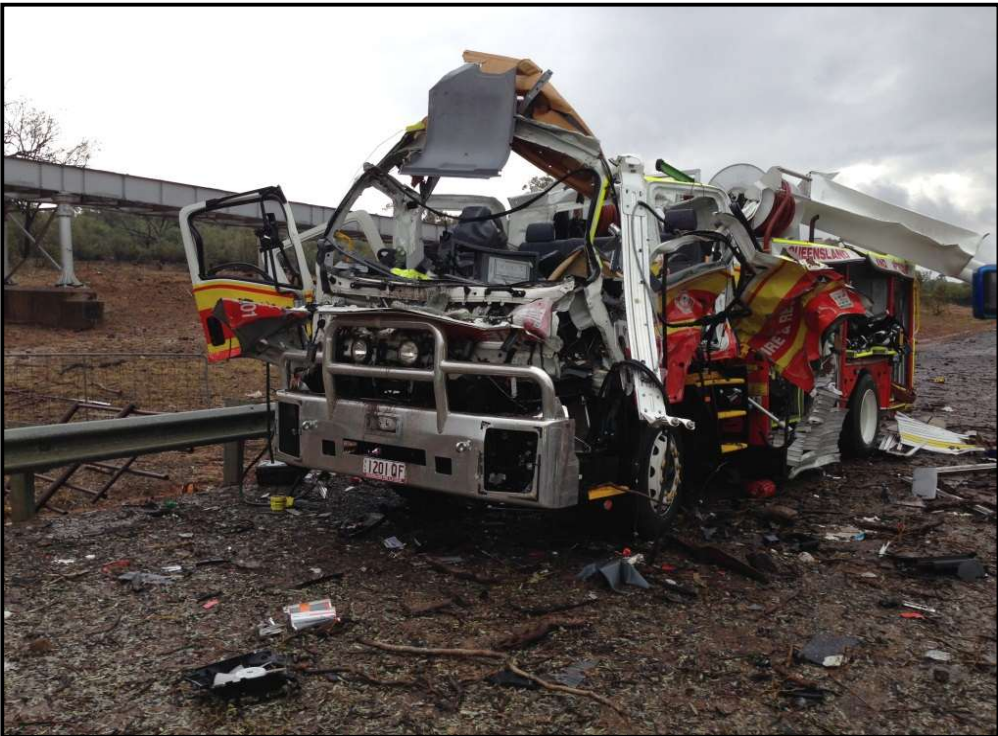
Picture 18 – Frontal view of damage to fire engine from blast

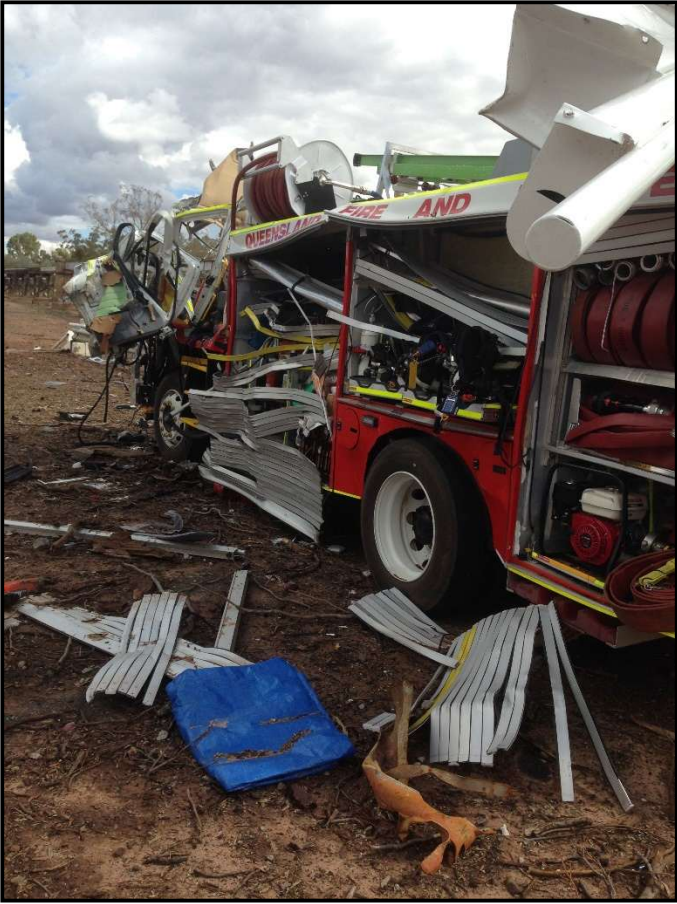
Picture 19 – Rear view of damage to fire engine from blast

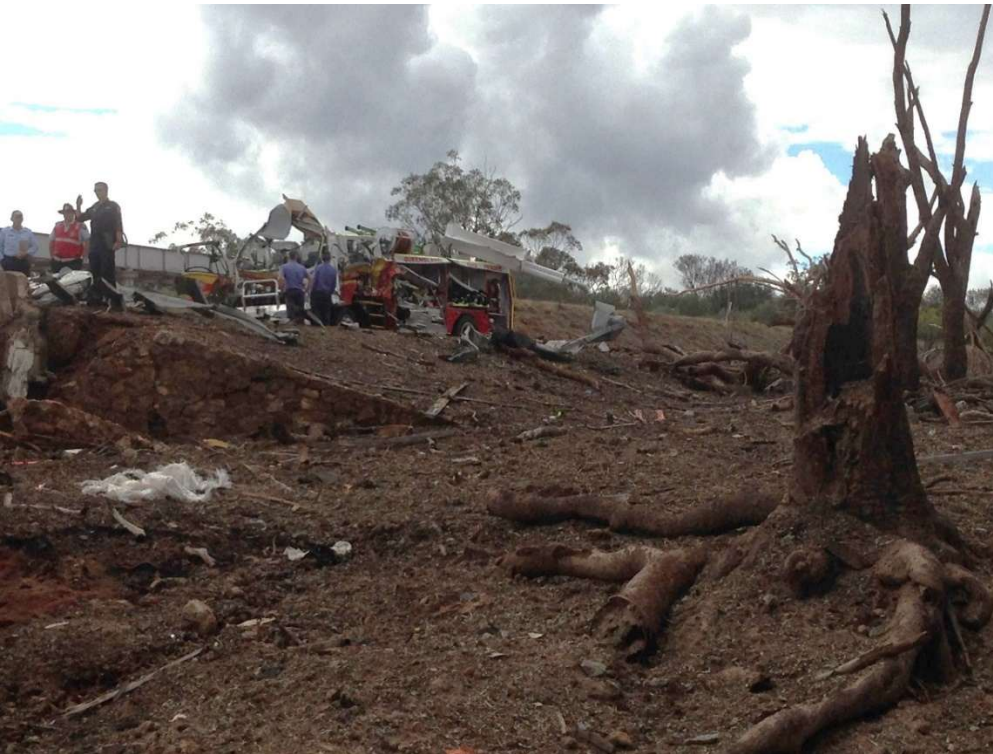
The depth of the creek bed and the angle of the creek bank together with their location at the edge of the creek provided the shadow of the blast wave and the degree of protection of the people and parts of the fire engine in the shadow. Pictures 8, 9, 21 and 22 give an idea of the angle of the banks of the creek. In Pictures 21 and 22, people are standing in the approximate location of where the driver was being treated. Anyone standing in that spot would have been directly exposed to the blast. Examination of Pictures 8, 9 and 21 also shows the approximate exposure of the fire engine to a blast wave and low angle debris.

Picture 20 – Looking towards fire engine and first aid area from creek bed

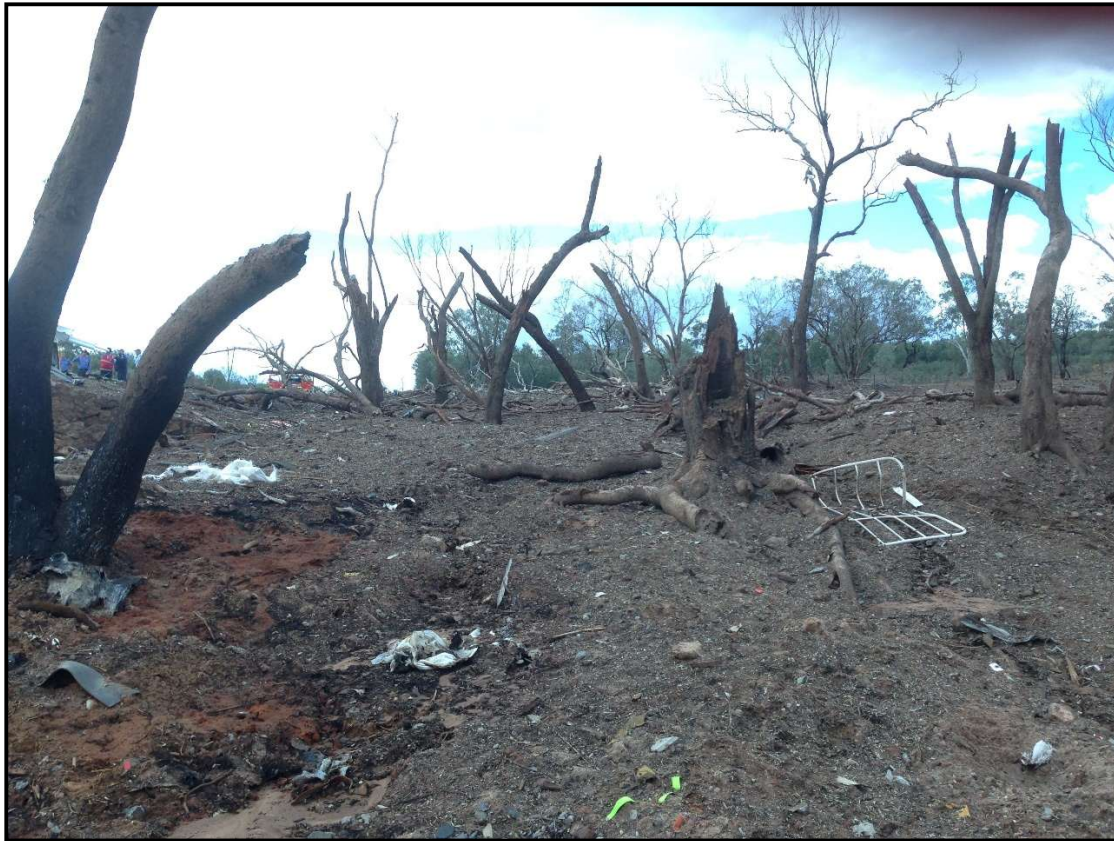
Picture 21 – Different location looking towards fire engine and first aid area from creek bed

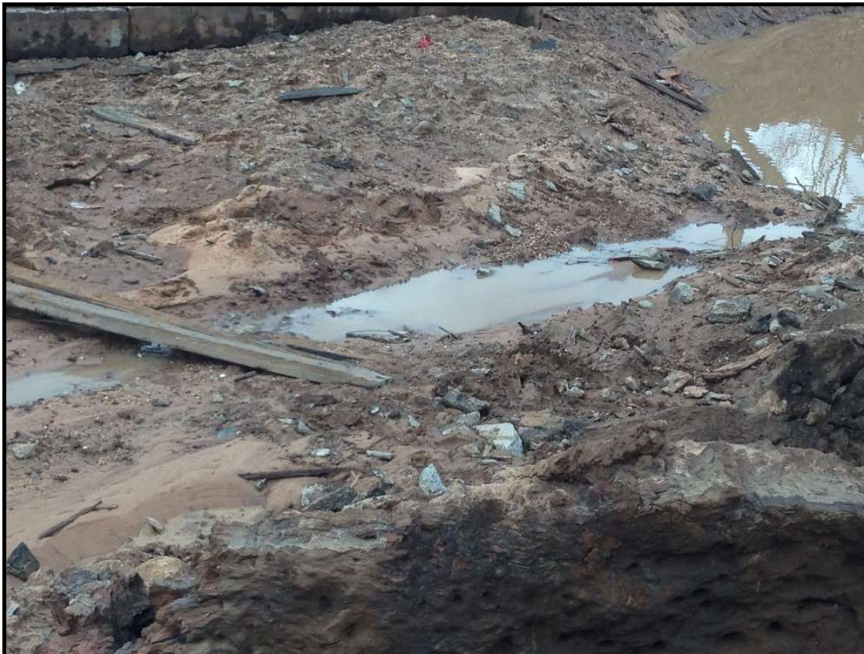
The creek bed was dry at the time of the incident. The surface of the creek bed was sandy. Surface sand is shown in Picture 23 in the creek bed adjacent to the crater. Underneath the sand was clay as seen in Pictures 7 and 8 for the crater. It is also normal to expect significant amounts of dry and decaying vegetation from the trees, branches, twigs, leaves, grasses etc in the creek bed in addition to any other unknown significant features. We also know that reactive clay soils when dry can be porous due to cracks from the dry conditions. This is a hot and dry area.

Picture 22 – Sandy creek bed adjacent to crater
