Emulsion Truck Fire Incident

SAFEX Webinar - October 2022

Ammonium Nitrate
Emulsion Bulk Trailer Fire
Wowan – Lecharadt Highway
Queensland
12/03/2018

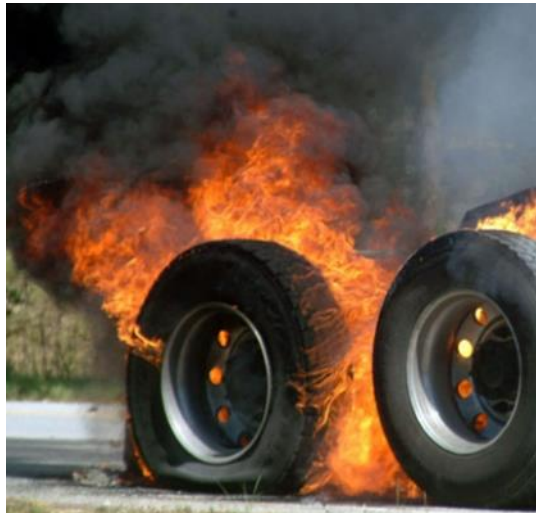
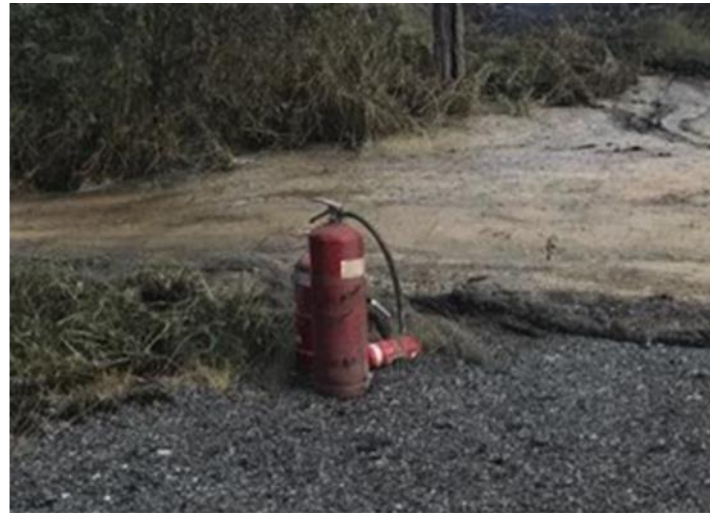
- At approx. 12:30pm AECI Australia received notification from Crawford’s Freightliners that a B-Double Truck & Trailer transporting AECI S100 Ammonium Nitrate Emulsion from AECI Bajool to Mt Owen mine in New South Wales (NSW) had sustained a fire on the rear axle and tyres of the “B” trailer (rear trailer) 5km South of Wowan on the Leichardt Highway.
- The driver attempted to extinguish the fire using 8 x 9kg Dry Chemical Powder extinguishers (additional vehicle stopped to assist), however he could not extinguish the fire.
- The driver then followed the transport company’s Transport Emergency Response Plan (TERP) and was able to disconnect the trailer that sustained the fire and drove the prime mover and lead trailer to a safe distance (2km) without injury or damage.

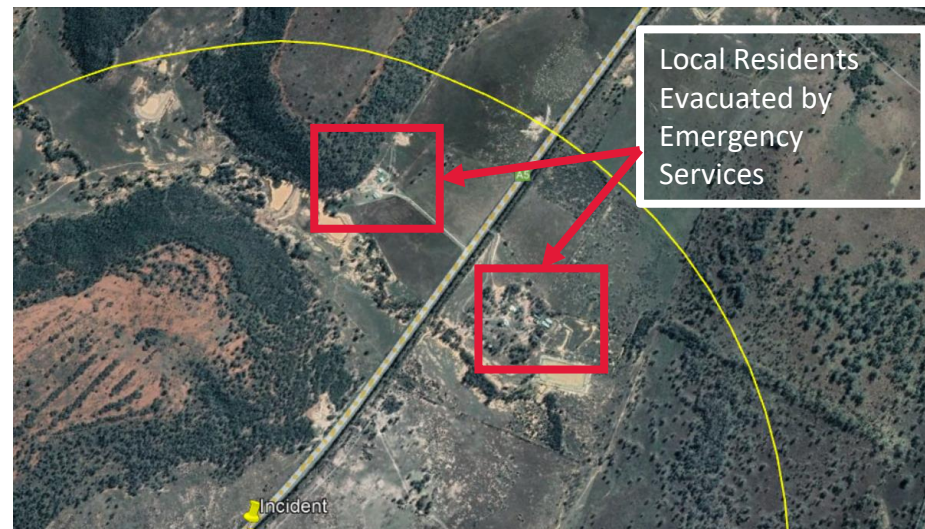
- QLD Fire & Emergency Services and police attended the scene and established a 2km exclusion zone, closing the Leichardt Highway in both directions. This was maintained until the fire had self extinguished. Local residents within the exclusion zone were evacuated.
- A number of grass fires were initiated by the fire and were brought under control by both Queensland Fire and Emergency Services & local rural firefighters.
- The rear trailer continued to burn for an extended period and sustained significant structural damage and loss of containment, spilling approx. 22 tons of S100 Ammonium Nitrate Emulsion to ground. The emulsion was largely contained in road runoff areas.

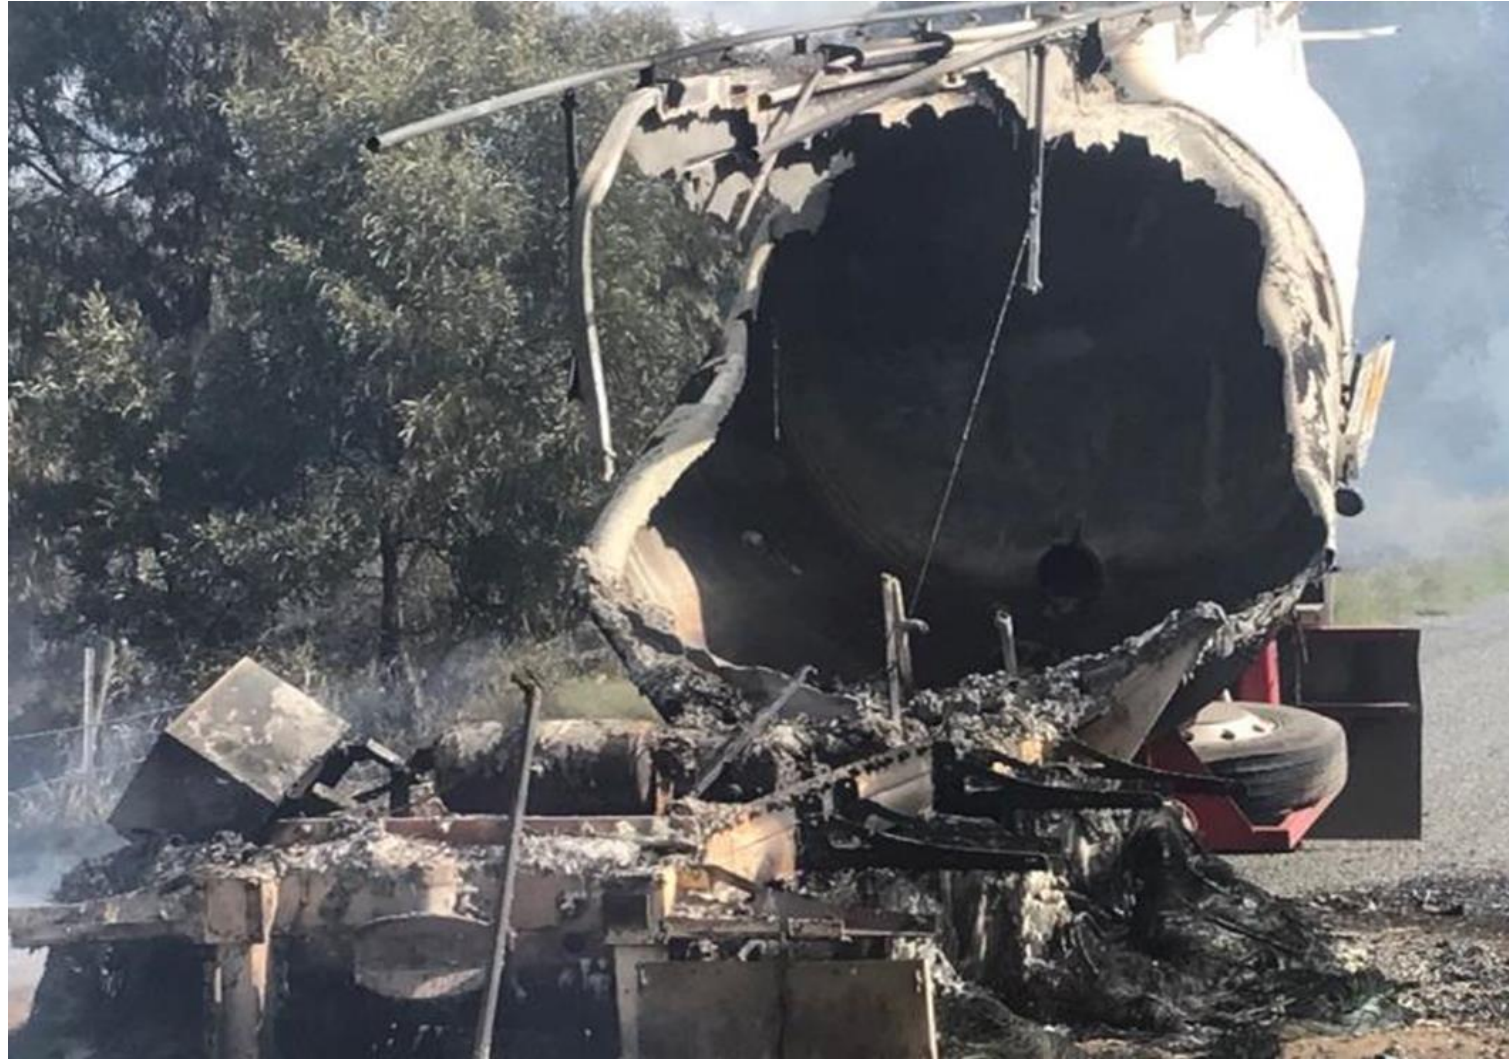
Remains of the trailer

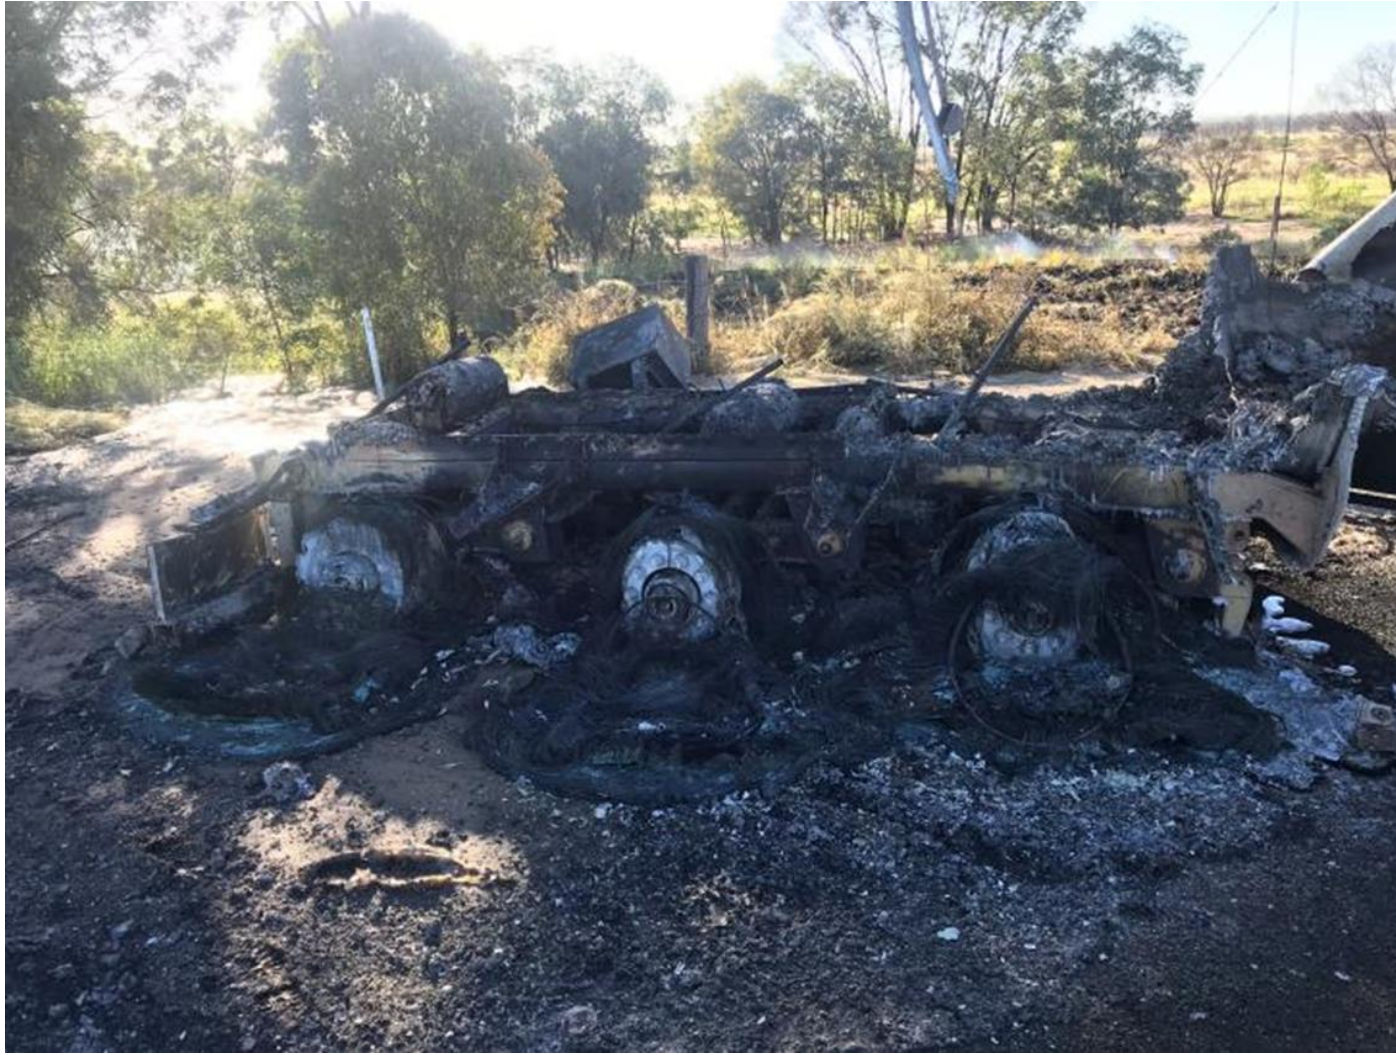
Remains of the trailer

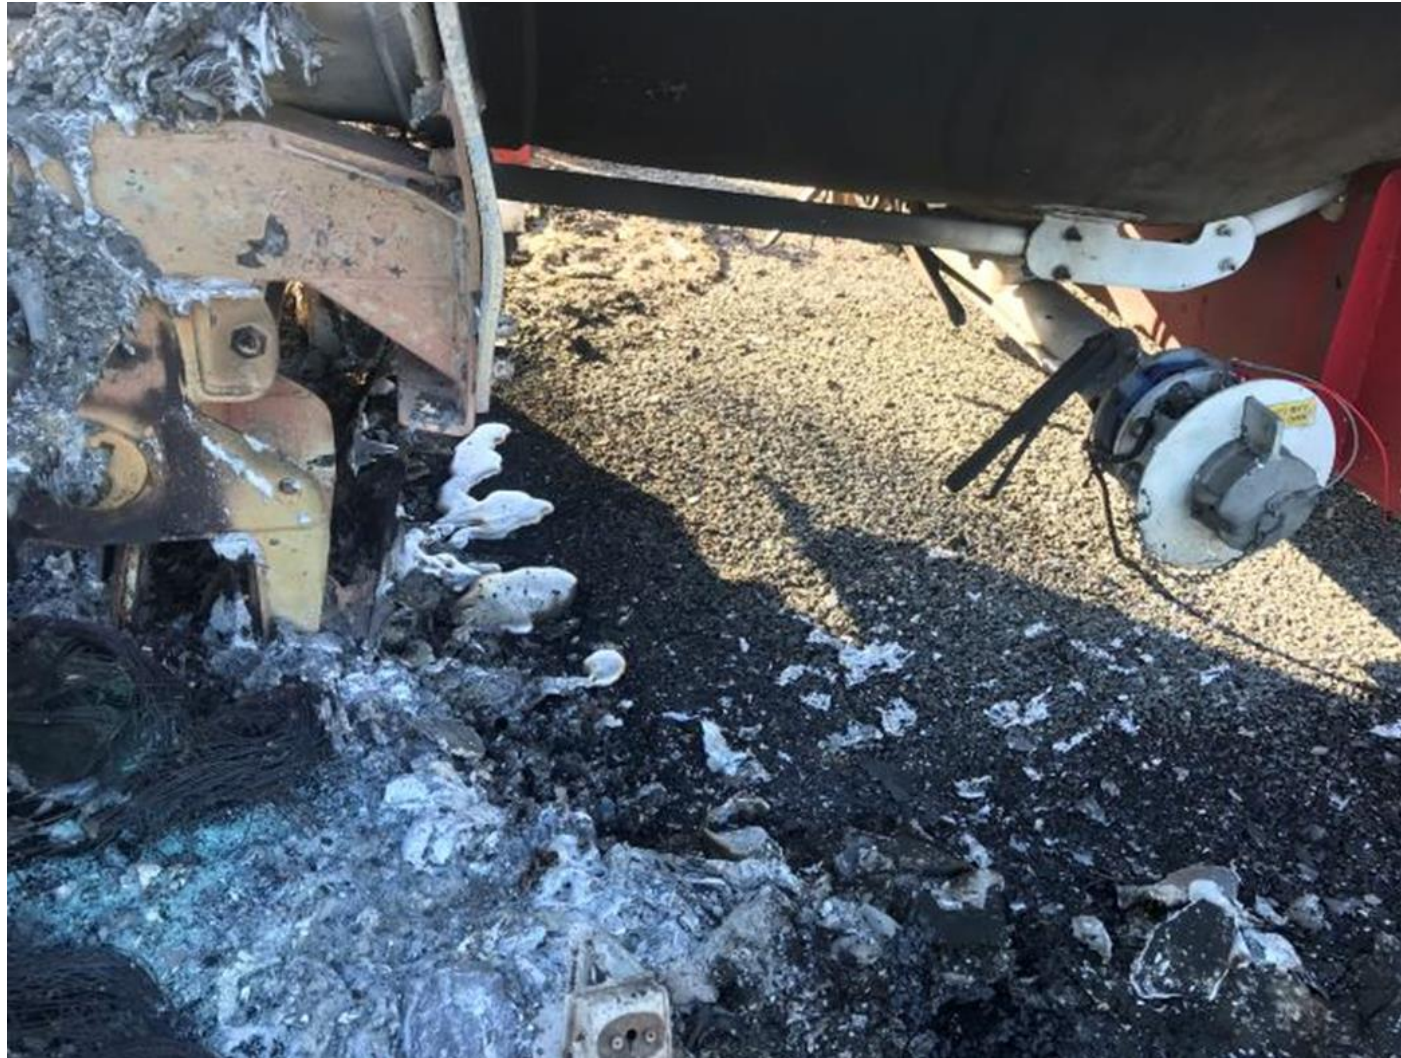
Note the molten aluminium from the load bin

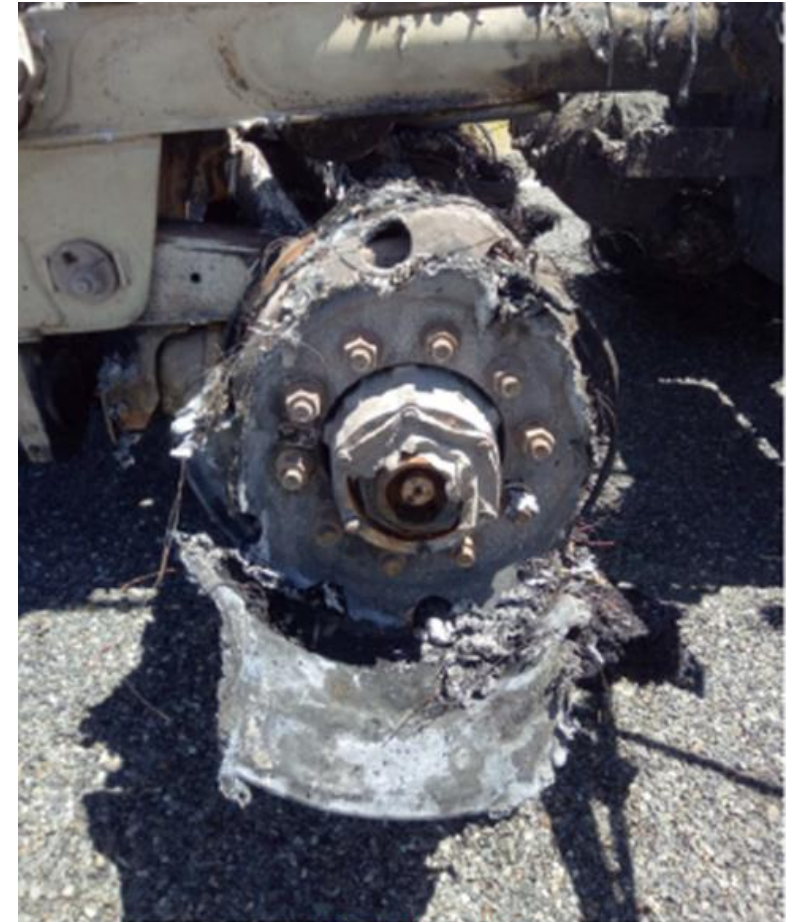
350QU Passenger Side Front Axle

- A review of the service history of the trailer determines that the wheel bearings were not replaced during the life of the trailer. The manufacturer guarantees the use of the bearing for 1,000,000km. The manufacturer does not make any recommendations for the interval to replace the bearing. The Contracted Transporters Maintenance System also does not make any recommendations for the replacement of the bearing based on distance usage. It was found that the trailer travelled a total of approximately 1,042,149km, prior to the mechanical failure.

- It was determined that the trailer travelled a total of approximately 48,226km since the last bearing service where the hub was opened, bearings physically inspected, adjusted and greased. This occurred on the 28/11/17 which is outside the Contracted Transporters Maintenance Schedule.

- The fire was most likely caused by excessive friction due to the mechanical failure of a main bearing within the second triaxle group on the trailer.
- Although it was difficult to clearly identify the failure mechanism after the prolonged exposure to fire, a detailed inspection of the second axle found this area as the most likely point of initial failure.
- The initial ignition of the adjacent tyre material was most likely due to the intense direct heat generated from mechanical failure of the bearing, and ejected hot fragments,
