SAFEX Webinar #4: Transportation of Explosives

19 October 2022: Session 2

AN TRANSPORT INVESTIGATION BY DEPT OF NATURAL RESOURCES AND MINES QLD

NOËL HSU

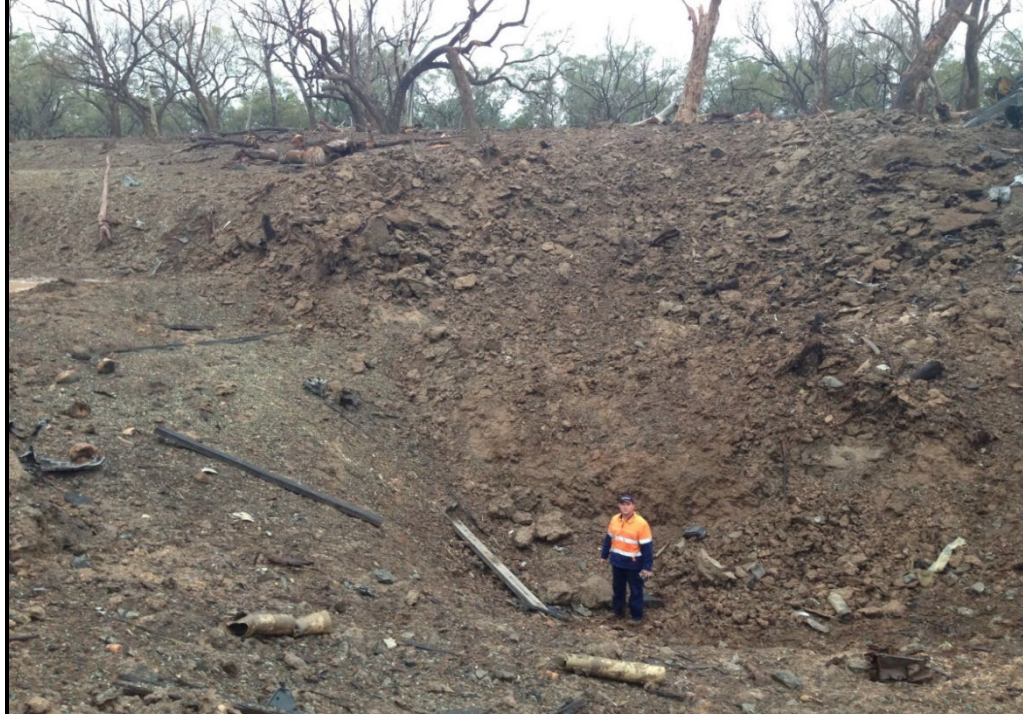
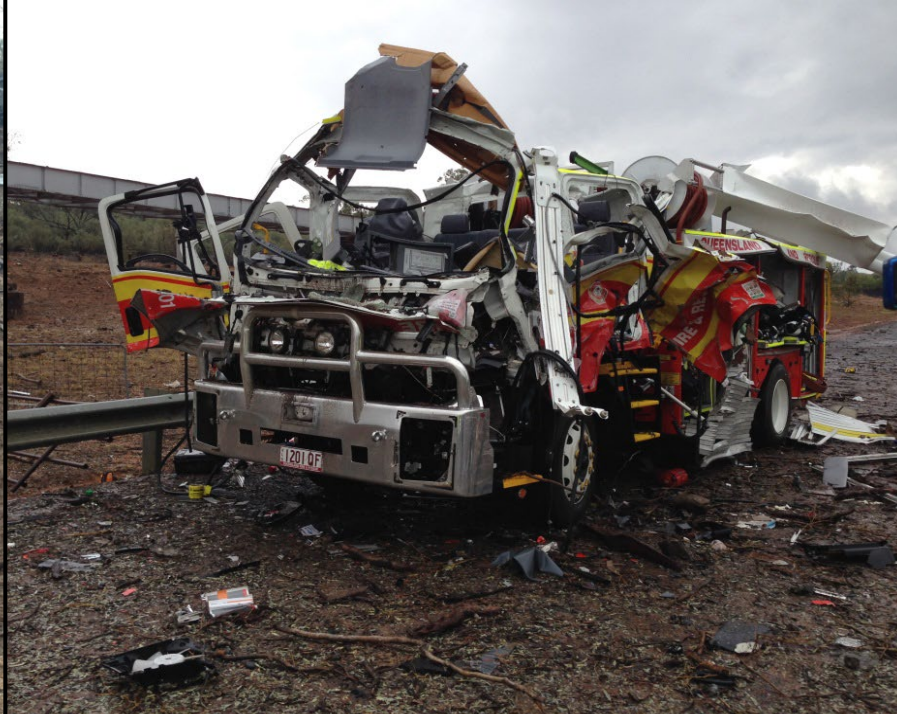
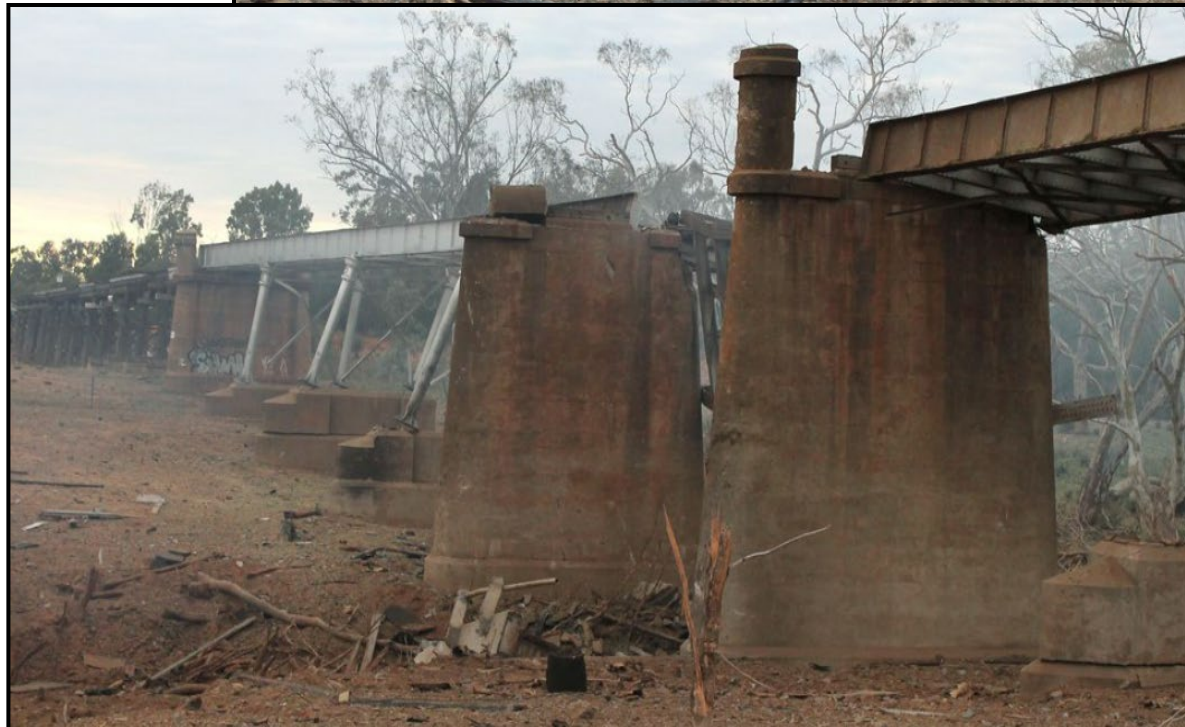
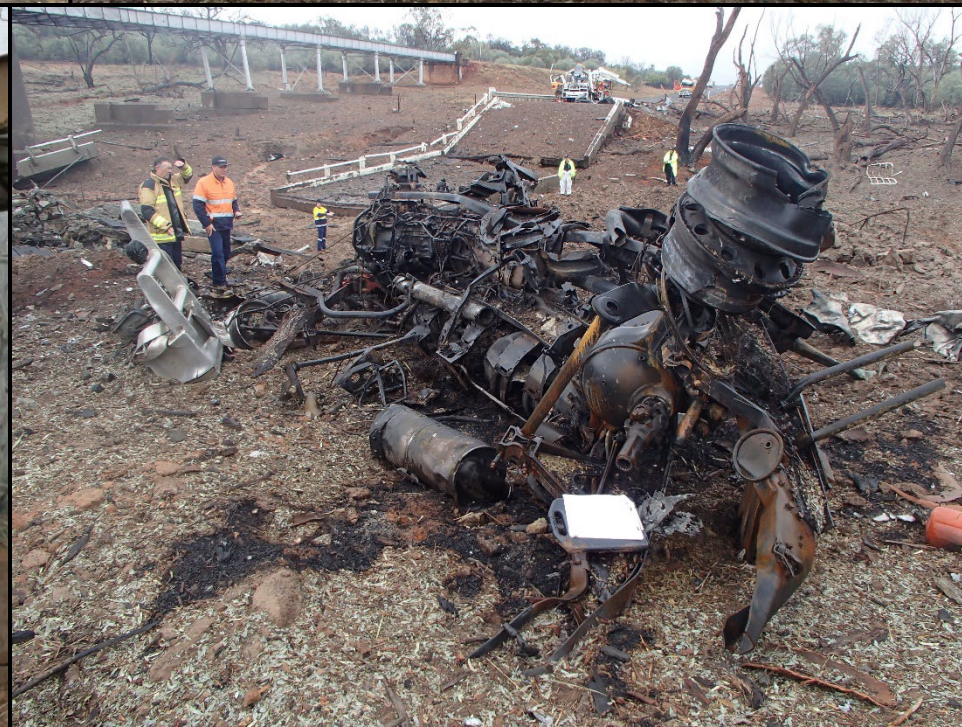
- Exact time fire started unknown; likely result of crash
- No phone signal at site; 30 minutes to contact emergency services
- Fire burned for about 1 hour 20 minutes
- Two explosions about 1-2 minutes apart
- Explosion measured 2.1 on Richter Scale at the site
- Estimated to be equivalent to 10 to 15 t TNT
- Blast injuries to eight people, some serious
- Driver 35% burns, crash and blast injuries

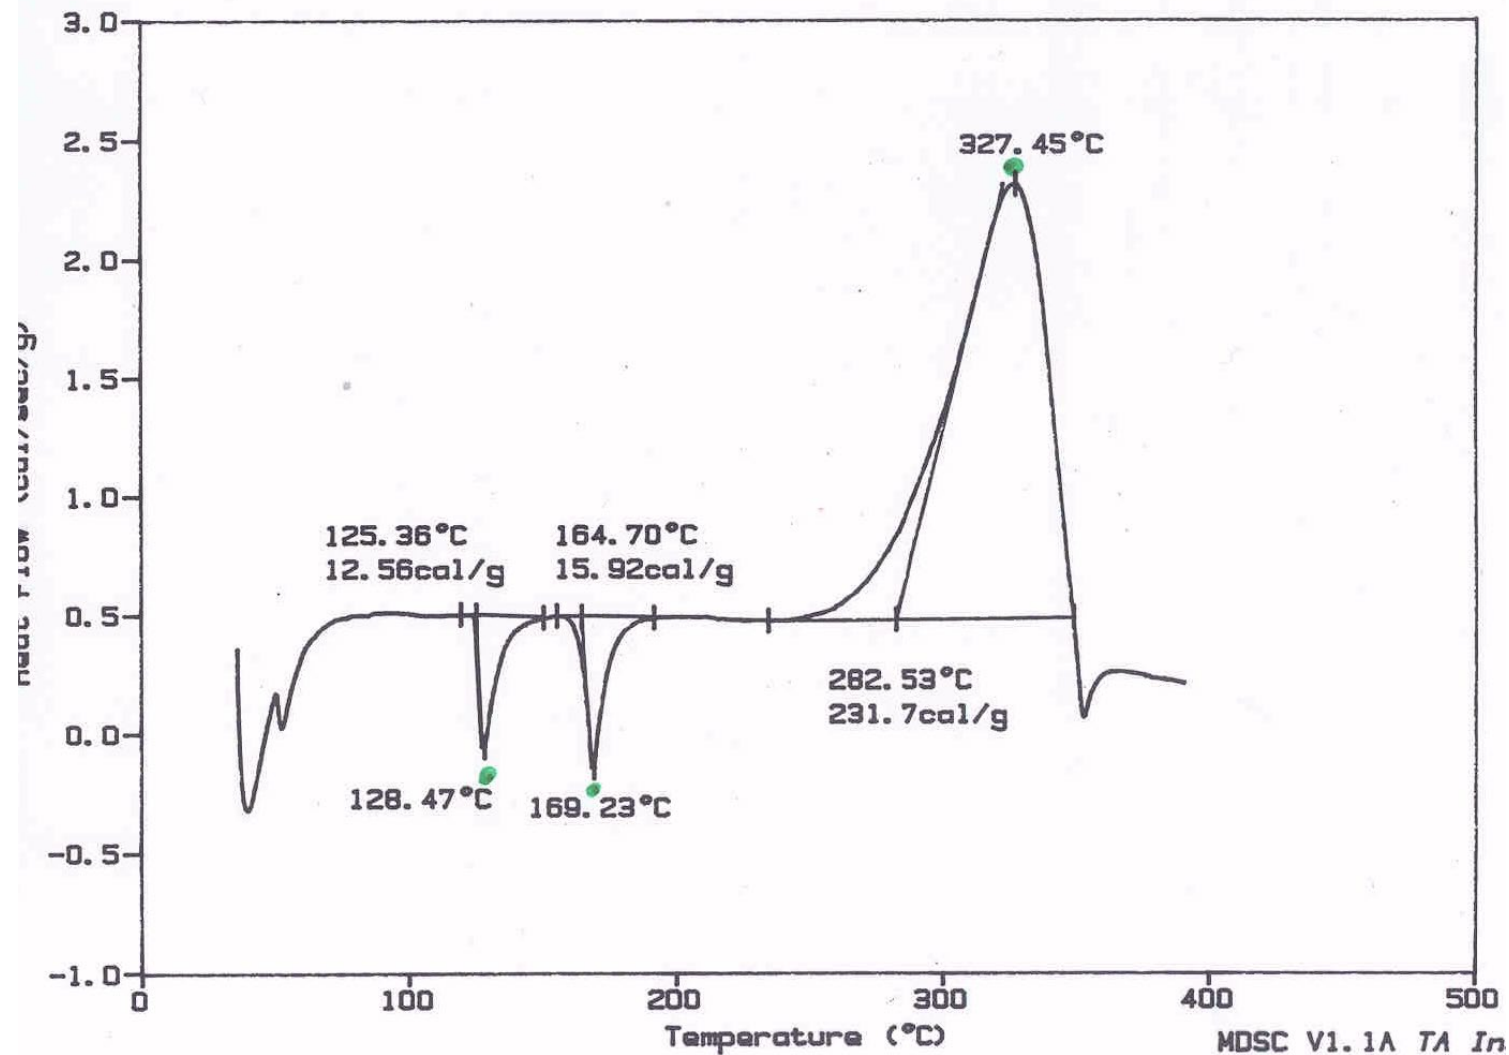
Thermogram of Ammonium Nitrate

Sample: NEAT AN 20C/MIN
Size: 0.2360 mg
Method: AN

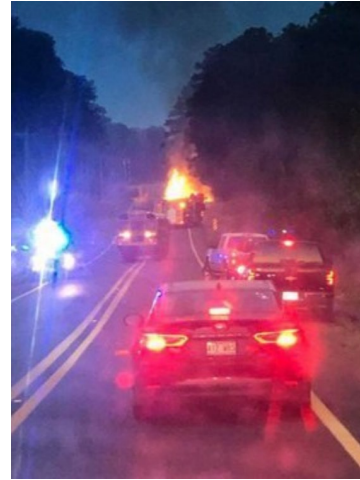
Camden, Arkansas, March 27, 2019

Fire initiated in tire (from faulty brake).
Call made to emergency services at
~06:40. They were told what the truck
was carrying.

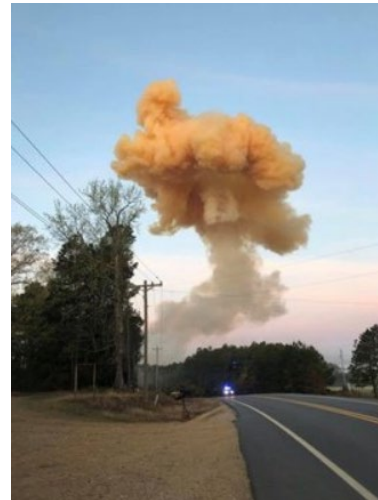
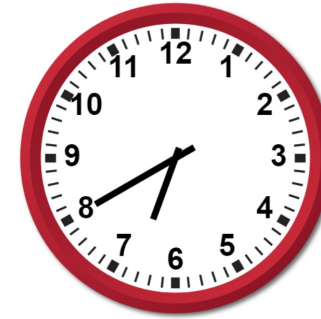
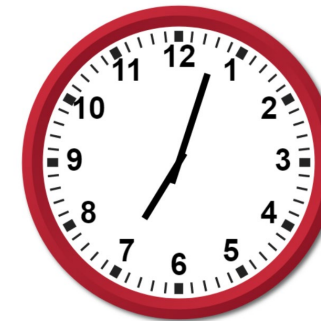
Mass explosion at 07:03 (from
seismograph)

... As the building became more involved [in the fire] the roof collapsed and an explosion occurred.
