Central Control Room Explosion in a Gas Treatment Plant

“A freak Accident”

Ruurd Abma, Chief Operating Officer of Rakgas

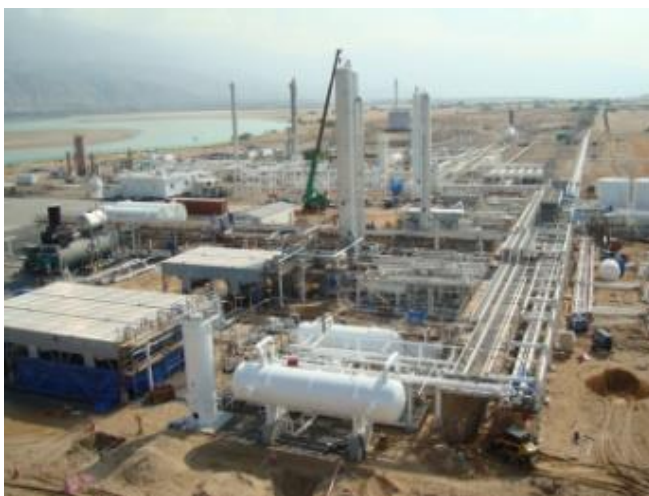
Figure1: Installation of the new processing train

In 2006 a new gas contract was negotiated, requiring a substantial expansion of the current plant. A new (second) processing train was installed over 2007/8 and was being commissioned in the month of July.

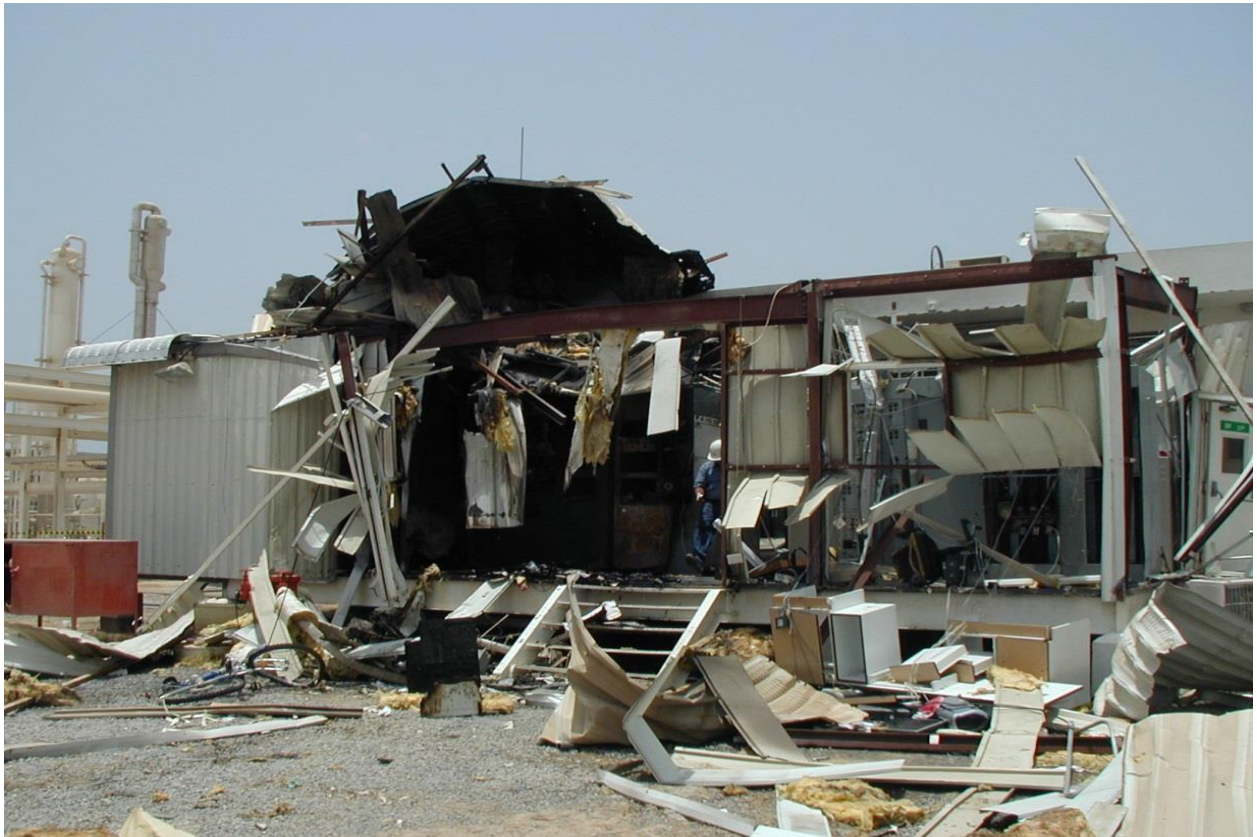
Figure 2: The Central Control Room annex Motor Control Center after the explosion.

On Wednesday July 16th 2008 around 18:00 hours, RAKGAS's Plant Control Room, consisting of the Central Control Room (CCR) and Motor Control Room (MCC), exploded from within. The roof and side walls were blown off. The entire control room and control panels were destroyed thereby disabling the 2 main processing trains and various utility systems. All of a sudden the plant could not be controlled anymore. This could be compared with "a body without brains"

The result was an explosion and a fire.

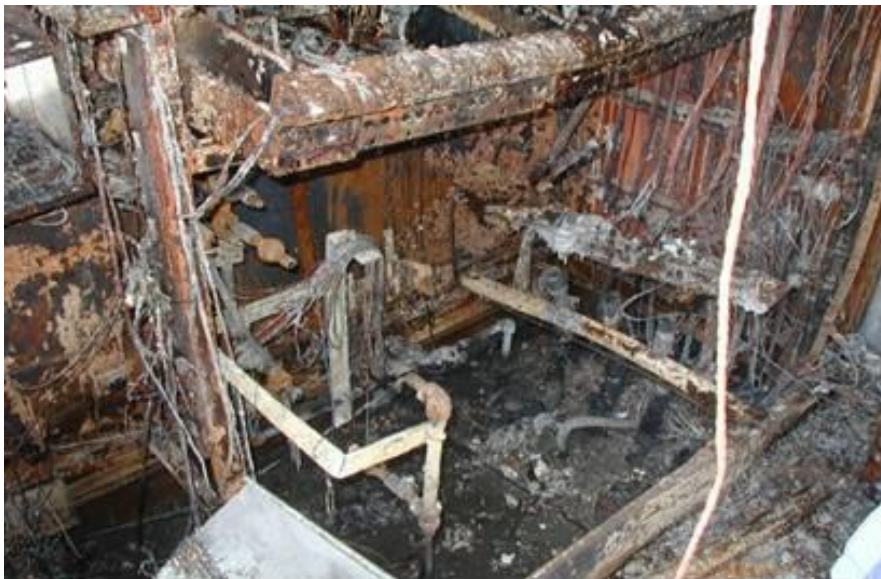
Figure 3: The pneumatic system with regulator after the explosion.

The only system, which could feed such fire, was the pneumatic regulator. Most instrumentation was pneumatically based and the regulator was installed in the CCR annex MCC. Air samples were taken from the air storage vessels and indeed (2 days later) traces of hydrocarbons were found in the samples. How could this have happened?

- A new "real" control room and office block was built outside the premises of the plant with only fiber optic cables and computers, i.e. no pneumatic system nor any electric panels
