Initiating Systems Automated Plant Pyrotechnic Fire

A plant operator was burnt in a pyrotechnic fire in the auto sieving compartment S4-1 at 23h48 on the 6th December 2011. He sustained burns to his left ear, top of his head and both knees.

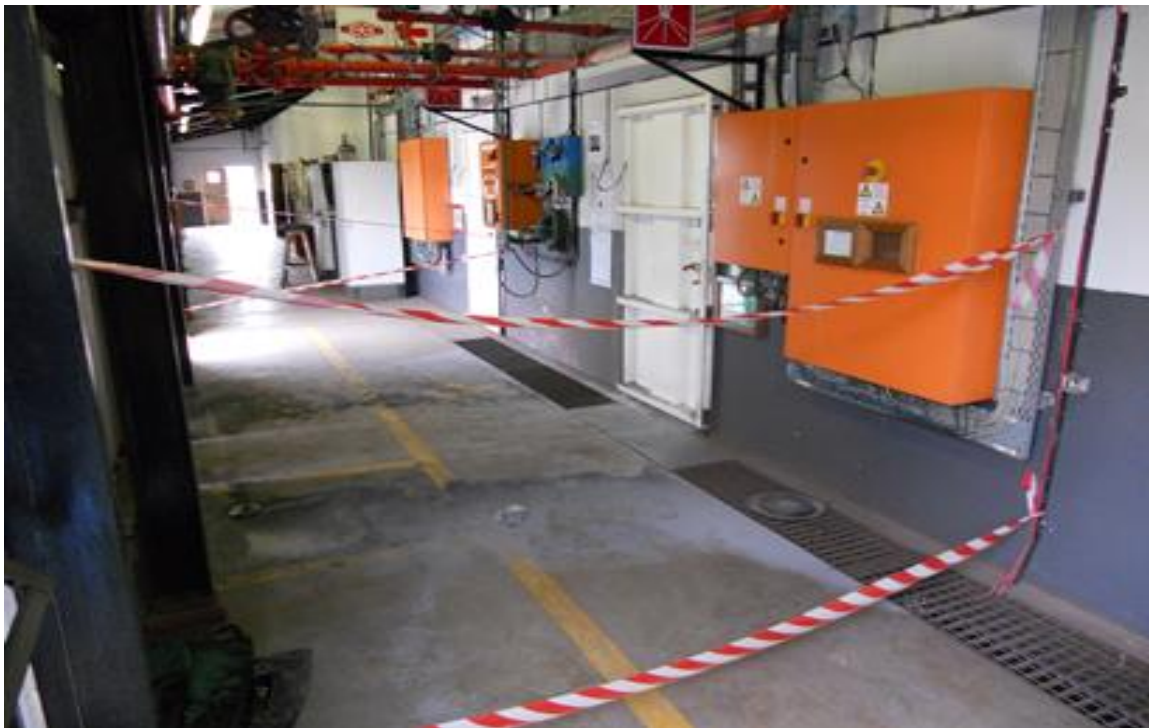
Picture – Cordoned off Area where the Incident Occurred

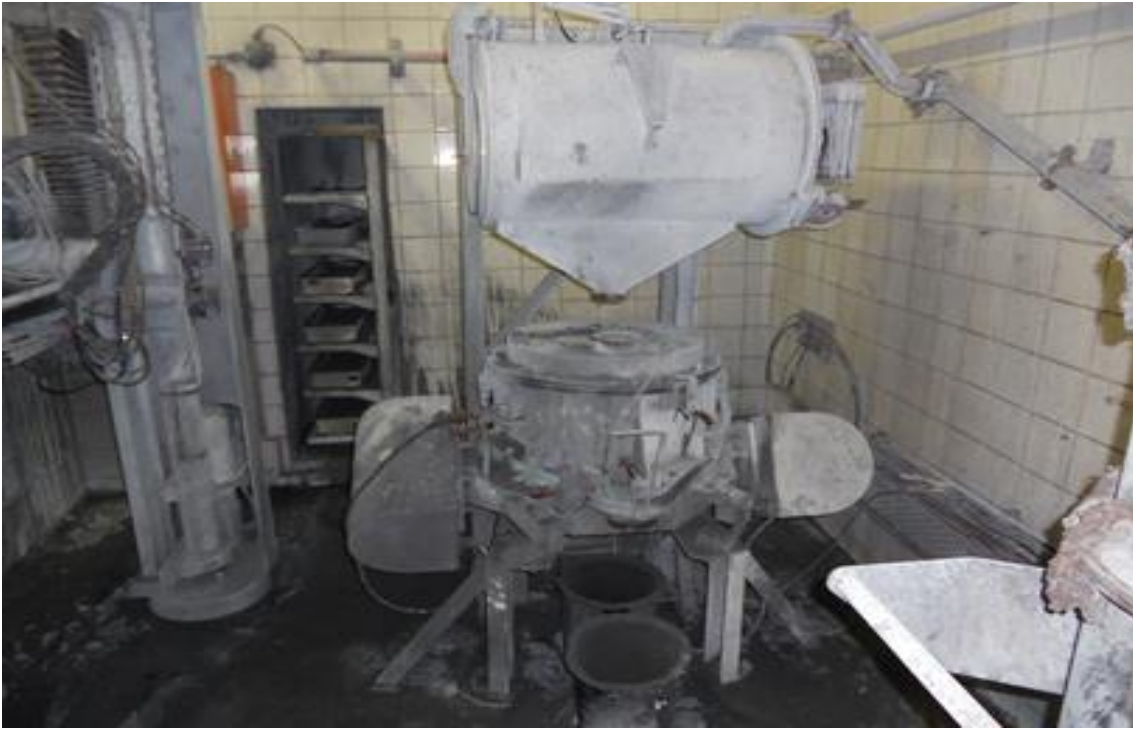
Picture of the damage and equipment.

Damage was caused to equipment where air lines, sensors, cables, buckets, socks and protective bellows were burnt. The compartment was blackened from the fire. The repairs to equipment and re-painting of the compartment eventually took four days. The incident had no effect on any adjacent equipment or operations, other than to stop their operation during the repair period.

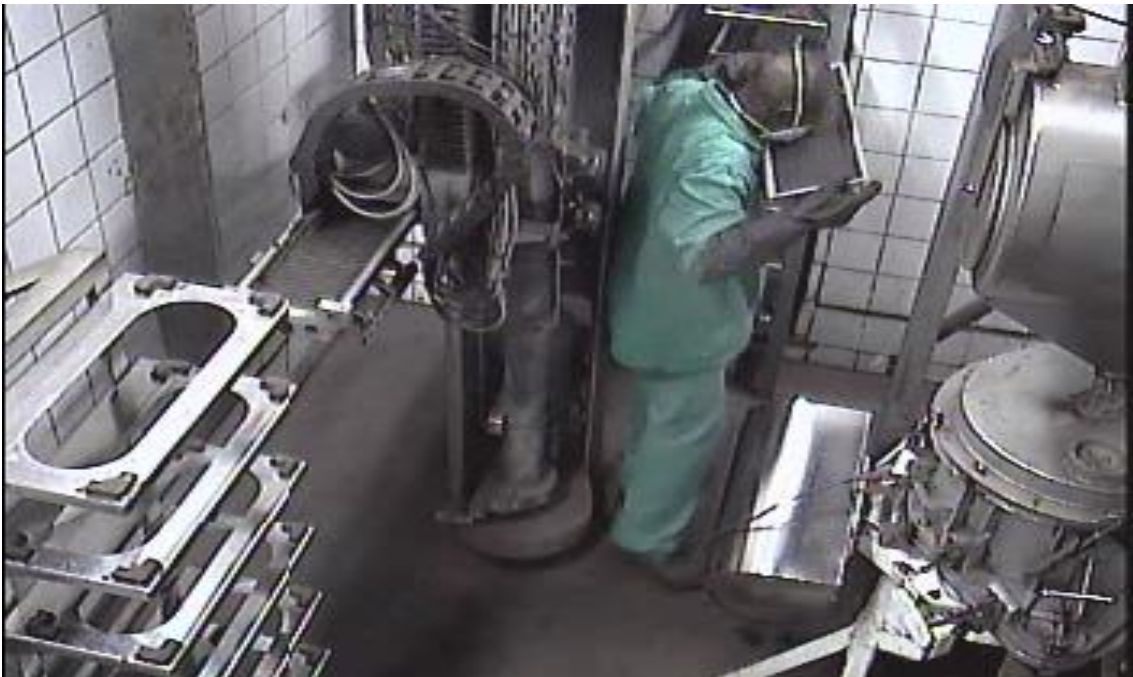
Employee entered compartment at 23:47:43 and removed the top tray from the loading rack.

As can be seen, Employee gave the tray a sniff presumably to detect amyl acetate fumes. Subsequently he must have decided that the tray was wet as he left the compartment and only returned at 23:47:57, a full 15 seconds later with what we believe was a tray presumably drier pyrotechnic powder which he has exchanged from the trolley parked outside the cubicle door.

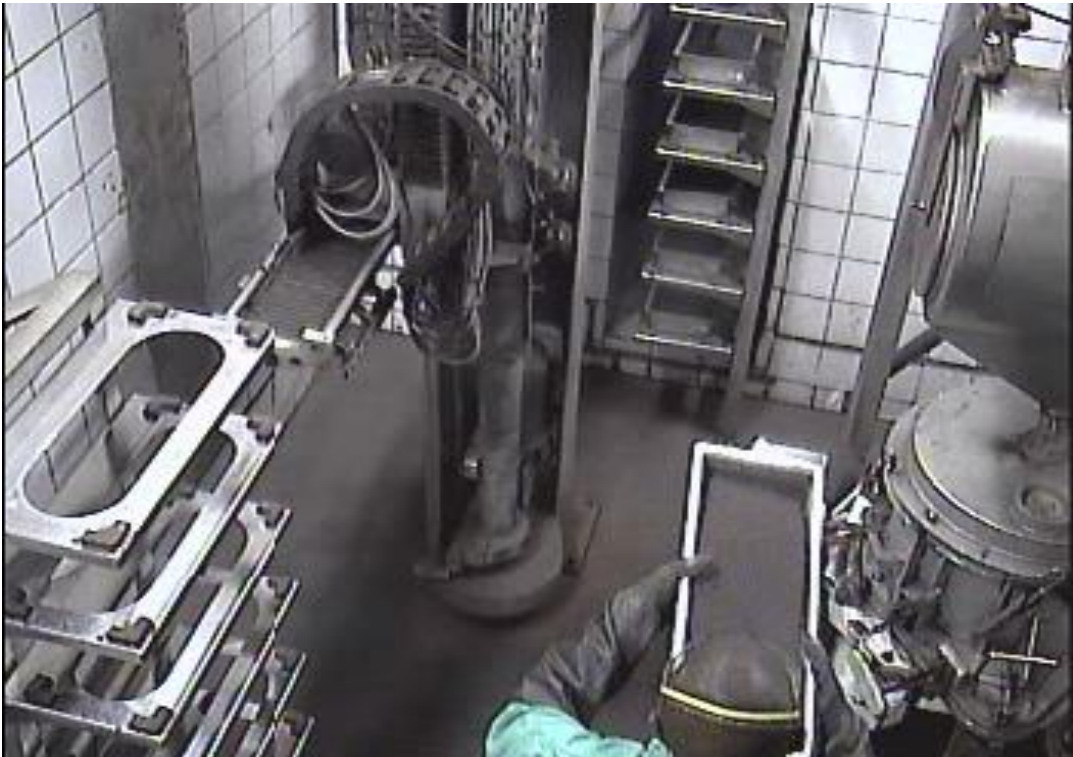
Employee approached the auto tipper at 23:47:57 with tray of dry G composition.

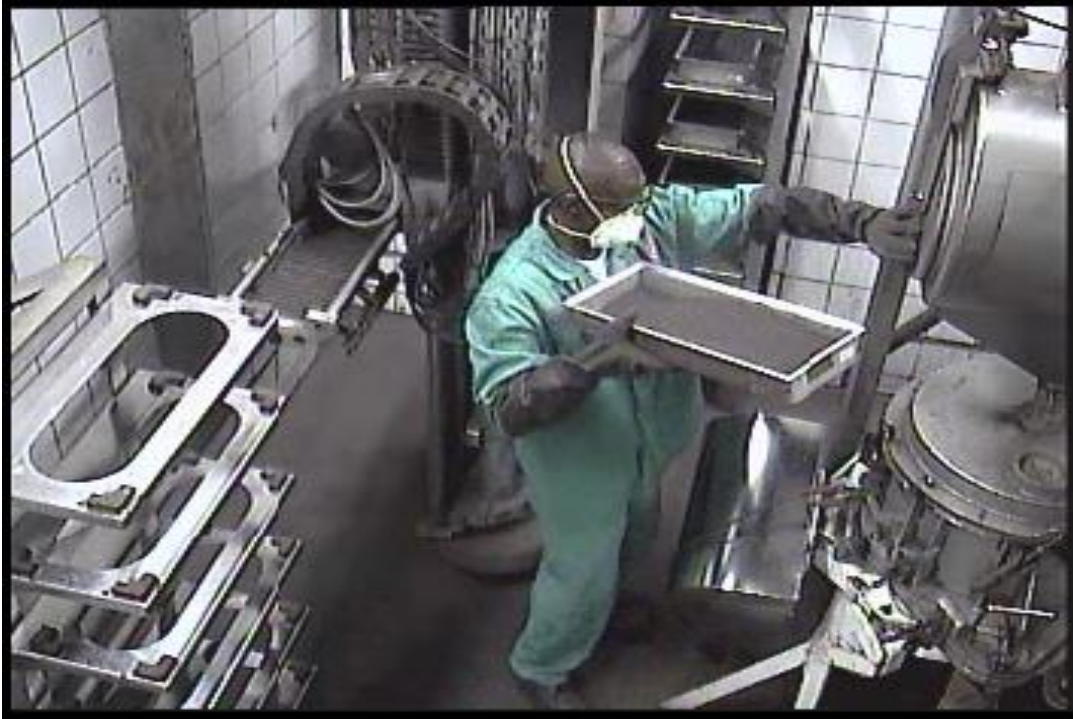
Employee grabbed auto tipper hatch to open it. Tray was held precariously in right hand only.

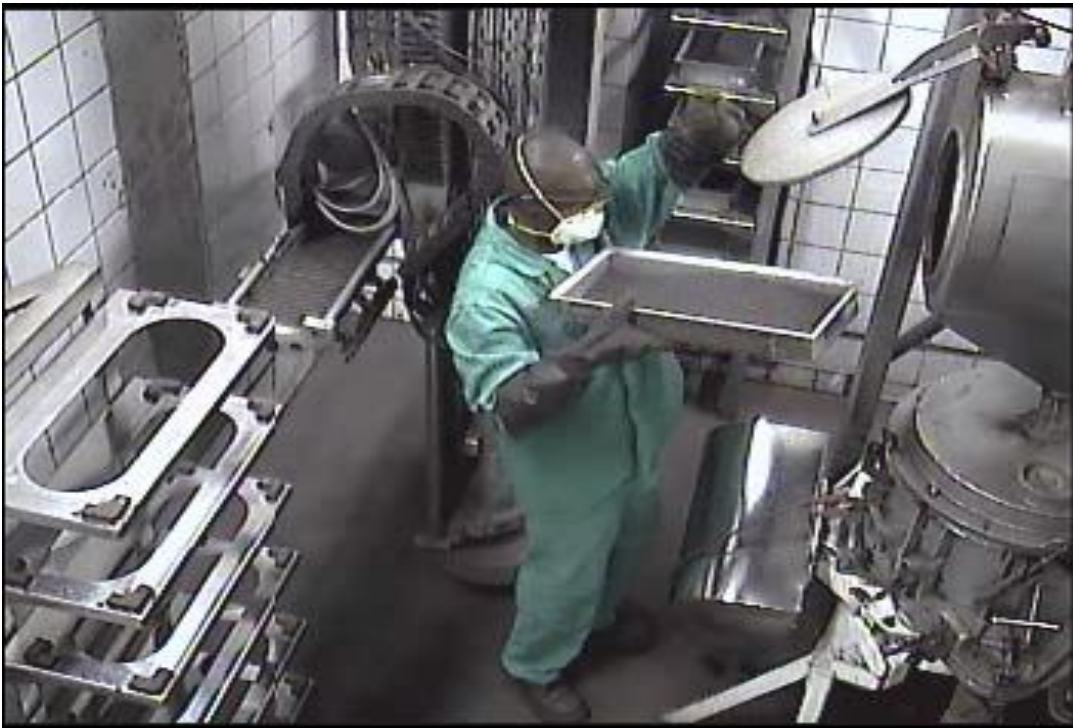
Employee tried to insert tray of G composition into auto tipper but lost his grip on the tipper hatch which began to fall under gravity.

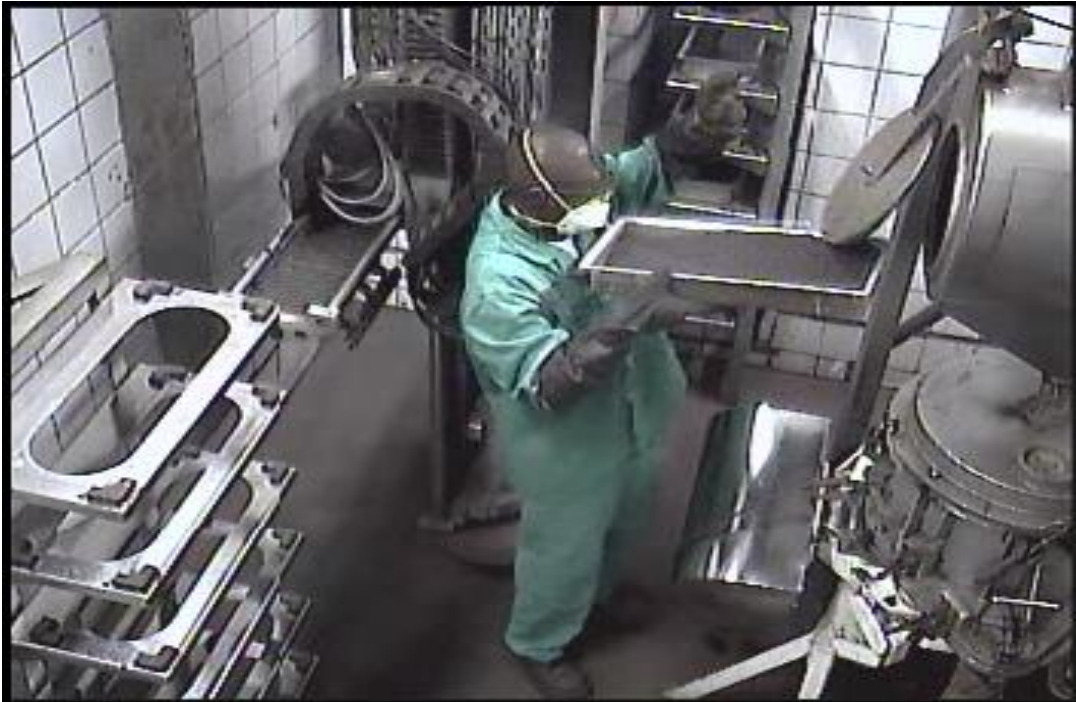
The falling hatch struck the side of the tray of G composition and the employee lost his grip on the tray

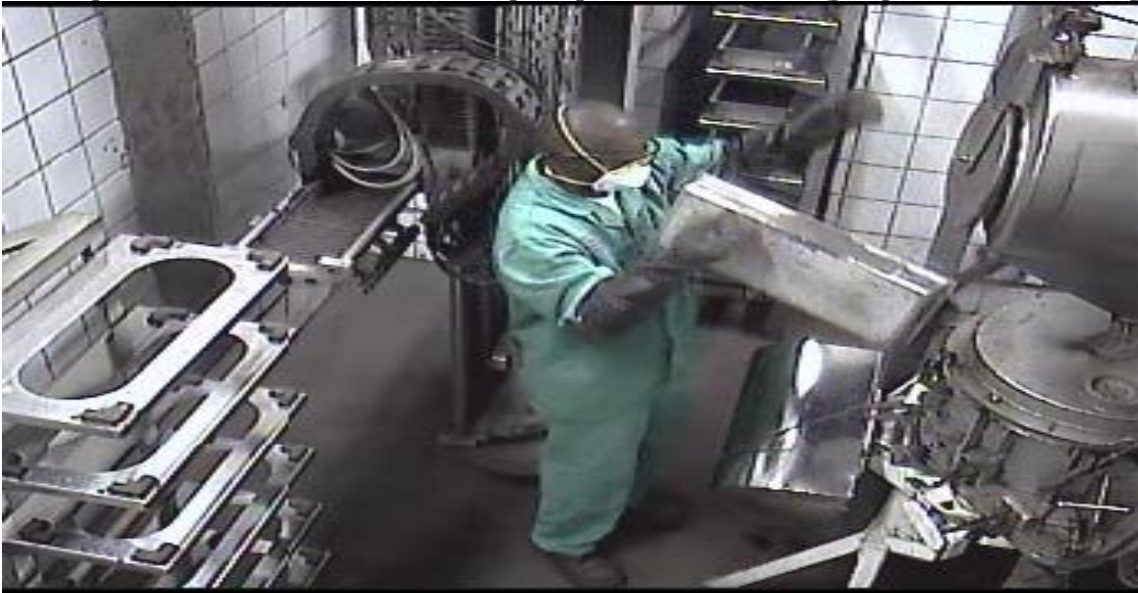
The Tray of G composition began to fall whilst the employee tried to move his left hand down to catch it.

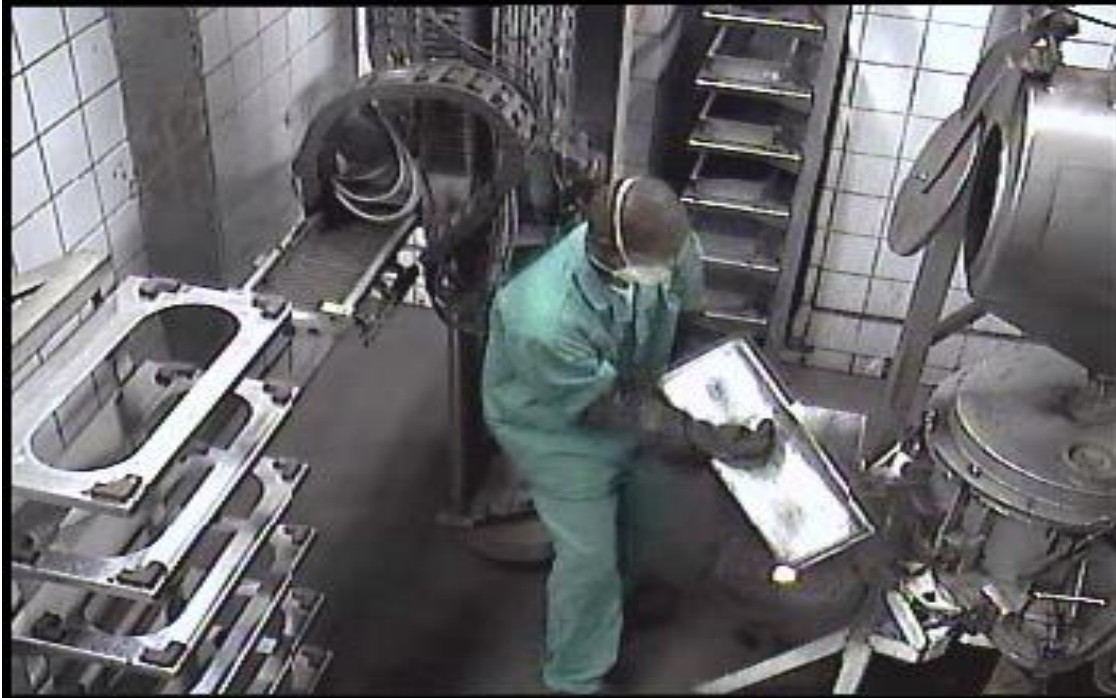
The employee was unable to catch the tray which struck the side of the Auto sieving machine and initiated the G Composition at the point of impact.

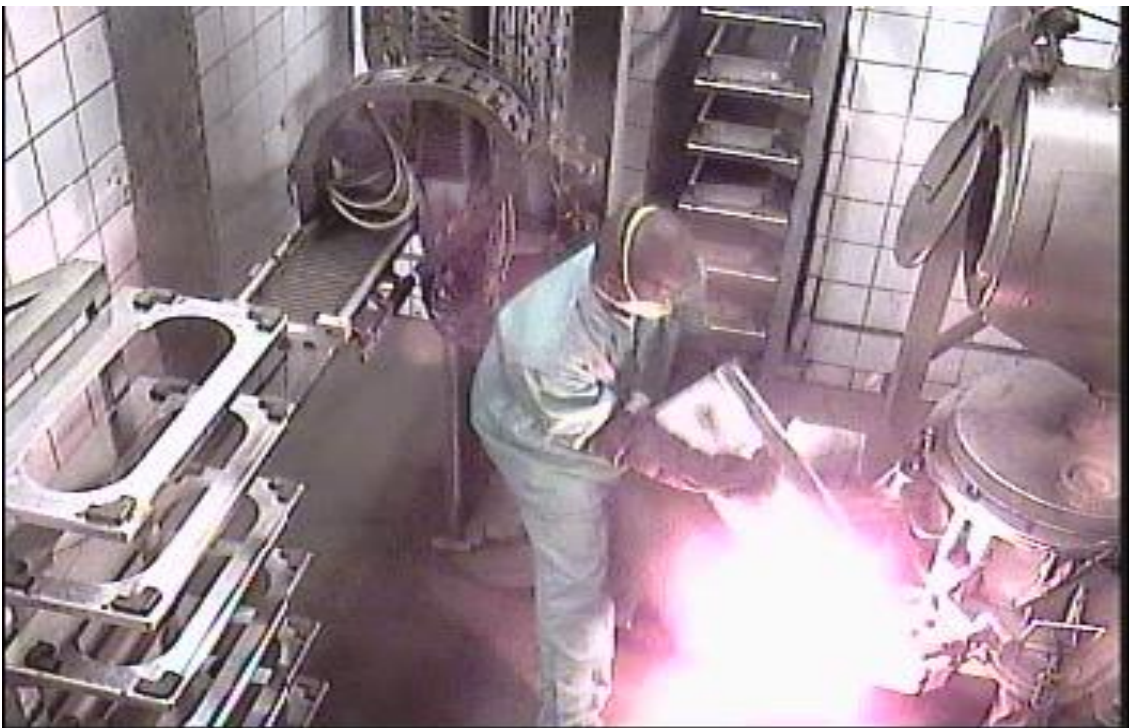
The G Composition initiation spread.

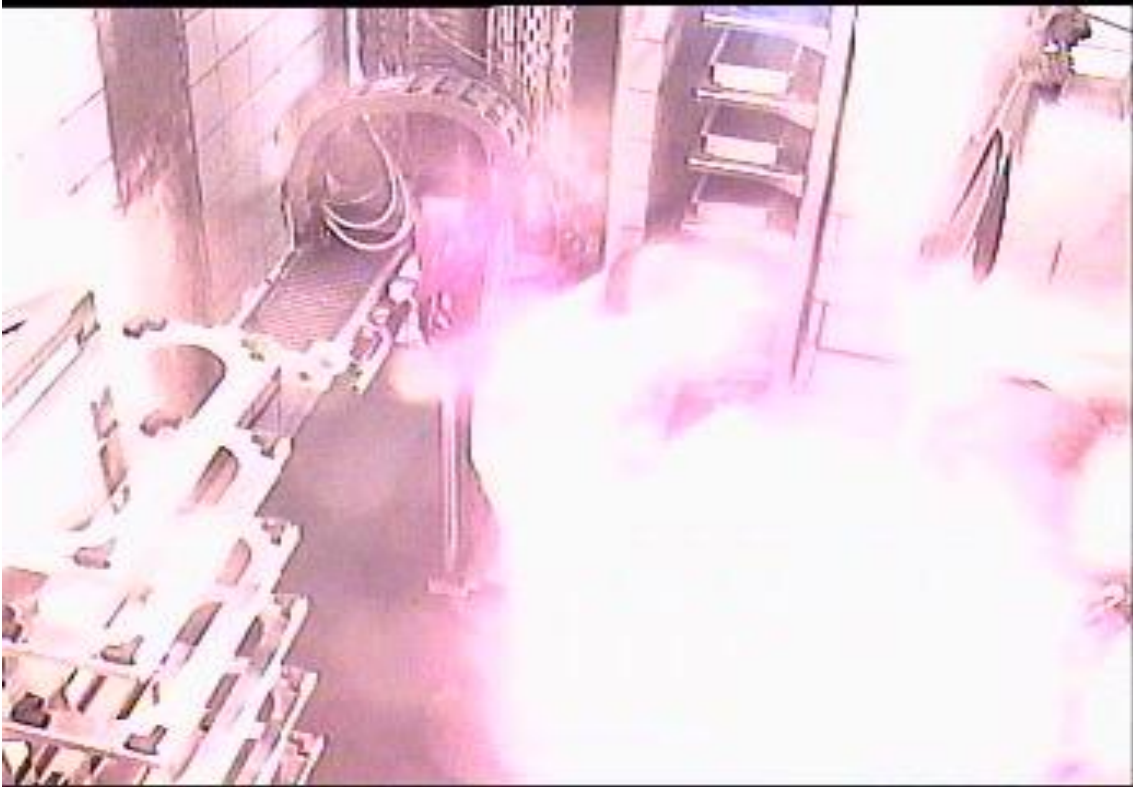
Even further spread and employee engulfed in flame **After the Fire**

The fire drenching system activated within 12ms after detecting the flash of the fire. This system sprayed water across the inside of the doorway and on either side of the outside of the doorway in the corridor outside the compartment. It also flooded the compartment with water which drained off in the effluent channel provided. The

drenching system effectively prevented the fire from spreading to an open trolley containing 6 trays of dry powder parked in the corridor almost directly opposite the door to the compartment.

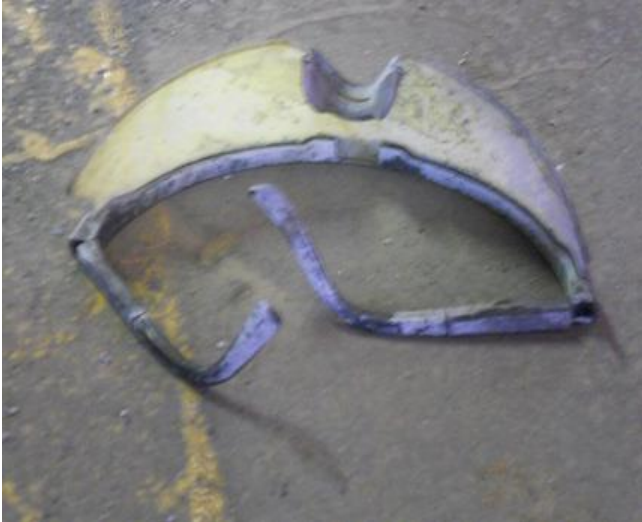
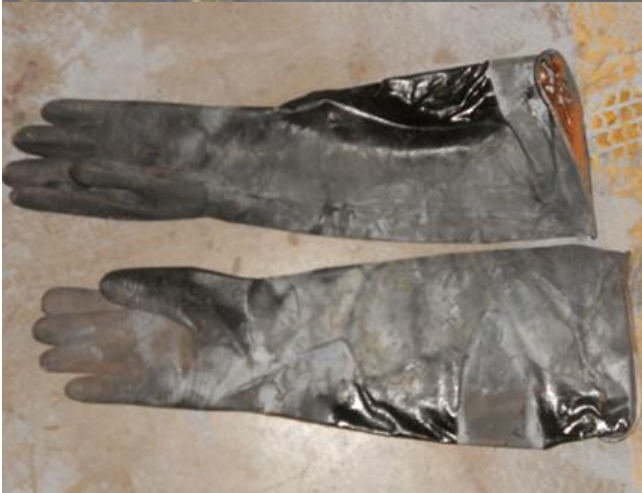
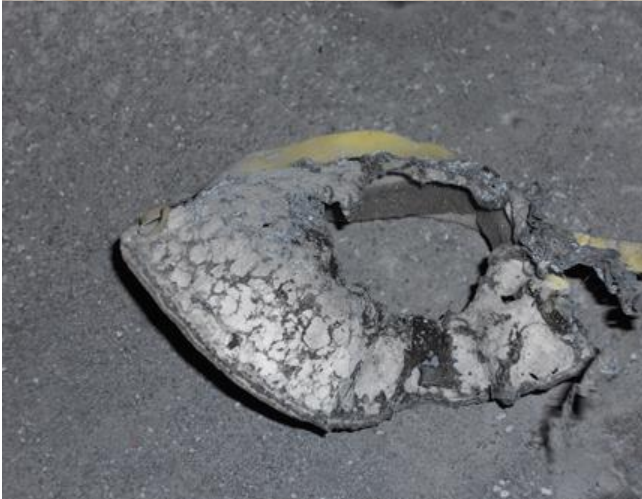
At the same time the Plant Manager was informed. He arrived at the plant within 12minutes. The Plant Manager removed the employee's fire retardant jacket and trousers and collected his rubber gloves, dust mask and safety glasses and placed them at the entrance to the sieving compartment of future examination by the investigating team. The employee was also wearing Company issued cotton long john underwear and it is assumed that this may well have prevented worse burns to his legs.

Pictures – safety glasses, gloves and dust mask.

Definitions:	Nature of Task	PPE Required
	Normal	2 Piece flame retardant overall, safety glasses long rubber gloves, dust mask & conductive shoes
	Hazardous tasks - Abnormal	Two piece Kevlar Suit- with long john trousers, Face Shield, long rubber gloves, dust mask & conductive shoes
	Supervision	Navy blue dust coat, safety glasses, dust mask & conductive shoes
