Contractor management and employee awareness in transportation of explosives and hazardous raw materials

- SAFEX Open Day -

**XVIII SAFEX Congress
Warsaw, May 21st – 24th**

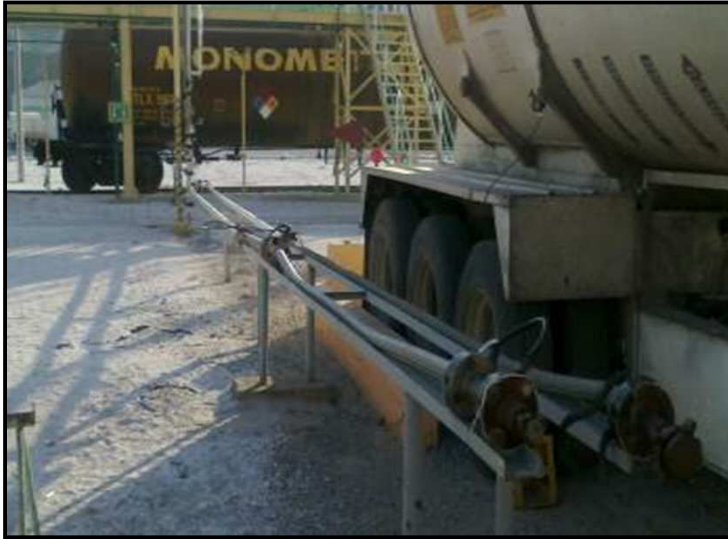
Picture 1: MMA unloading area with tanks and unconnected discharge hoses

- Liquid MMA is unloaded from tank trailers and transferred into storage tanks. MMA is highly flammable and toxic.
- The operator detected a leak after the interrupted process (due to high level in the storage tanks) had been restarted.
- The tank trailer (third party ownership) had been on repair prior to that delivery of MMA.
- The joint of an internal stabilizer bar had to be rewelded.
- The tank had been properly prepared for welding, but not sufficiently cleaned afterwards.
- Slag particles remained inside close to the outlet and contaminated the connection/coupling valve.
- The gasket sprung a leak.
- The operator did not strictly follow the operating instruction that required the transfer hose to be disconnected when unloading was stopped.

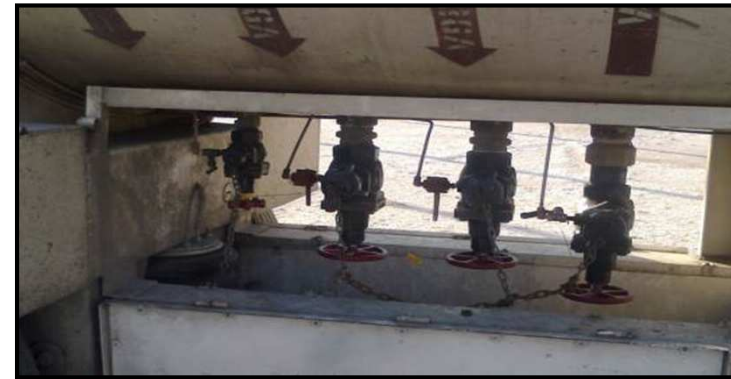
Picture 2: Tank trailer discharge valves (one for each chamber)

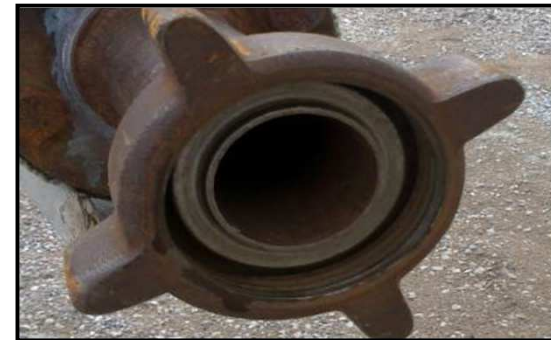
Picture 3: Hose coupling

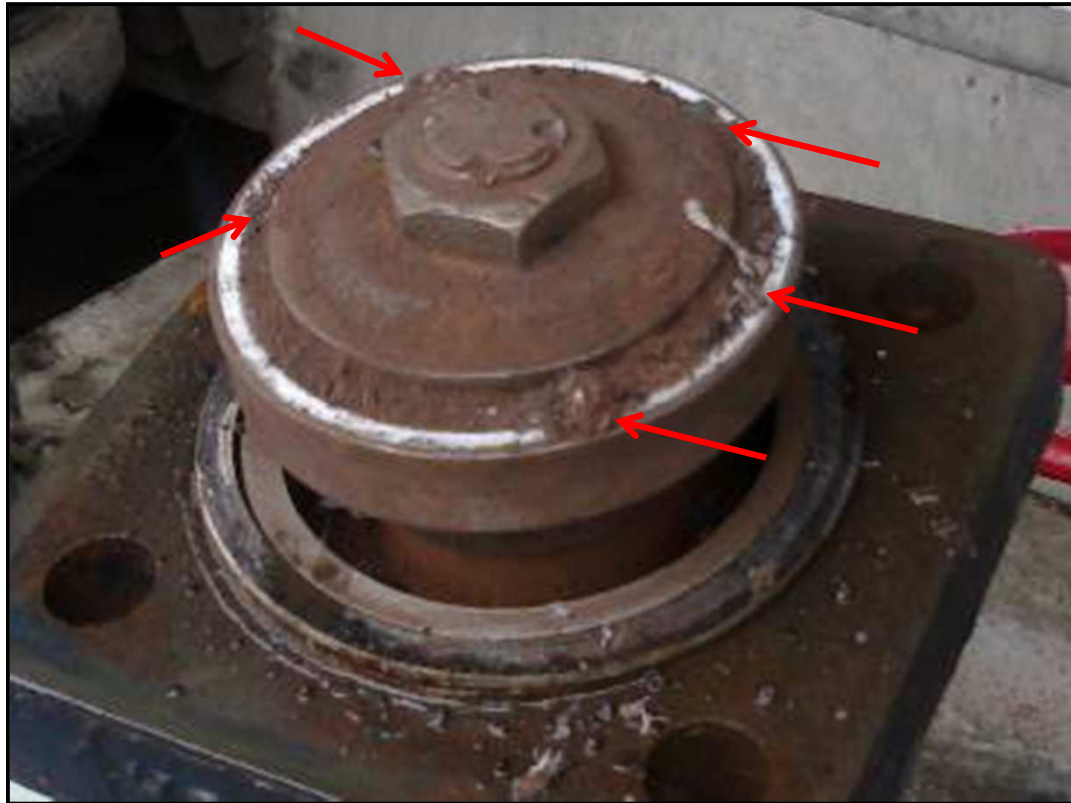
Picture 4: Dismantled gasket showing slag particles that contaminated the Teflon sealing

- In the first incident, checks required by the operating instruction were not verified or properly conducted.
- Transport company is experienced in the transportation of dangerous goods.
- Trailer tanks used here are exclusively for the transport of MMA.
- It was agreed that future repairs on tank trailers will be announced and an independent inspection of the repair will be conducted prior to customer's authorization for re-use.

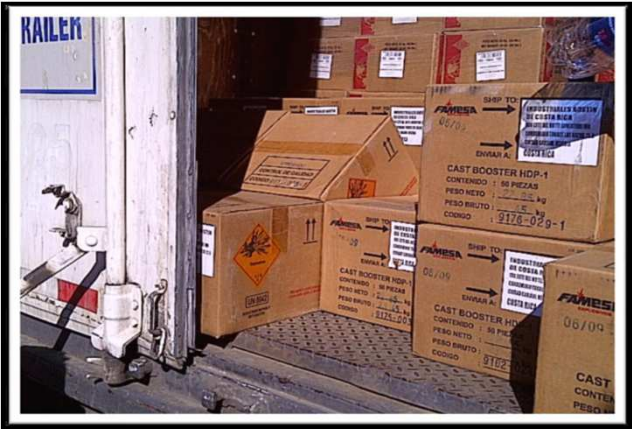
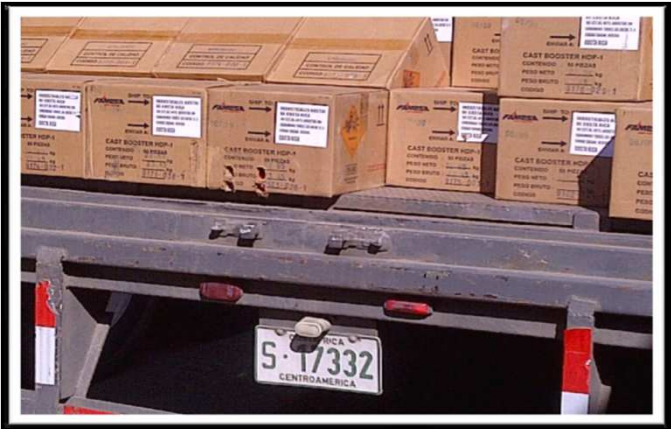
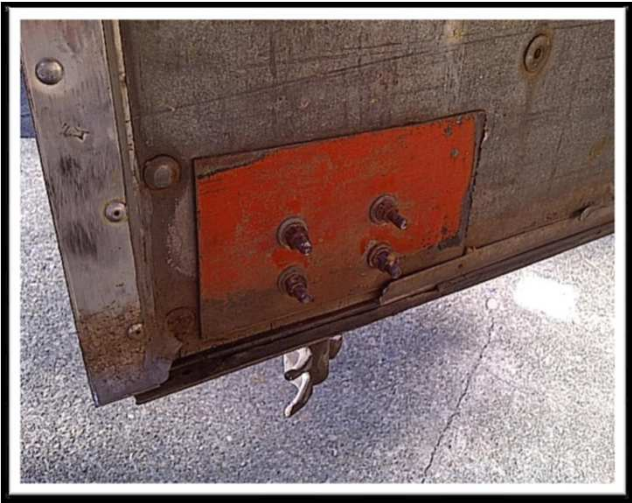
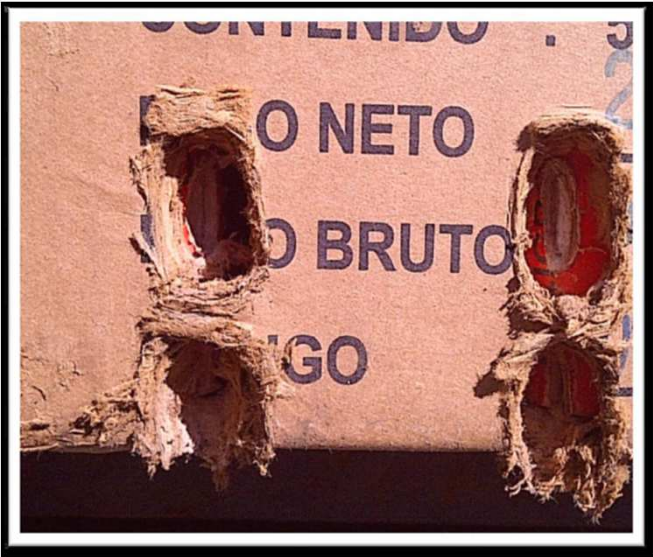
Pictures

- During a transport of packaged explosives from Costa Rica to Panama, a box containing 1 # boosters was punctured by 4 screws.
- The screws were exposed on the back door of the transportation truck.
- Truck and trailer are owned by a long term third party contractor.
- The booster boxes were placed in the last row behind 1.5 D product.
- During hauling the upper booster boxes started to shift and slide towards the back door.
- One box fell to the trailer bottom and became jammed between load and back door.
- One wing of the trailer back door had been repaired and a steel plate at the bottom had been fixed with screws/bolts that protruded to the inside.
- The protruding screws punctured the box and damaged the booster shells.

- In the second incident, the protruding bolts where either overlooked or not identified as a hazard or ignored (complacency).
- Costa Rican entity agreed with forwarding agency to review maintenance procedures and report forms.
- Training in explosive BOS principles for transportation was conducted.
- Trailers used in transportation of explosives were inspected at the sites of all contractors and audits were conducted.
- In cooperation with the transportation companies an agreed norm on trucks and trailers for transportation of explosives material was developed.
- This can be used as a practical guidance (good and poor practices).

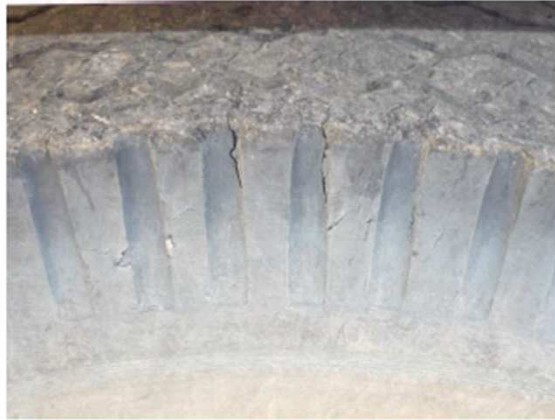
Llanta con rajaduras

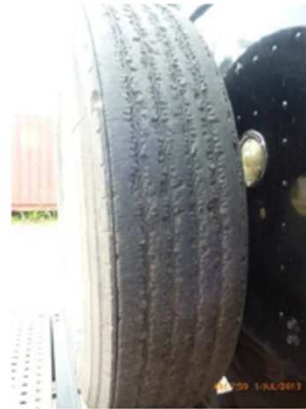
Llanta de repuesto con desgastes en huellas

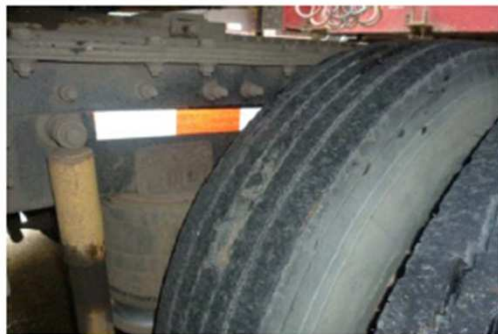
Llanta con huecos

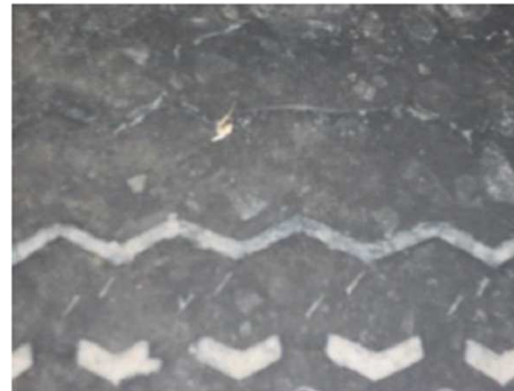
Llanta desgastada de forma no uniforme

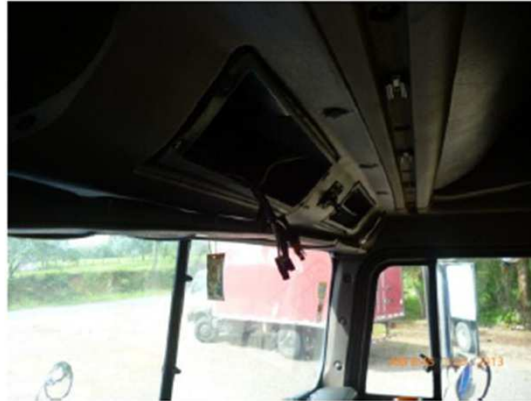
Instalaciones electricas fuera de uso

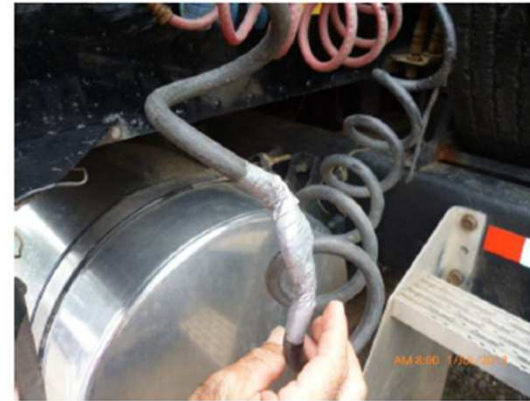
Cables con reparaciones improvisadas

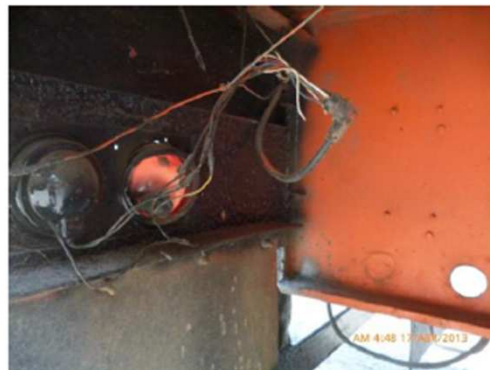
Cables empatados y pelados

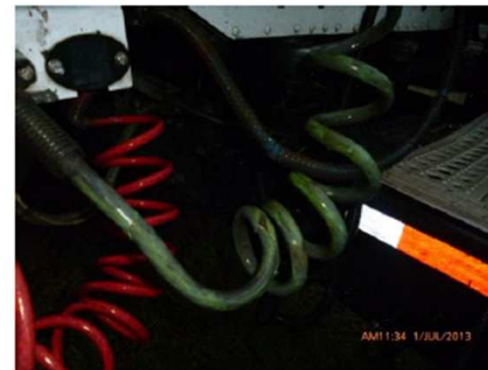
Cableado pelado

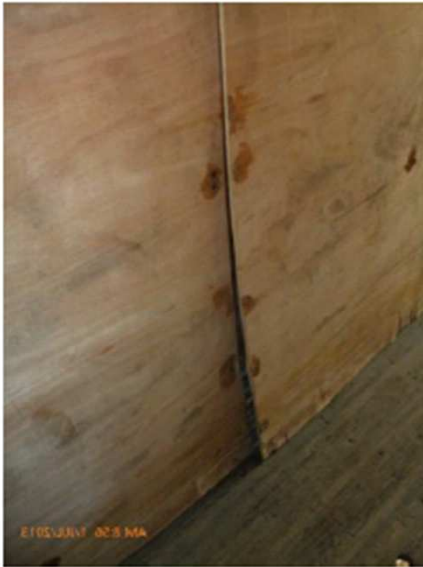
Laminas de plywood levantadas

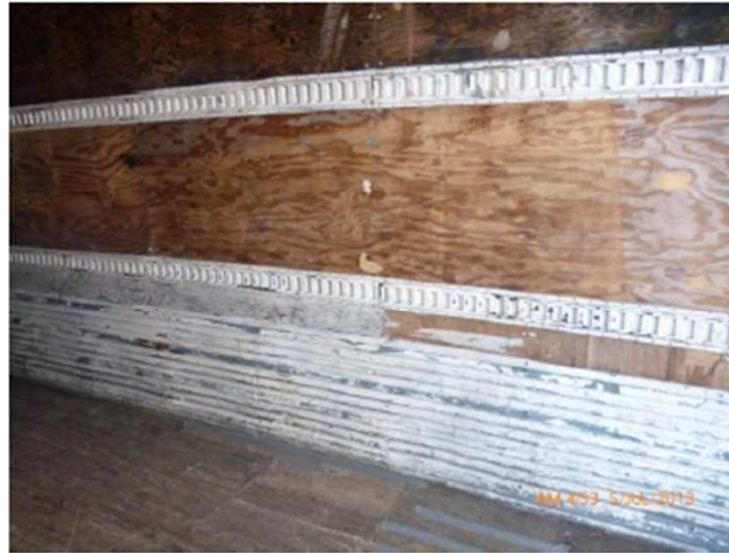
Laminas de metal en paredes de furgón
