Detonating Cord Plant Fire Investigation - Gomia

SAFEX Congress - May 2014

Executive Summary

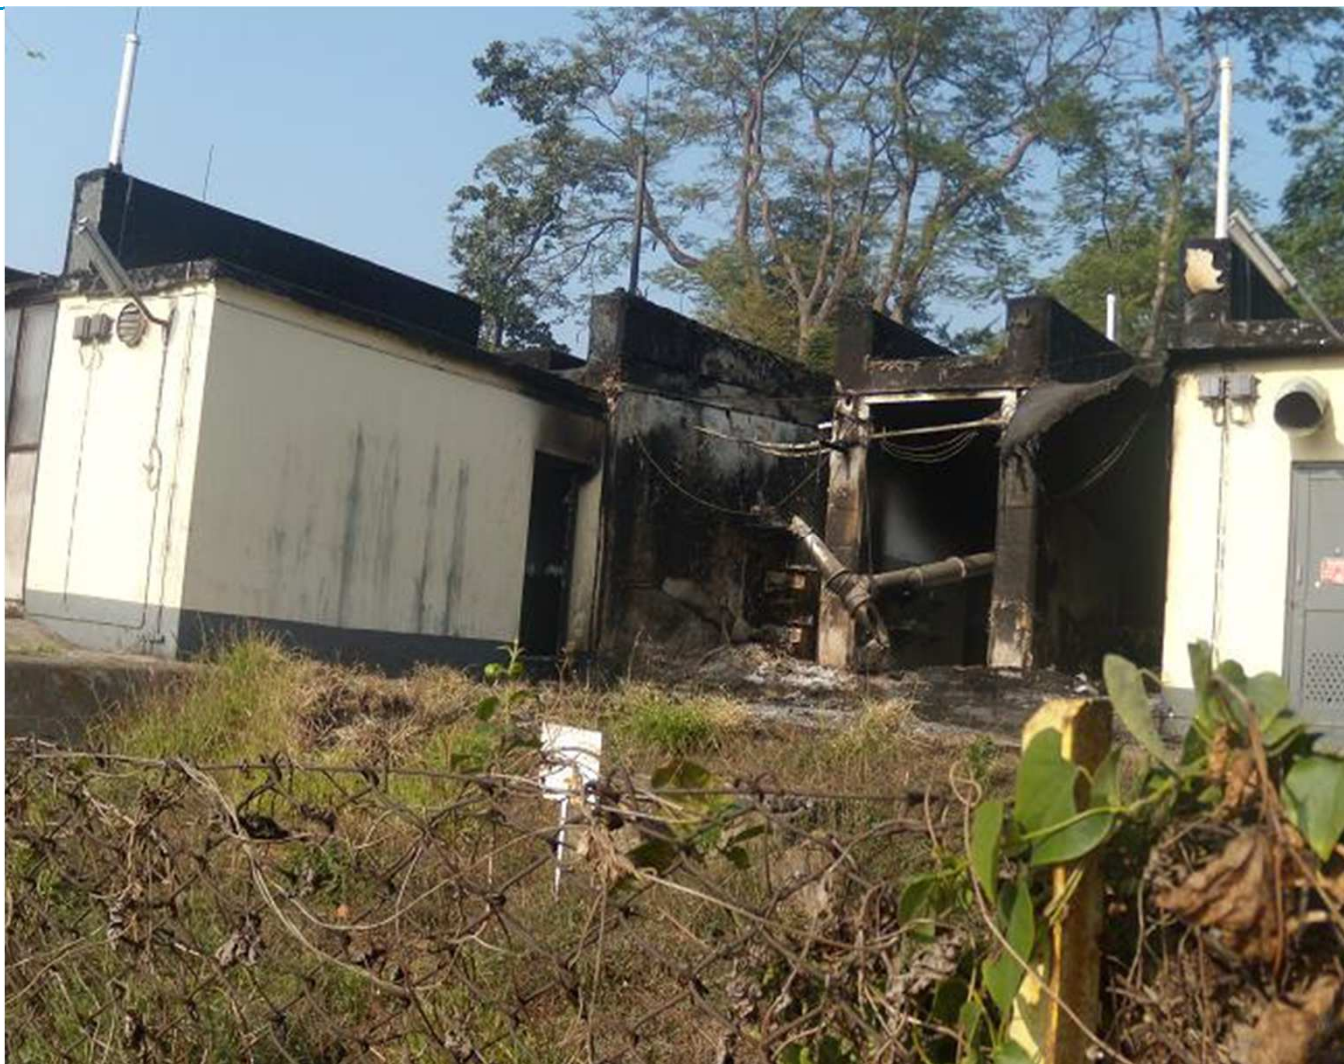
What we found

On the 17th of December 2011 a fire in spinning compartment 1 (SM1) at the Gomia cord manufacturing plant located in Jarkland, India, completely destroyed compartments 1 & 2. It is believed that there was a total of 8kgs of PETN and 1800mtrs of semi fuse spread across both machines. There were no injuries and there was no explosion. The ensuing fire consumed both spinning compartments and destroyed both machines but the fire was confined to that area only. The rest of the plant suffered smoke and soot damage only.

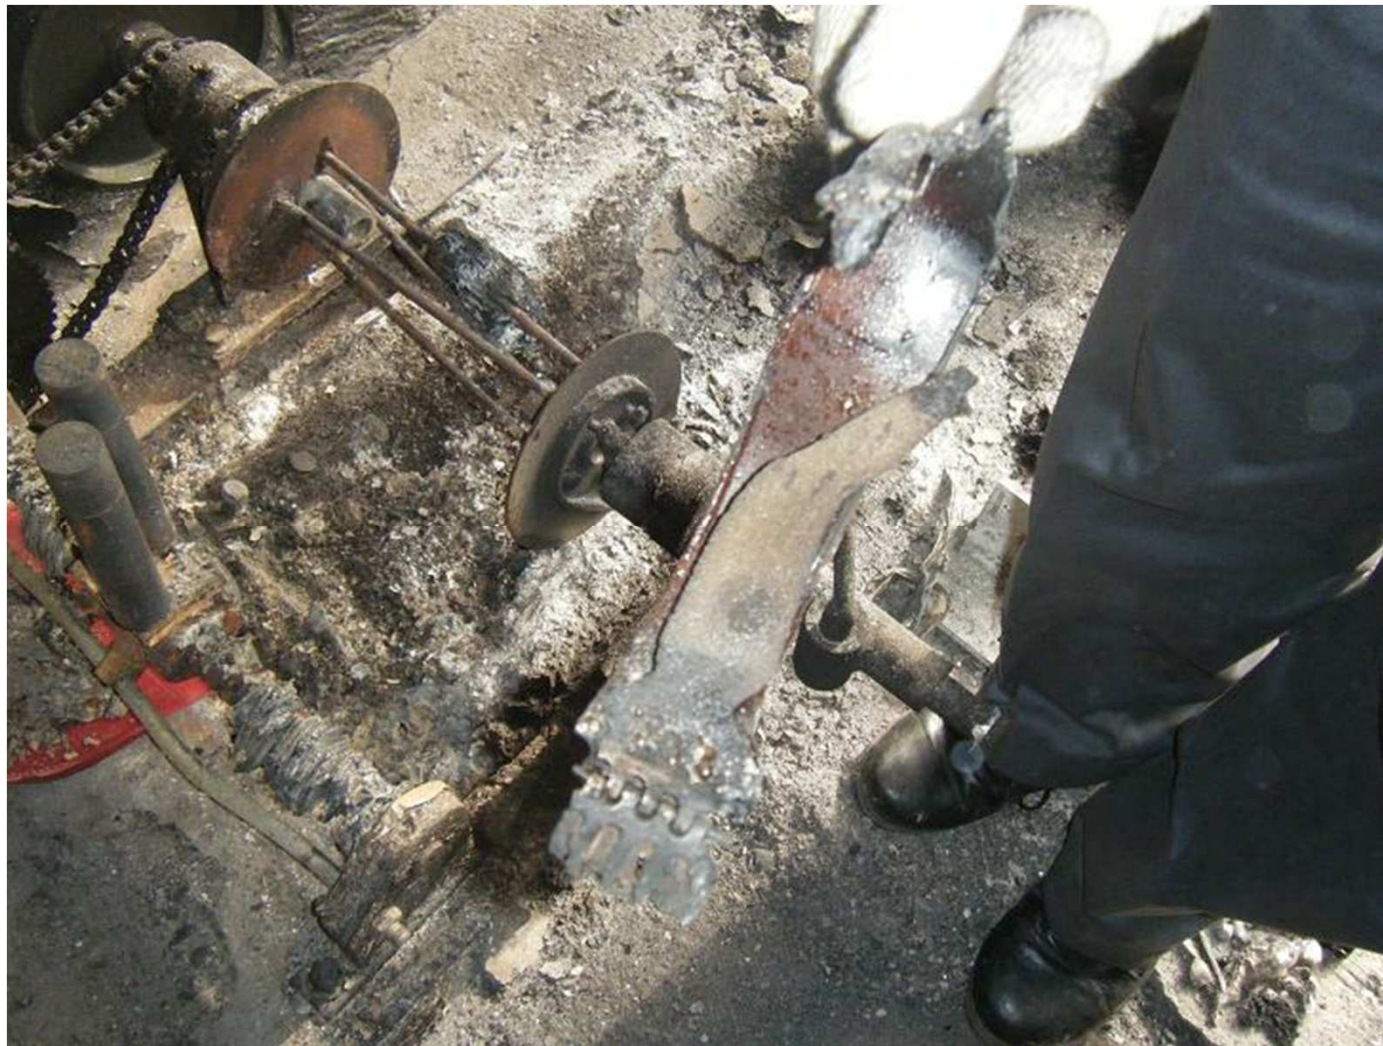
Investigation - Belt

-
- 10.00pm Night Shift started – Spinning Machines 1 & 2 running
 - 11.00pm Changed belt on Spinning Machine 1, used second hand belt
 - 5.30am Night shift operator cleaned all machines and signed out

- 6.00am Day shift started
 - 6.30am Operator started Spinning Machine 1 followed by machines 2, 3 and 4
 - 8.45am Changed reel on Spinning Machine 1, retentioned belt & restarted SM 1
 - 9.15am Operator stopped all Machines and went to canteen

- Drive systems to be located outside of manufacturing area
- Need for fused leather belts without metal joins
- Need for tension system without manual intervention or slippage controlled
- Single button activated deluge systems
- Guards to be in fixed position at all times
