SAFEX CONGRESS - POLAND
May, 2014

Initiation on systems automated plant pyrotechnic fire – Challenges with automated operations!

Initiating Systems Automated Plant Pyrotechnic Fire

Where: Initiating Systems Automated Plant –
(ISAP) – Modderfontein, South Africa

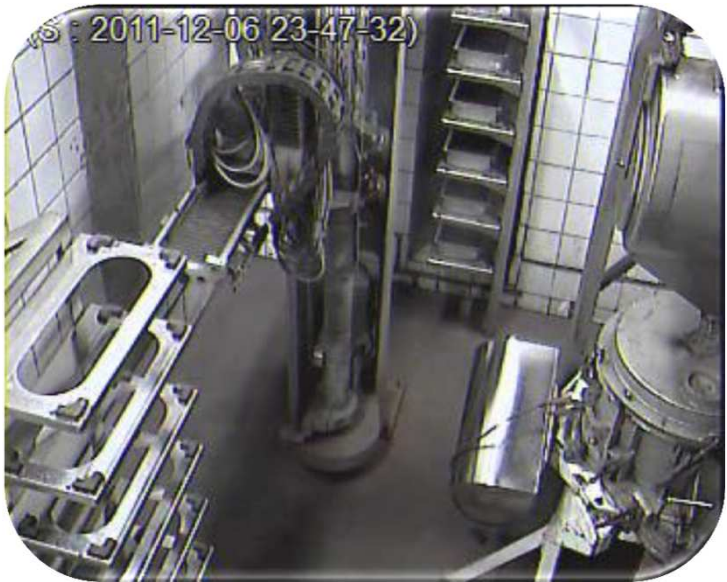
Drying oven
1 tray (3 kg)

Sieving Compartment

1 tray is Automatically
loaded into the tipper

Tray is tipped dispensing
the powder into the
sieve

Tipper is off loaded
automatically

Powder is sieved

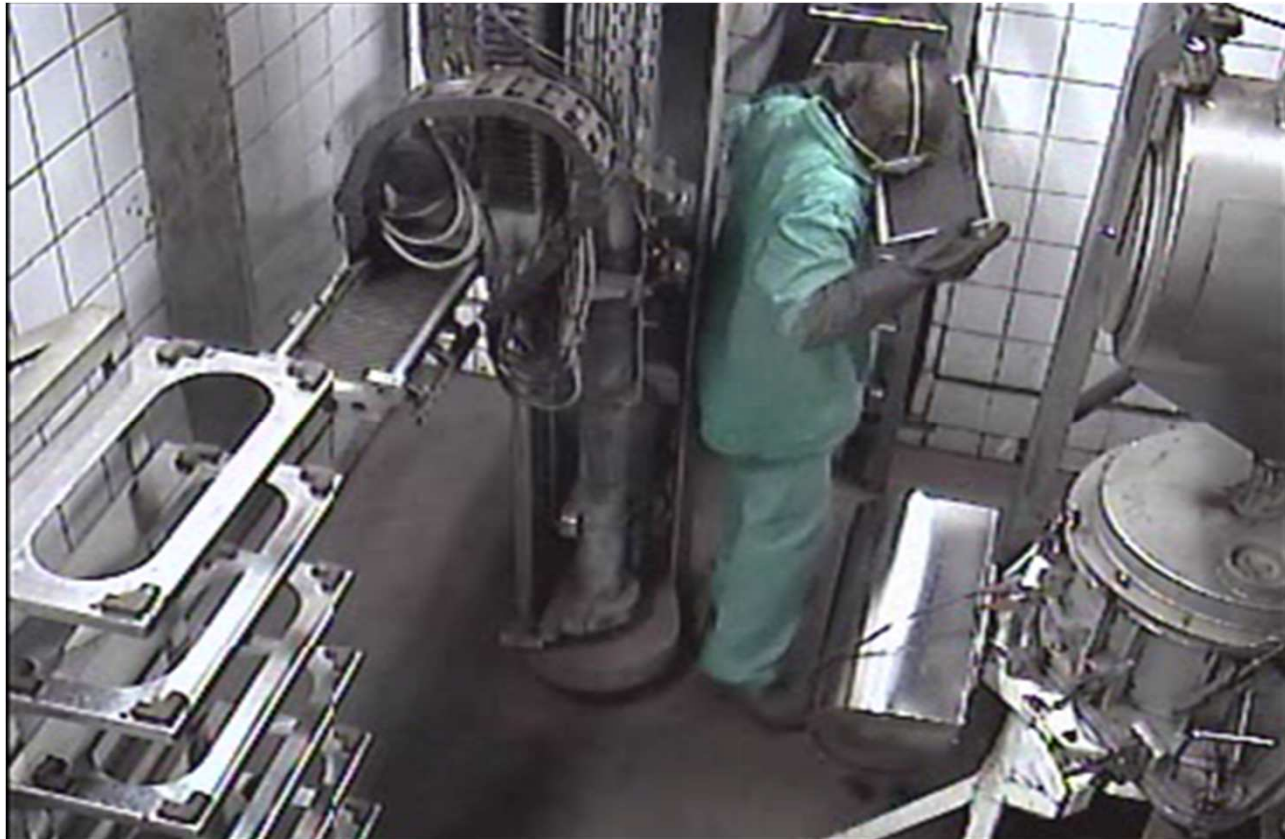
Sequence of Events 1

Employee entered the compartment at 23:47:43 and removed the top tray from the loading rack.

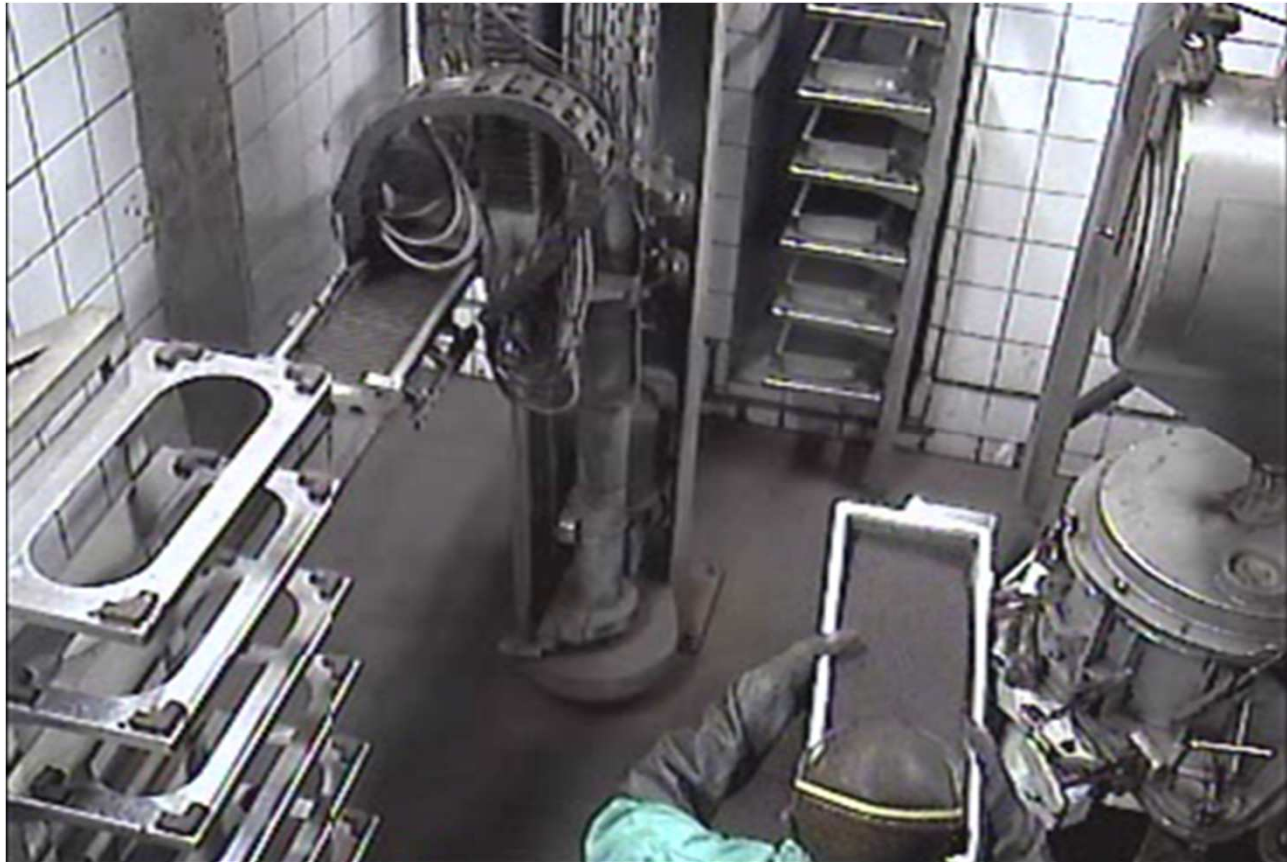
Sequence of Events 2

Employee approached the auto tipper at 23:47:57 with a tray of dry G - composition.

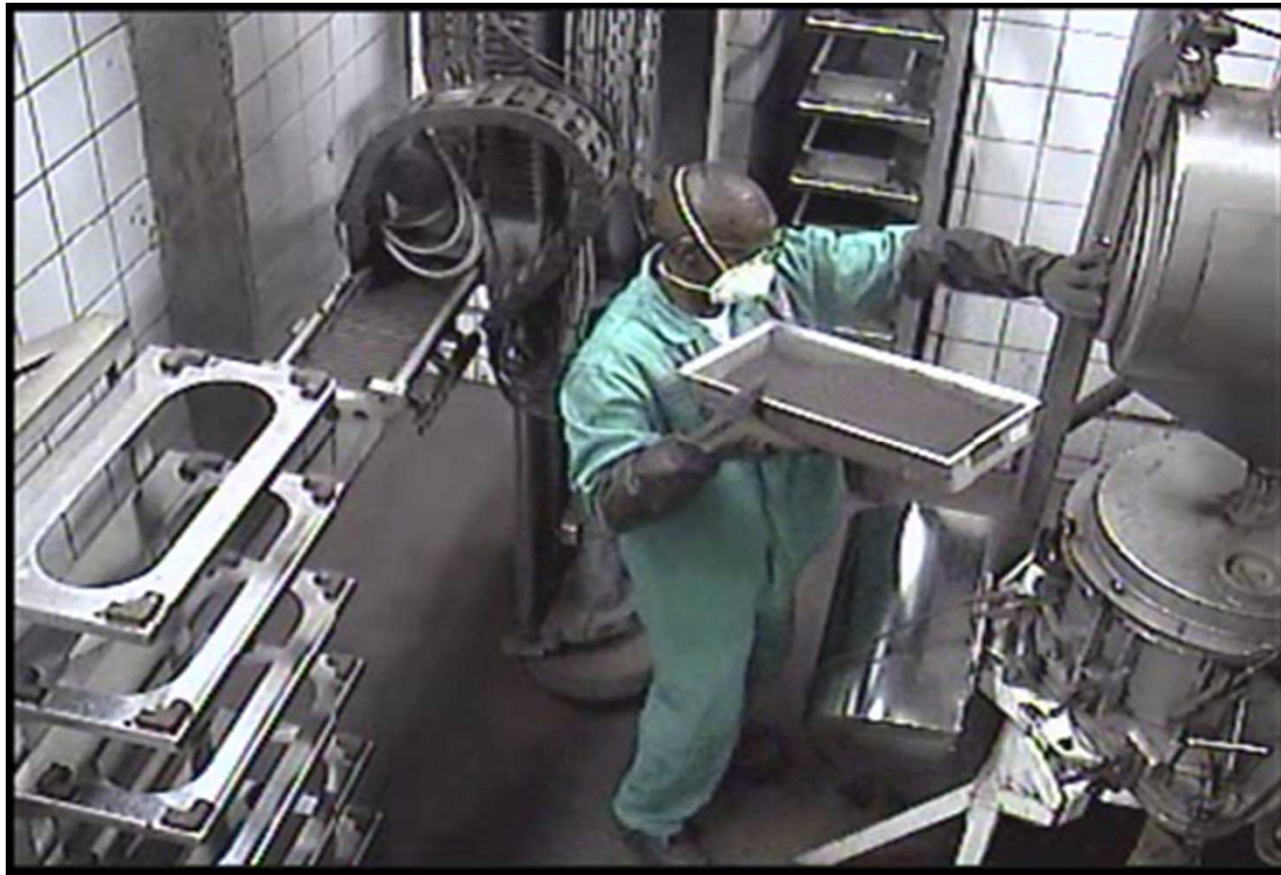
Sequence of Events 3

Employee grabbed the auto tipper hatch to open it. The tray was held precariously in his right hand only.

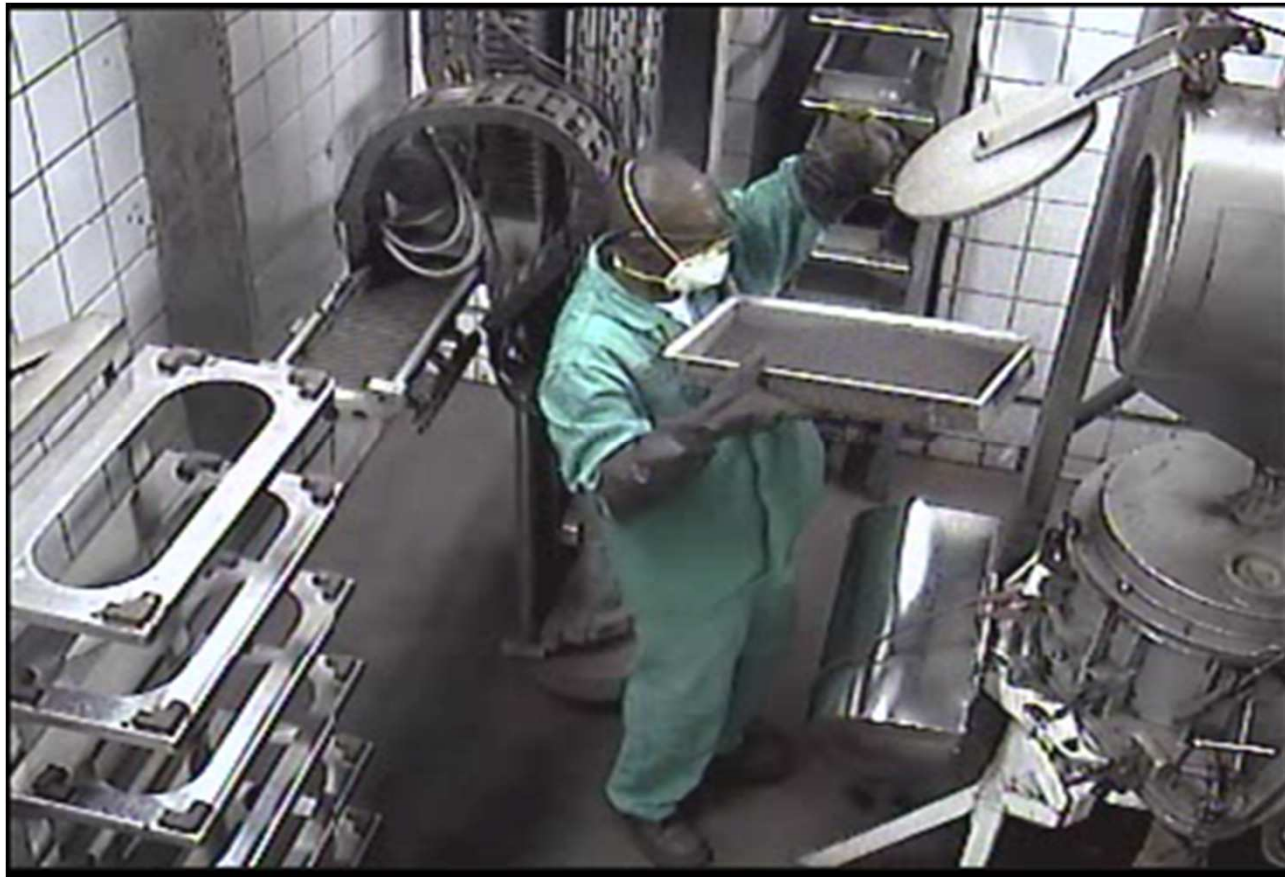
Sequence of Events 4

Employee tried to insert the tray of G composition into the auto tipper but lost his grip on the tipper hatch which began to fall under gravity.

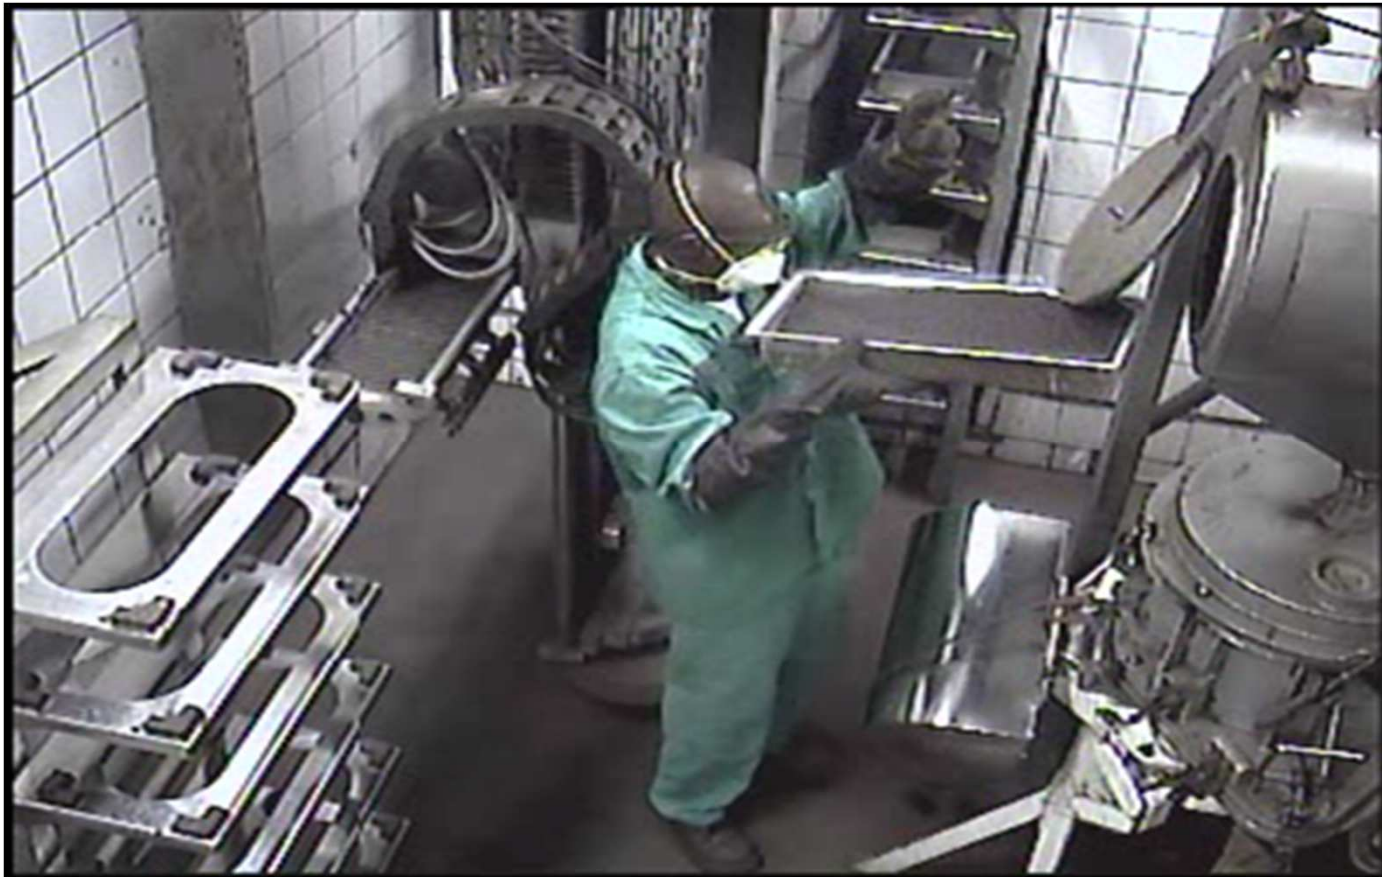
Sequence of Events 5

The falling hatch struck the side of the tray of G composition and the employee lost his grip on the tray.

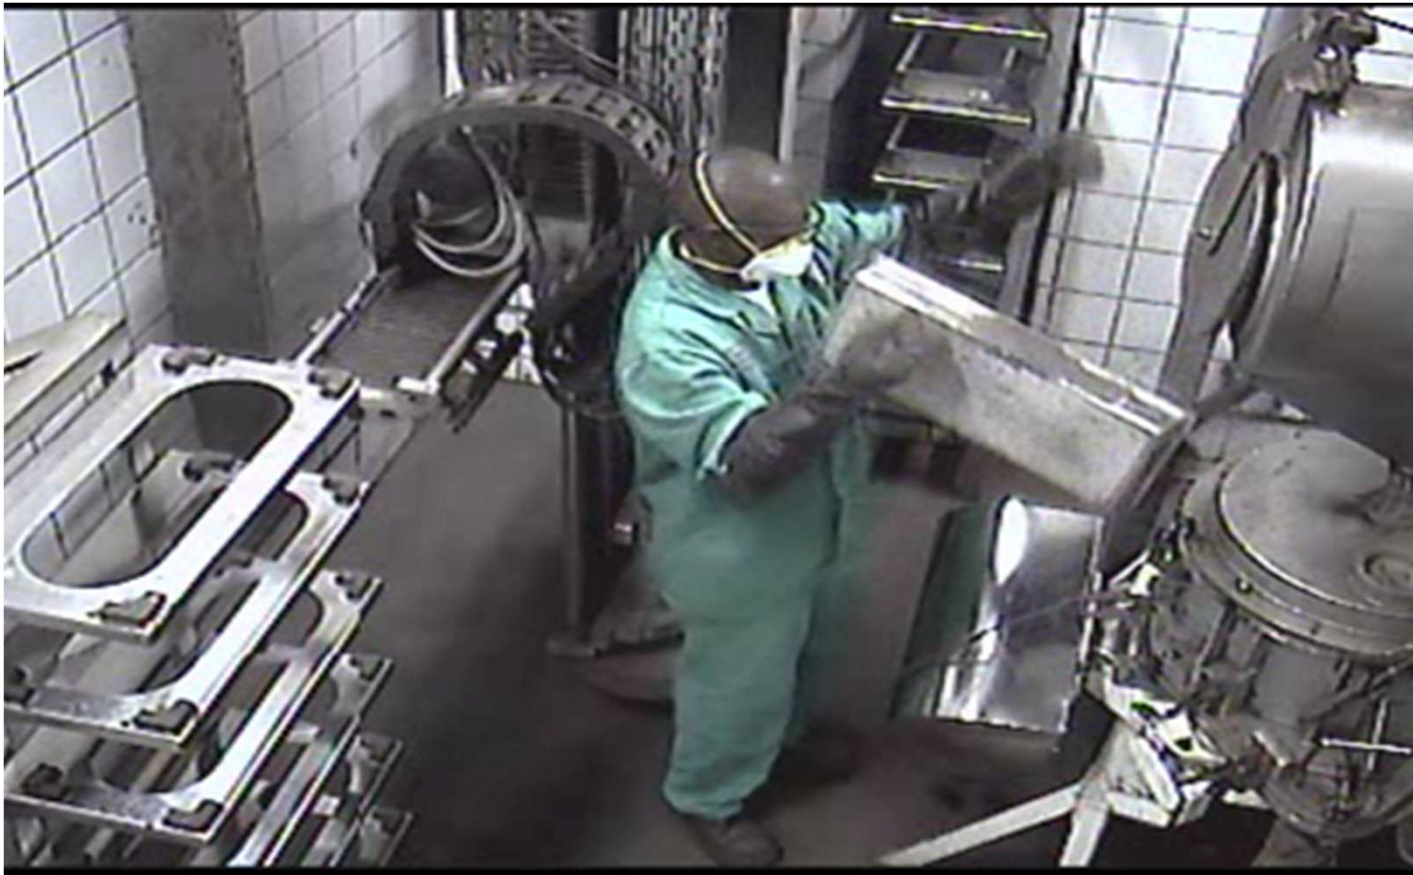
Sequence of Events 6

The Tray of G composition began to fall whilst the employee tried to move his left hand down to catch it.

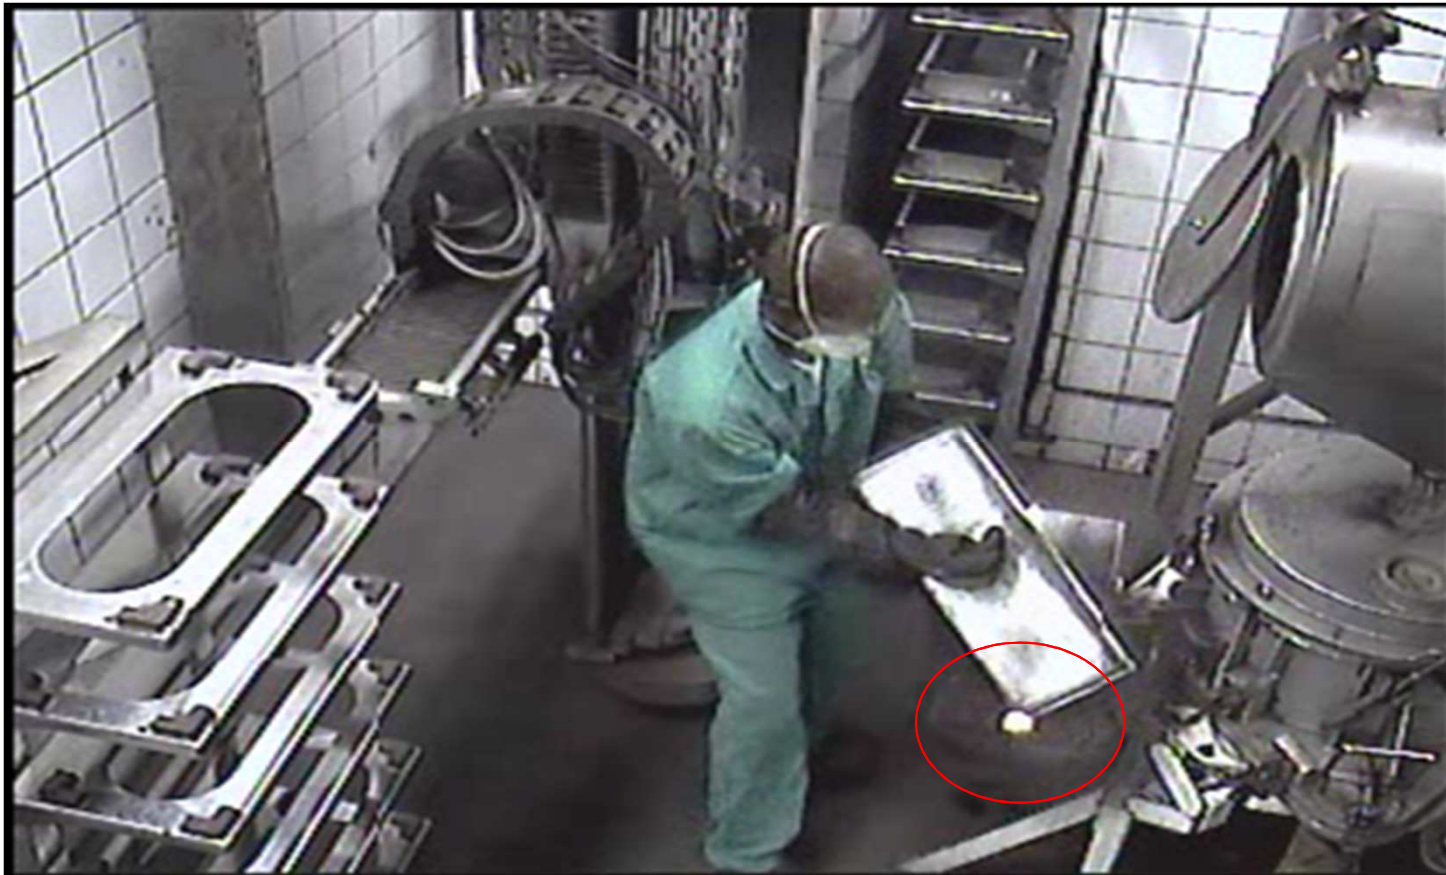
Sequence of Events 7

The employee was unable to catch the tray which struck the side of the Auto sieving machine and initiated the G Composition at the point of impact.

- Good explosives practices remain applicable, manual processes or automated processes.
- On-going Basis of Safety Training is critical.
- Camera monitoring proved to be essential in establishing root causes as well as identifying non-conformances. Supervision Complaisance.
- Continue with actual planned job observations to test the conformance levels and understanding.
- Assess PPE requirements and conformance.

- Zero tolerance rules remains applicable – ensure that these rules are adhered to – example when working with pyrotechnic powders.
- Shortcuts more often than not only shortens your life. Bypassing of interlocks should not happen at all.
- Emergency equipment and proper emergency plans are critical – saved this employee's life.
- Sharing the learning is critical – group wide and industry wide.

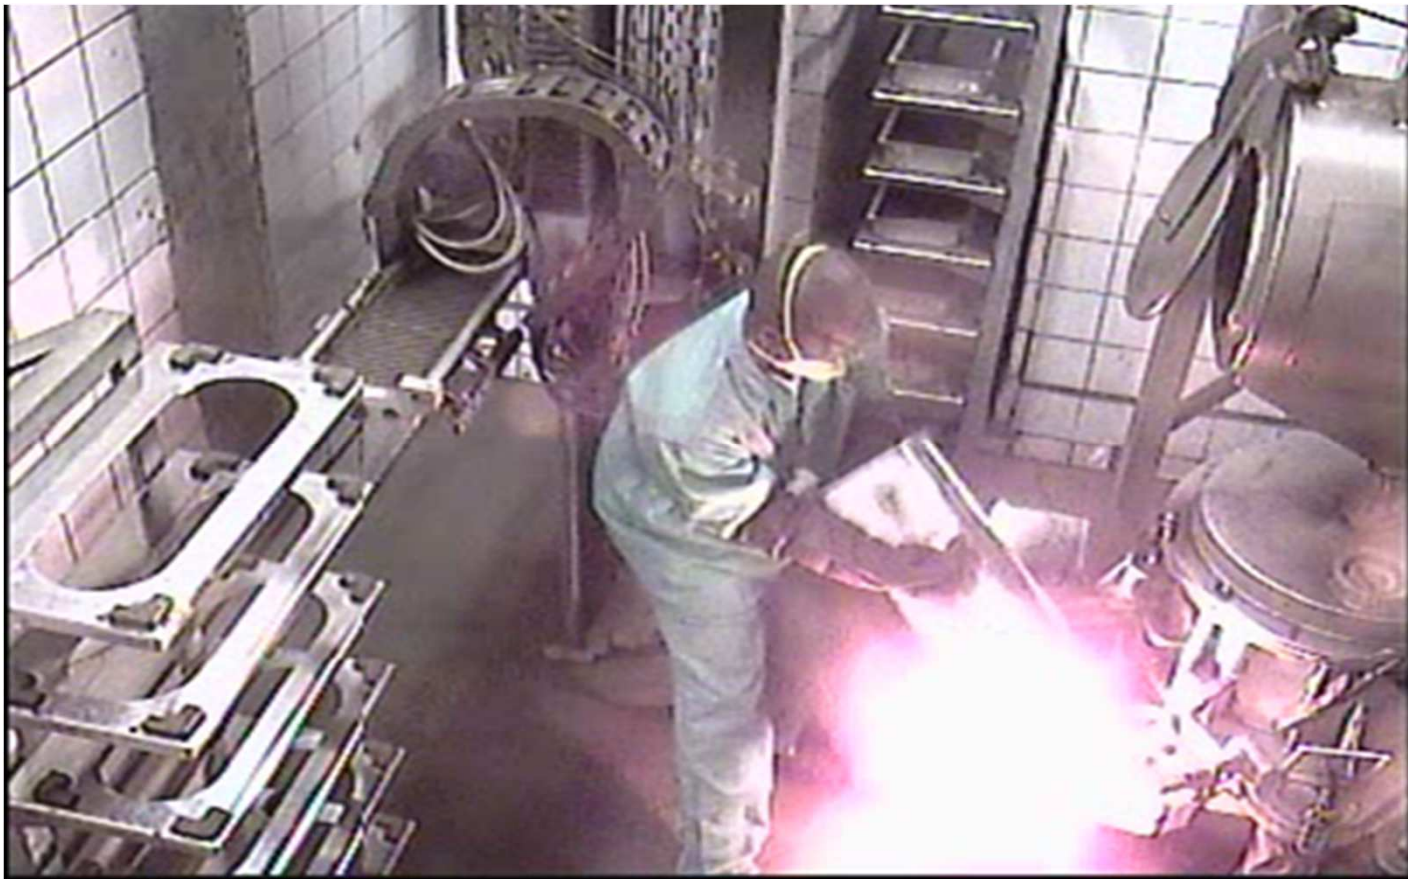
Sequence of Events 8

The G Composition initiation spread.

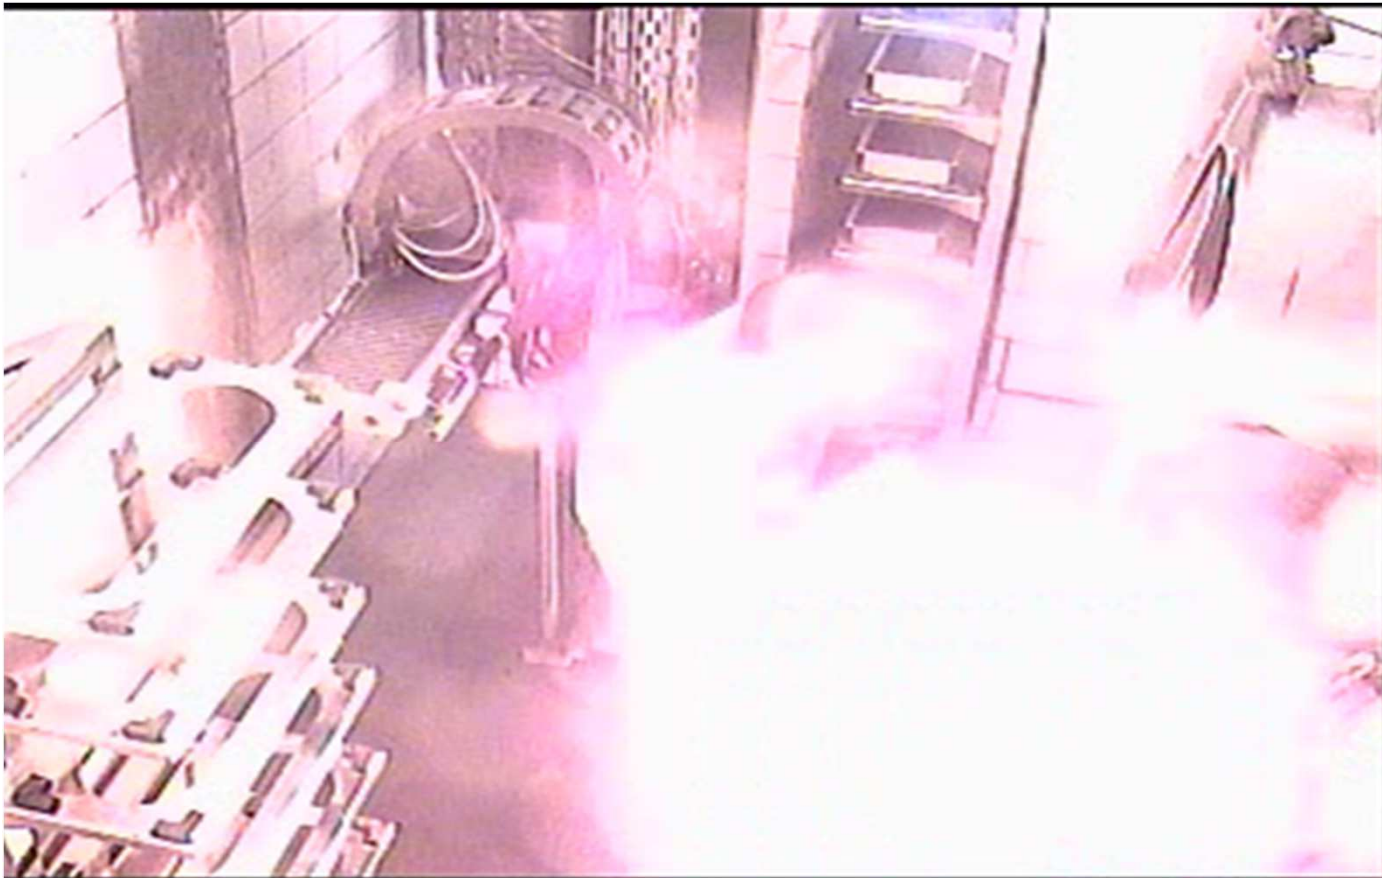
Sequence of Events 9

Even further spread and the employee engulfed in flames.

- The fire drenching system activated within 12ms after detecting the flash from the fire.
 - This system sprayed water across the inside of the doorway.
 - On either side of the outside of the doorway in the corridor outside the compartment – this possibly saved his life.

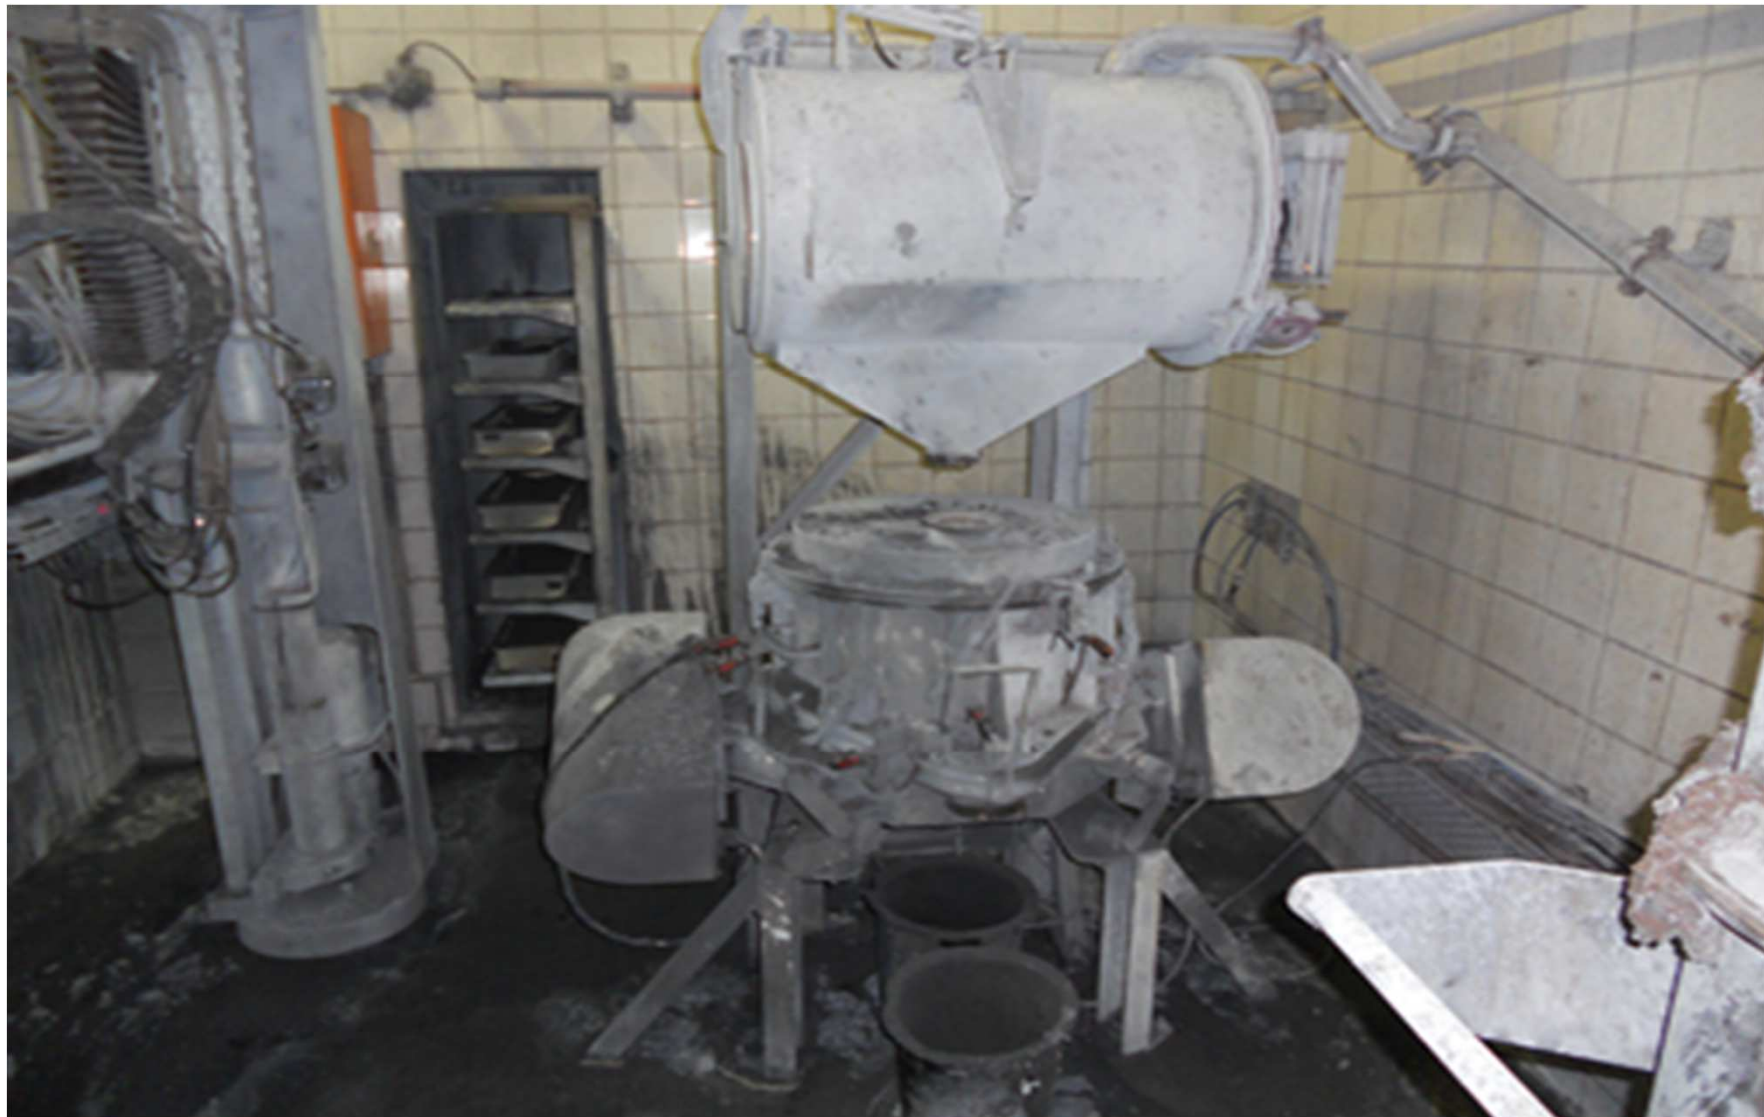
Damage

- About half an hour later an ambulance arrived and the injured employee was taken to the local Hospital.
- The Injured sustained burns on his ear, head and knees.
- Equipment was damaged and air lines, sensors, cables, buckets, socks and protective bellows were burnt.
- The compartment was blackened from the fire.
- Repairs to the equipment and compartment eventually took four days.

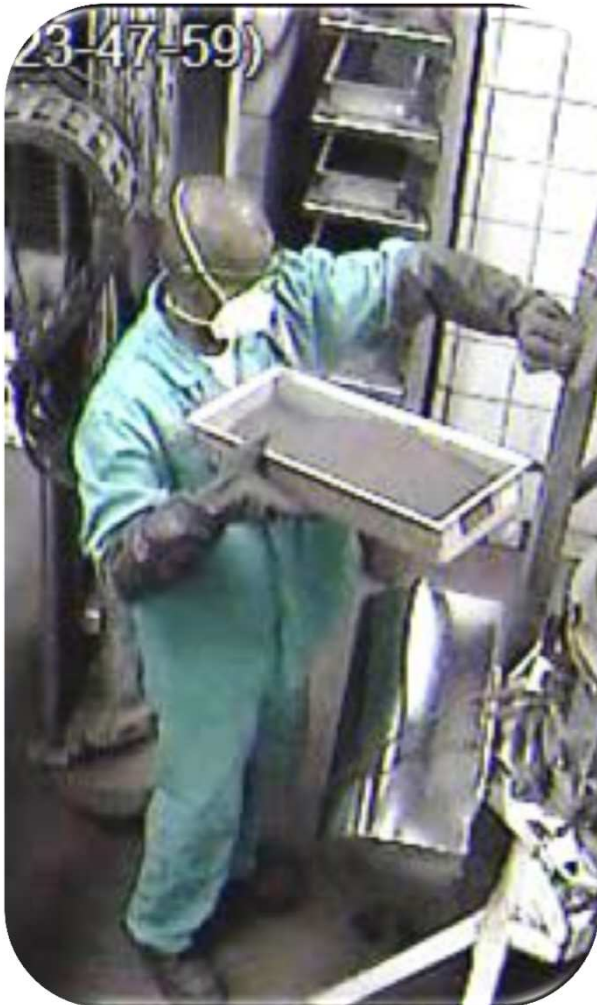
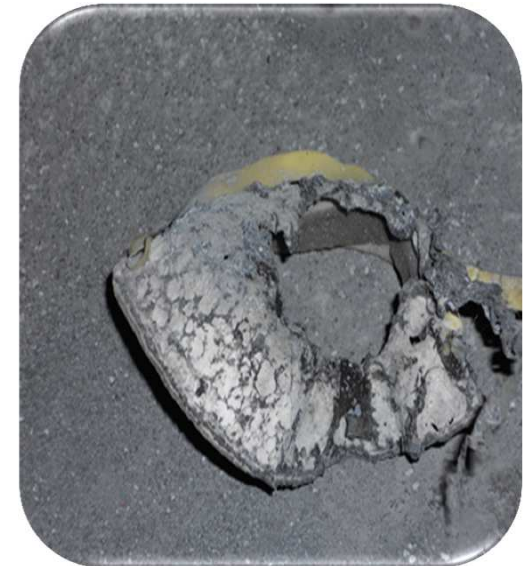
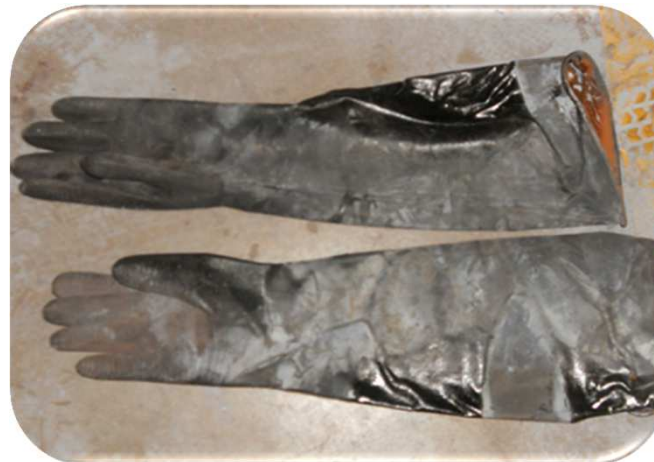
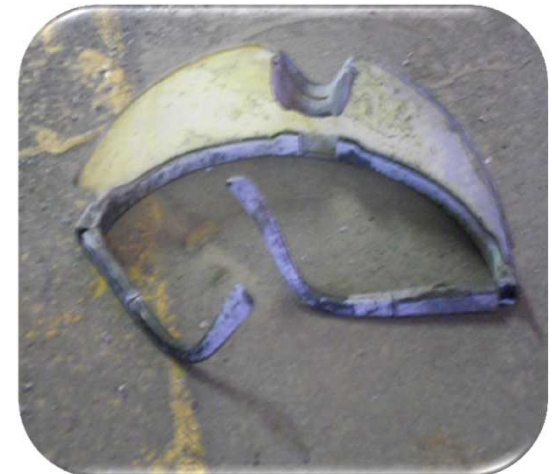
PPE

Normal

- **2 Piece Flame retardant overall**
- **Safety glasses**
- **Long rubber gloves**
- **Dust mask**
- **Conductive shoes**
