## **XVII SAFEX CONGRESS – May 2011**

### **Experiences and learning around the decontamination and remediation of explosives facilities**

Ellen van Dongen, Group Environment Manager, AEL Mining Services  
May 2011

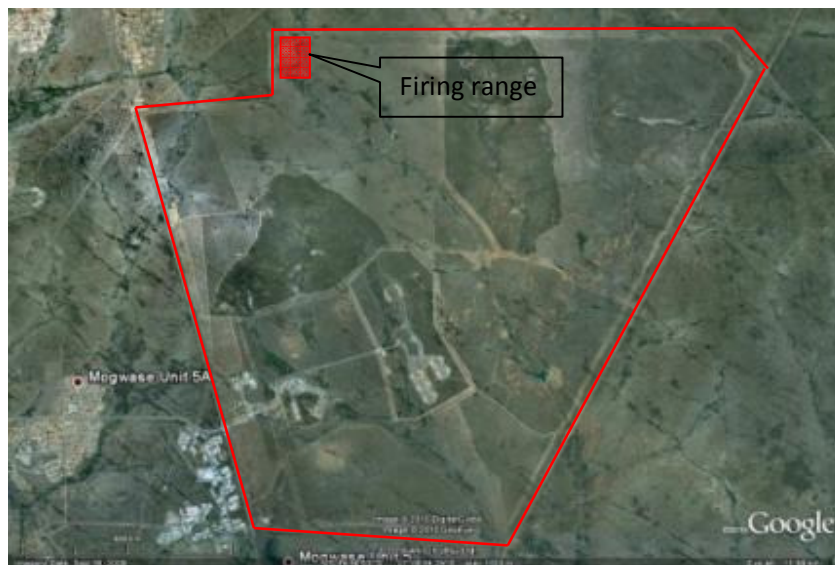
**Figure 2: The remediation site at the Mankwe Factory**

An initial site visit showed that an area of 300m by 300m (90 000m<sup>2</sup>) (figure 2) was contaminated with visible and buried detonators and associated components (partially detonated detonators, explosive contaminated debris, connectors, safety fuse and electric detonator wire). Because the site had been vacated for 3 years it was covered in grass and had extensive growth of thorn trees (figure 3) and some of the twenty one explosive pits had filled with water (figure 4).

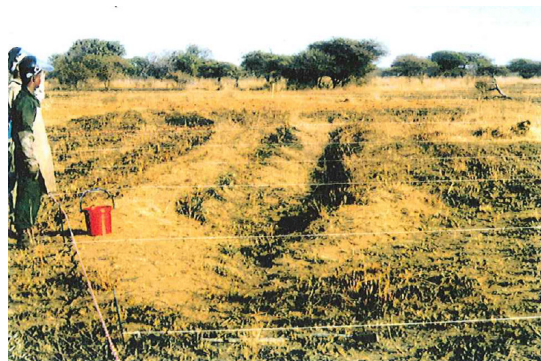
***Figure 5: The remediation site divided into blocks***

- Step 1 The grass was burned to get a clear view of the ground surface
- Step 2 Where detonators were found in trees, the trees were burned and then removed
- Step 3 The remediation site was divided into blocks (50m x 50m) using dropper poles and tape, these were further sub-divided into lanes 5m wide using rope, each block was numbered. There were a total of 36 blocks.

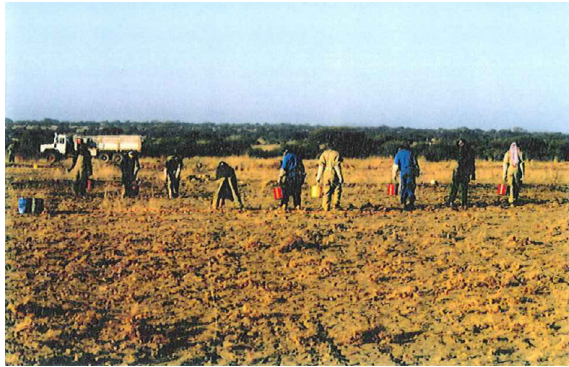
**Figure 6: Teams walking the blocks collecting detonators**

- Step 4 Three people teams were used in grids to inspect the site.

A visual inspection was conducted for detonators and associated components by the teams of people walking up and down and left and right in the lanes. This meant that the ground was inspected four times. Detonators and associated components found were placed in buckets half filled with oil. Buckets with live detonators were emptied into larger drums.

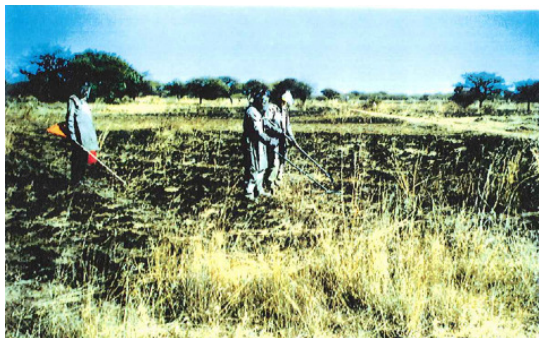
**Figure 7: Checking with metal detectors**

The area was then checked with a metal detector.

**In the first visual inspection 548 live detonators were found.**

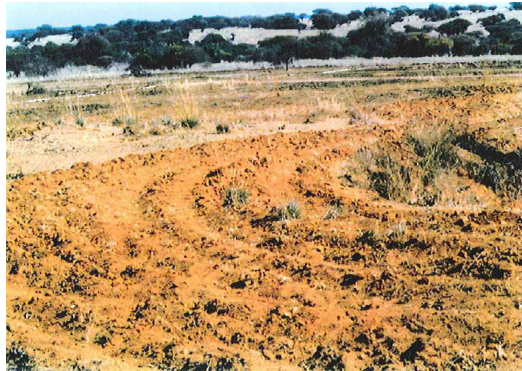
**Figure 8: Area ripped**

- Step 5      A mechanical rake was used to break up the top 50mm of the soil surface. The soil was first raked in one direction then again at 90 degrees to the first direction. People walked behind the rake collecting detonators and associated components. The mechanical raking also resulted in the collection of the burned grass which was hand raked into piles which were then burnt.
- Step 7      The area was checked with metal detector.  
**In the raking phase 265 live detonators were found**
- Step 8      The soil was then ripped 250mm deep using a mechanical ripper and the area cross ripped at 90 degrees. People walked behind the ripper collecting detonators and associated components that were exposed.

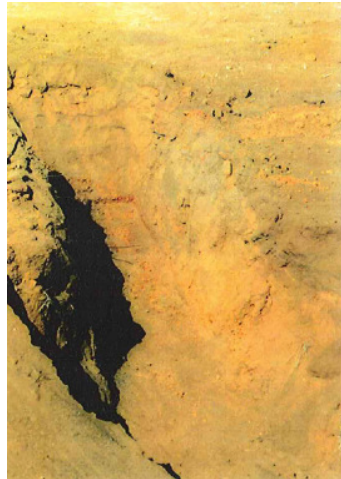
**Figure 11: Trench to assess effectiveness of decontamination**

- Step 12 Effectiveness of decontamination was assessed:  
In order to determine the effectiveness of the decontamination trenches 1 meter deep, 1 meter wide and 2 meter long were dug in selected areas in order to determine the depth of excavation necessary to remediate the site. Inspection of the trenches found no live detonators and associated components deeper than the 250mm.

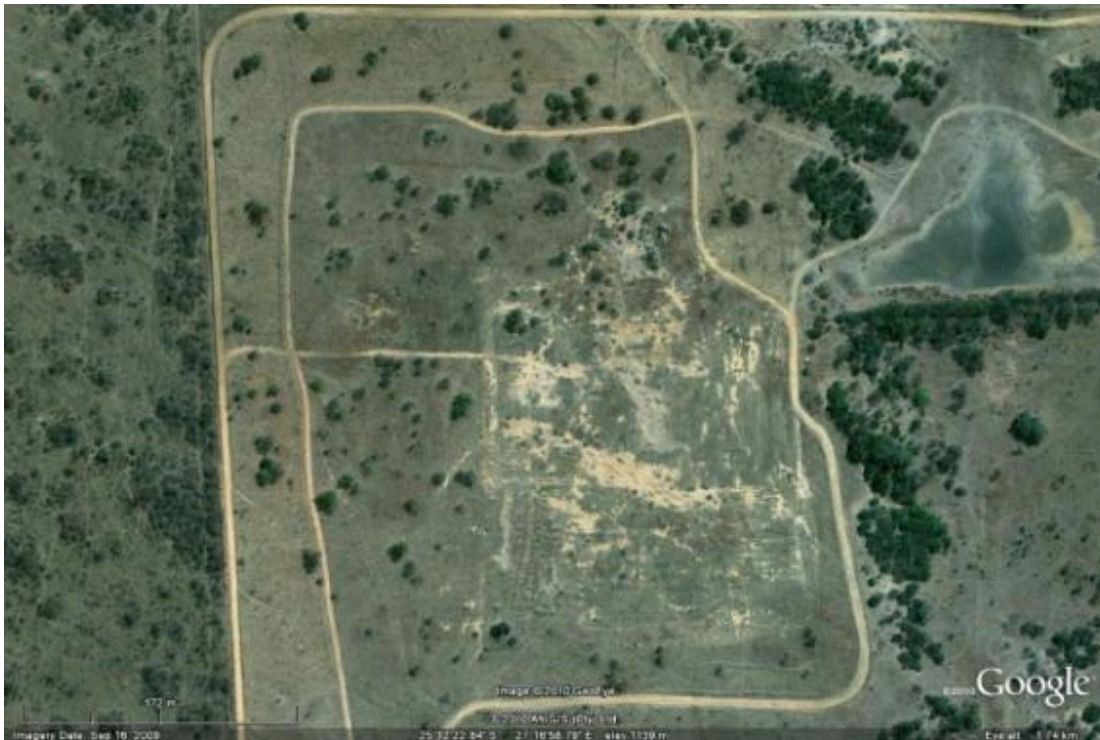
**Figure 12: The remediated site in 2010**

- This process took until 23 April 1998 when an audit confirmed that there were no more detonators and the area was decontaminated.
- In the final audit 30 front end loader buckets of soil were randomly selected and sieved. No detonators or any debris related to explosives was found. The coarse material was sieved 4 times and only small pieces of exploded detonators were found.

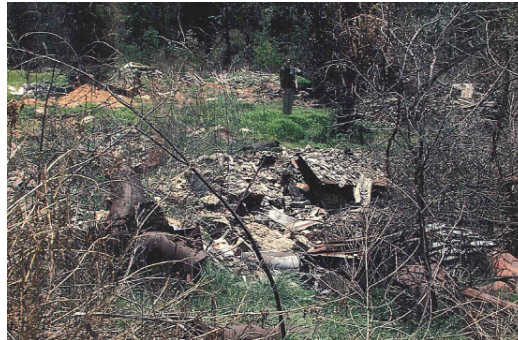
***Figure 13: Part of the black powder dump before remediation***

The black powder plant operated from 1965 to 1993. During this time any waste (plant equipment, bitumen, etc) from the plant was disposed onto a site in Modderfontein which became known as the Black powder dump.

The dump was about 10 000 m<sup>2</sup> in area and was of variable depth up to about 3 m. Test pits were excavated to determine the content of the dump as well as the extent and type of chemical contamination present. Toxicity Characteristic leach procedures (TCLP) were used to determine the leachability of the chemical contaminants as this would indicate the environmental risk and dictate the type of disposal required. It was established that the dump comprised heterogeneous material and amongst the chemical contaminants lead was present.

The easiest option was to remove the entire contents of the dump to a hazardous landfill site. The cost estimate for this was R15,4 million (2008). However, it was decided not to follow this route but to rather segregate the different materials, conduct atomic adsorption analyses on the material which would then determine whether the material had to be disposed to a hazardous landfill site, could be treated and delisted to a lower class landfill site which had lower disposal costs or whether it could remain in situ or could be recycled such as metal. The final cost for the waste separation option which included disposal and backfilling was R9.5 million (2008).
