**XVII SAFEX Congress, Istanbul  
May 2011**

# **Experiences and learning around the decontamination and remediation of explosives facilities**

**by: Ellen van Dongen  
Group Environment Manager**

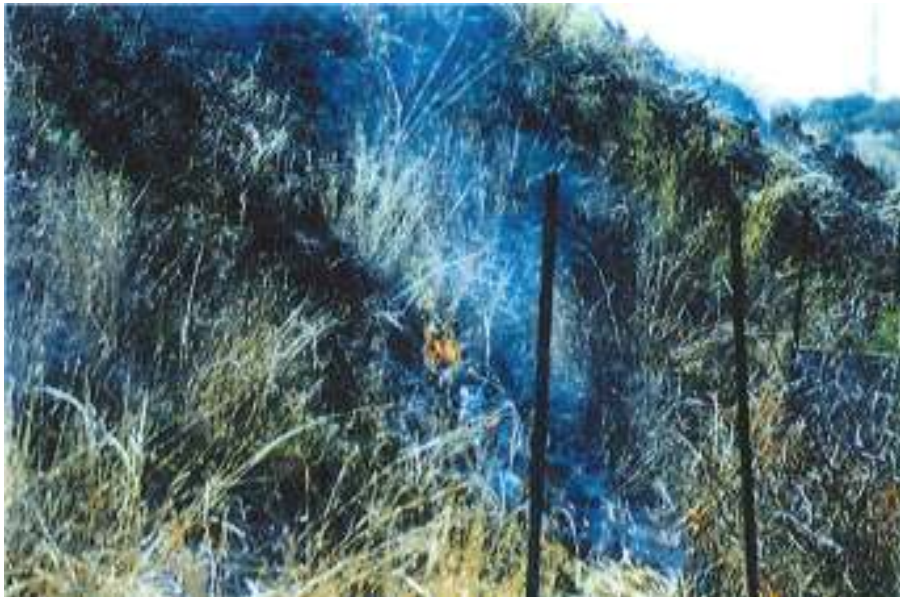
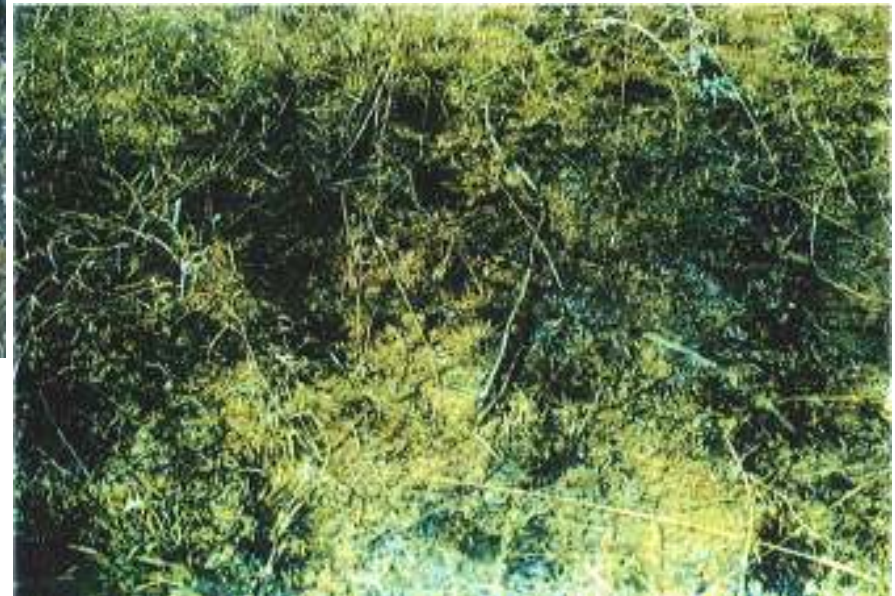
- Step 1
  - Grass burned

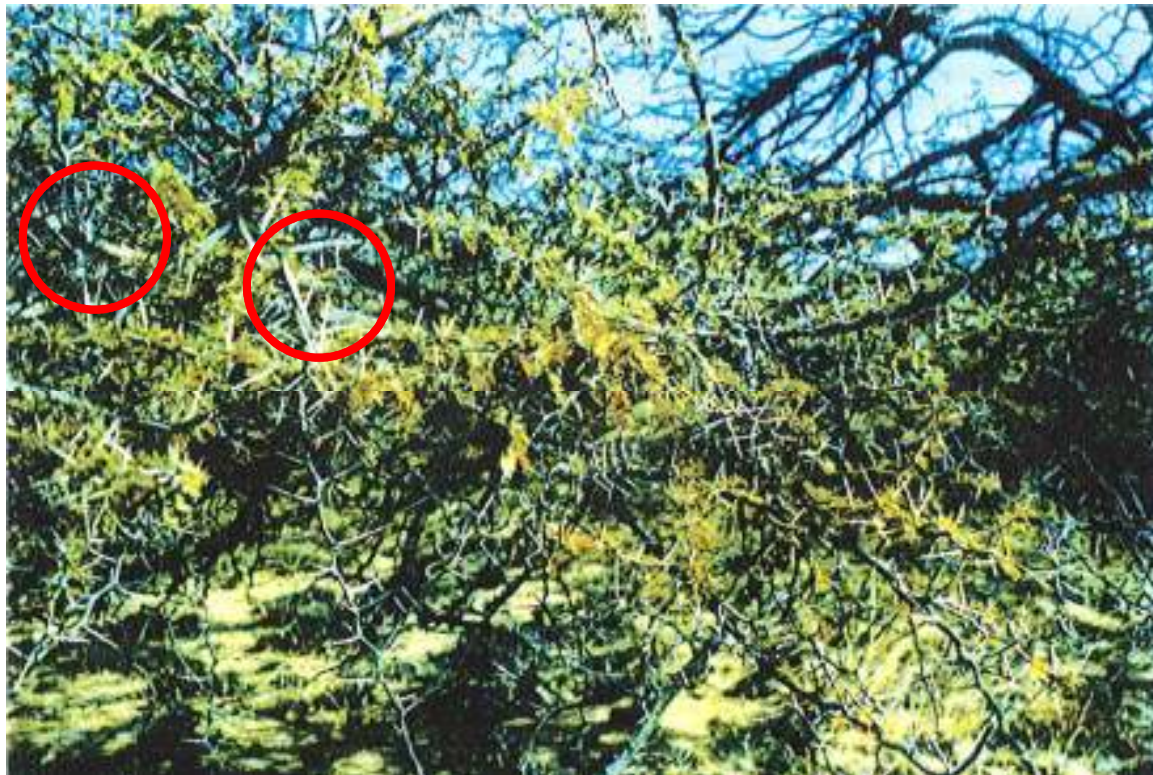
- Step 2
  - Detonators in trees : cut and burned

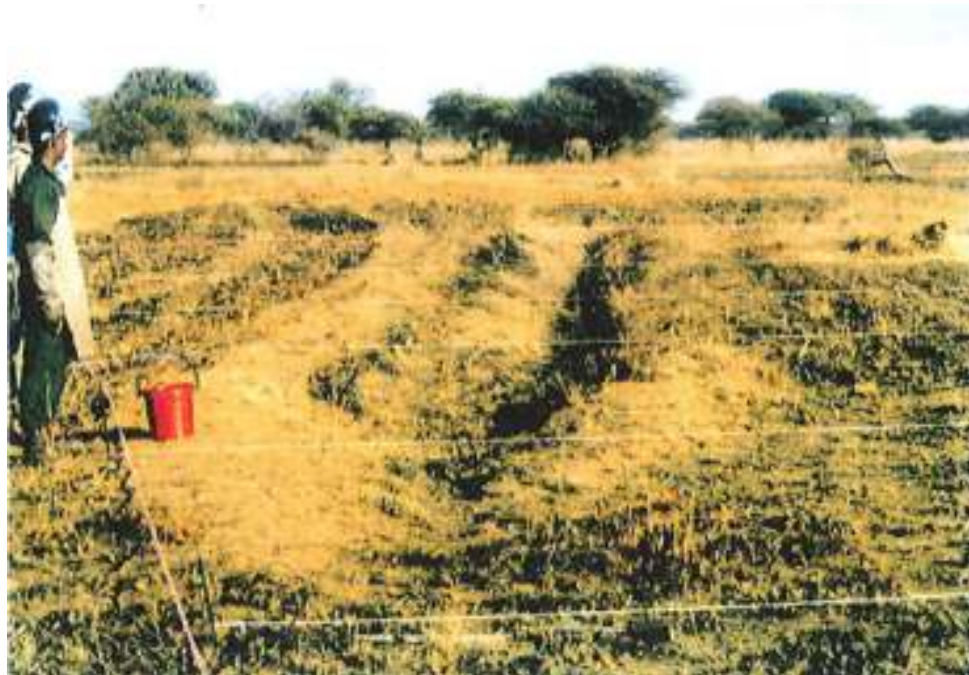
- Step 3
  - The remediation site was divided into blocks (50m x 50m) using dropper poles and tape
  - Total of 36 blocks – each block was numbered
  - These were further sub-divided into lanes 5m wide using rope

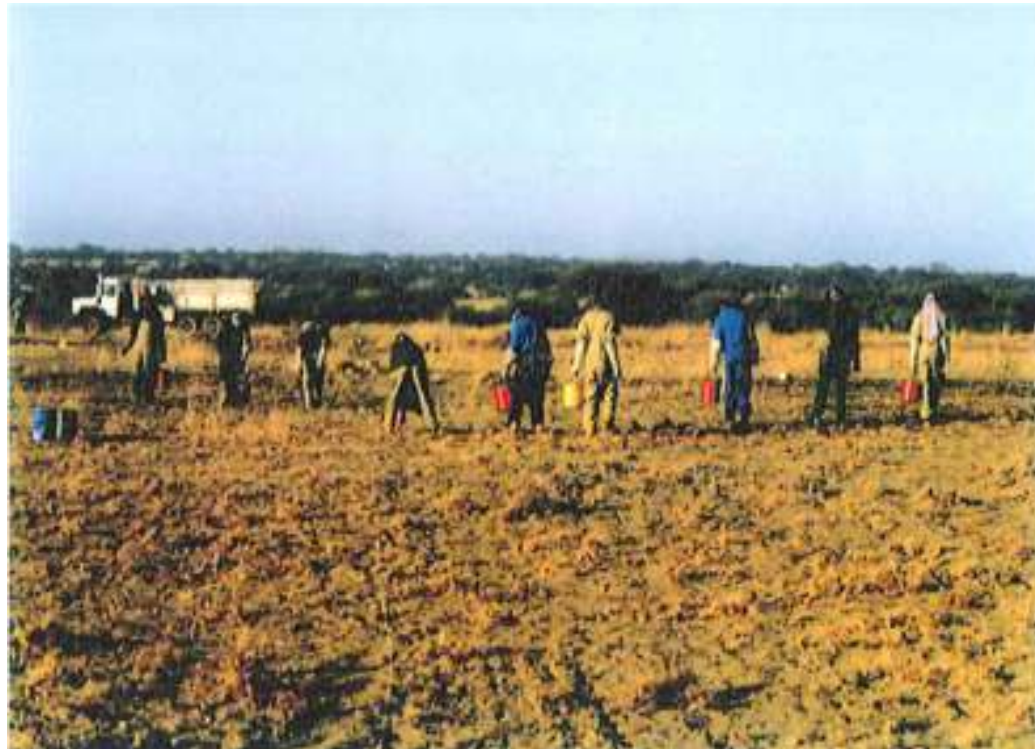
- Step 4
  - Teams, three people each, were used in the lanes to look for detonators and associated components.

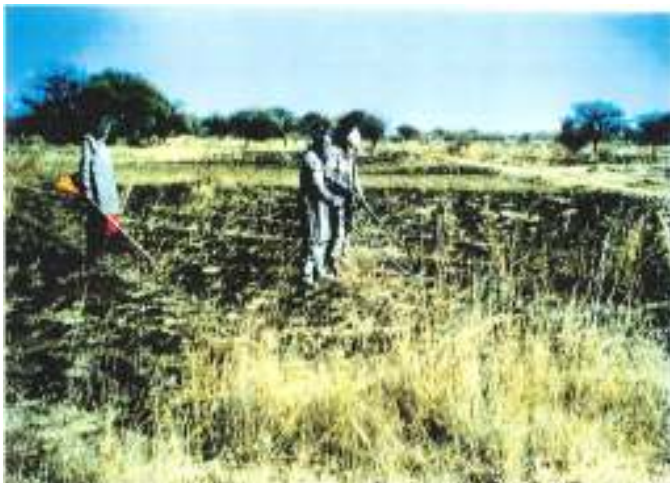
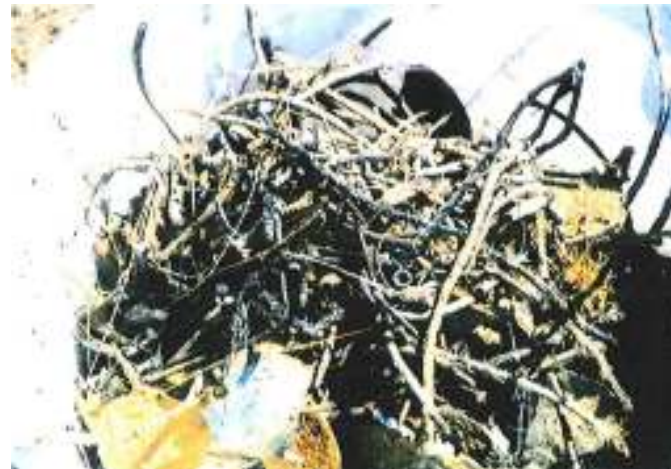
- The teams walked up and down and left and right in the lanes.
- This meant that the ground was inspected four times.
- Detonators and associated components found were placed in buckets half filled with oil which were emptied into larger drums.
- The area was then checked with a metal detector.

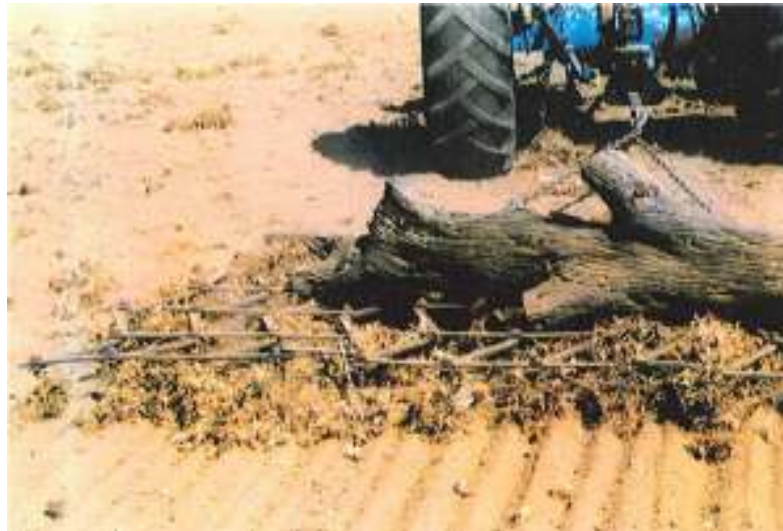
- Step 5
  - A mechanical rake was used to break up the top 50mm of the soil surface.

- The soil was first raked in one direction then again at 90 degrees to the first direction.
- People walked behind the rake collecting detonators and associated components.

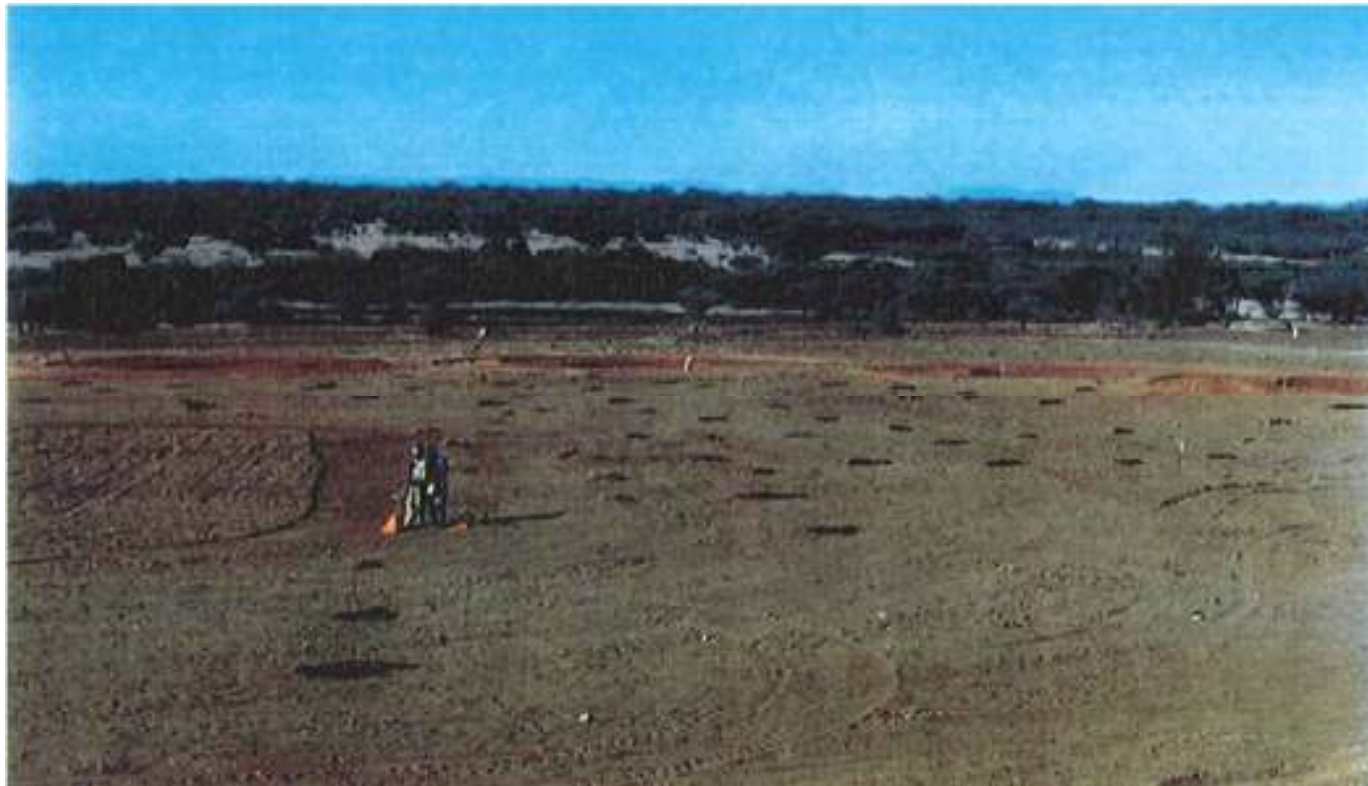
- The mechanical raking also resulted in the collection of the burned grass which was hand raked into piles for further burning

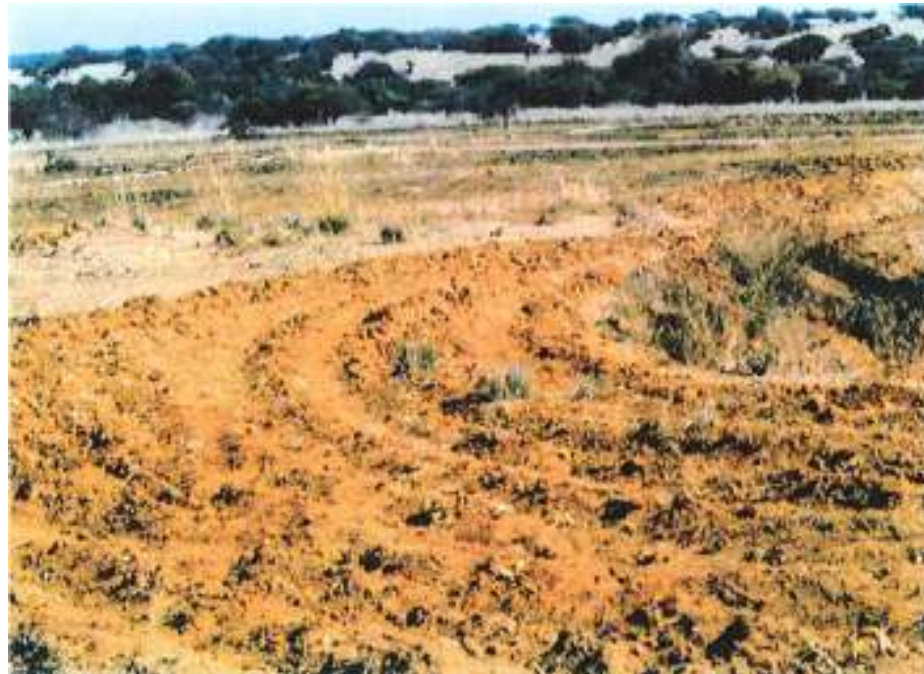
- Step 7
  - The soil was ripped 250mm deep using a mechanical ripper and the area cross ripped at 90 degrees.
  - People walked behind the ripper collecting detonators and associated components that were exposed

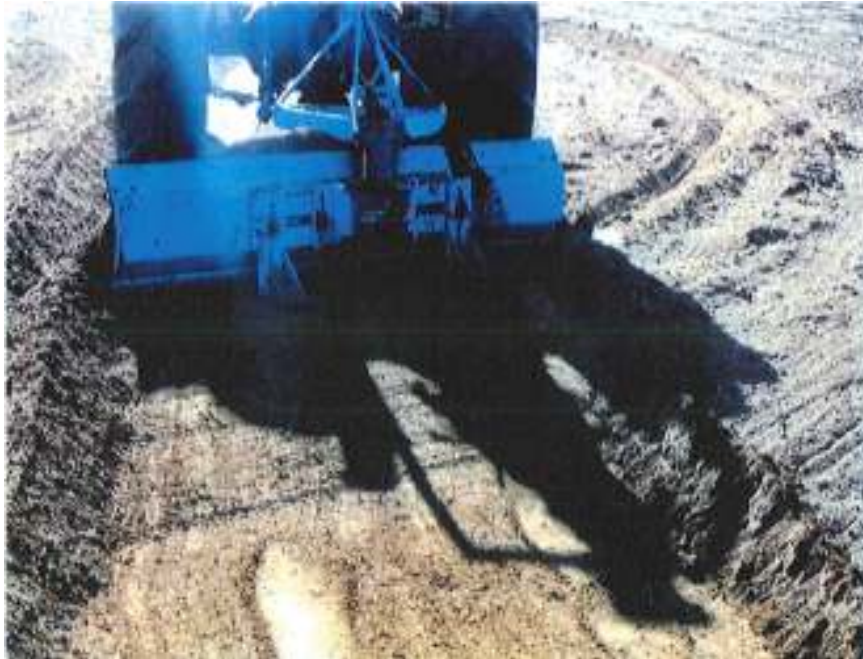
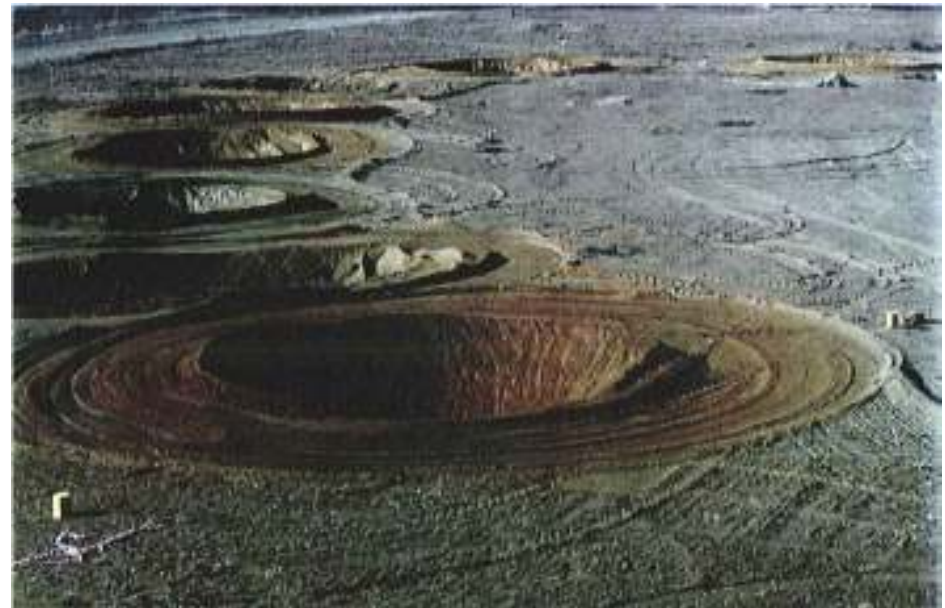
- Step 9
  - The 21 explosive pits were then decontaminated:
    - The grass in each pit was burned.
    - Each pit was visually inspected and live detonators and associated components removed.
    - The soil in each pit was loosened by firing a series of explosive charges connected with detonating cord
    - Rubber rakes and prodders were used to further loosen soil in and around the walls of the pits to a depth of 500mm
    - A metal detector was used to check that no detonators were left in the pits
    - As fly soil from the destructions in the pit may have covered some detonators, the ridges of the pit were graded down to 250mm lower than the original surface level. The soil was raked out to a thin layer and visually inspected for detonators and associated components.

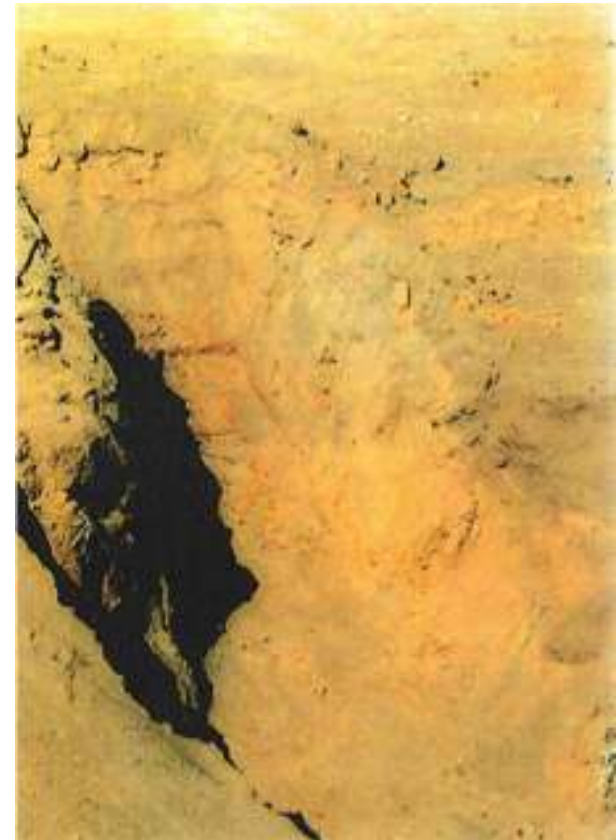
- Step 11
  - To determine the effectiveness of the decontamination, trenches 1m deep, 1m wide and 2m long were dug in selected areas in order to determine the depth of excavation necessary to remediate the site.
  - Inspection of the trenches found no live detonators and associated components deeper than the 250mm.

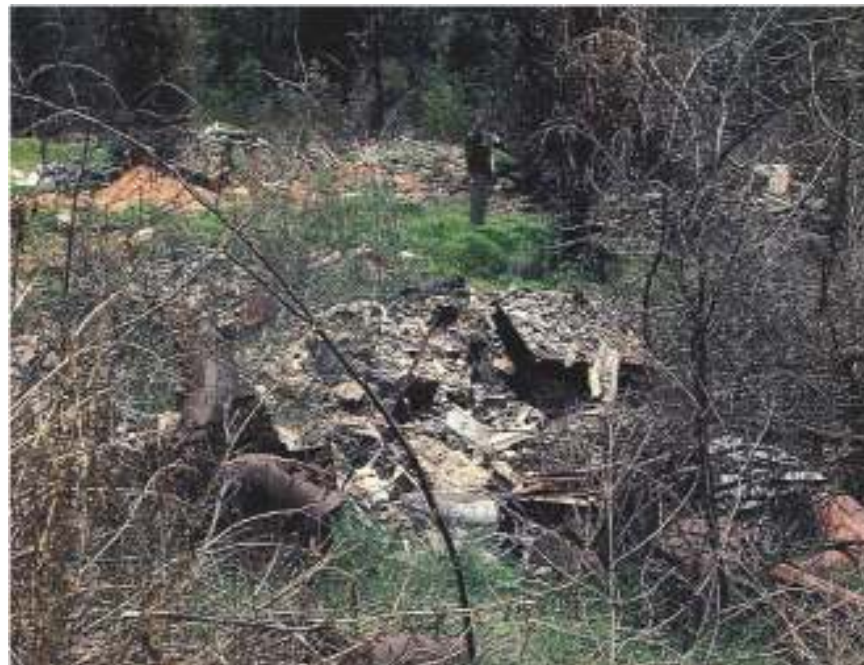
- Black powder plant closed in 1993
- Decision to remediate Black powder dump in 2008
- Heterogeneous dump
- Dump was about 10 000 m<sup>2</sup> in area and was of variable depth up to about 3 m.

- Easy option :remove the entire contents to a hazardous landfill site.
- Easy option cost estimate: R15,4 million (2008).
- Cost reduction option:
  - segregate the different materials
  - conduct atomic adsorption analyses on the material to determine whether the material
    - had to be disposed to a hazardous landfill site
    - could be treated and delisted to a lower class landfill site (lower disposal costs)
    - could remain in situ
    - could be recycled e.g.metal.
- The final cost for the waste separation option, which included disposal and backfilling, was R9.5 million (2008).
