## Incident at AN solution preparation tank funnel

**Bengt Folkesson**  
**EPC Sverige AB**  
**Director Operations and  
Safety**

## Incident – What happened?

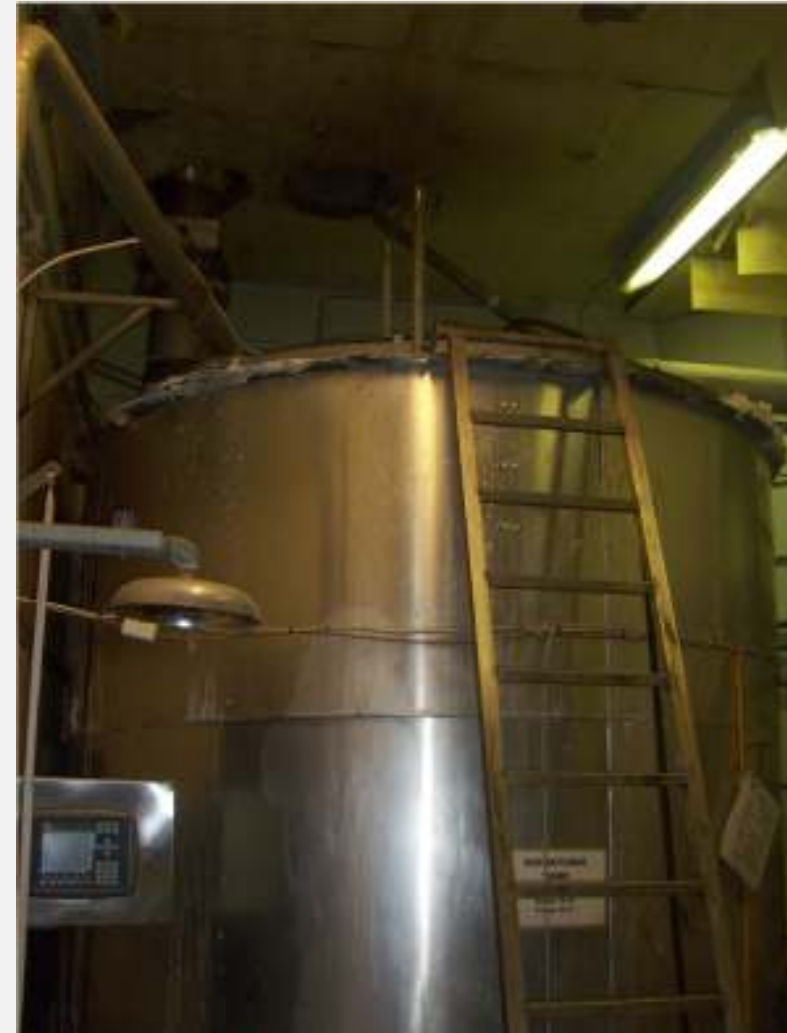
Preparation tank 15 ton

Deliveries in 13 ton batches from  
Yara, Köping

Cooled down from 110 to 80 °C  
by adding solid ANE

An-solution preparation tank  
Inlet funnel is located  
outdoors 2<sup>nd</sup> floor level

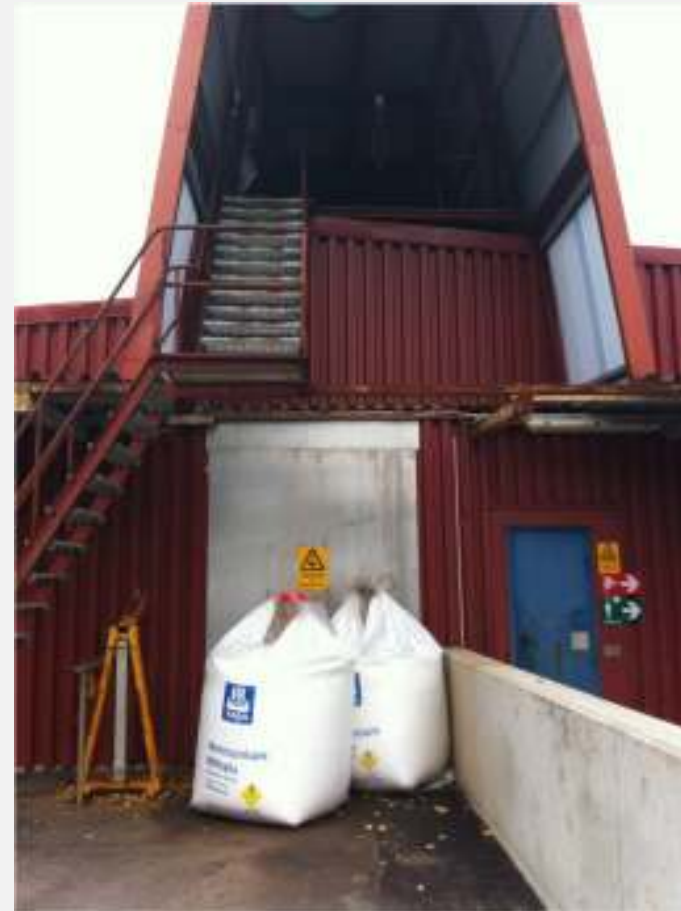
Adding:

ANE for cooling  
Sulphamic acid  
Sodium Thiocyanate

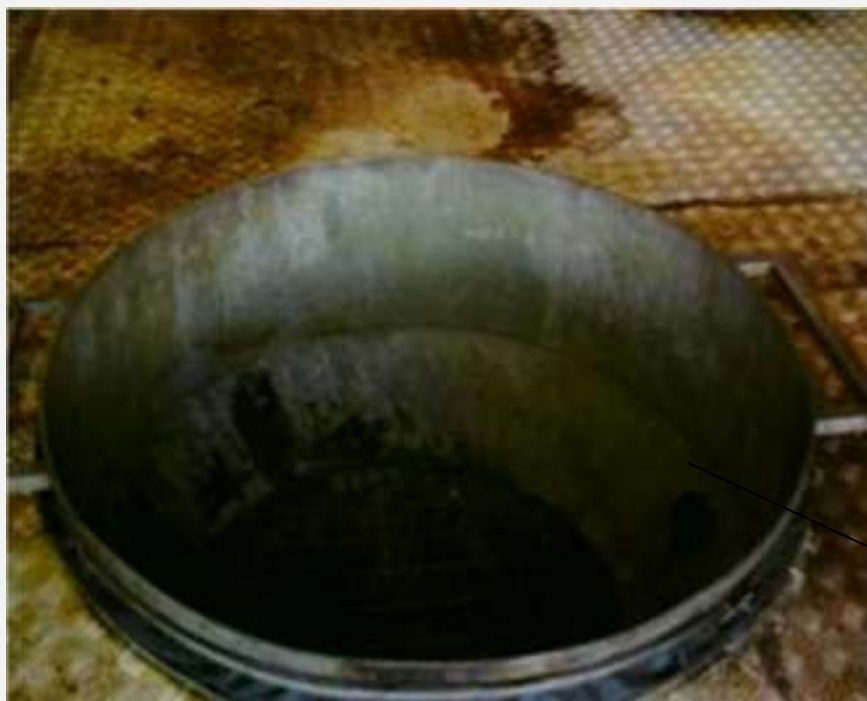
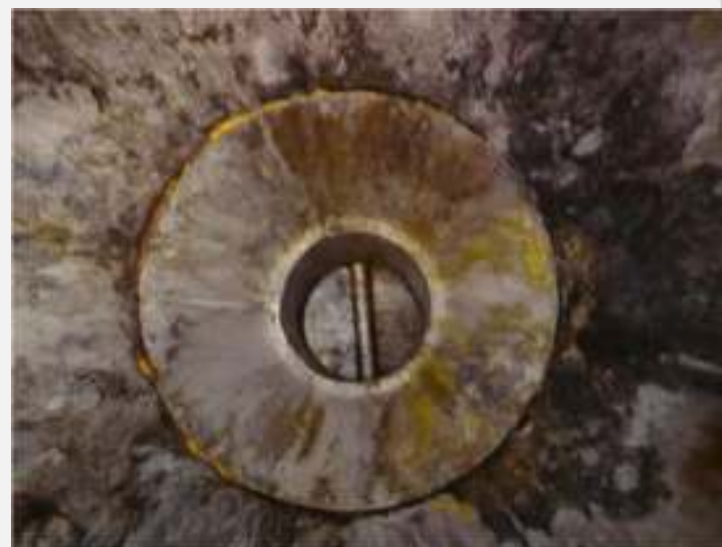
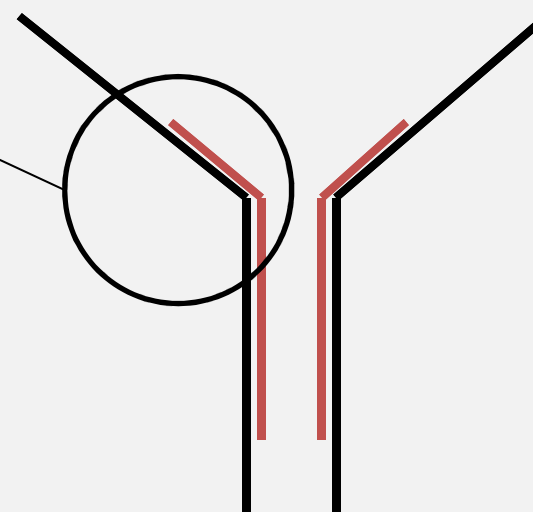
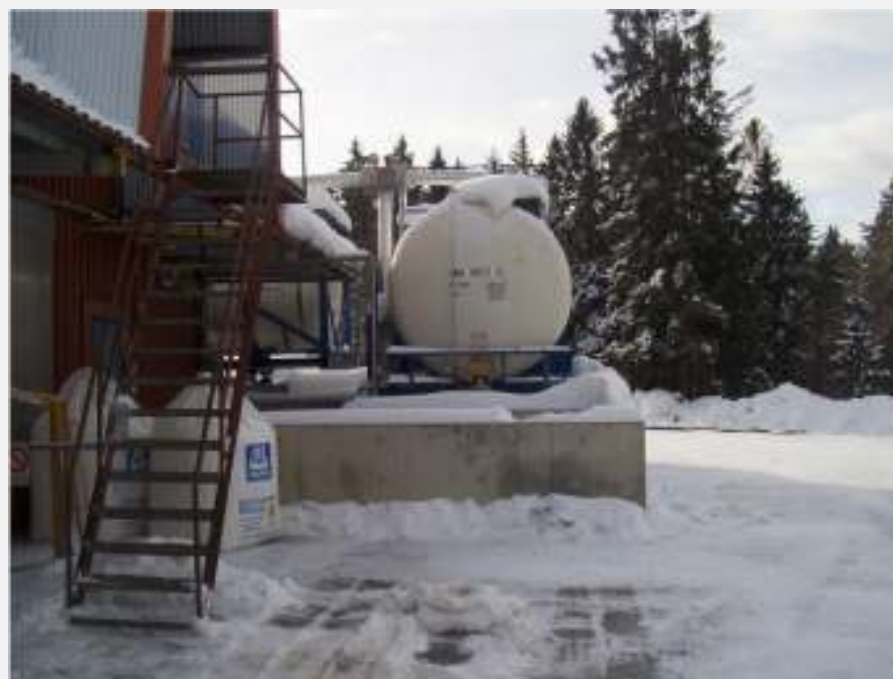
Due to the cold climate at winter there was no water flush system installed.

Pipes freeze and floor can be icy and slippery.

Cleaning was by scraping the funnel once or twice a week.

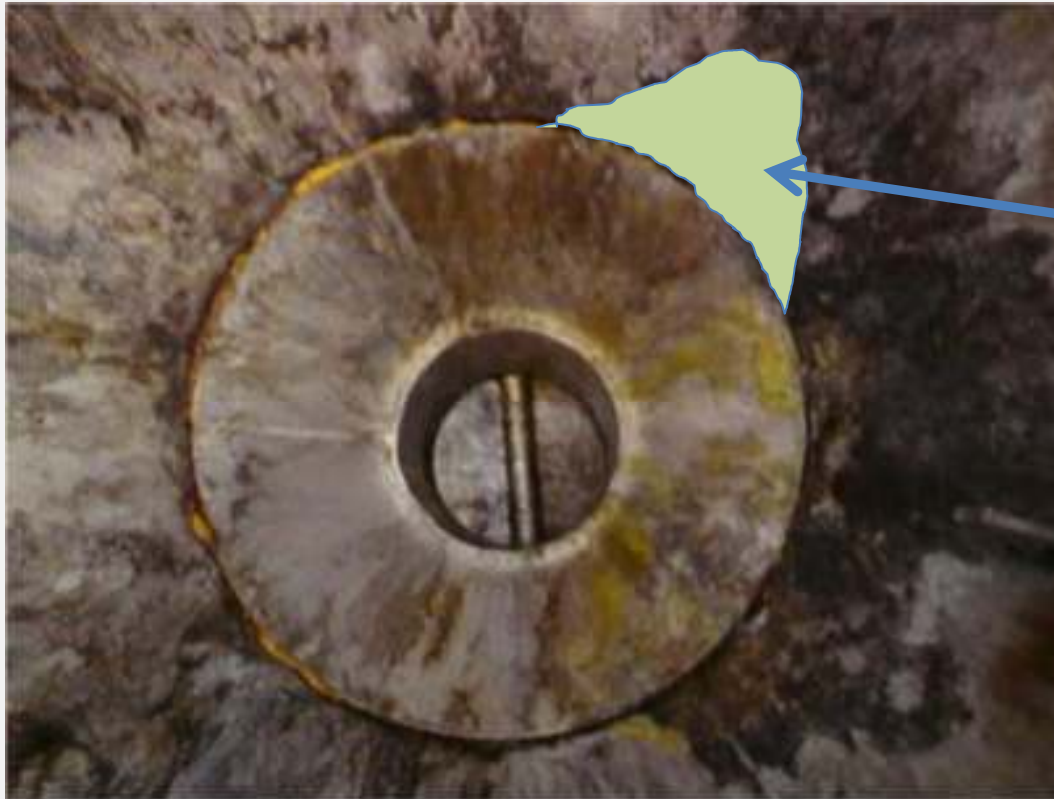
# "Glowing" funnel

Reaction area

•NOT a fire but something glowing.

- **The Operator emptied the fire extinguisher on the glow with no success.**
- **He went down the stairs and picked up the fire water hose. Returned up again and after some seconds flushing the glow reaction ended.**
- **No marks or other evidence of the reaction could afterwards be seen in the funnel.**
- **No other damage could be seen.**

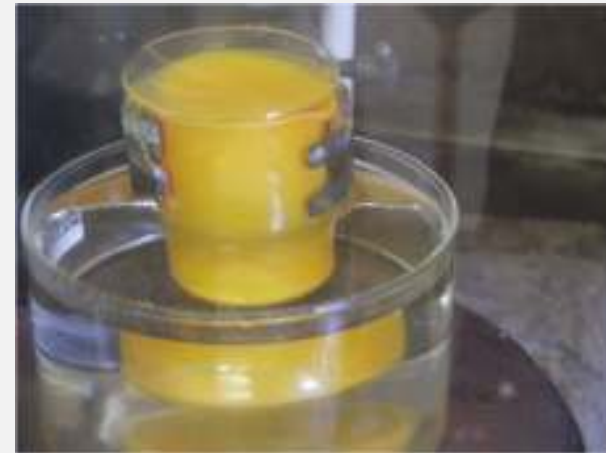
- The test used a 1:1:1 mixture of AN: NaSCN:H<sub>3</sub>NSO<sub>3</sub> totalling about 3 g altogether. This mixture, in a glass beaker, was put in a boiling water bath with a watch glass on top of the beaker.
- *“ Within a fairly short time there was a significant reaction, splattering the sides of the beaker and the underside of the watch glass with a yellow material. At the time I was turned away, washing out the mortar and pestle which had been used to grind the mixture. I was alerted by a glass noise, probably the watch glass lifting up and coming down on top of the beaker, and turned to see the yellow coating on the beaker and some fumes evolving. After turning the heating off and adding cold water to the bath, I went to get a camera. So these pictures were taken about 5-10 minutes after the reaction occurred.”*

The first picture shows the beaker still in its test position (the set up is inside a fume cupboard).

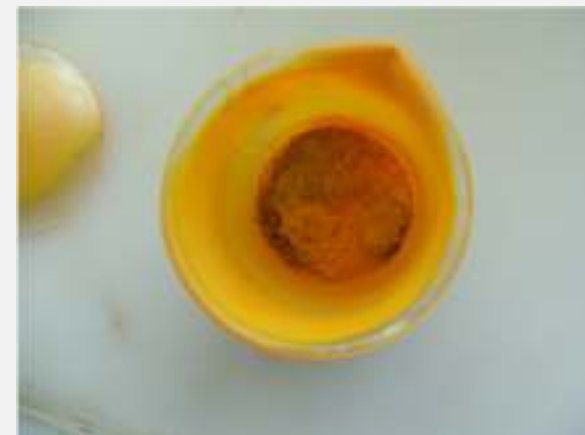
The second picture shows the inside of the beaker. The original 3 g, a white powder, was just a layer on the bottom of the beaker.
