# Explosion of Primary Explosive during Weighing Process

Tomoji Sunagawa  
Kayaku Japan Corporation  
Japan  
May 27, 2011

# Brief Description of the Accident

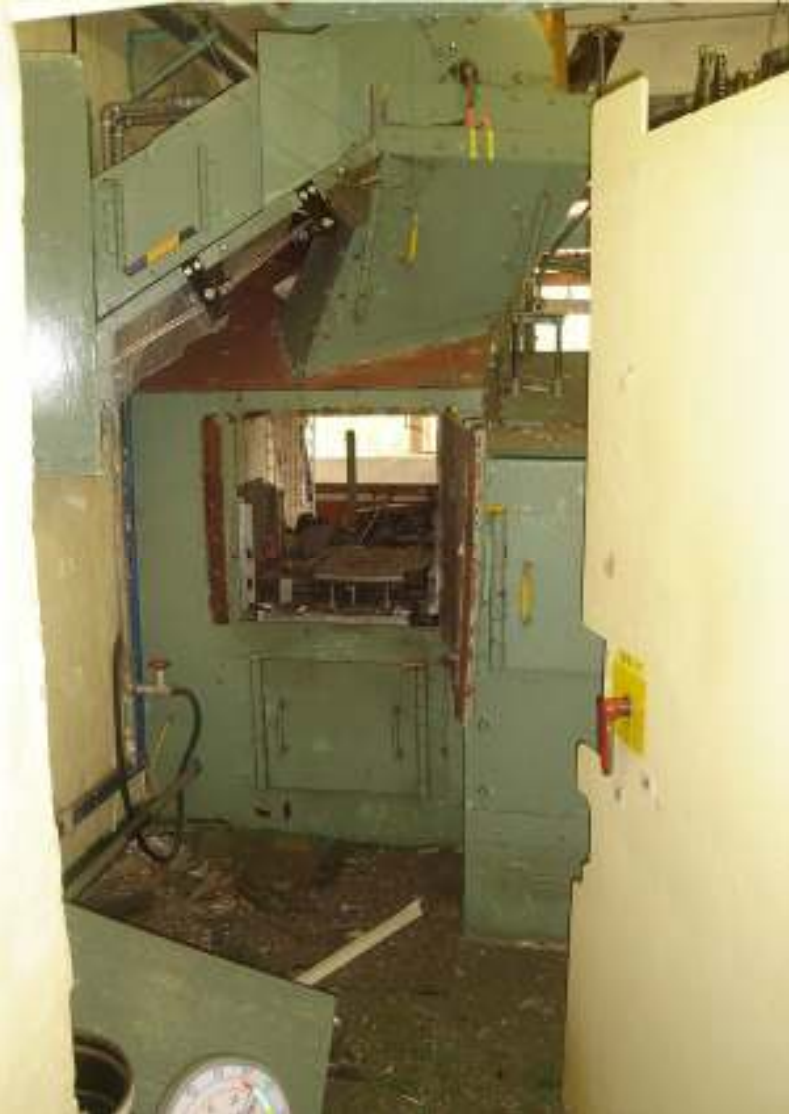
# Damage(Weighing Room)

**The explosion occurred in the primary explosive weighing room and the adjacent room where the 2nd inner tube is placed in position. About 400g of the primary explosive in the hopper of the weighing device, 300 electric detonators in the weighing room exploded. The 200 electric detonators in the adjacent room waiting for the insertion of the 2nd inner tube also exploded. Exploded amount was approximately 0.7Kg.**

**(2)Weighing Room and Insertion Room :  
Partially destroyed**
