# **Induced Fire on a Chemically Contaminated Truck Trailer**

**- SAFEX Closed Day Safe Transport Session -**

**Martin Held**

**XVI SAFEX Congress  
Madrid, May 28th – 31st**

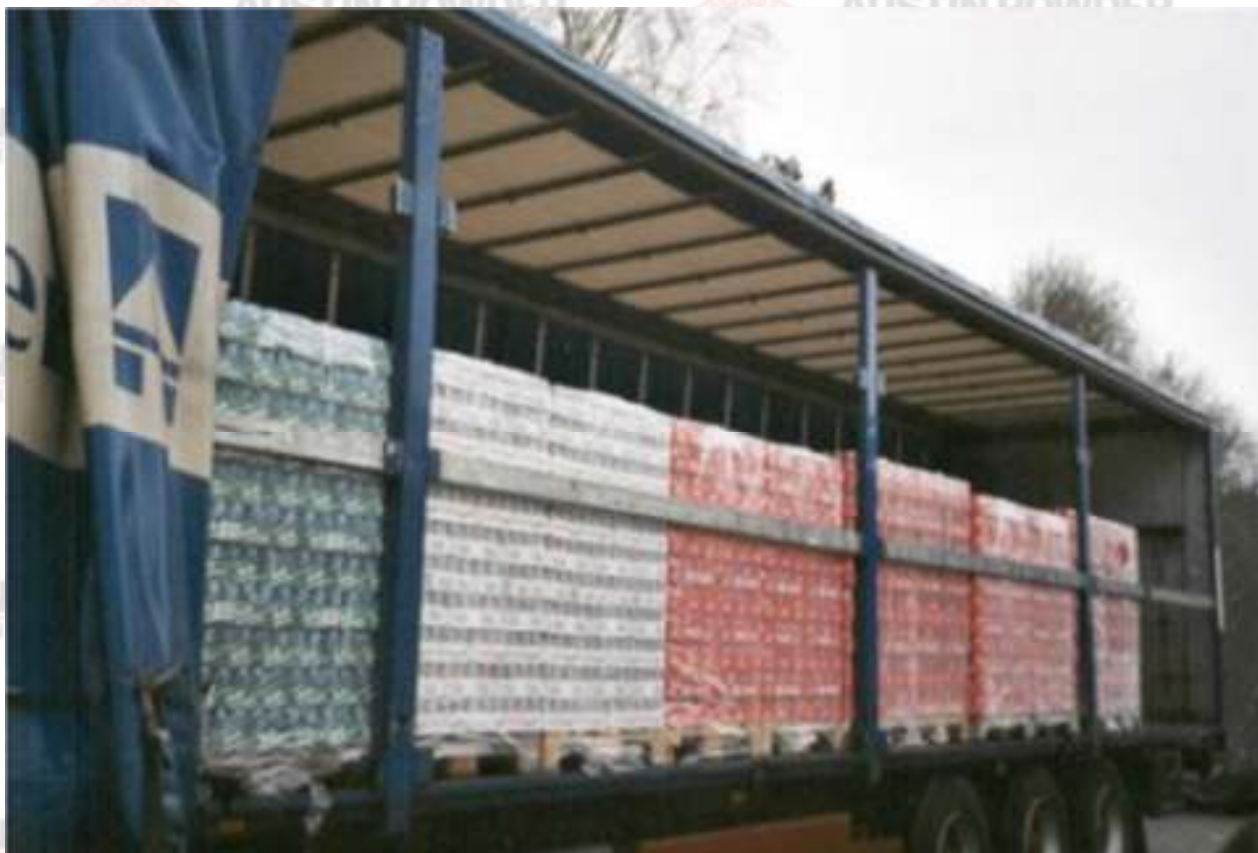
- Box trailer to transport the products Austin Bacis sells must be lined with plywood on the sides and have a wooden floor according to national legislation

- Ceiling of the box trailer was covered with rubber lined sailcloth supported by pipe steel beams along the trailer
- Trailer box was rebuilt in 2001
- Due to construction the trailer was not well accepted for transportation

- Previous to this job the trailer was used to transport emulsion in isocontainers for a competitor
- Pipe steel beams at low level above the trailer floor created difficulties to get the pallets with 50 boxes in

- While loading the trailer the operator removed the upper layer of boxes from the pallets prior to loading
