**SAFEX**  
**INTERNATIONAL**  
(Since 1954)

**INCIDENT NOTICE**

**INCIDENT TITLE:** PETN Burning Ground Explosion

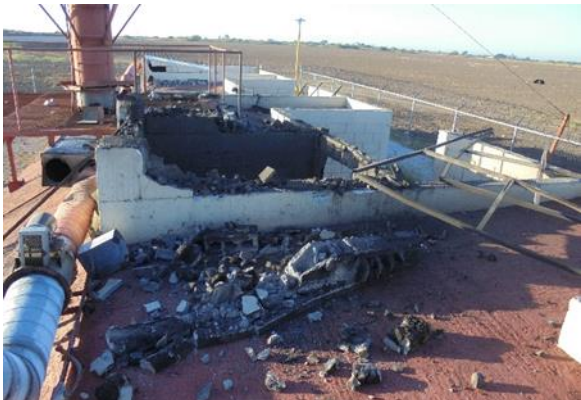
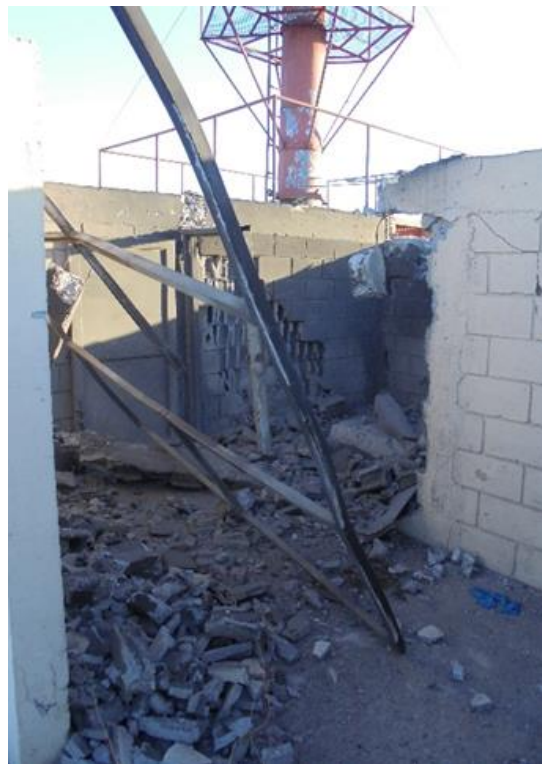
| <b>What was the impact?</b> | No injuries, significant damage to the bays (brick debris) and the vent ducts |

Photos showing damage and array of PETN on burning tray (simulated with sand)

Changes to process and its consequences (explosive waste for disposal) are to be assessed and reviewed in all detail. SOP's must not leave room for interpretation and give clear instruction (how to ..?, step by step). Safe methods for disposal (here PETN fines) have to be reviewed and experts be consulted if needed. Change of specification of purchased material (here PETN) with the supplier are to be considered to avoid creation of waste in the first place.

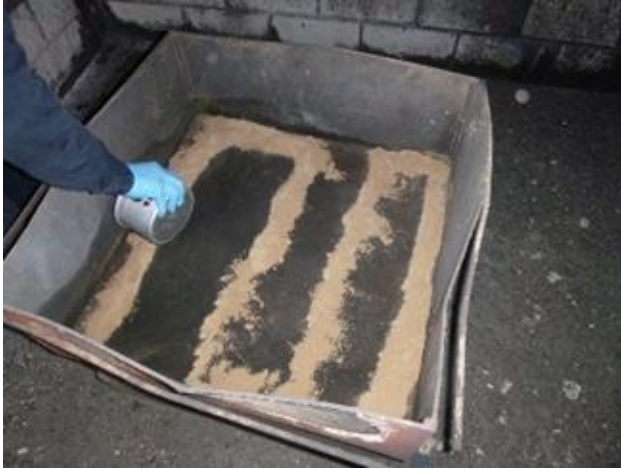
| <b>DATE POSTED</b><br>18 December 2020 | <b>REFERENCE</b><br>IN 20-06 | <b>SOURCE</b><br>Austin Powder |
|---|---|---|
| <b>Why did it happen – theory?</b> | <p>Recently, the main supplier of PETN had been switched and the new source produced significantly more fines than the previous supplier. The fines then became waste material for disposal (PETN had not been burned before).</p> <p>An operating procedure was then generated for the new waste stream. The procedure was drafted without including important details such as establishing a schedule to collect the fines on a regular basis, and institute explosive limits. The absence of details led the operator and others to create their own routine where dry PETN fines were collected on a weekly basis on Fridays (up to 4 – 5 kg). Methods for safe burning of PETN (mixing with sawdust) were neither reviewed nor implemented.</p> <p>It is assumed that, though the PETN was poured on a tray in an 'S' type pattern, there was variation of the PETN track in width and height that allowed the</p> | |

| | material to become self-confined. Simulations with fine sand support this theory. |

Simulation w/ Sand
